**NATIONAL TRANSPORTATION SAFETY BOARD**  
Vehicle Recorder Division  
Washington, D.C. 20594

## **Locomotive Event Record and Diagnostic Systems**

### **Specialist's Factual Report By George Haralampopoulos**

Location: Valhalla, New York  
Date: February 3, 2015  
Operator: MTA Metro-North Railroad  
Train #: 659  
Lead Car #: 4333  
NTSB Number: DCA15MR006

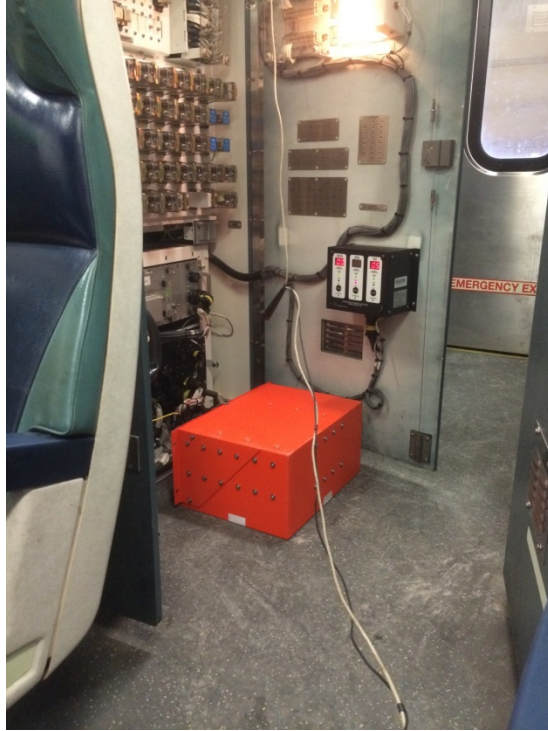
The event recorder from the lead pair, 4333-4332, was removed and placed in a surrogate car for download (figure 1). The event recorder was successfully downloaded with oversight by the NTSB.

Figure 1. The lead car event recorder connected to the surrogate car.

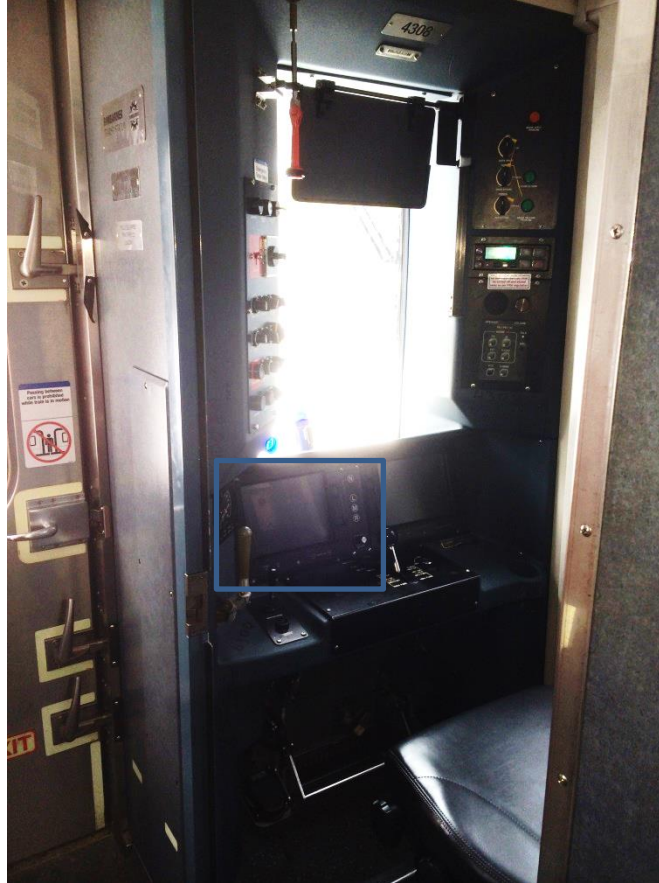
Seven of the eight CDS event logs were successfully downloaded on February 5, 2015 (figure 2). Due to severe thermal damage, a download of the car 4333's CDS was not possible. Car 4332's CDS was downloaded by applying external power to the CDS circuit breaker in order to avoid power application to the damaged 4333 B-Car.

Figure 2. CDS location of car 4309.

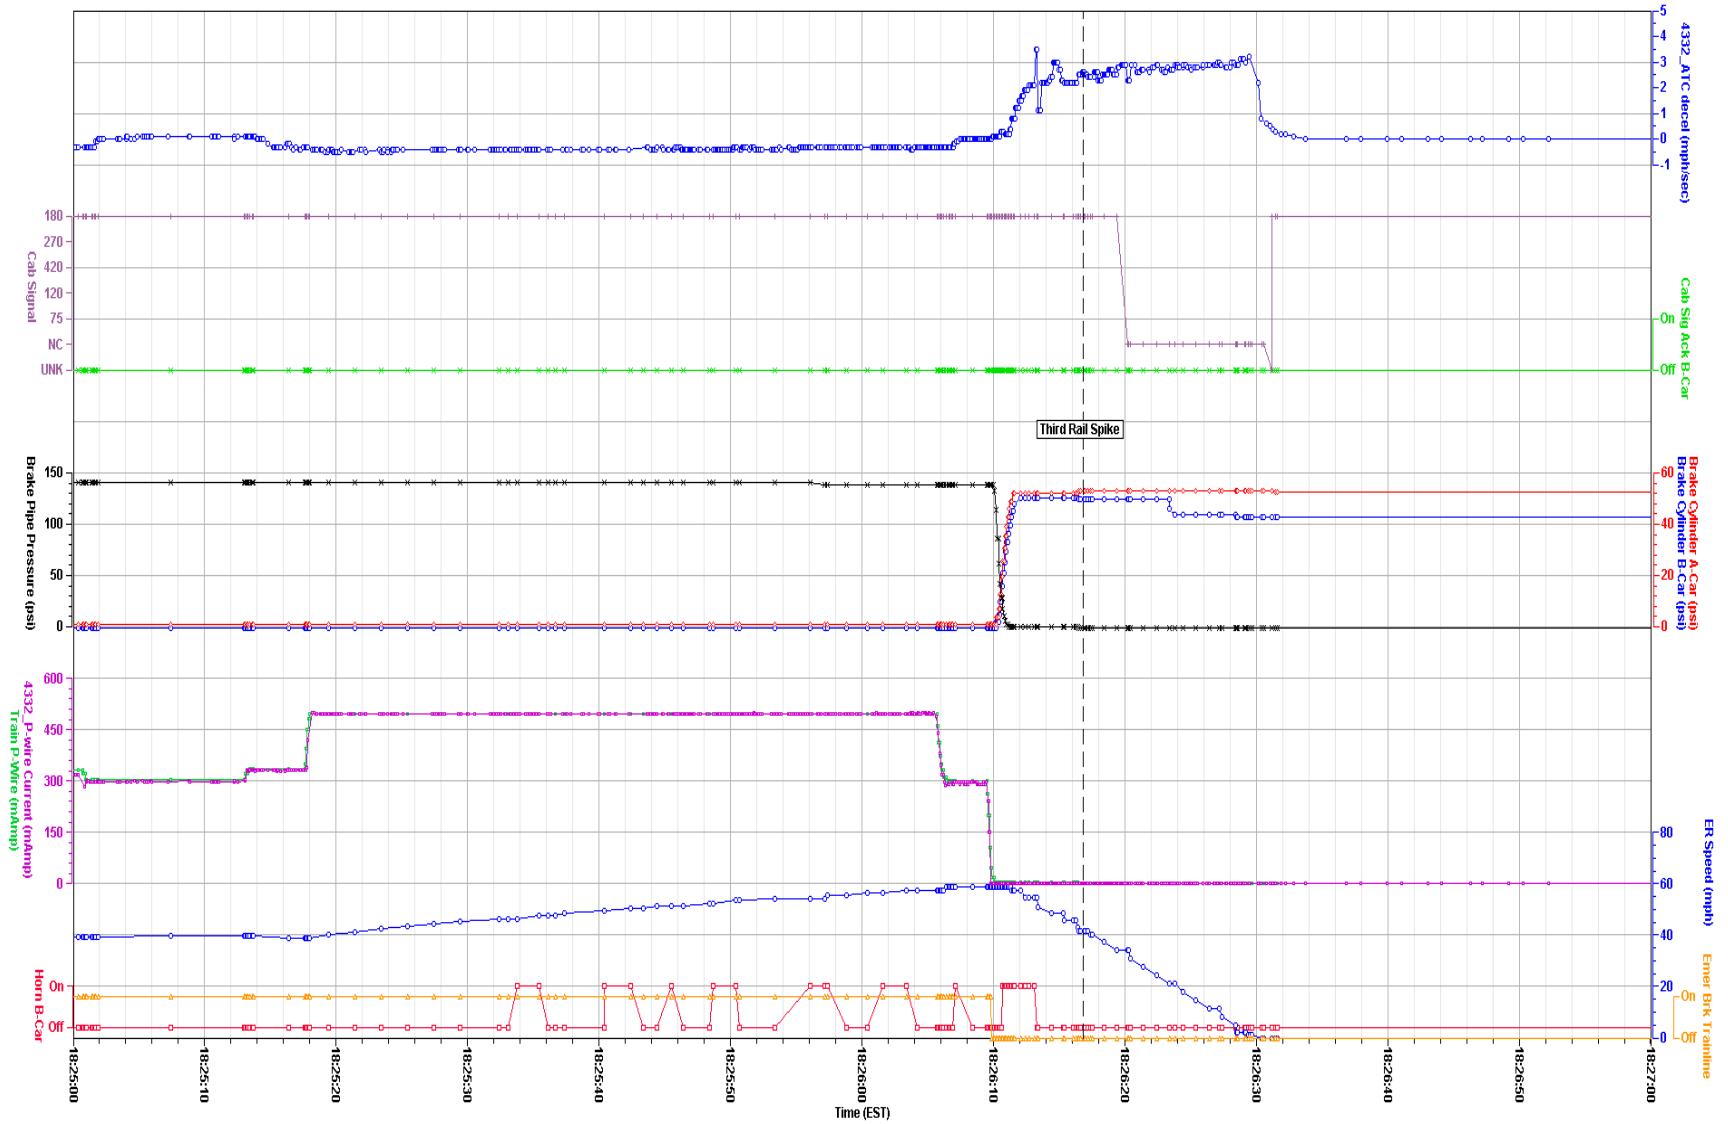
Prior to the emergency braking, a series of horn applications were recorded at 18:25:56, 18:26:02, and 18:26:07 EST.

The train's recorded speed during the emergency application was 59 mph and decreased to 51 mph when the CDS decelerometer recorded an increase in deceleration at 18:26:13 EST from 2.1 to 3.5 mph/sec, consistent with impact. The last horn activation was from the start of emergency braking at a calculated distance of about 230 feet from the recorded spike in the decelerometer.

Figure 4. Plot highlighting emergency brake application.

The tabular data used to generate figures 3 through 5 is provided in electronic comma separated value (\*.csv) format as attachment 1 to this report.
