**Highway Accident Brief: Pedestrian SIR**

**Scene and vehicle photographs**

**Manhattan, New York #2**

**HWY17SH006**

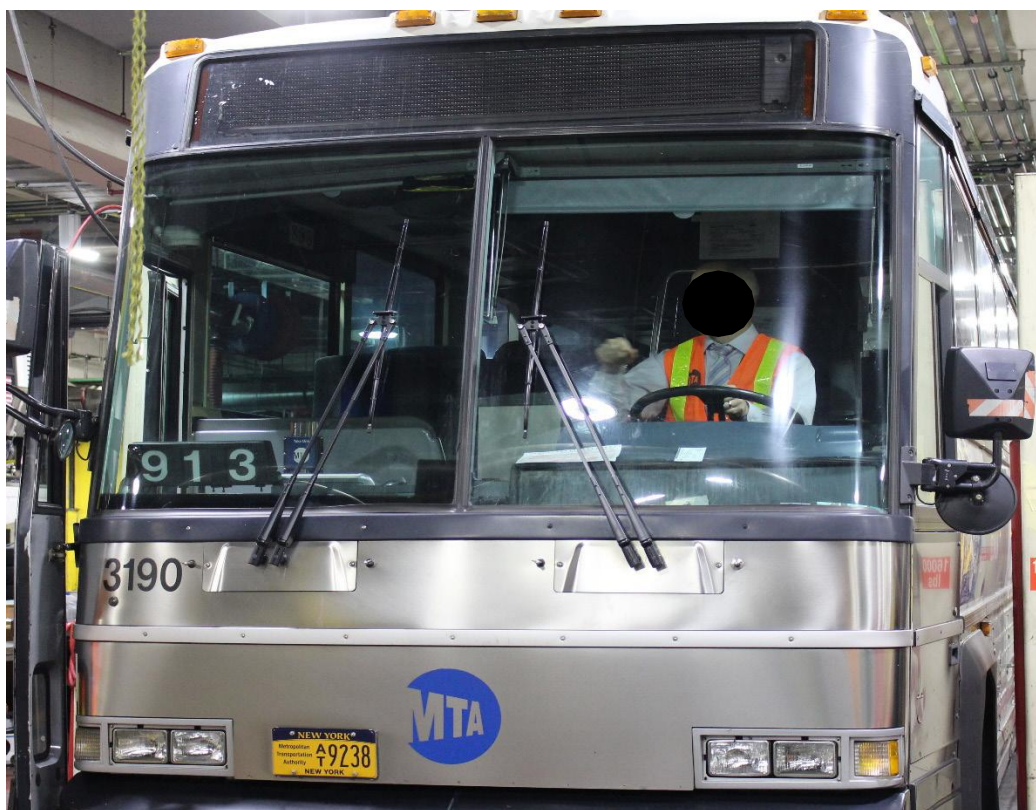
Photo #1: The front of the crash transit bus with a driver in seat position.

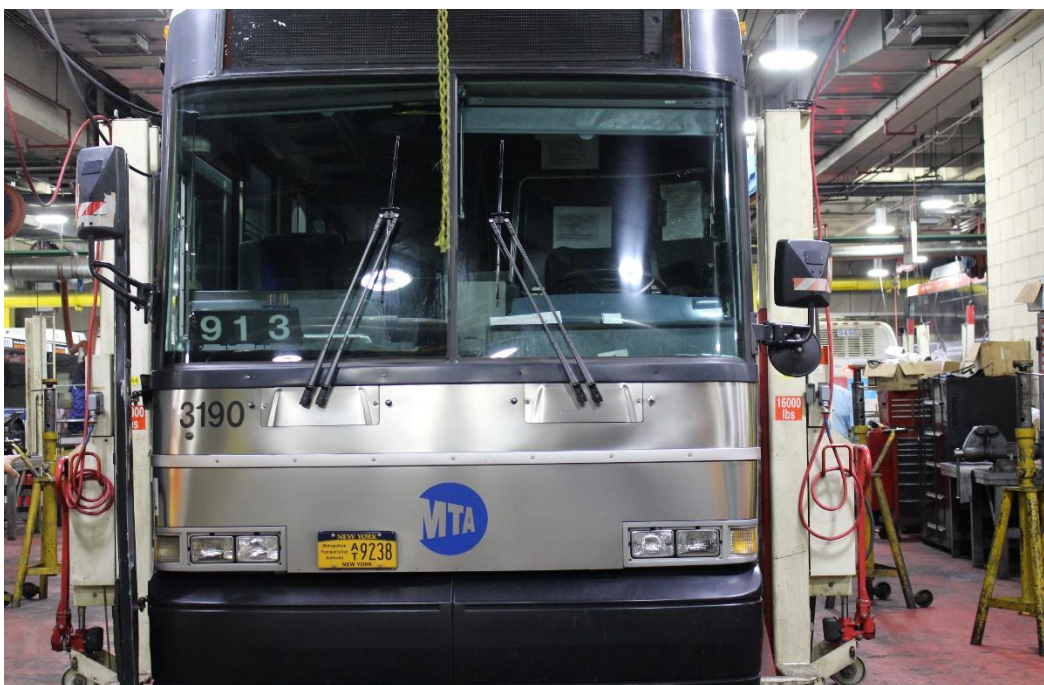
Photo #2: The crash transit bus showing the front bumper which struck the pedestrian.

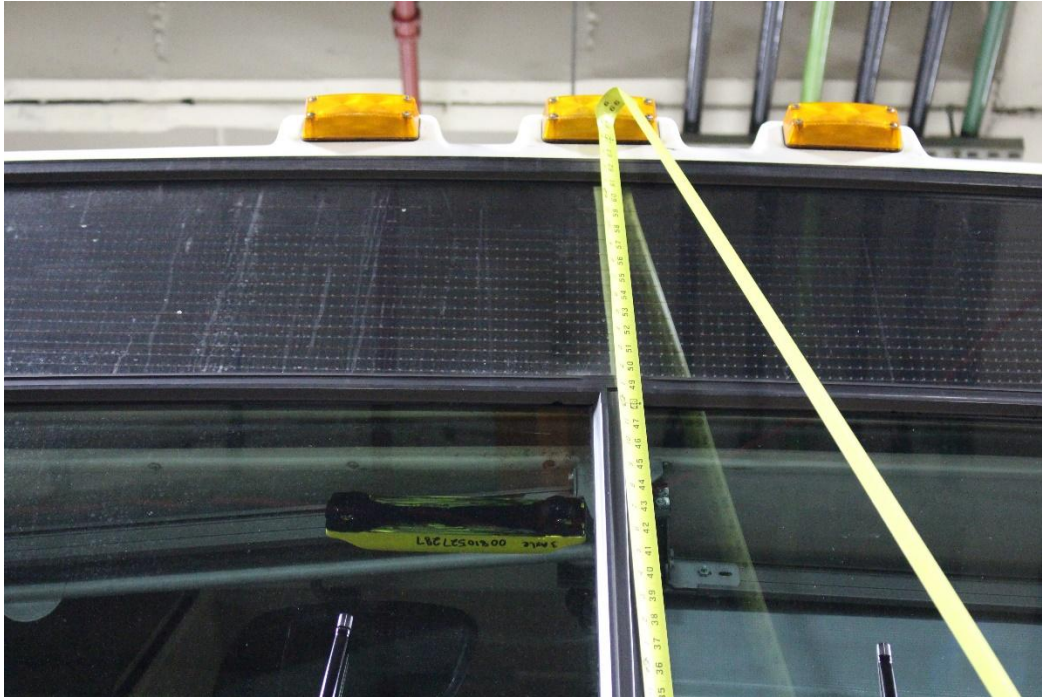
Photo #3: The photograph shows the measuring of the overall height of the transit bus. The transit bus is 11 feet 4 inches.

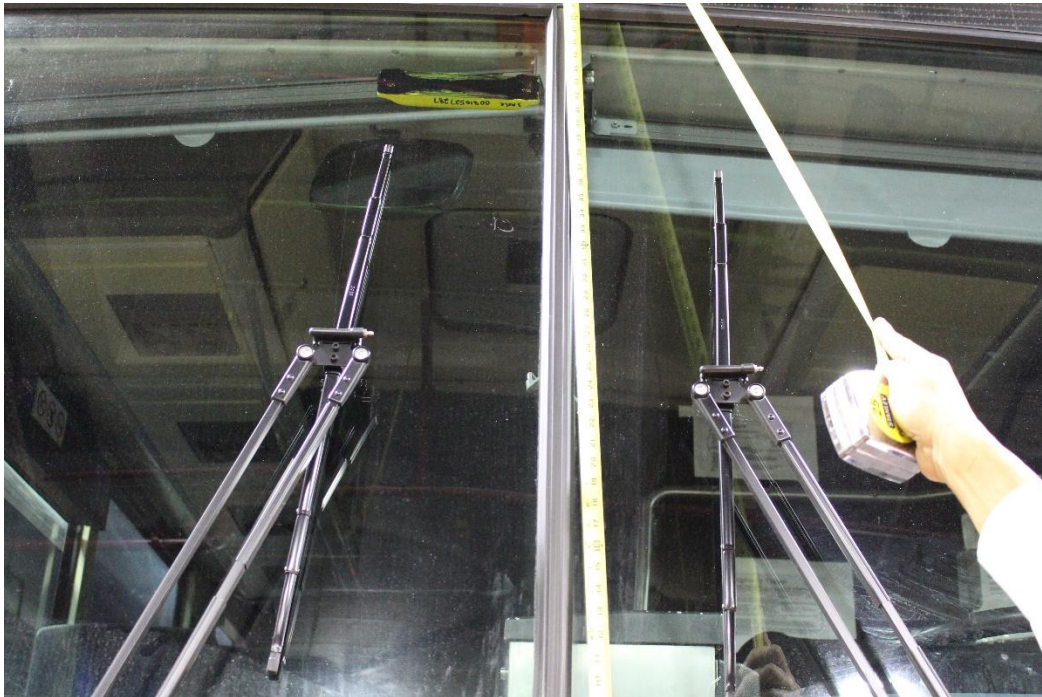
Photo #4: The front windshield's overall height was measured at 4 feet and 1 inch.

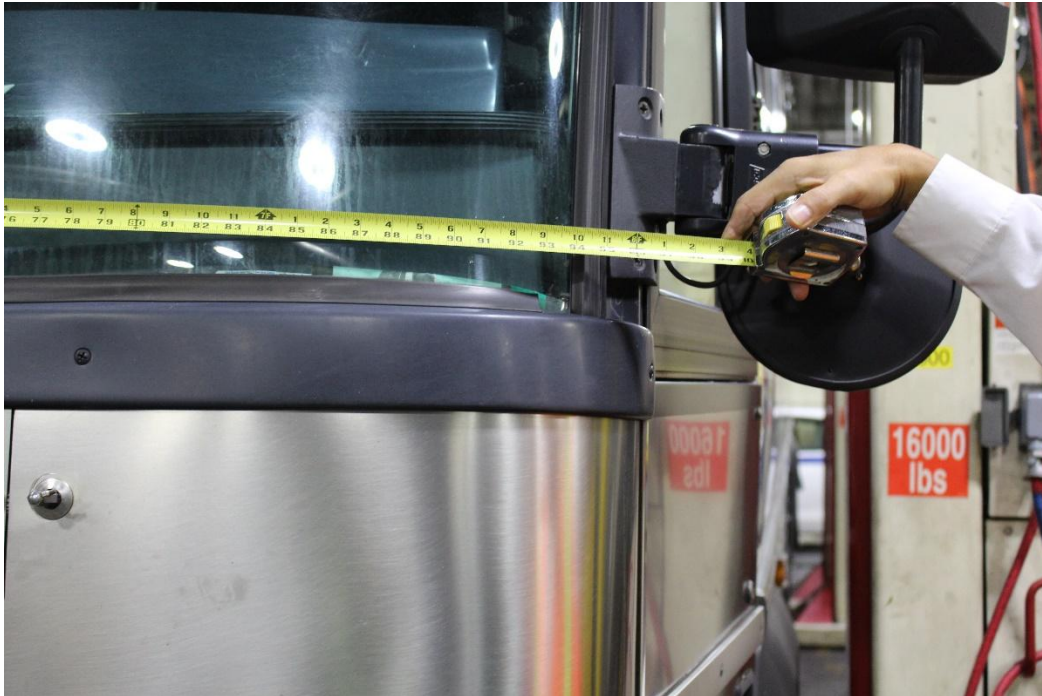
Photo #5: Measuring the overall width of the transit bus in the front. The transit bus is 8 ½ feet wide.

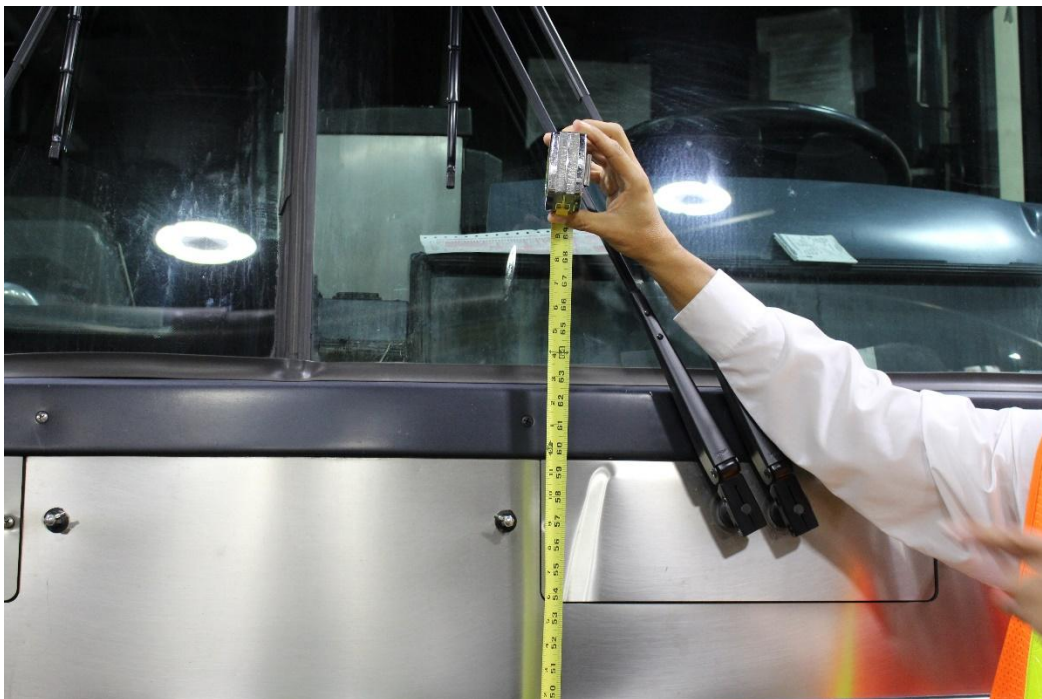
Photo #6: The photograph shows the measuring of the front windshield from the ground to the base of the windshield. The height from the ground is 5 feet 3 ½ inches.

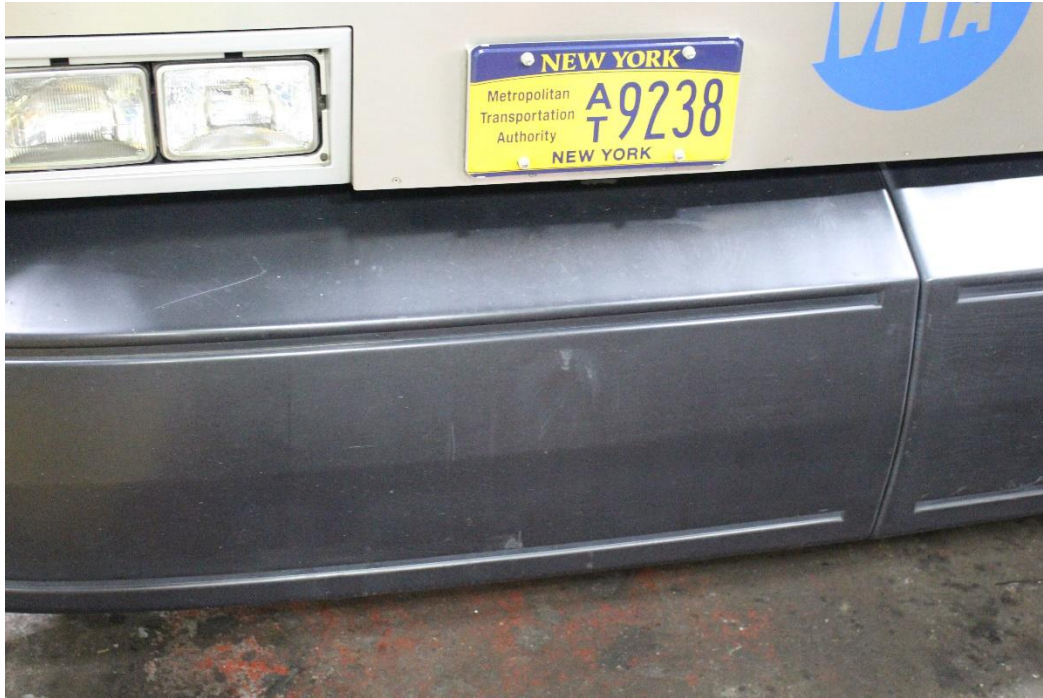
Photo #7: A close-up of the right side of the front bumper that struck the pedestrian.

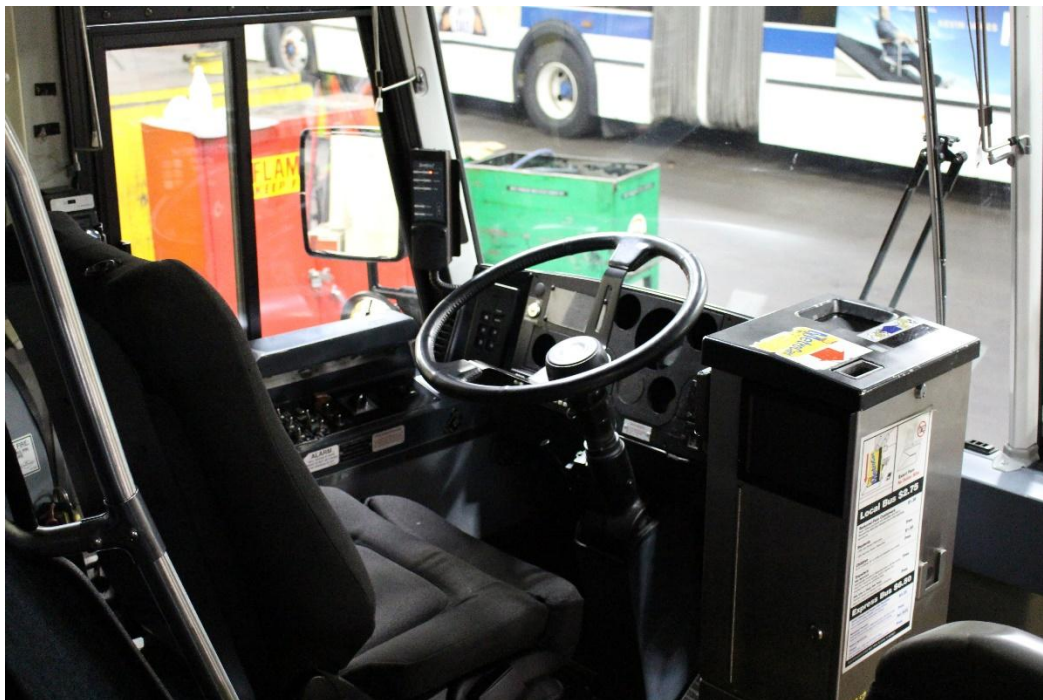
Photo #8: Interior view of the driver's seating position in the transit bus.

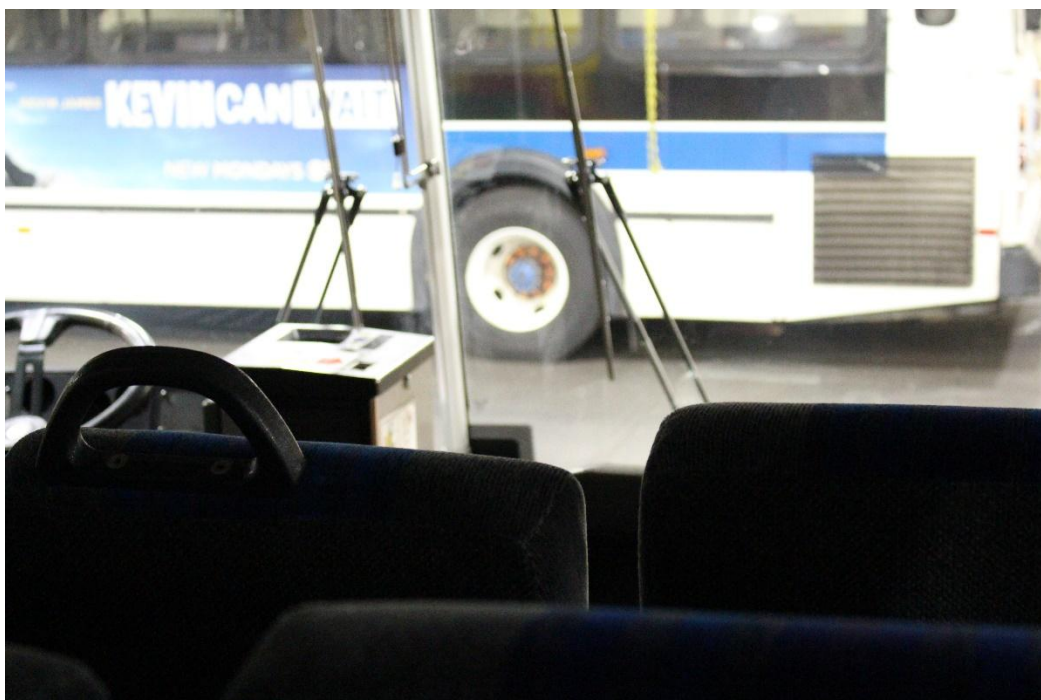
Photo #9: Interior view of the transit bus showing the field of view for the passengers seated in the front.

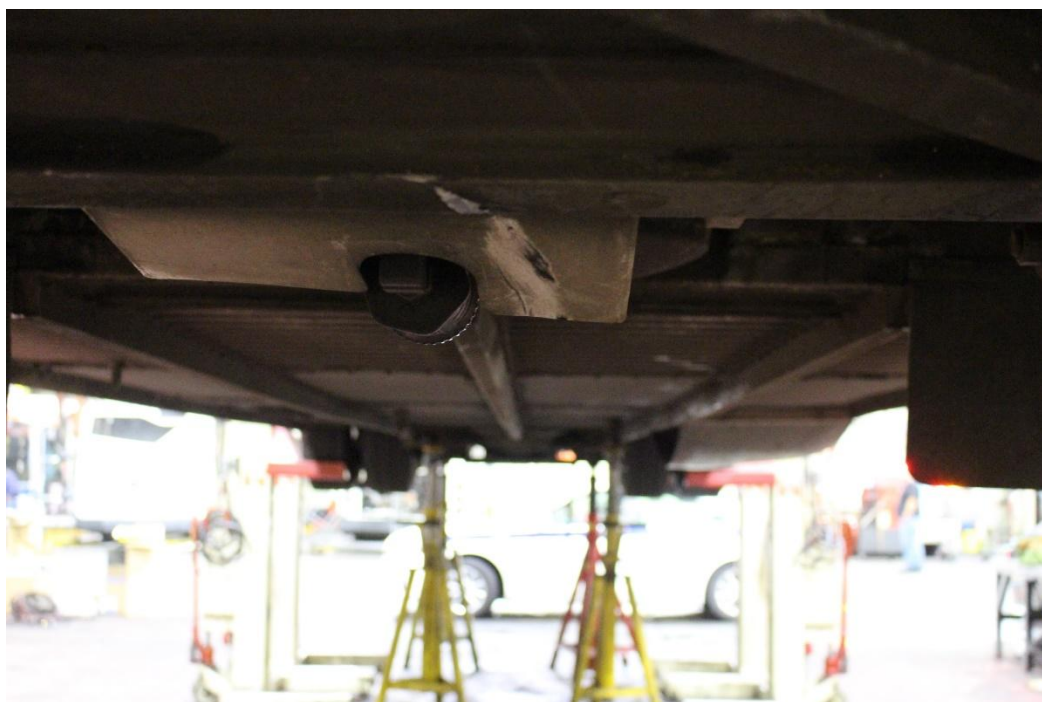
Photo #10: The undercarriage of the transit bus showing witness marks from the pedestrian

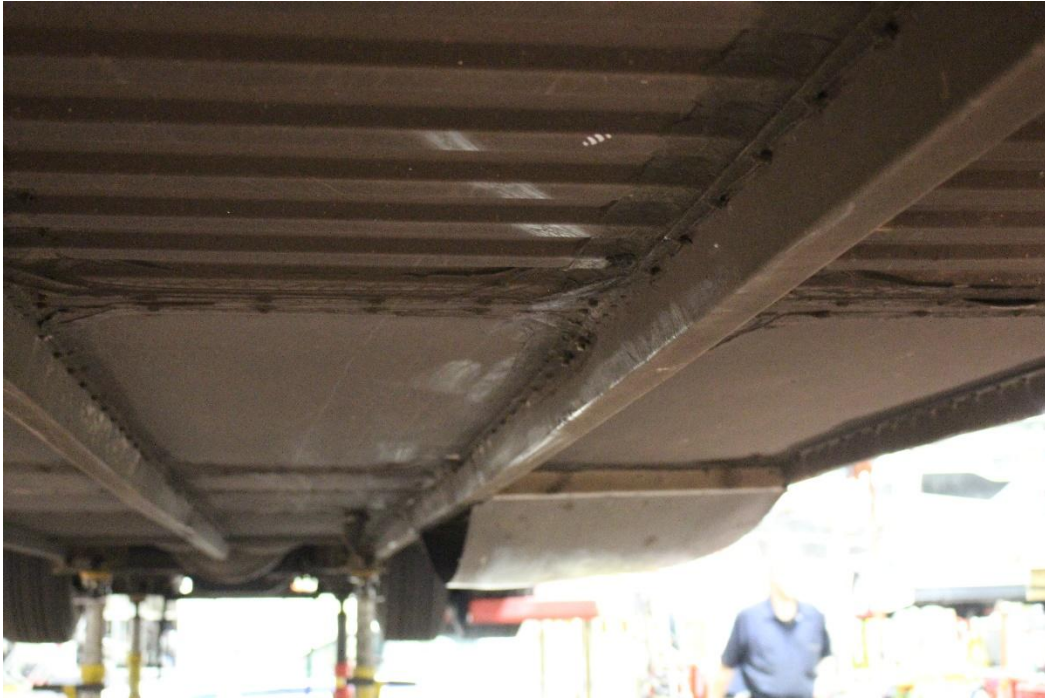
Photo #11: View of the undercarriage of the transit bus showing witness marks left by the pedestrian.

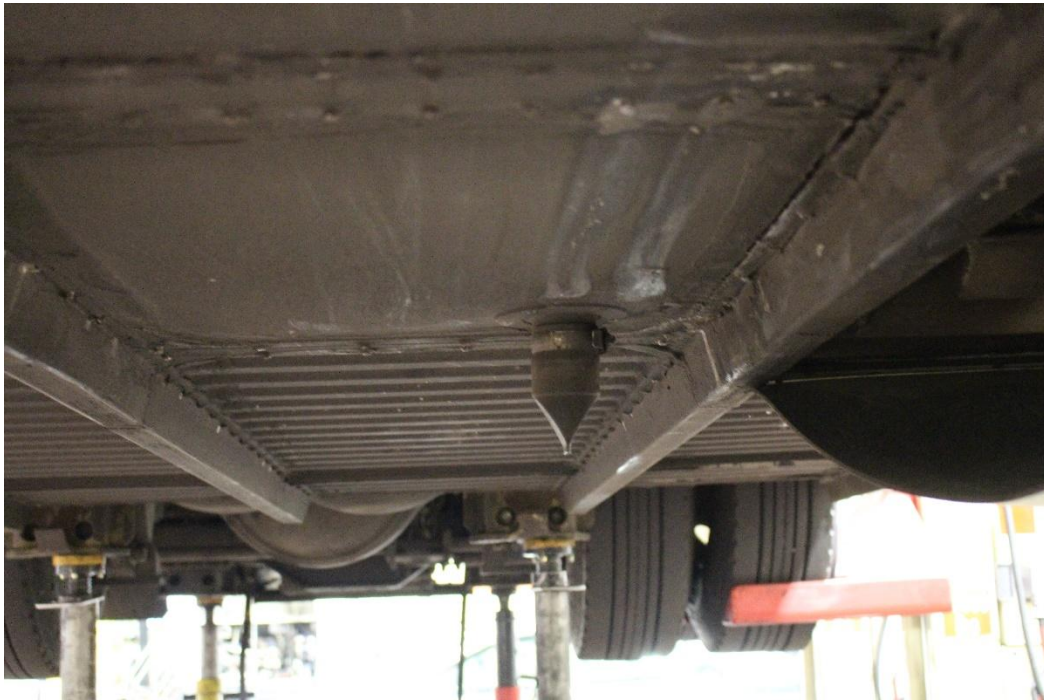
Photo #12: View of the undercarriage of the transit bus showing the distance the pedestrian traveled to the rear axle.

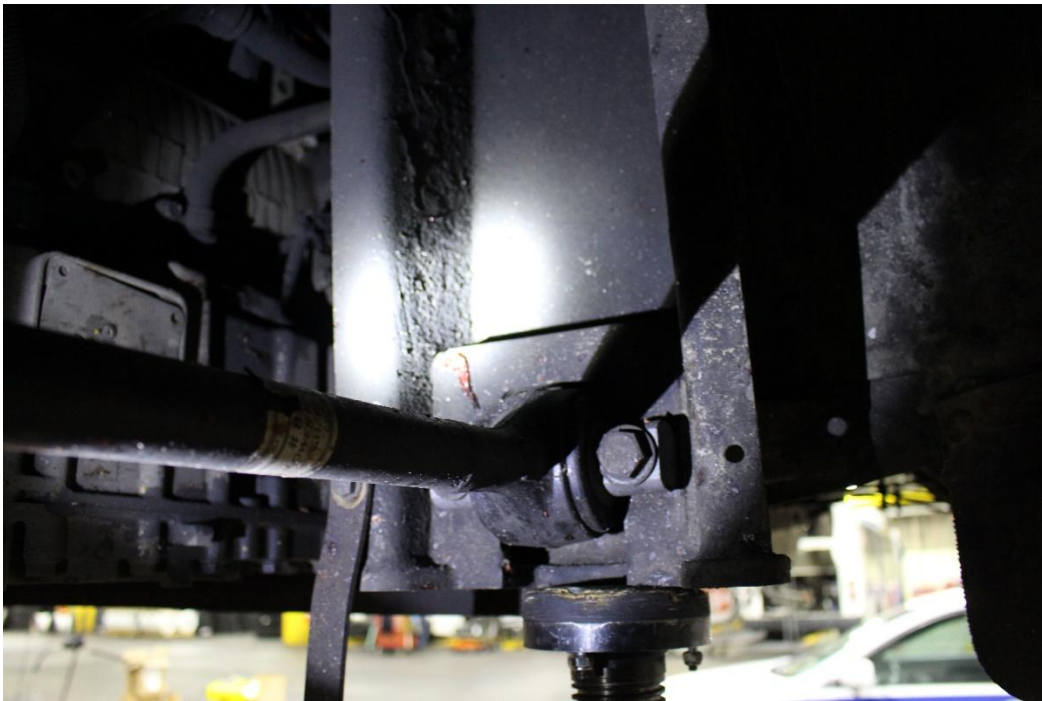
Photo #13: The view from the transit bus undercarriage of the pedestrian final rest position.

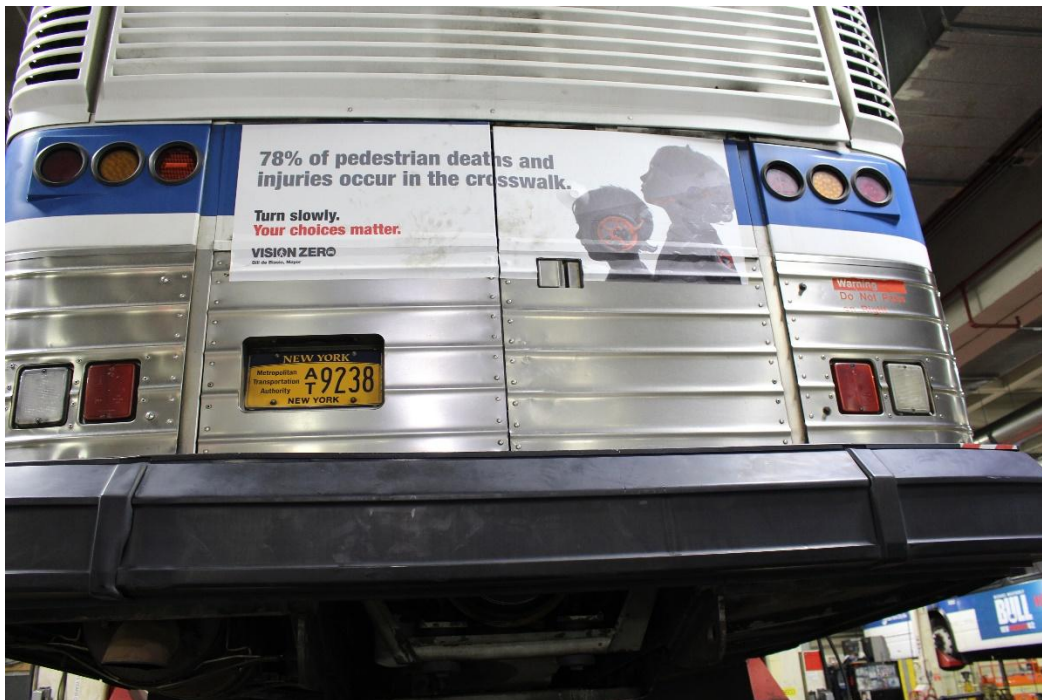
Photo #14: Rear exterior view of transit bus showing location of final rest for pedestrian.

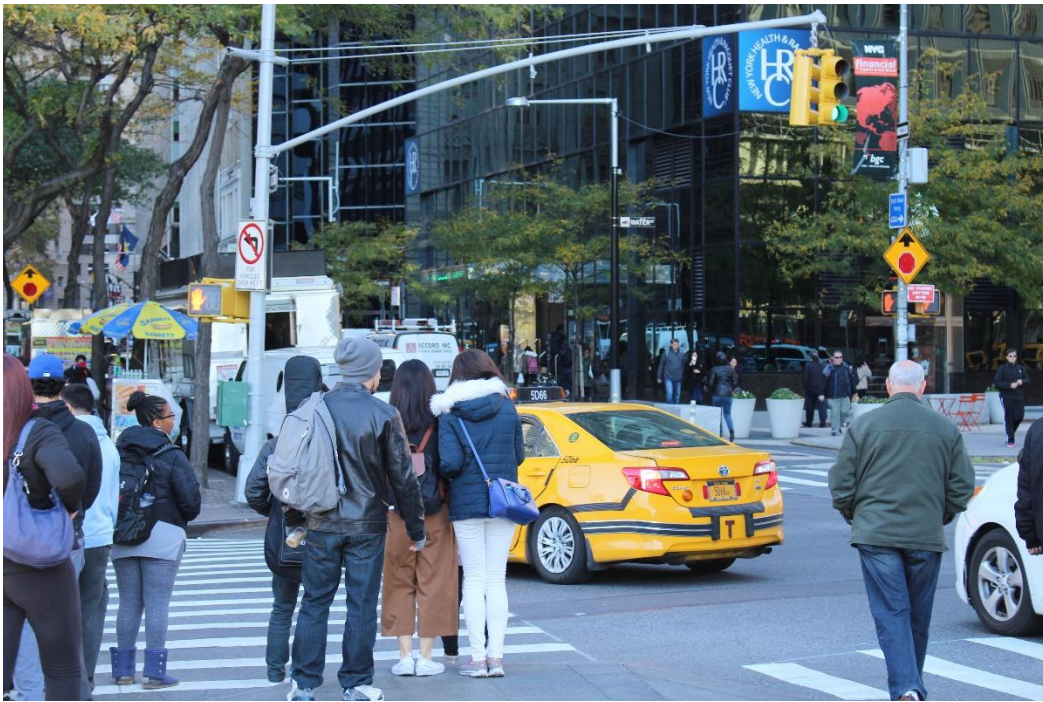
Photo #15: A view of the crash intersection showing the corner where the pedestrian began to cross the roadway westbound.

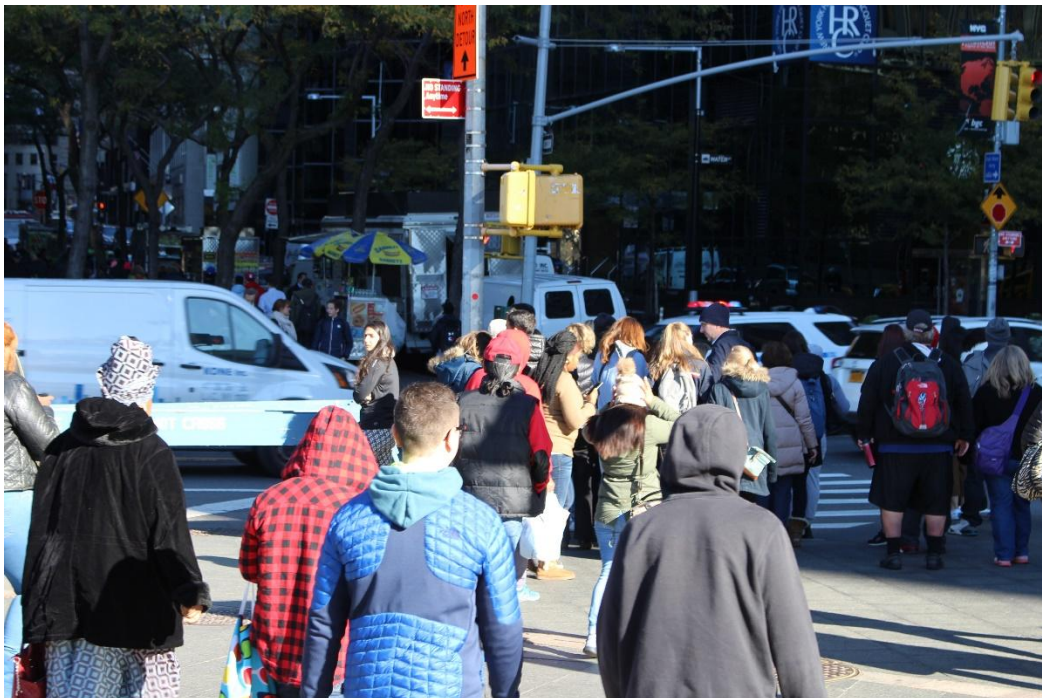
Photo #16: The crowded intersection of Water Street and Whitehall Street at the approximate time of day the crash occurred.

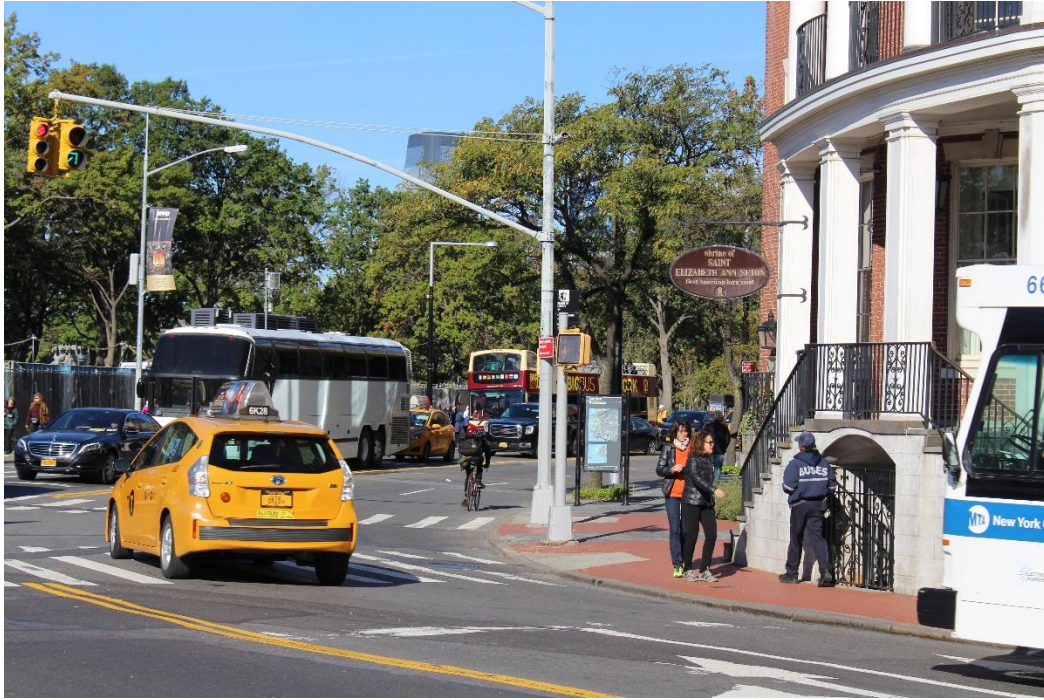
Photo #17: The intersection of Peter Minuit Plaza and State Street showing the traffic signal the transit driver was viewing from one block away.

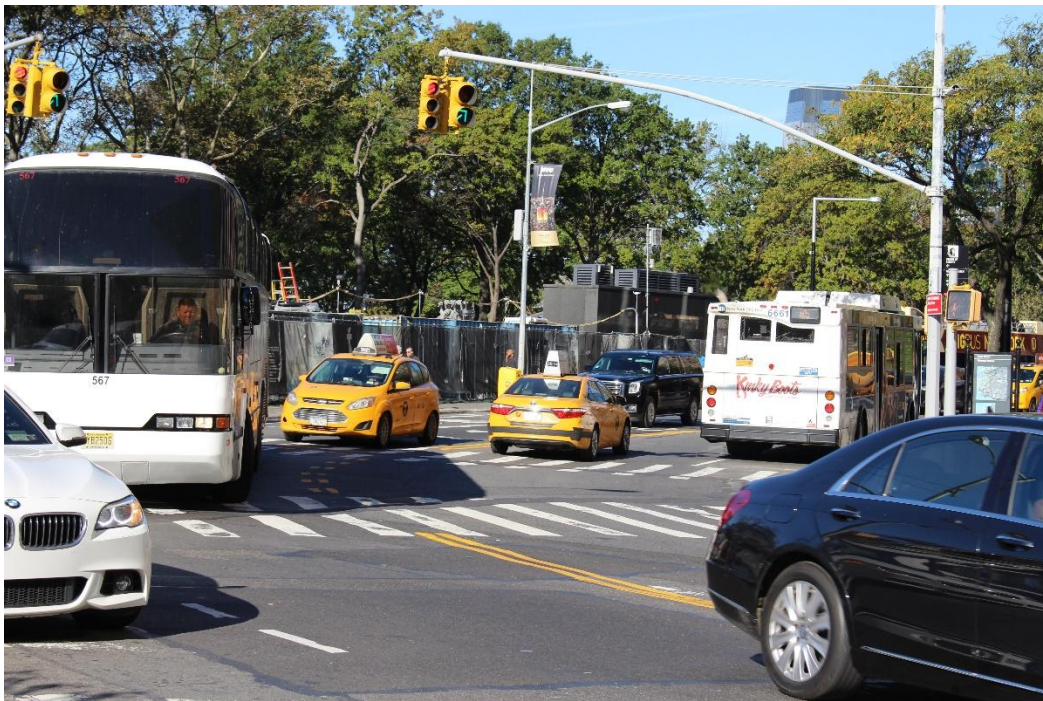
Photo #18: A close-up of the intersection of Peter Minuit Plaza and State Street and the intended direction of travel for the transit bus.

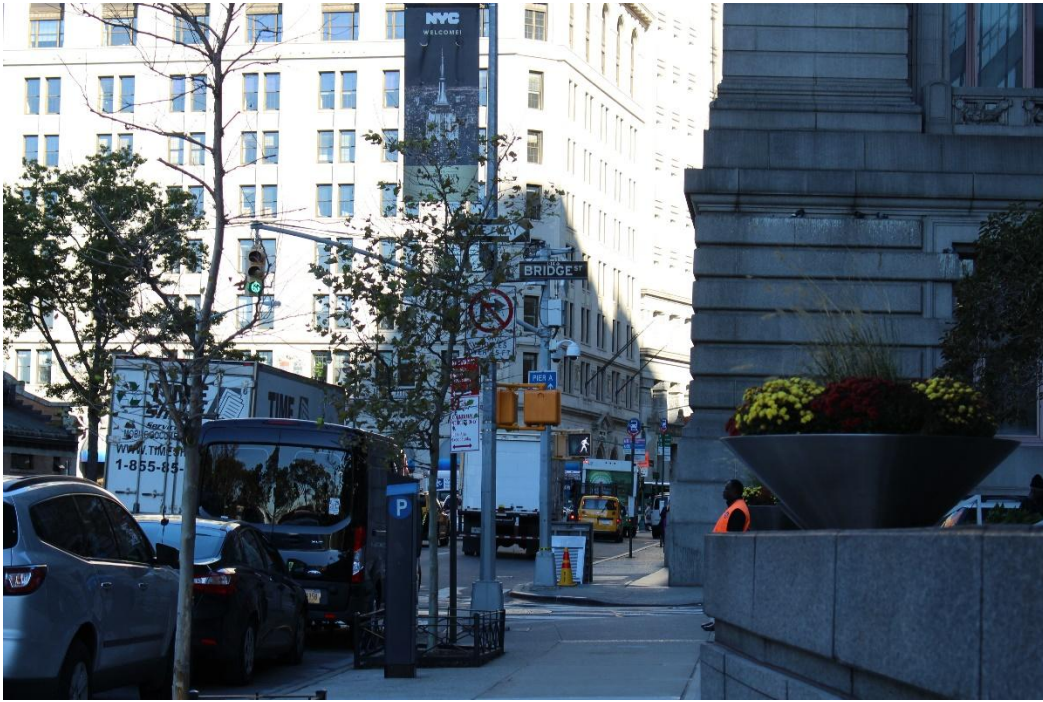
Photo #19: An overall view of the route of travel of the transit bus after striking the pedestrian.

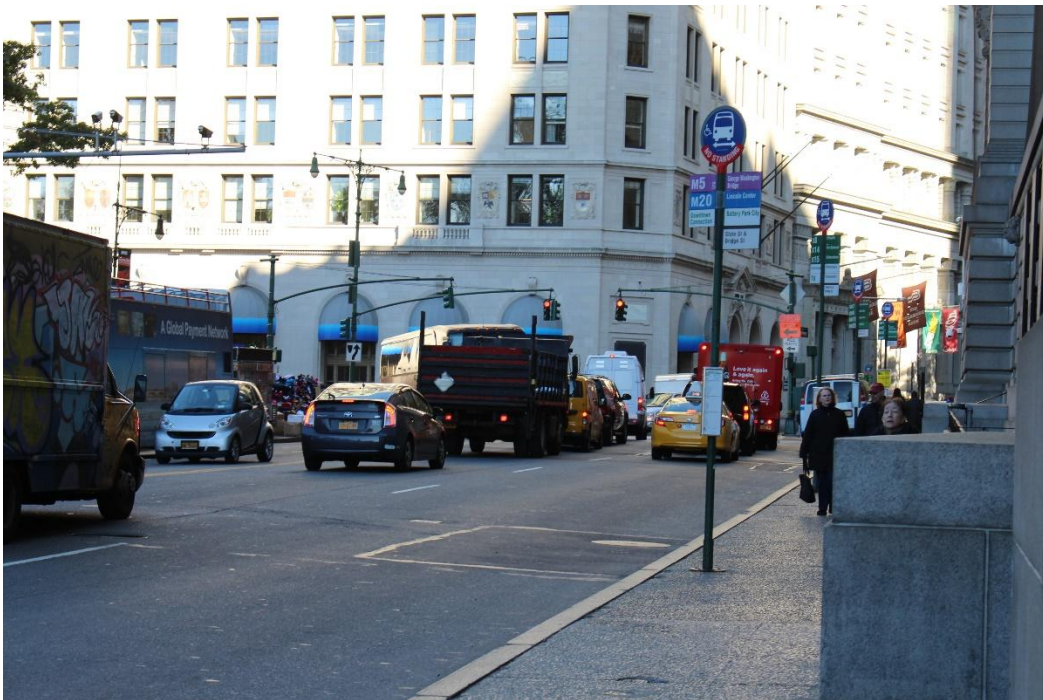
Photo #20: The direction of travel of the transit bus from the crash scene after striking the pedestrian.

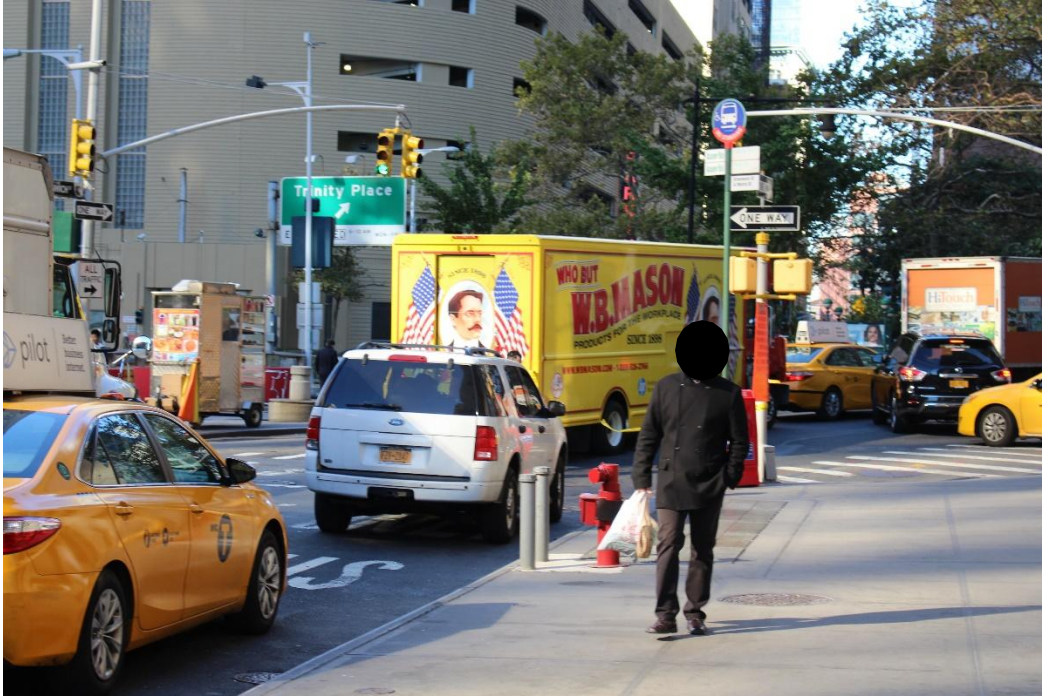
Photo #21: A long distance view of the approach to the area where the transit bus was eventually stopped.

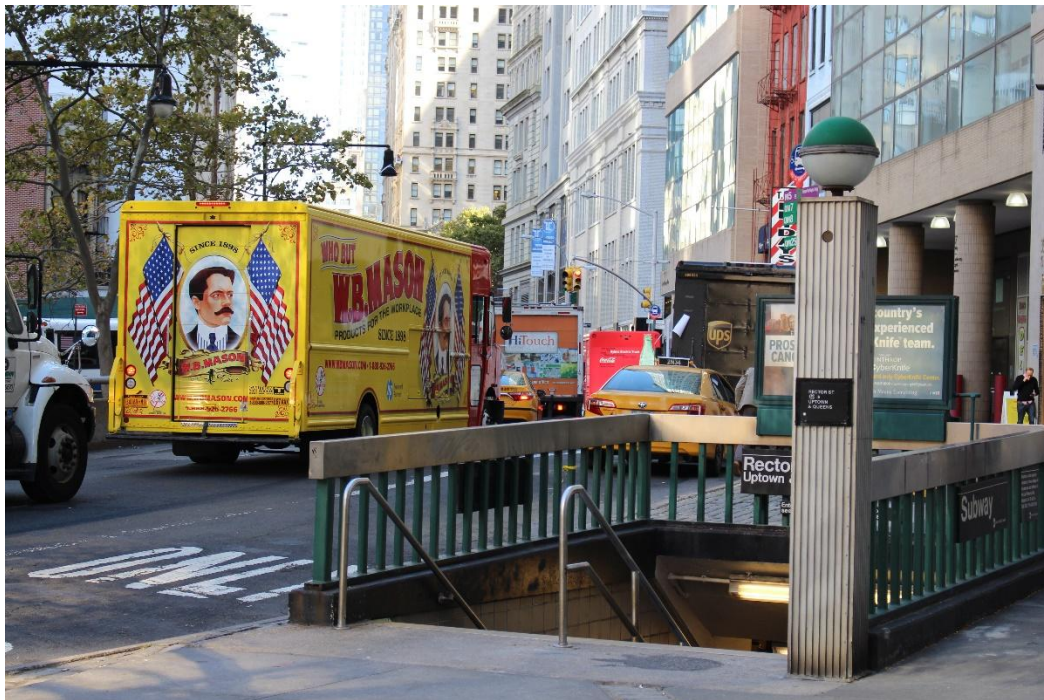
Photo #22: The transit bus stopped for the traffic signal in the distance. This is the location where the driver was notified of the pedestrian under the transit bus.
