# NATIONAL TRANSPORTATION SAFETY BOARD

# MATERIALS LABORATORY FACTUAL REPORT

Report No. 08-053

Vehicle : I-35W Bridge collapse NTSB No. : HWY07MH024

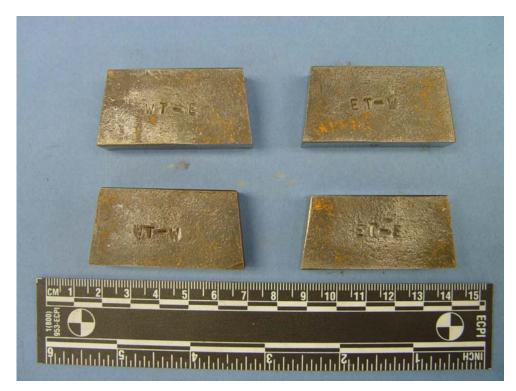
Figure 1: Portions cut from the U10 gusset plate.

The examination of the portions taken from the nodes U10 (figure 1) and L11 (figure 2) gusset plates consisted of thickness measurements and hardness measurements. The thickness measurements were taken on the portions of the gusset plates after the paint had been stripped from the material's surface. The measurements were made using a point type micrometer (tables 1 & 2). The hardness measurements were done using the Rockwell hardness B scale (tables 3 & 4).

Thickness (inch)					
Plate ID	T(1)	T(2)	T(3)	AVG	
U10W WP	0.491	0.489	0.490	0.490	
U10W EP	0.508	0.509	0.509	0.509	
U10E WP	0.505	0.504	0.506	0.505	
U10E EP	0.514	0.514	0.515	0.514

Hardness (HRB)					
Plate ID	T(1)	T(2)	T(3)	AVG	
U10W WP	85.6	82.9	82.7	83.7	
U10W EP	85.6	83.4	84.4	84.5	
U10E WP	84.1	84.4	84.1	84.2	
U10E EP	82.4	82.0	82.5	82.3

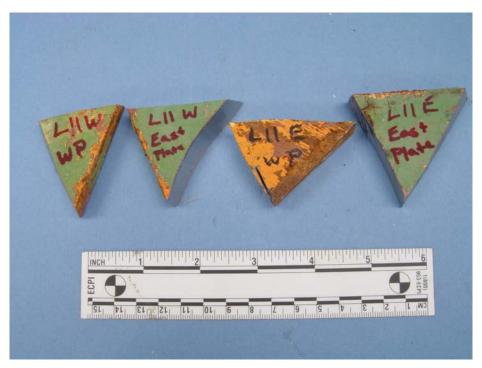
Figure 2: Portions cut from the L11 gusset plate.

Thickness (inch)					
Plate ID	T(1)	T(2)	T(3)	T(4)	AVG
L11E EP	0.483	0.479	0.478	0.479	0.480
L11E WP	0.494	0.489	0.487	0.490	0.490
L11W EP	0.485	0.487	0.490	0.486	0.487
L11W WP	0.497	0.498	0.499	0.498	0.498

Hardness (HRB)					
Plate ID	T(1)	T(2)	T(3)	AVG	
L11E EP	88.1	88.2	88.7	88.3	
L11E WP	89.9	93.1	90.9	91.3	
L11W EP	89.2	87.8	89.5	88.8	
L11W WP	87.7	87.5	89.2	88.1
