NATIONAL TRANSPORTATION SAFETY BOARD

MATERIALS LABORATORY FACTUAL REPORT

Report No. 08-073

Place : Minneapolis, Minnesota
Date : August 1, 2007
Vehicle : I-35W Highway Bridge
NTSB No. : HWY07MH024
Investigator : Mark Bagnard

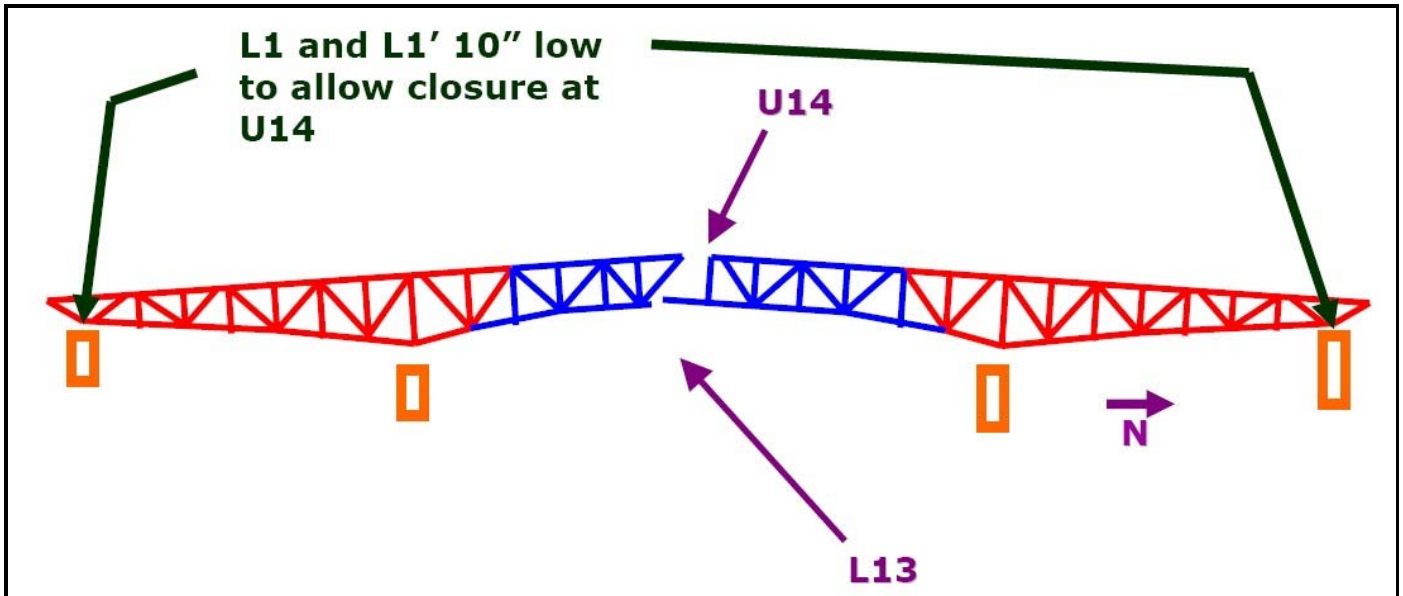
Figure 6: Truss Orientation Prior to Closure

After Span 6, 7 and 8 had been erected according to the Erection Procedure on drawing ES-4.1, the two truss portions had the exaggerated configuration because nodes L1 and L1' were constructed 10" below their final elevations.

1. When all main truss members had been erected, the truss was ready for final closure at midspan. Because nodes L1 and L1' were constructed 10" below the final elevations, the two portions of the truss met in the center of span 7 at an angle to their final position. This misalignment at the center is shown exaggerated in figure 6.

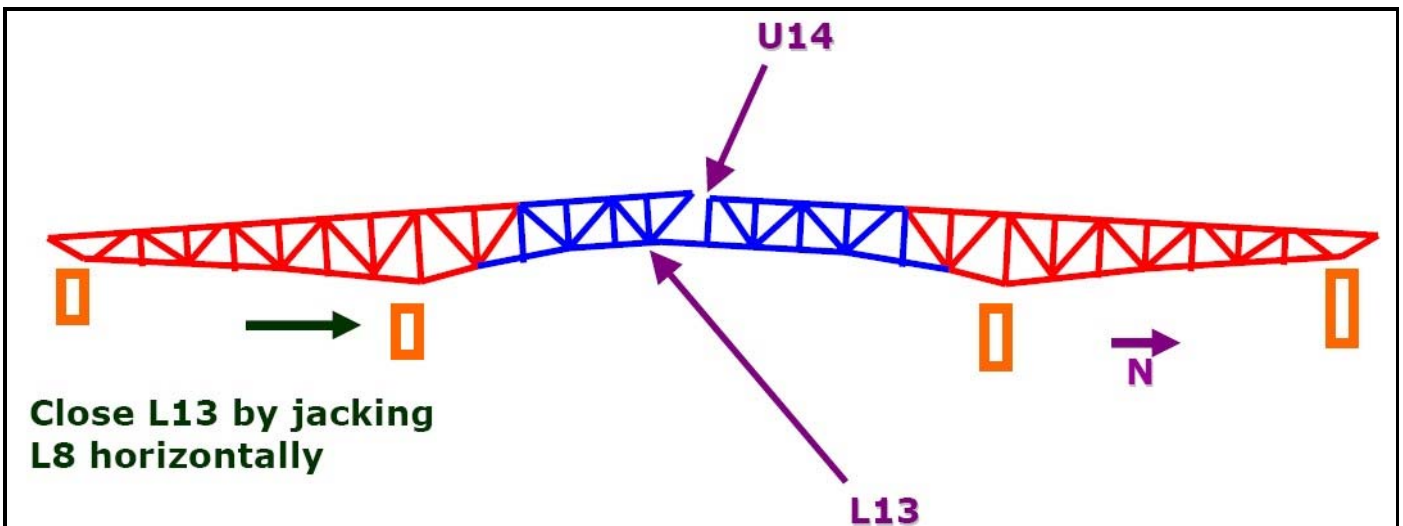
Figure 7: Joining Node L13

The truss was joined at midspan by first closing L13. Node L8 was jacked horizontally until the south portion of the truss met the north portion at L13. A single bolt was installed to maintain connection but allowed member rotation at L13.

2. To begin the closure process, node L8 was jacked to the north joining the north and south portions of the truss at node L13. A single bolt was installed at L13 to maintain alignment but allow member rotation at L13. This allowed partial connection of member L13/L13' into node L13, as depicted in figure 7.

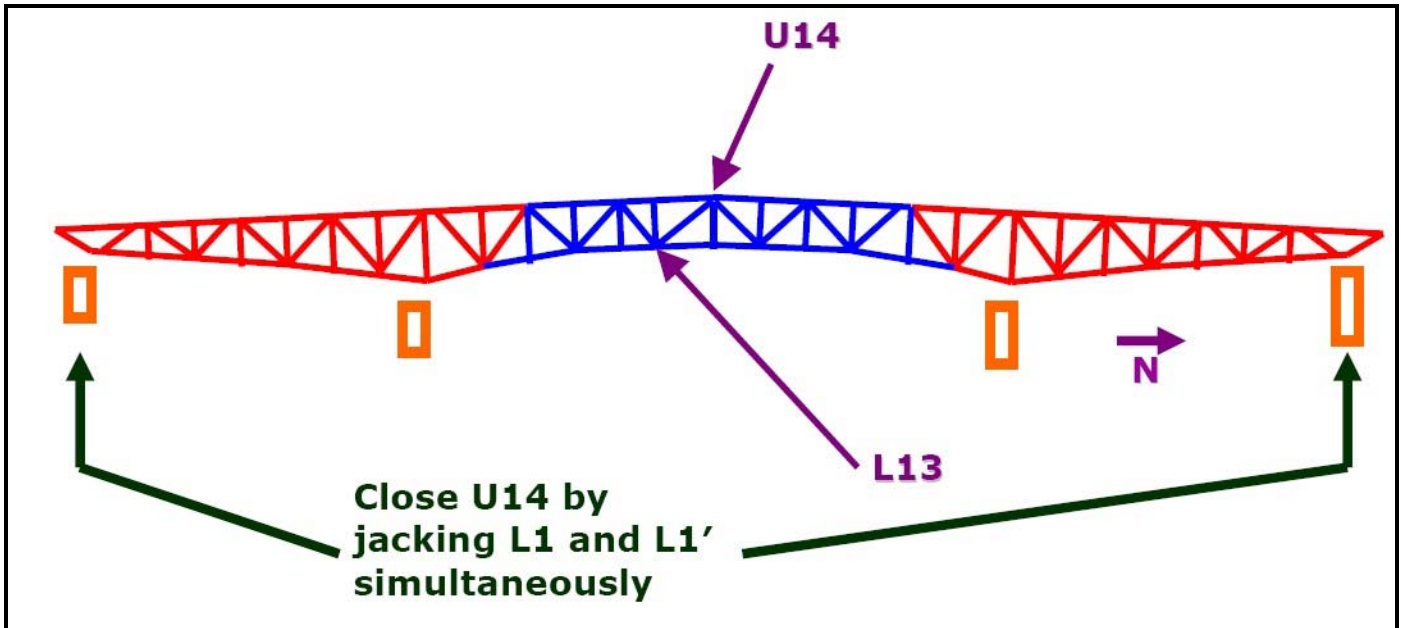
Figure 8: Joining Node U14

Nodes L1 and L1' were jacked upwards simultaneously to make the connection at node U14. Following alignment of U14, both L13 and U14 were riveted.

3. Nodes L1 and L1' were jacked vertically until node U14 was joined, as indicated in figure 8. After node U14 was joined, the remaining bolts and rivets at nodes L13 and U14 were riveted. Closure at midspan was now complete.

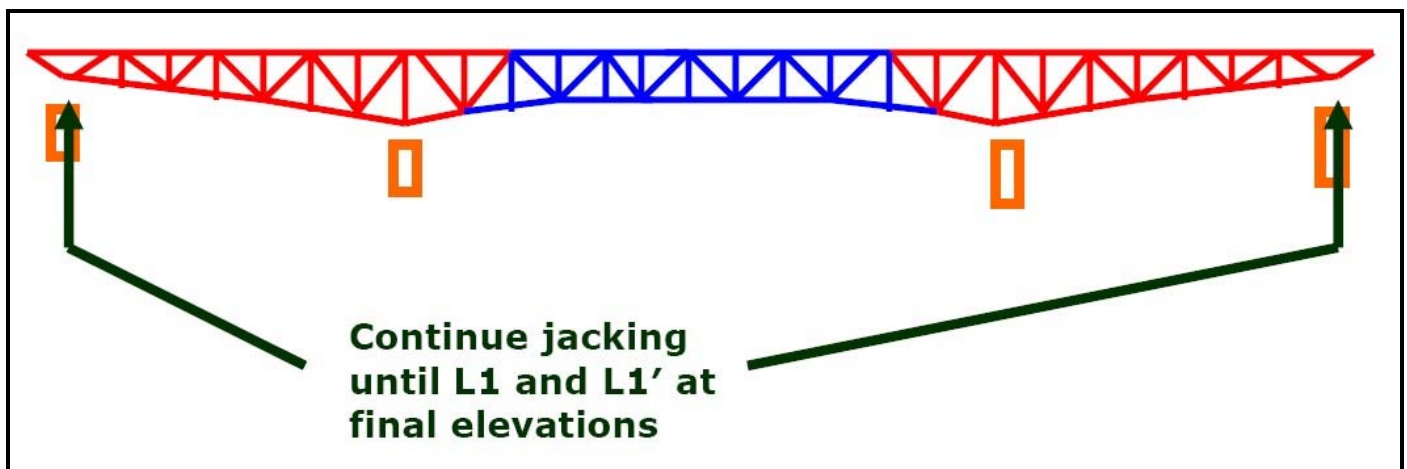
Figure 9: Completing the Erection

After closure was complete at midspan, nodes were fit-up 66.7% and blocking removed at L8. L1 and L1' were jacked to their final elevations, remaining steel erected and expansion bearing castings placed.

4. The jacks and blocks at L8 were removed to allow horizontal expansion of the structure. Nodes L1 and L1' were jacked to their final elevations as illustrated in figure 9.

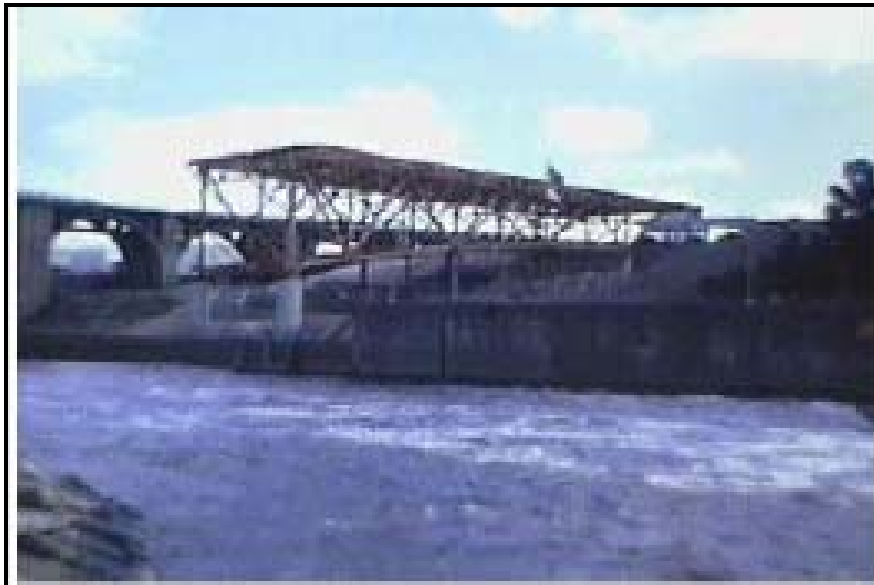
Figure 11: Span 6 Under Construction

Still image from video footage of Bridge 9340 during construction of deck truss superstructure. Image shows erection of Span 6 has been completed, including the deck stringers. Falsework is at the appropriate locations and still in place as requested by the contractor.

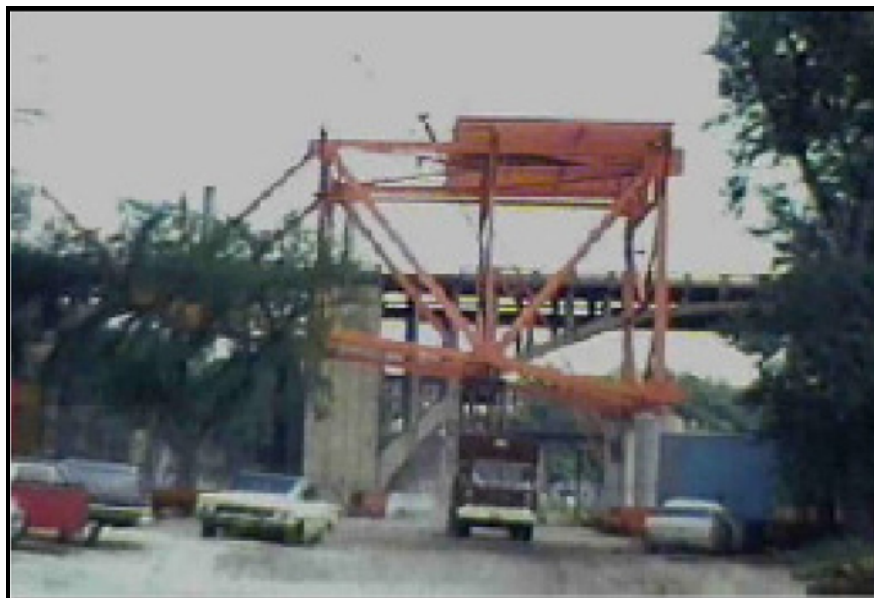
Figure 12: Span 8 Under Construction

Still image from same video file showing the erection of steel in Span 8. The progress in Span 8 appears to be near the closure at node U6'.
