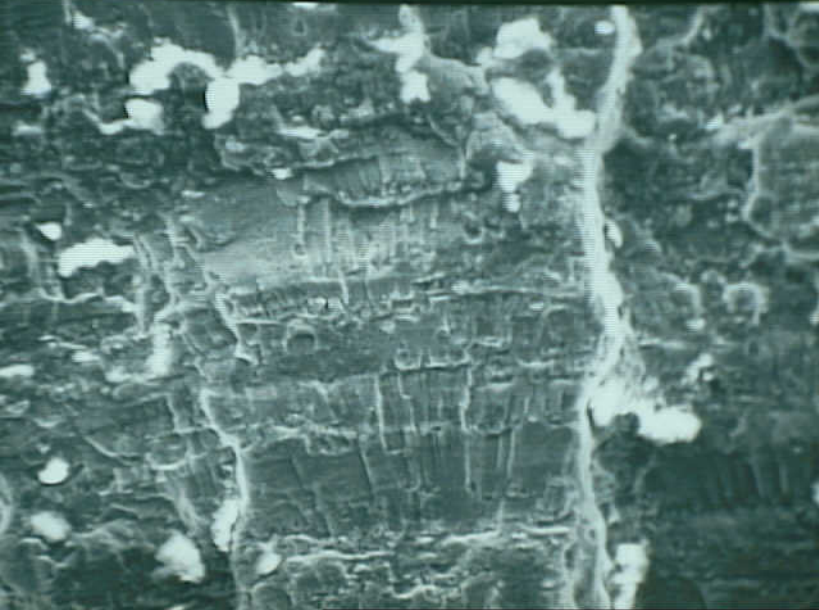
Materials Laboratory 15 - Exhibit No. 15A - Photo 3.
SEM photograph showing ratchet marks separating origin areas along the fillet radius (at the bottom of the photograph) and the fatigue banding pattern adjacent to the radius. (134X)
