NATIONAL TRANSPORTATION SAFETY BOARD

MATERIALS LABORATORY FACTUAL REPORT

Report No. 11-126

Place : Mosby, Missouri
Date : August 26, 2011
Vehicle : AS-350-B2
NTSB No. : CEN11FA599
Investigator : Jim Sillman
NTSB-CEN

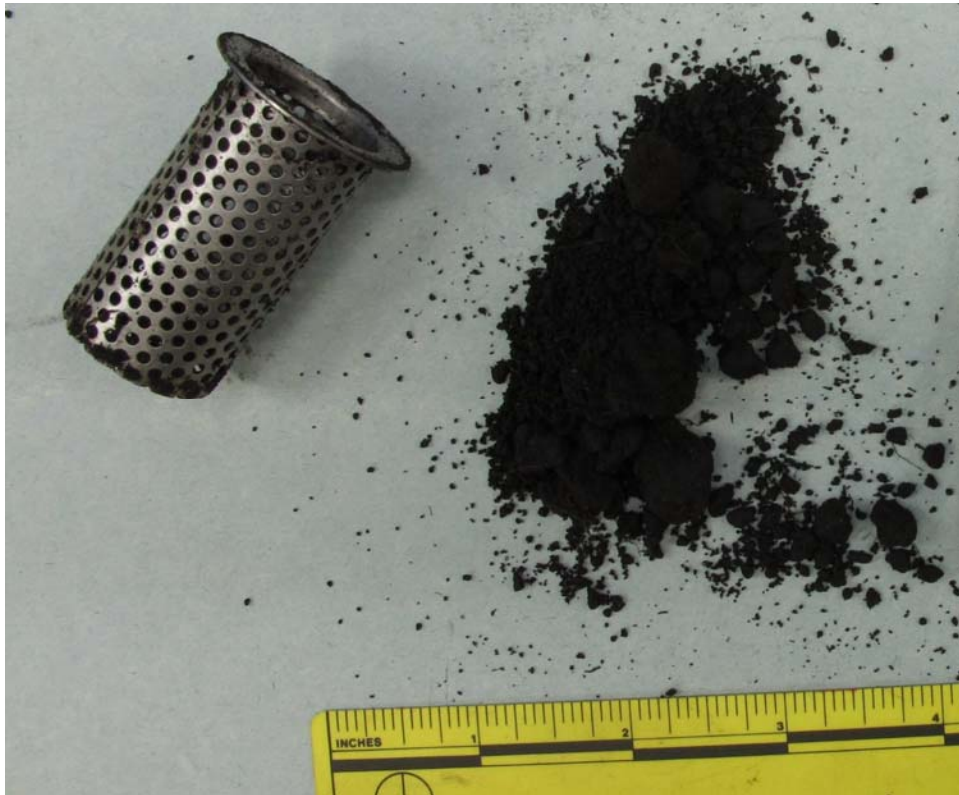
A visual examination under magnification (using a 5x to 50x stereo zoom microscope) of the material removed from the filter screen revealed granular particulates similar in morphology to sand or soil as shown in Figure 1. The debris had a slightly oily appearance on the surface as well as strong hydrocarbon odor.

Figure 1. Overall picture of tail rotor gearbox filter and debris.

A sample of the debris was examined by scanning electron microscopy (SEM) and quantitative standardless energy dispersive x-ray spectroscopy (EDS) in accordance with ASTM E1508¹. The EDS analysis of representative particulates showed the presence of aluminum, silicon, oxygen and iron. These constituents are consistent with elements found in soil.

wavelength absorbance/transmission spectra of the sample³. The spectrum obtained from the unknown sample suggests that the material was organic as evidenced by the presence of characteristic carbon-hydrogen bonding peaks between $\sim 3000\text{ cm}^{-1}$ and $\sim 2800\text{ cm}^{-1}$ as well as a small group of peaks at 1400 cm^{-1} . This peak configuration is indicative of a straight chained, aliphatic hydrocarbon. When compared to the spectra of known materials, the unknown material most closely matched spectra from lubricating oils.
