Materials Laboratory Hydraulic Fluid Testing Factual Report

MATERIALS LABORATORY FACTUAL REPORT

Place : Lubbock, Texas
Date : January 27, 2009
Vehicle : ATR 42-320
NTSB No. : CEN09MA142
Investigator : Kristi Dunks
AS-WPR

Investigation object : analysis of 9 samples of hydraulic fluid in use on ATR42, registered N902FX, crashed on the 01-27-09, in AD Lubbock (USA)

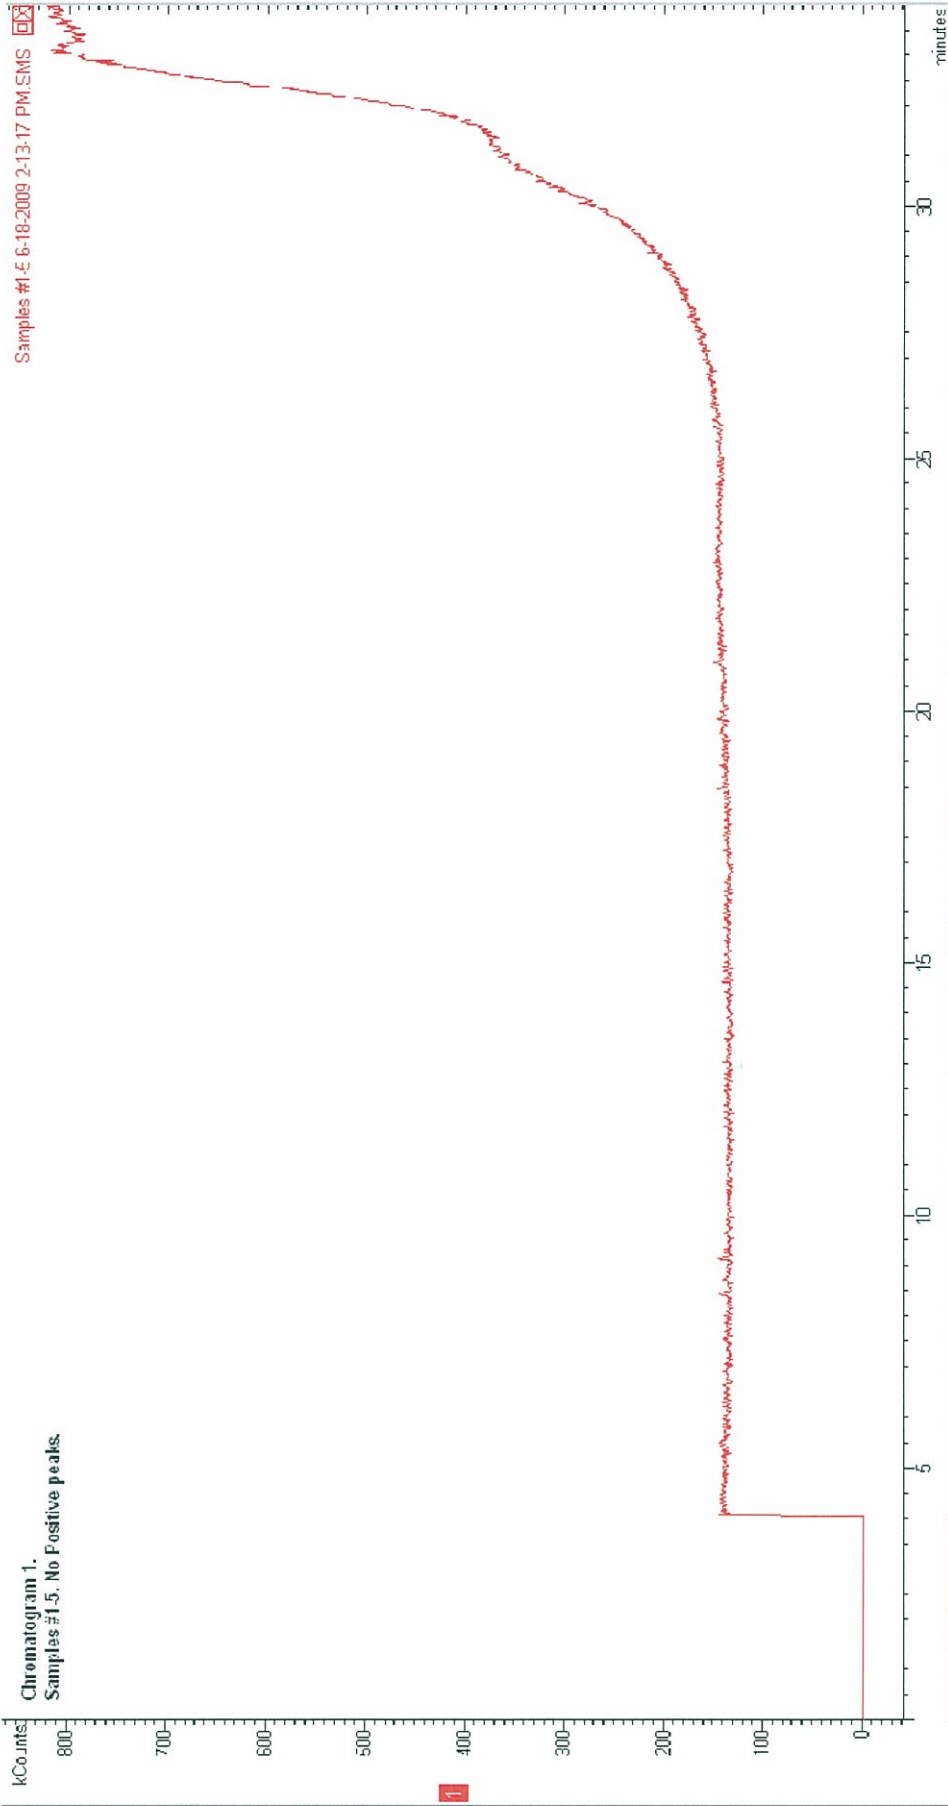
Chromatogram 1: Samples #1-5

- Samples #1-5 show no evidence positive chromatographic peaks (see Chromatogram 1). Chromatogram 1 is not significantly different to that of Chromatogram 2, which represents the swab blank (see chromatogram 2 attachment).

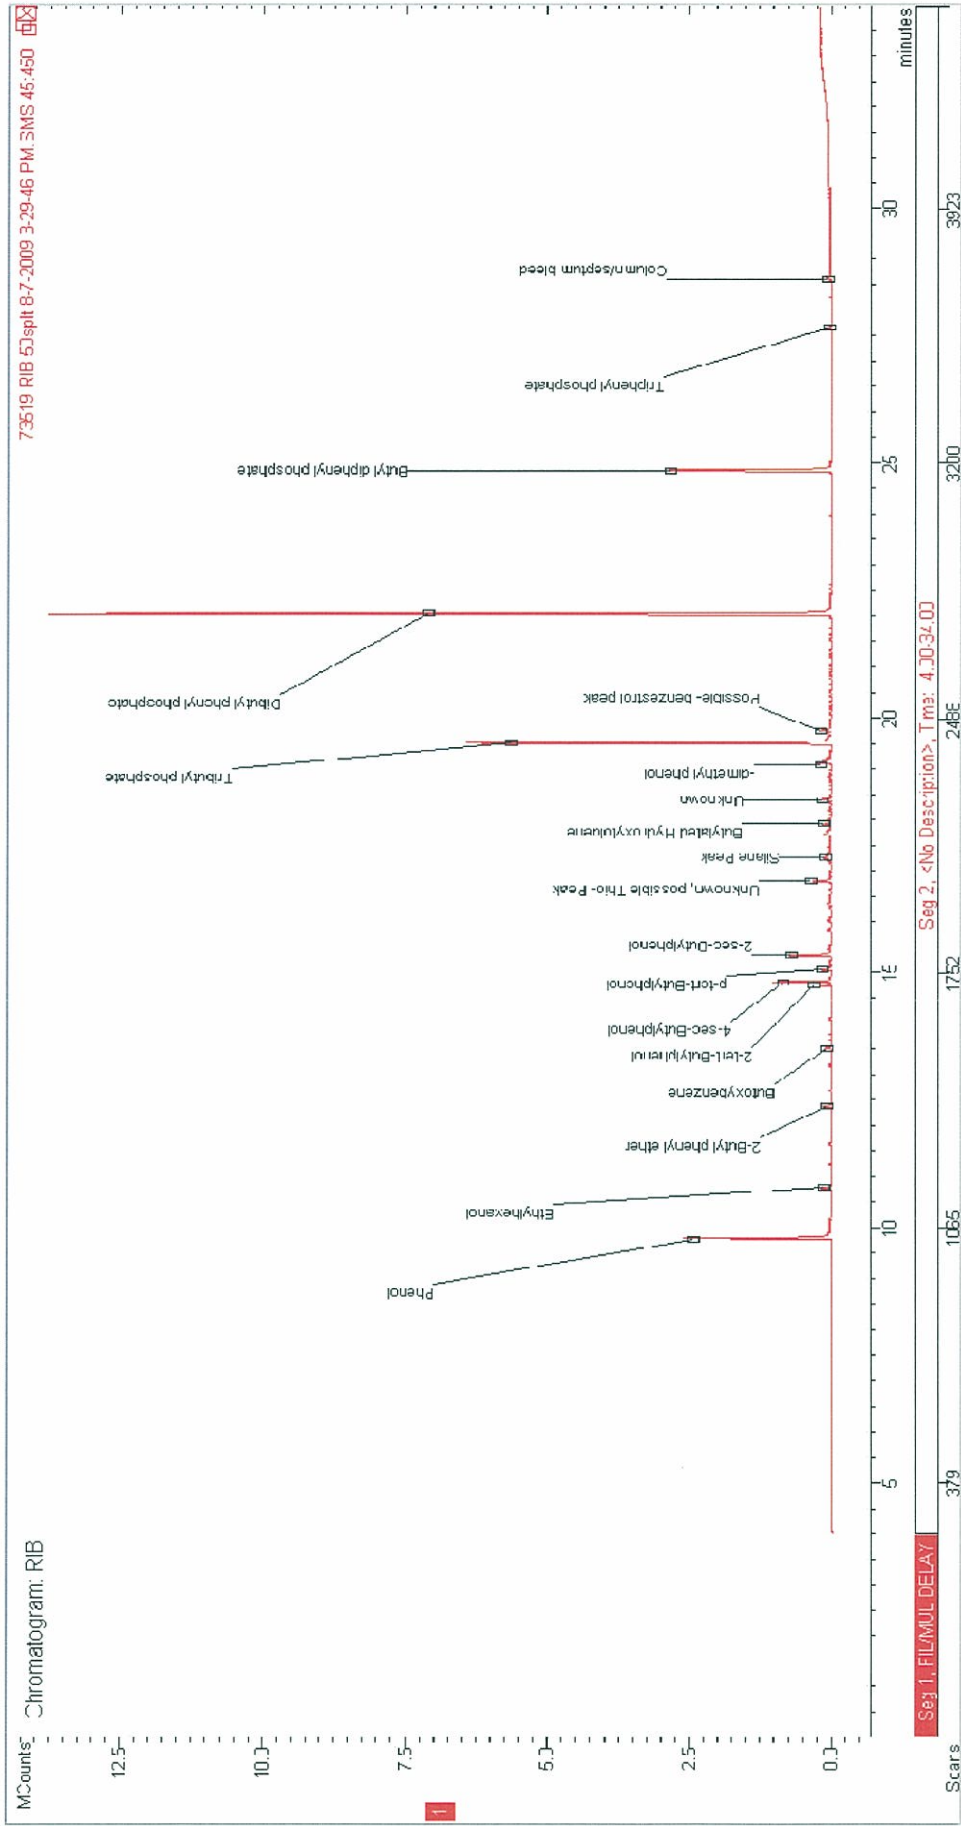
Chromatogram 2: Right Inboard Actuator

- The RIB sample chromatogram (see attachment) expresses many positive peaks mainly consisting of phenols. There are also large phosphate ester peaks in the chromatogram, which may indicate the presence of hydraulic fluid.

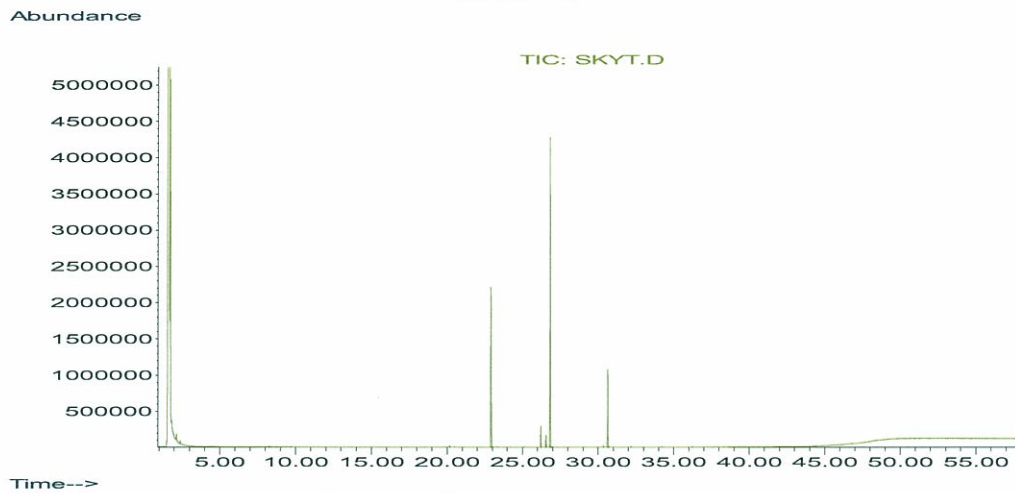
Picture 1 : reference of skydrol 500 B-4

Chromatograms were all in compliance with the referenced hydraulic fluid skydrol 500 B-4 one, analysed under the same conditions.

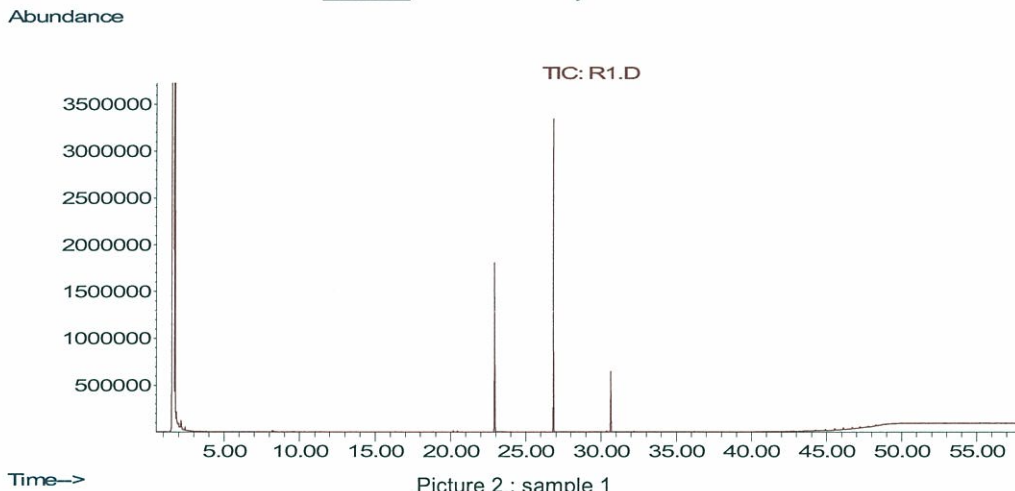
Picture 2 : sample 1

In chromatograms from samples 1, 6, 7, 8, and 9, some peacks were very reduced by comparison with the reference. And, they were only detected as traces. Those fluids may had been altered when plane burned. Therefore, we could say that no initial organic pollution was detected.

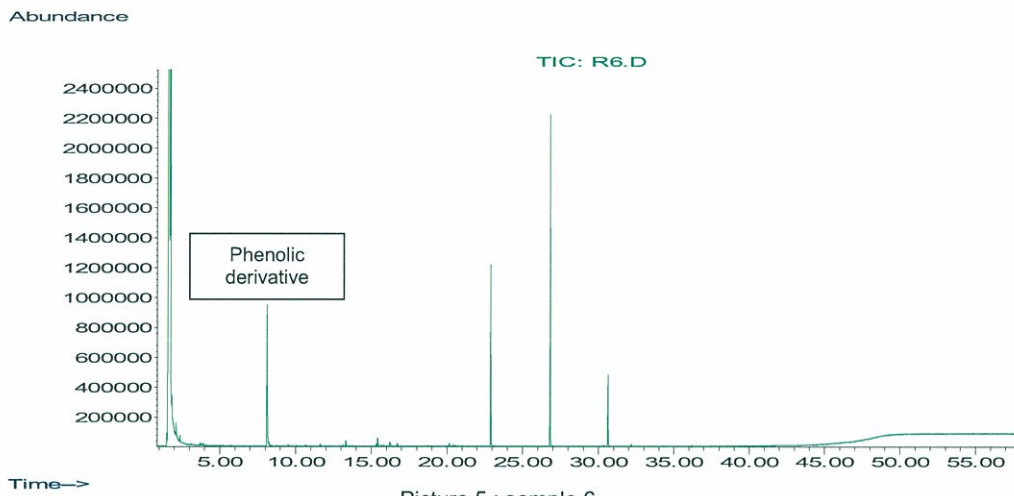
Picture 5 : sample 6

In chromatograms from samples 6 and 7 (hydraulic jack 3) and sample 9 (hydraulic jack 4), phenol and derivates were detected. They probably resulted from degradation of skydrol compounds during combustion, when the plane caught fire.
