NATIONAL TRANSPORTATION SAFETY BOARD

MATERIALS LABORATORY FACTUAL REPORT

Report No. 06-054

Place : Ketchikan, Alaska
Date : January 25, 2006
Vehicle : Aero Vodochody L-39MS
NTSB No. : ANC06FA018
Investigator : Scott Erickson

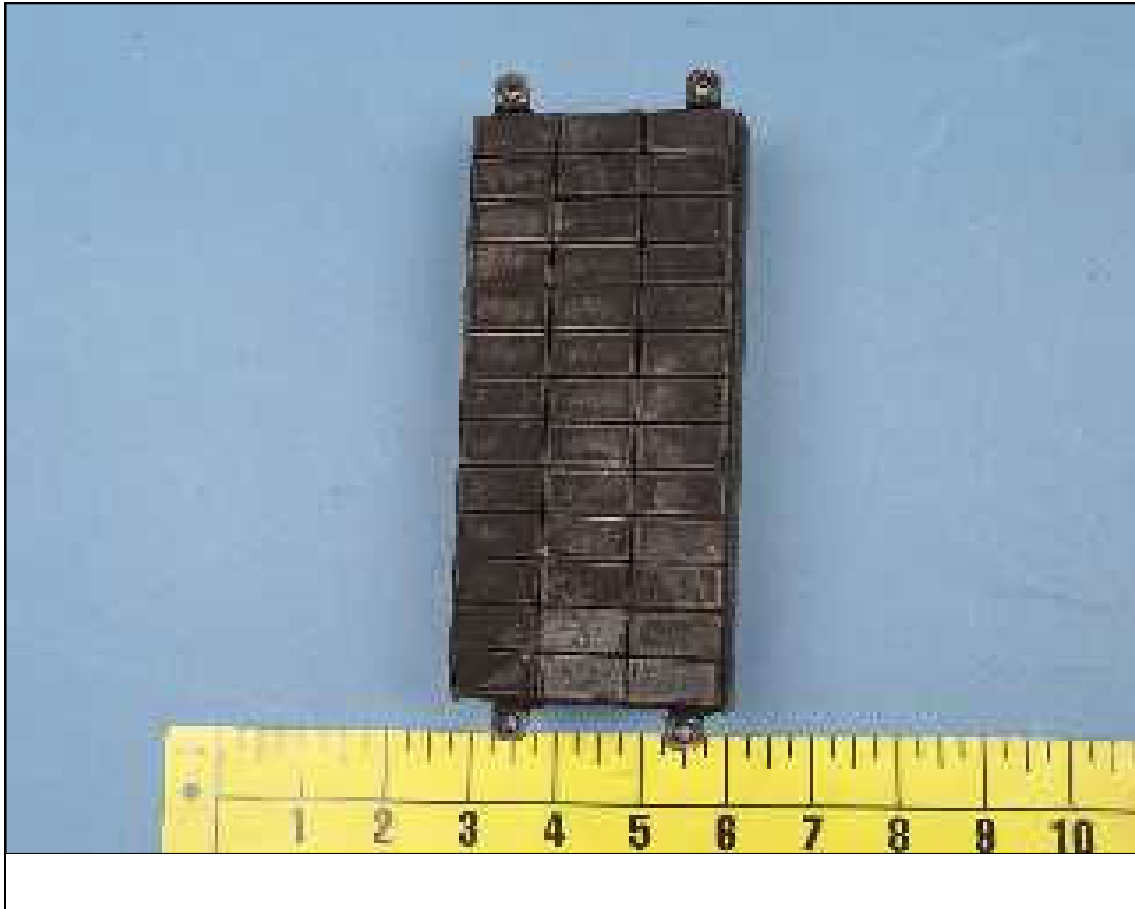
Image No.:0603A00215, Project No.: 2006030002

The rear cockpit annunciator panel received for examination consisted of thirteen rows of three indicators, each with three micro-sized single filament light bulbs. The received panel is shown in Figure 1 and was heavily sooted. Figure 2 shows a diagram of the annunciator panel. The light covers for the "Generator Overheat" and "Sapphire Low Oil Pressure" lights were cracked. Most of the bulbs had intact filaments. The "Min Alt", "Minimum Fuel Pressure", "Sapphire Starting", and "Anti-ice On" lights each had one bulb with a broken filament. The "H Hyd Failure", and "Chip Detector" lights each had two bulbs with a broken filament. None of the filaments had hot stretching relaxation of the coils (damage that, if present, would be an indication of impact loading while the filament was on). However, the "Emergency Hyd", "Emergency Generator" and "Brake Fail" indicators each had one bulb in which the filament had been tightly stretched between the filament posts during the bulb manufacturing process.

Figure 1. Rear cockpit annunciator panel.
