NATIONAL TRANSPORTATION SAFETY BOARD

MATERIALS LABORATORY FACTUAL REPORT

Report No. 14-052

Place : New York (Bronx), New York
Date : July 18, 2013
Vehicle : CSX freight train
NTSB No. : DCA13FR009
Investigator : Cy Gura, RPH-10

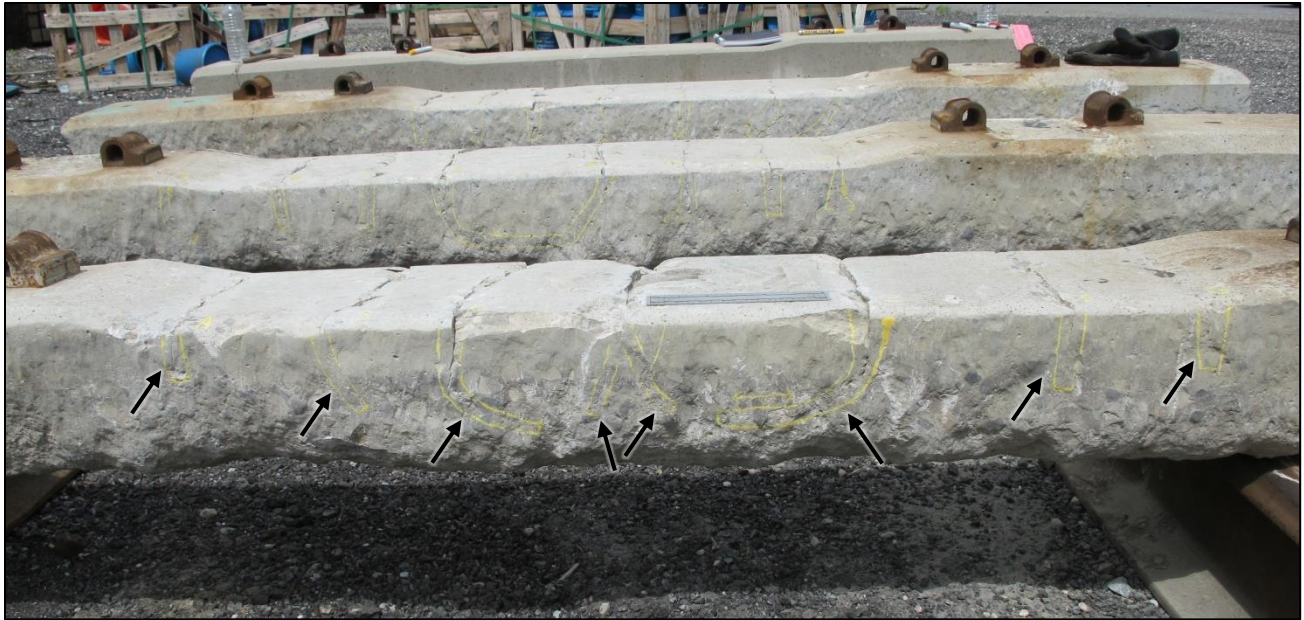
Multiple transverse cracks were observed by visual inspection in the middle portion of each of the used ties. A closer view of ties S3 and S4 is shown in figure 2 where arrows indicate the transverse cracks. Ties S4 and N16 had 8 cracks, and the remaining used ties had 7 cracks. For reference, the cracks were labeled from west to east with lower-case letters a through g or h. The spacing between the cracks was measured at the tie centerline, and results of the measurements are listed in table 1.

Figure 2. Middle portions of ties S3 and S4 showing multiple transverse cracks as indicated with arrows.

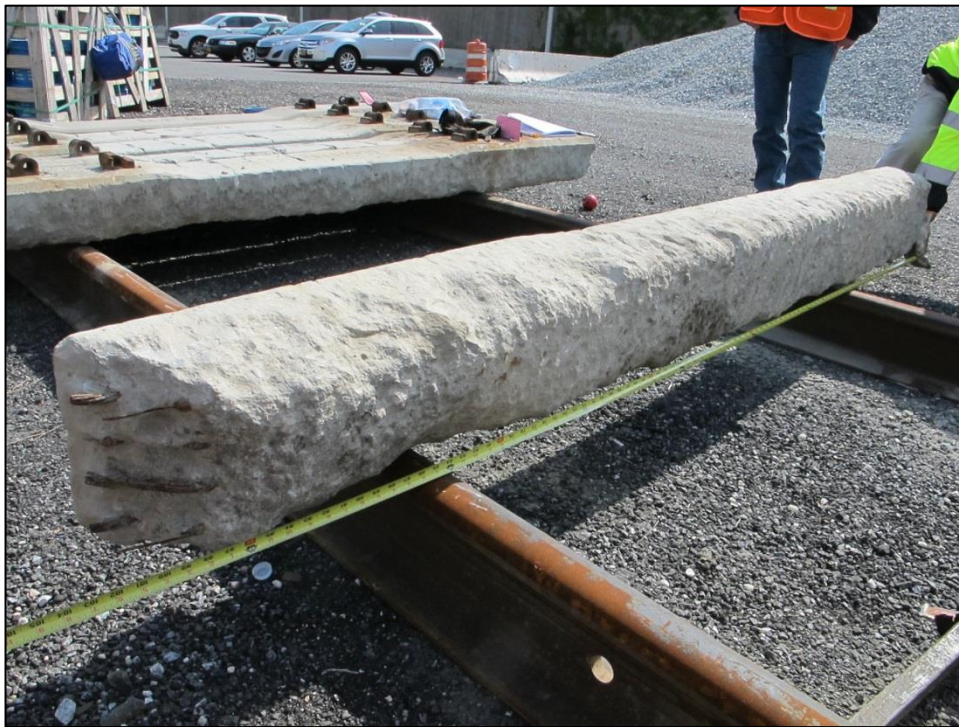
The crack depths were determined by close visual inspection on both the north and the south faces of the ties. The measured crack depths from the top surface are listed in table 1. The cracks were oriented approximately in a vertical transverse plane near the top surface, and the tips of many of the cracks curved toward a longitudinal plane orientation consistent with bending deflections (top surface in tension) and interaction with the stress field of the reinforcement. A view of the south faces of ties S3 and S4 is shown in figure 3. A yellow paint marker was used to outline the locations of the cracks, as can be seen in figure 3.

Figure 3. View of the south faces of ties S3 and S4 showing crack features outlined with yellow paint as indicated with arrows on tie S3.

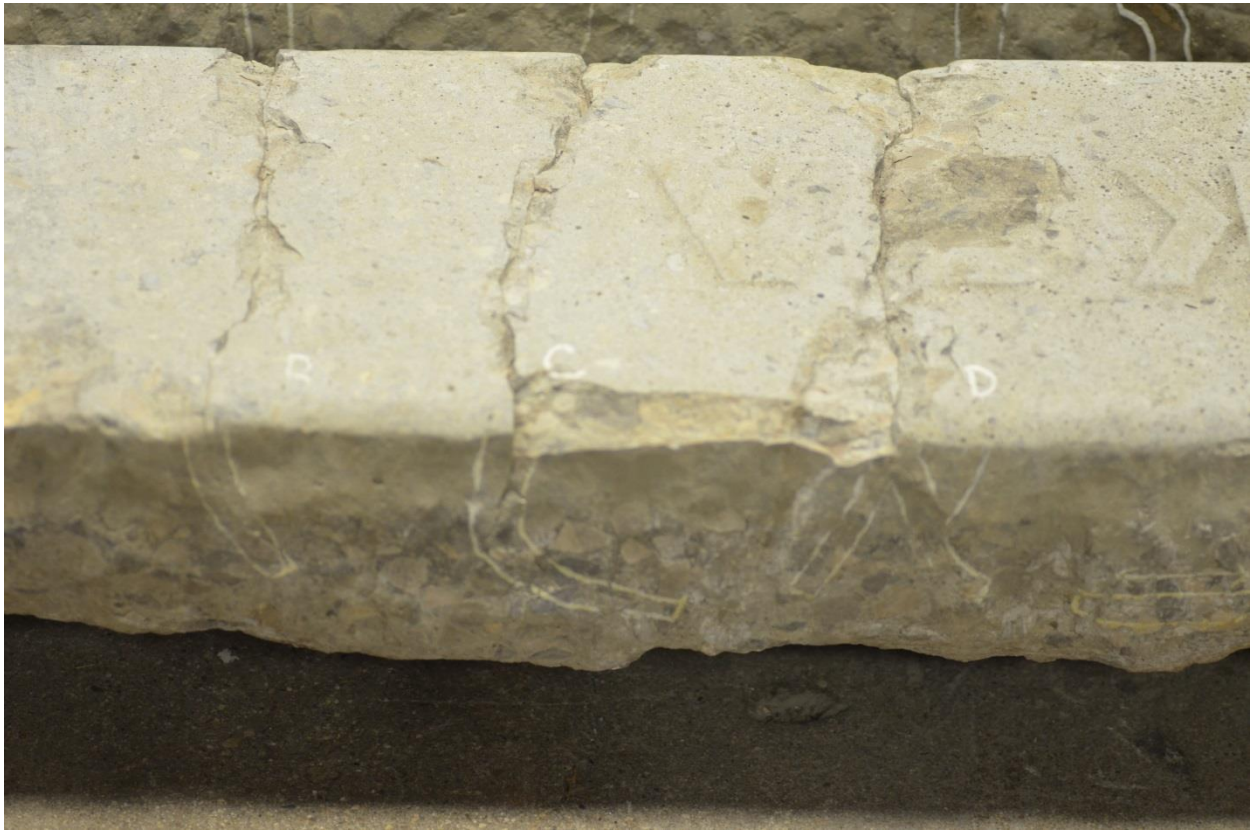
Figure 3. Example of observed in-service top surface conditions. Railroad tie S3 shown in the photo. Note the crack tracings on the side of the tie by others.

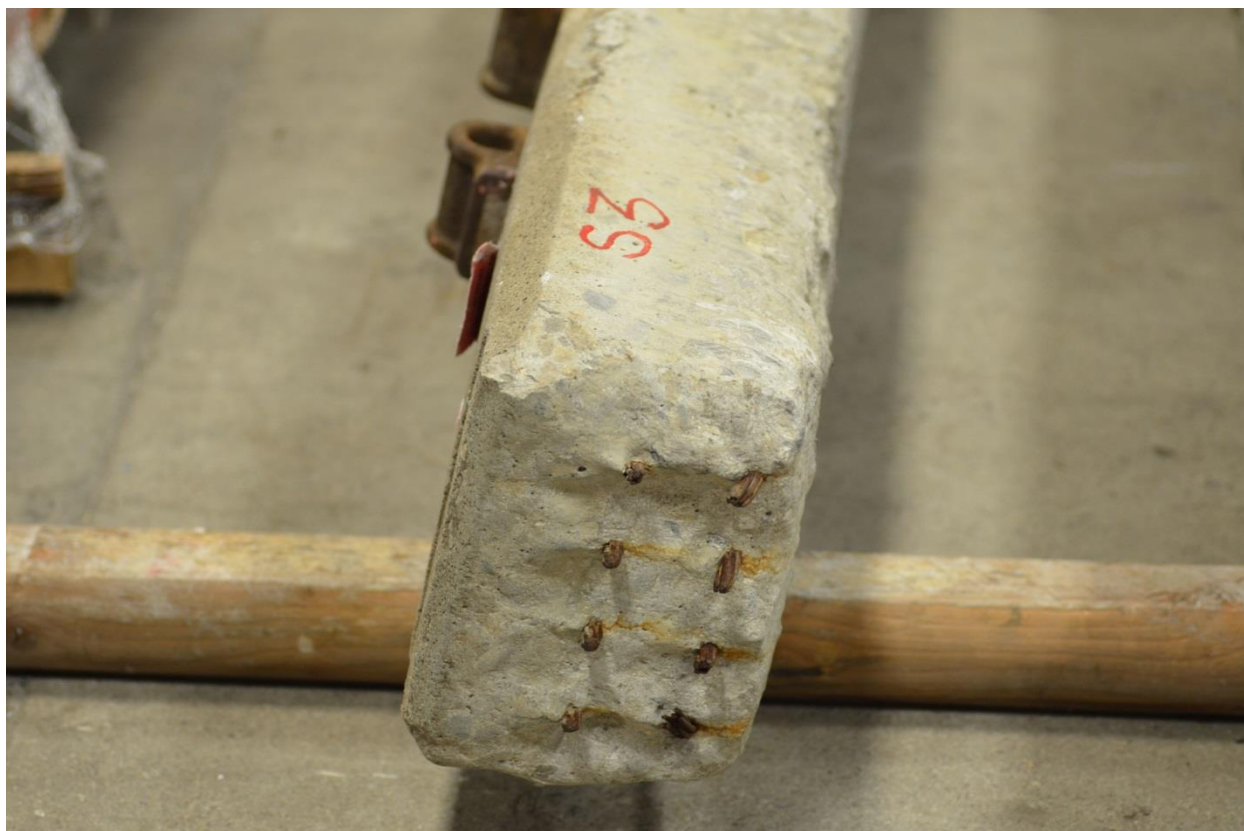
Figure 4. Example of abrasion typically observed at the ends of the railroad ties that sit at the lower elevation side of the curve (Specimen S3).

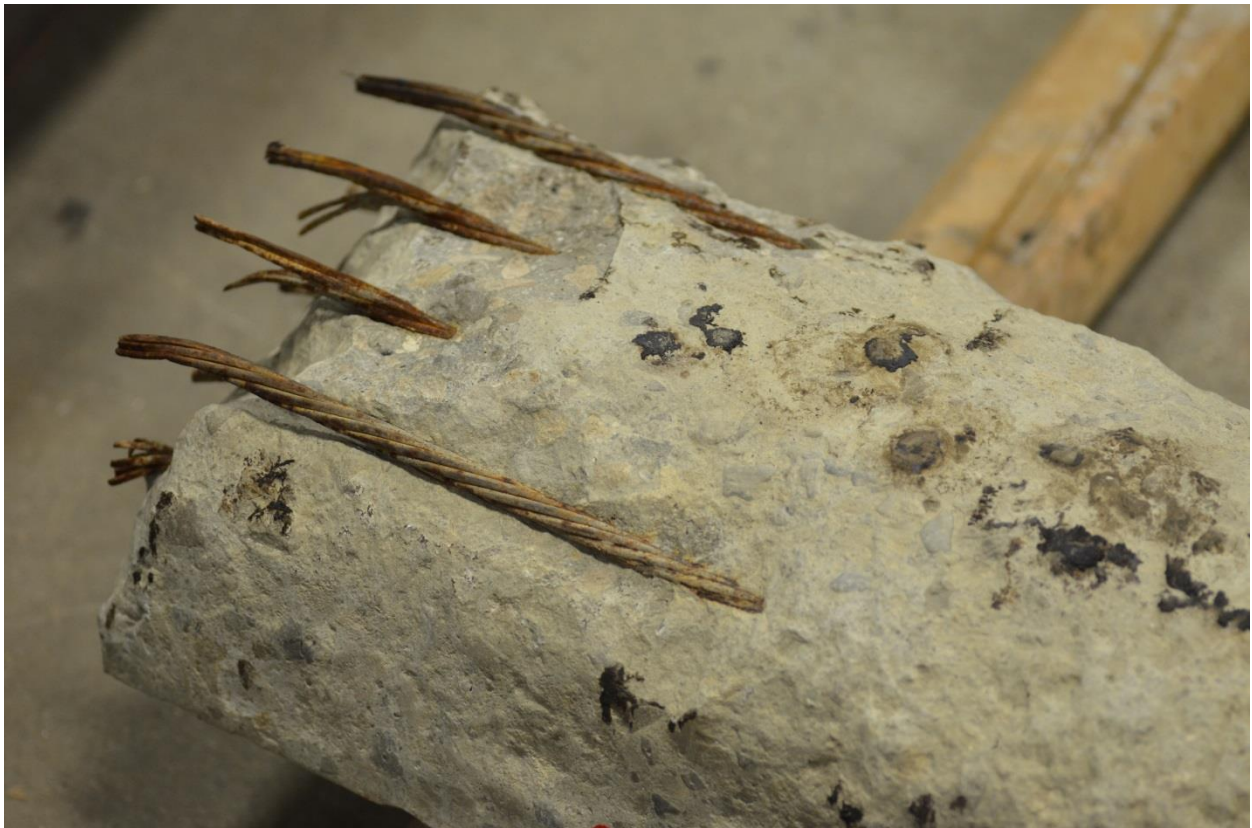
Figure 5. Example of abrasion typically observed at the ends of the railroad ties that sit at the higher elevation side of the curve (Specimen S3).

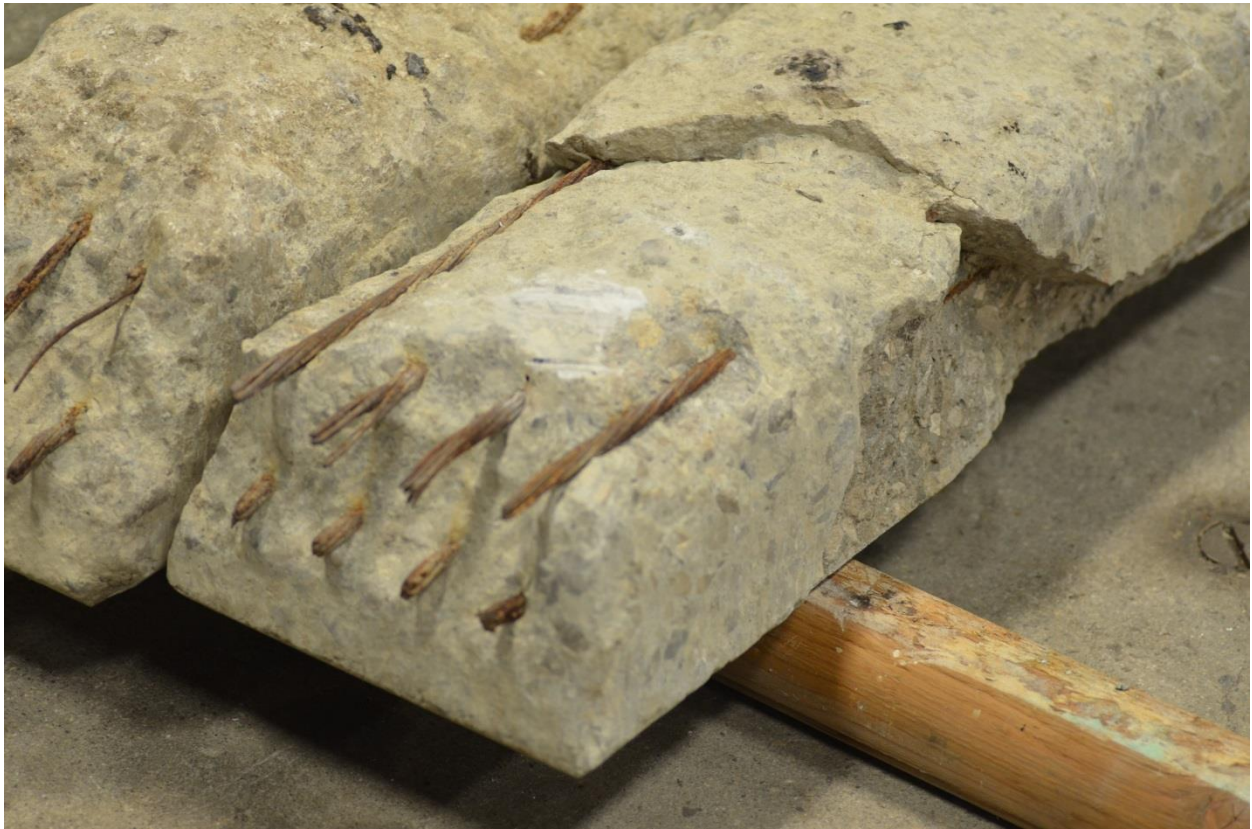
Figure 6. View of freshly broken off concrete area on Specimen S4.

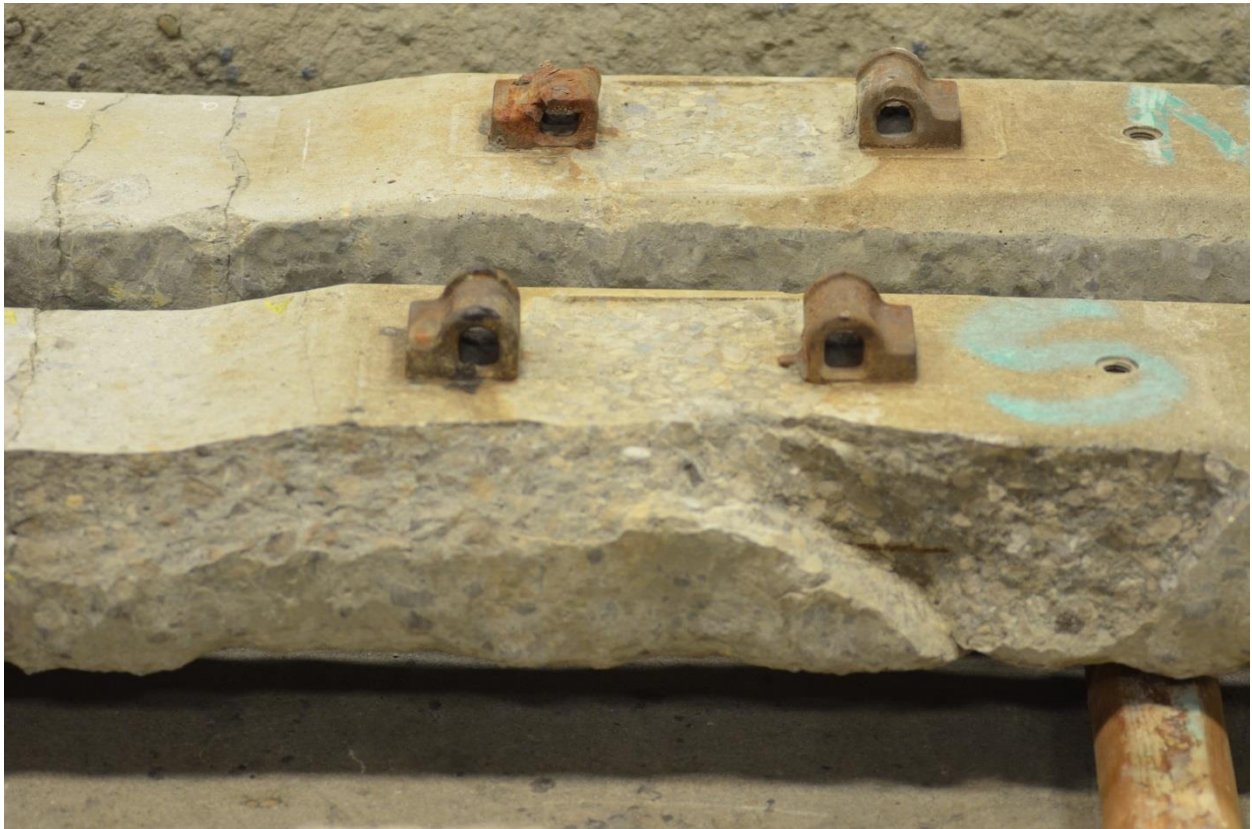
Figure 7. View of freshly broken off concrete area on Specimen S4.

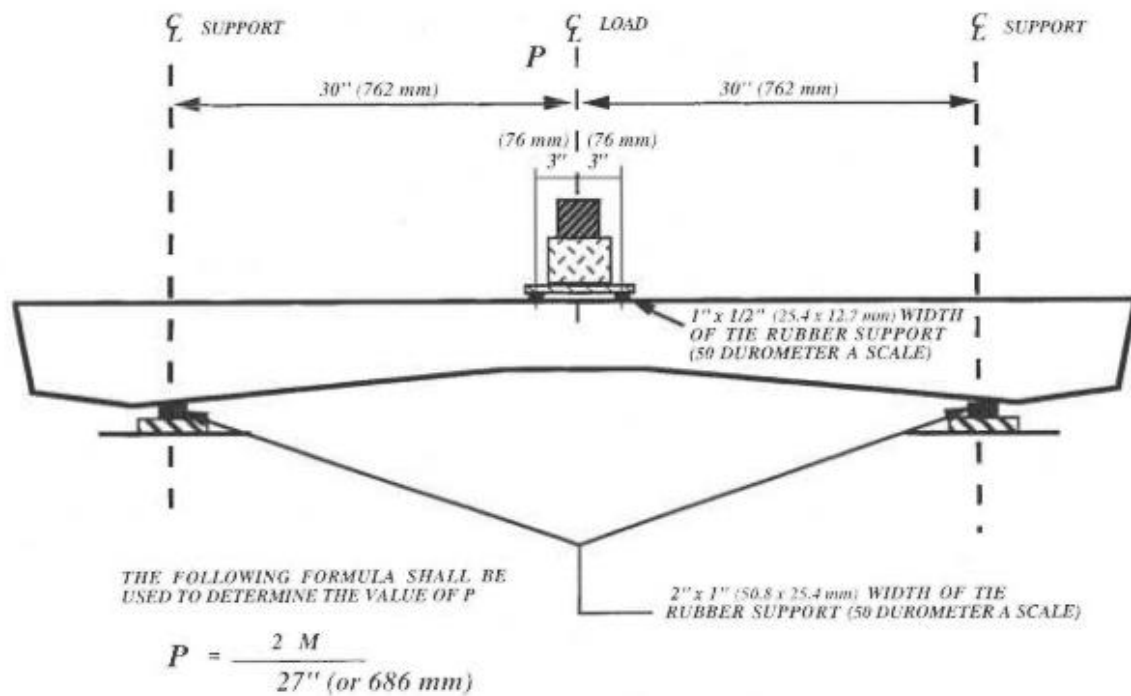
All Bend Tests were conducted using the Tie Center Negative Moment Test configuration per American Railway Engineering and Maintenance-of-way Association (AREMA) Manual for Railway Engineering, Chapter 30, Part 4, Concrete Ties (AREMA Manual). Test setup requirements in the AREMA Manual, such as the support and loading conditions used for the tests are provided in Figure 8.

M = NEGATIVE MOMENT AT THE CENTER OF THE TIE AS REQUIRED IN ARTICLE 4.4.1

Figure 8. Tie Center Negative Moment Test setup reproduced from the AREMA Manual.

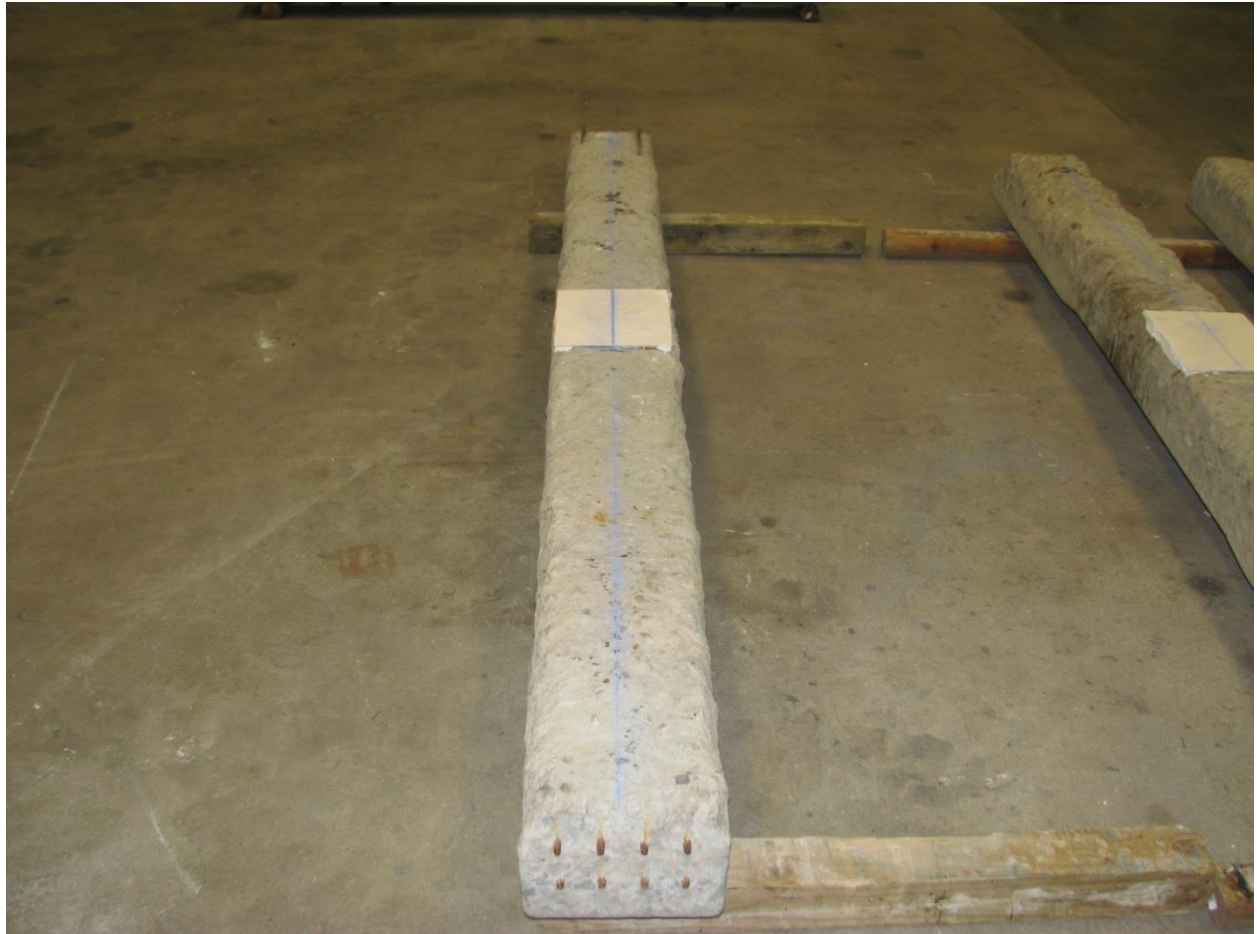
AREMA's test set-up required the railroad ties be tested upside down, supported 5 feet apart on supports placed between the two rail hold downs, and loaded at mid-span by a concentrated load. Because of the significant roughness of the abraded bottom surfaces of the used ties, WJE applied a thin capping compound to create a smooth and level surface beneath the loading point so that the applied load was uniformly distributed across the width of the ties (Figures 9 through 11). The capping compound was prepared using the gypsum-based material, Hydrostone, which is manufactured by United States Gypsum Corporation. Since the used ties also had significant abrasion on their sides, precise location of the geometric centerlines relative to the sides was obscured. Accordingly, the centerlines were determined relative to the centroid of the prestressing strands visible in each used tie.

Figure 9. Hydrostone capping used at the loading area on used railroad tie S3.

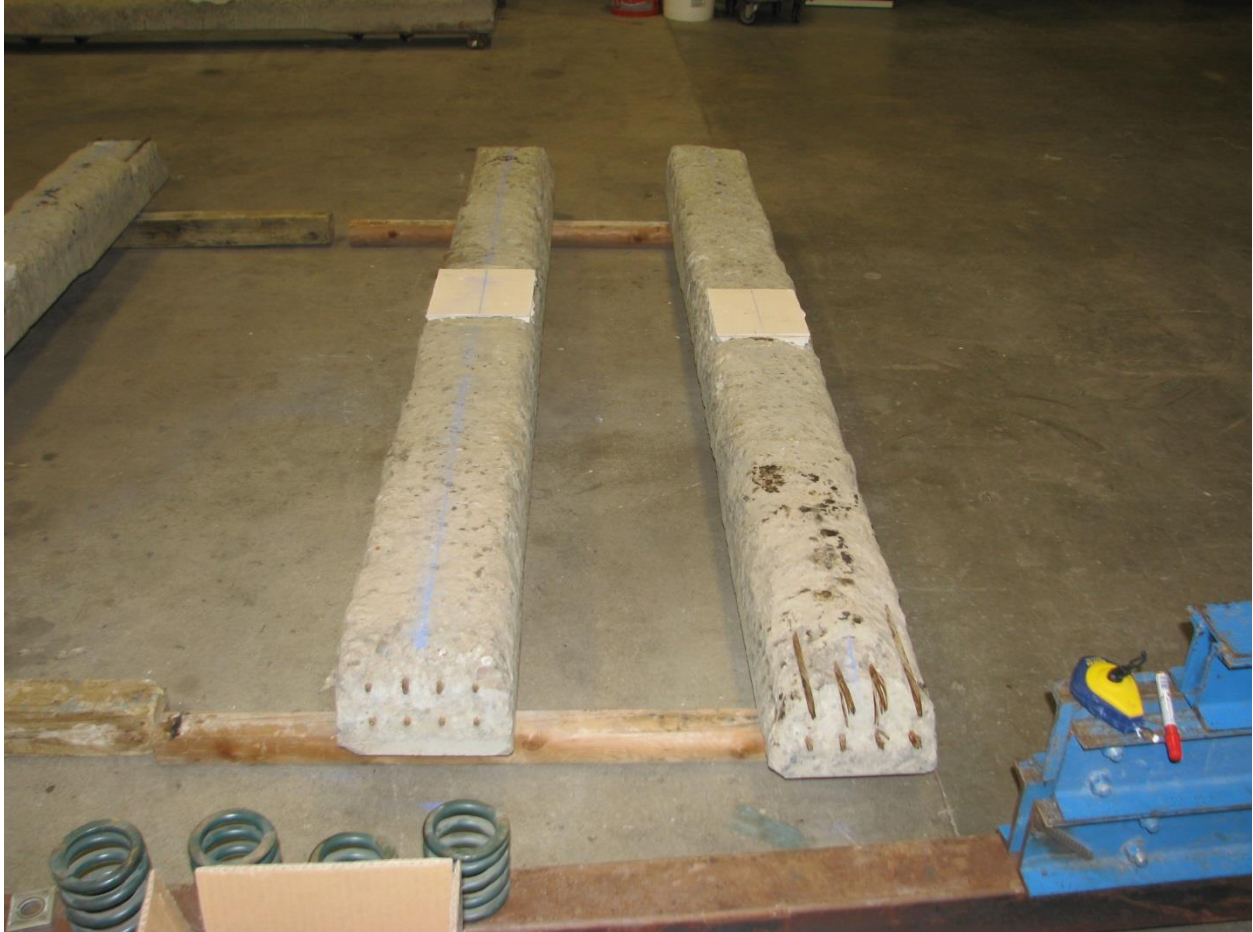
Figure 10. Hydrostone capping used at the loading area on used railroad ties N16 (left) and S4 (right).

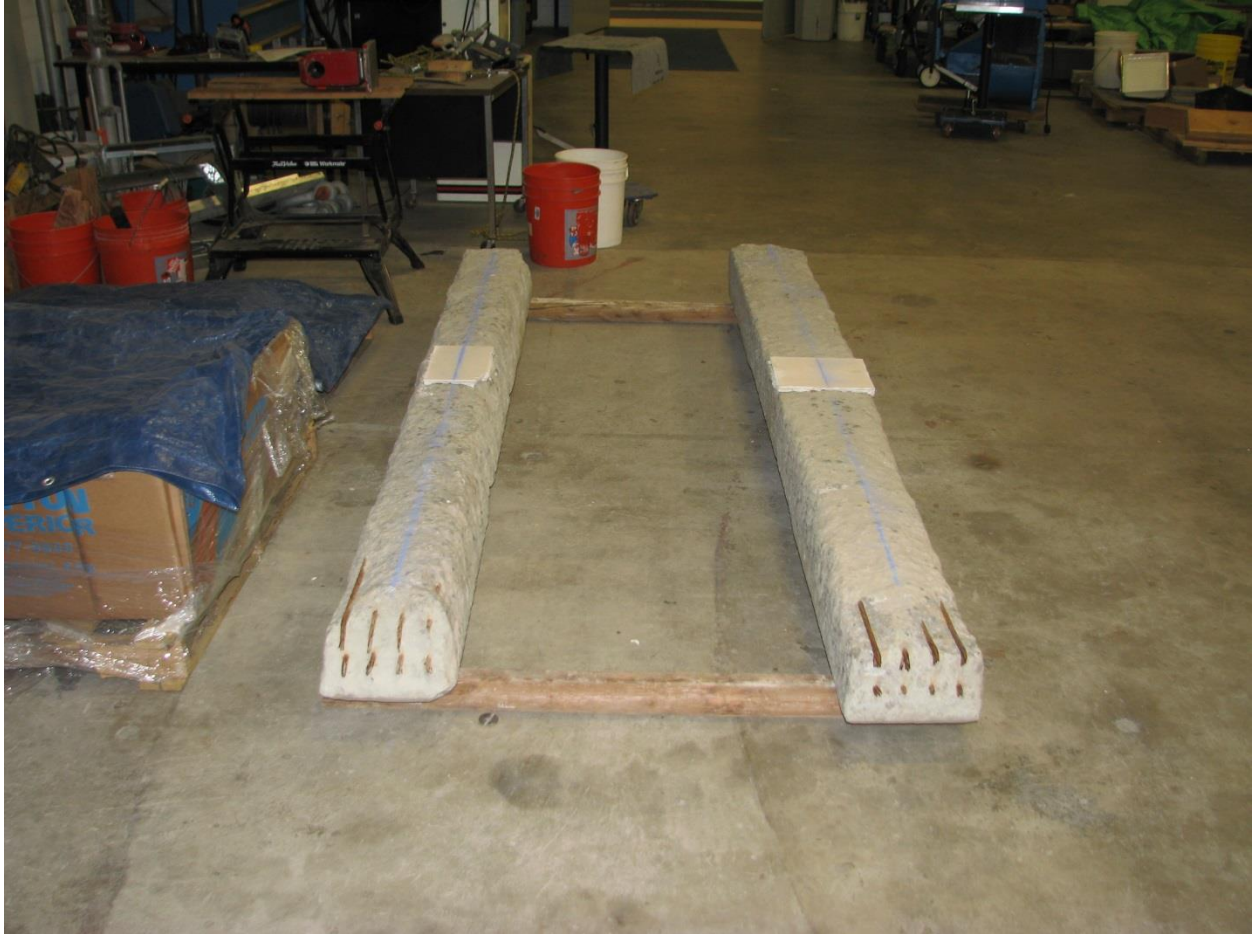
Figure 11. Hydrostone capping used at the loading area on used railroad ties N10 (left) and S5 (right).

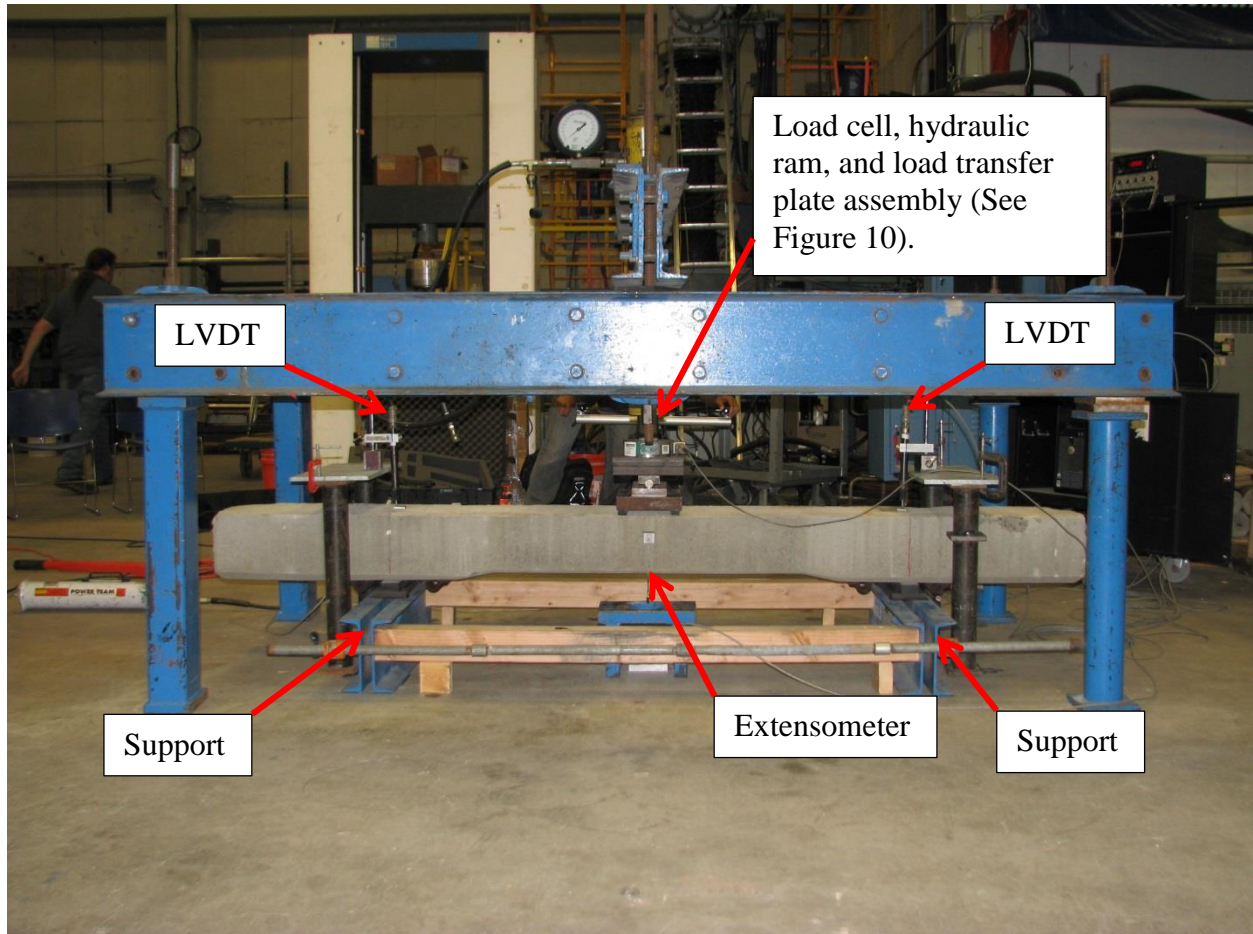
Views of the loading hardware and test setup are provided in Figures 12 through 15. Load was applied using a 30-ton calibrated hydraulic jack, with a 50 kip capacity load cell placed between the specimen and the hydraulic jack. The hydraulic pump was equipped with a flow rate control manifold to facilitate application of load and reduce sudden changes that may occur when cracks form or start to open up. Deflections were measured at each support using Linear Voltage Differential Transducers (LVDT). The

Figure 12. View of actual test setup with new railroad tie in place.

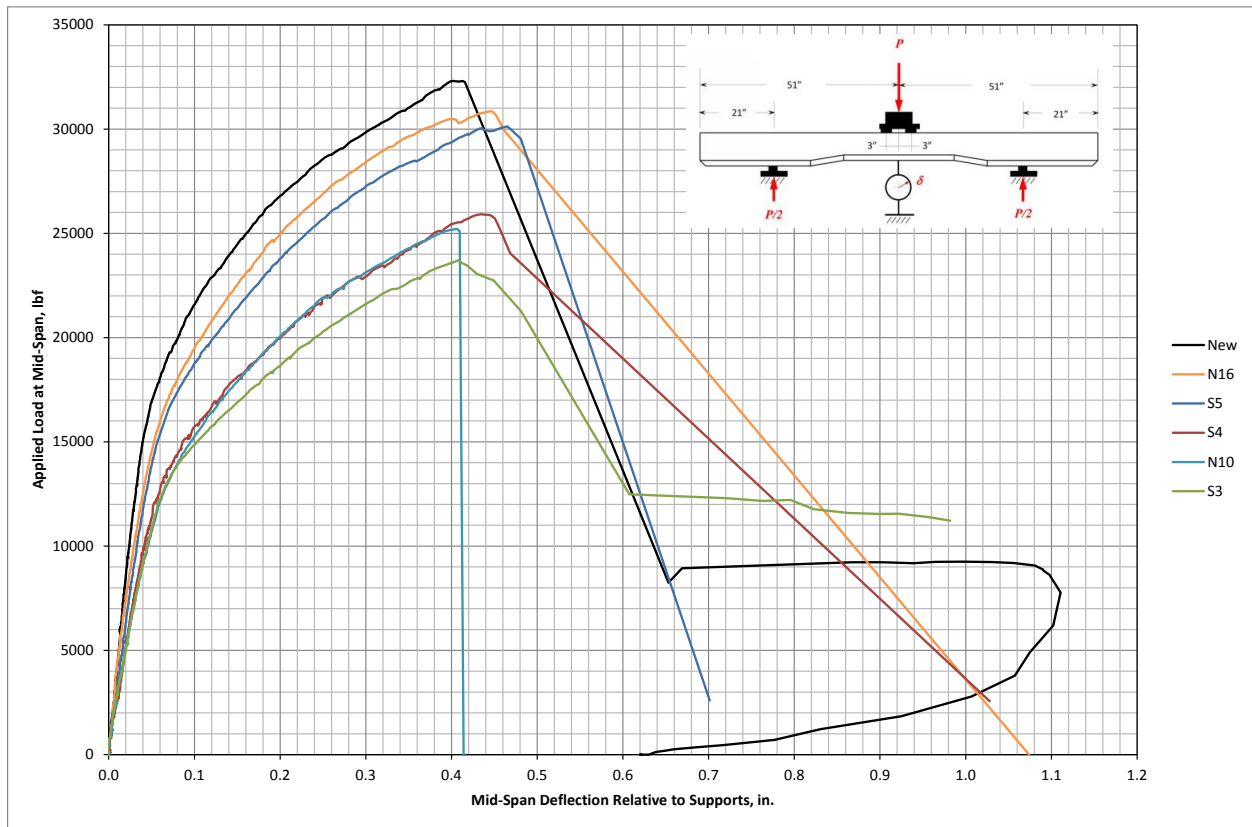
Load versus deflection curves for each specimen tested to failure are presented in Figure 17. The maximum load that was recorded during testing and corresponding mid-span deflection for each specimen is provided in Table 1. Overall photographs of each face of each specimen after failure are provided in Figures 18 through 29.

Figure 17. Load deflection curves for all specimens that were tested to failure.

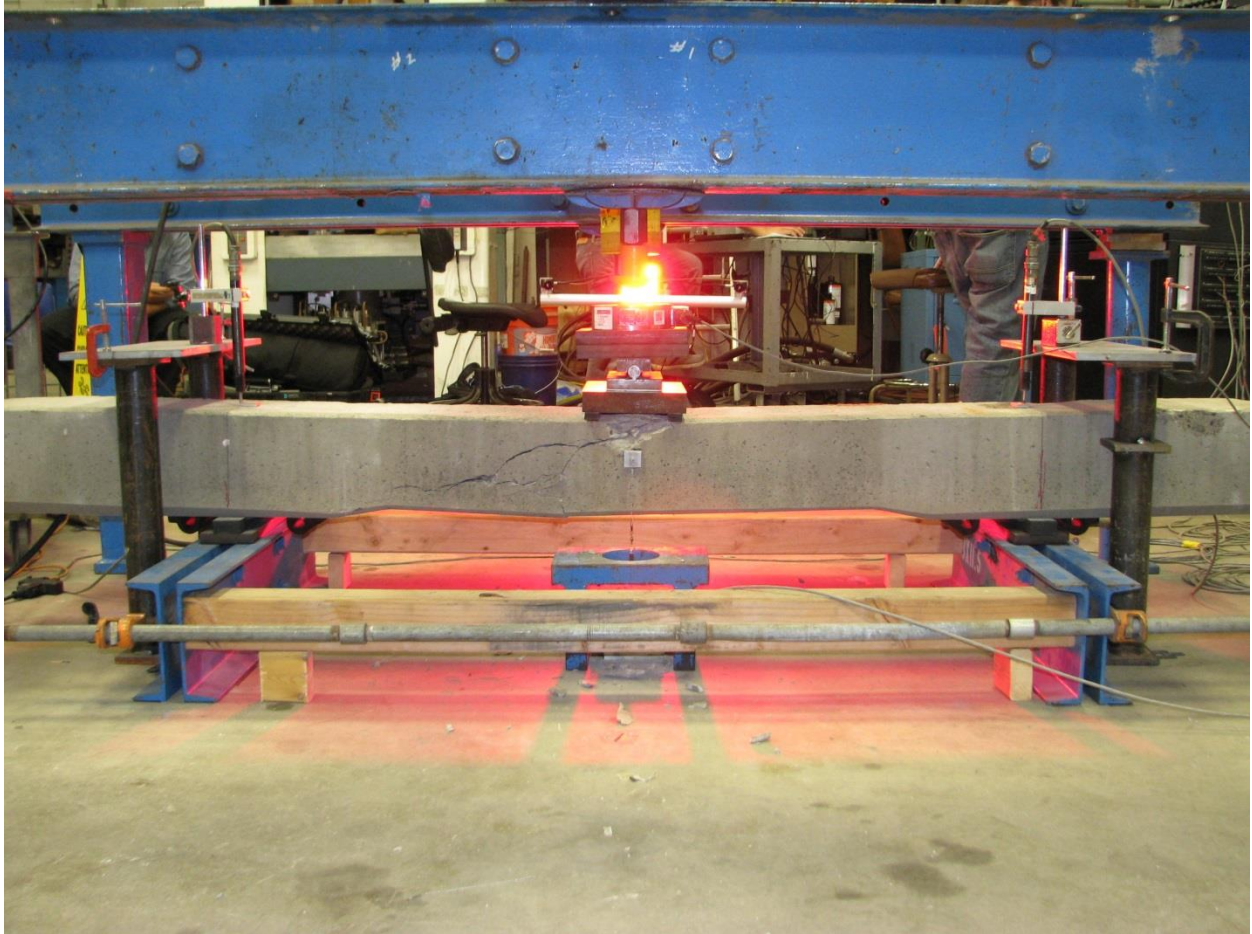
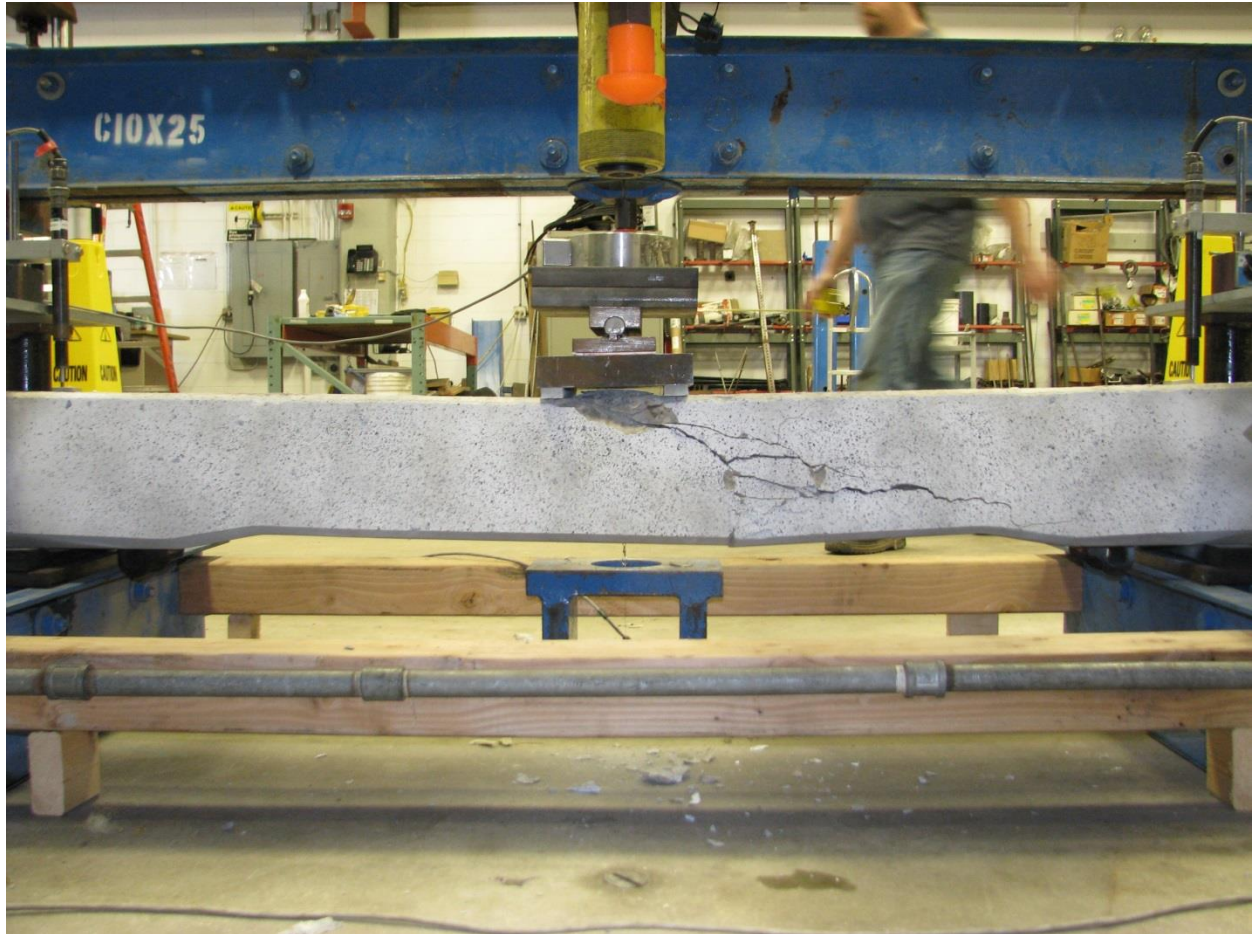
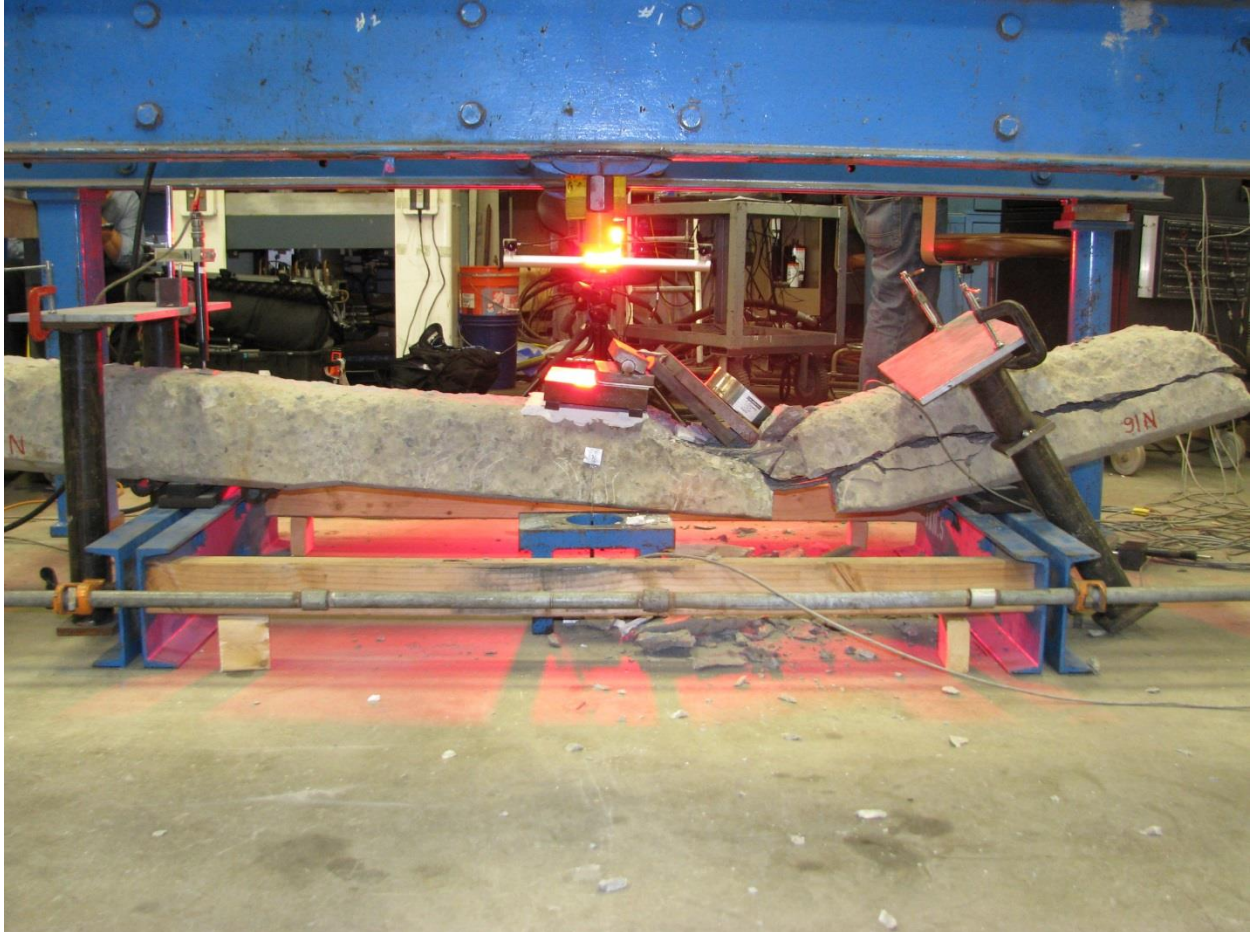
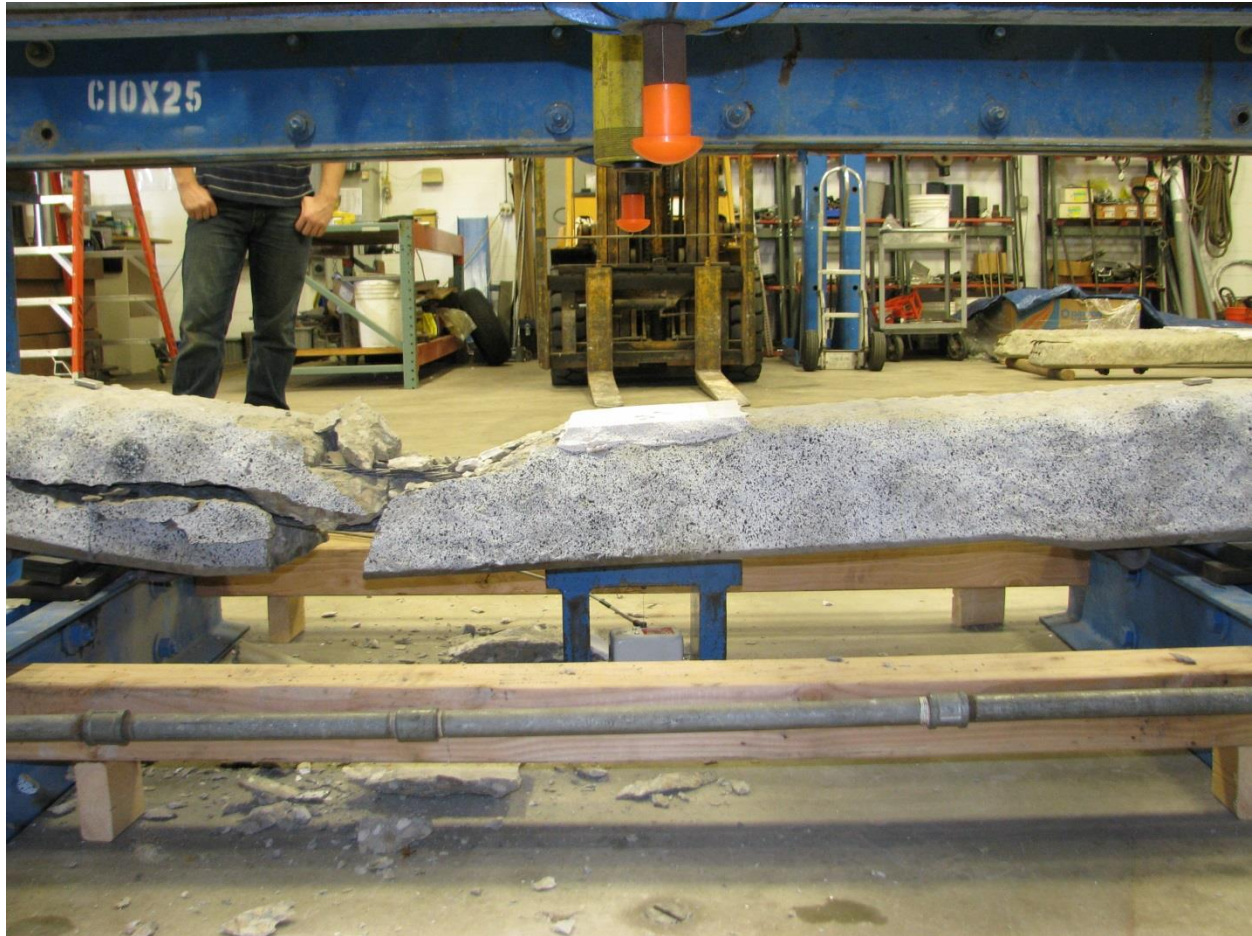
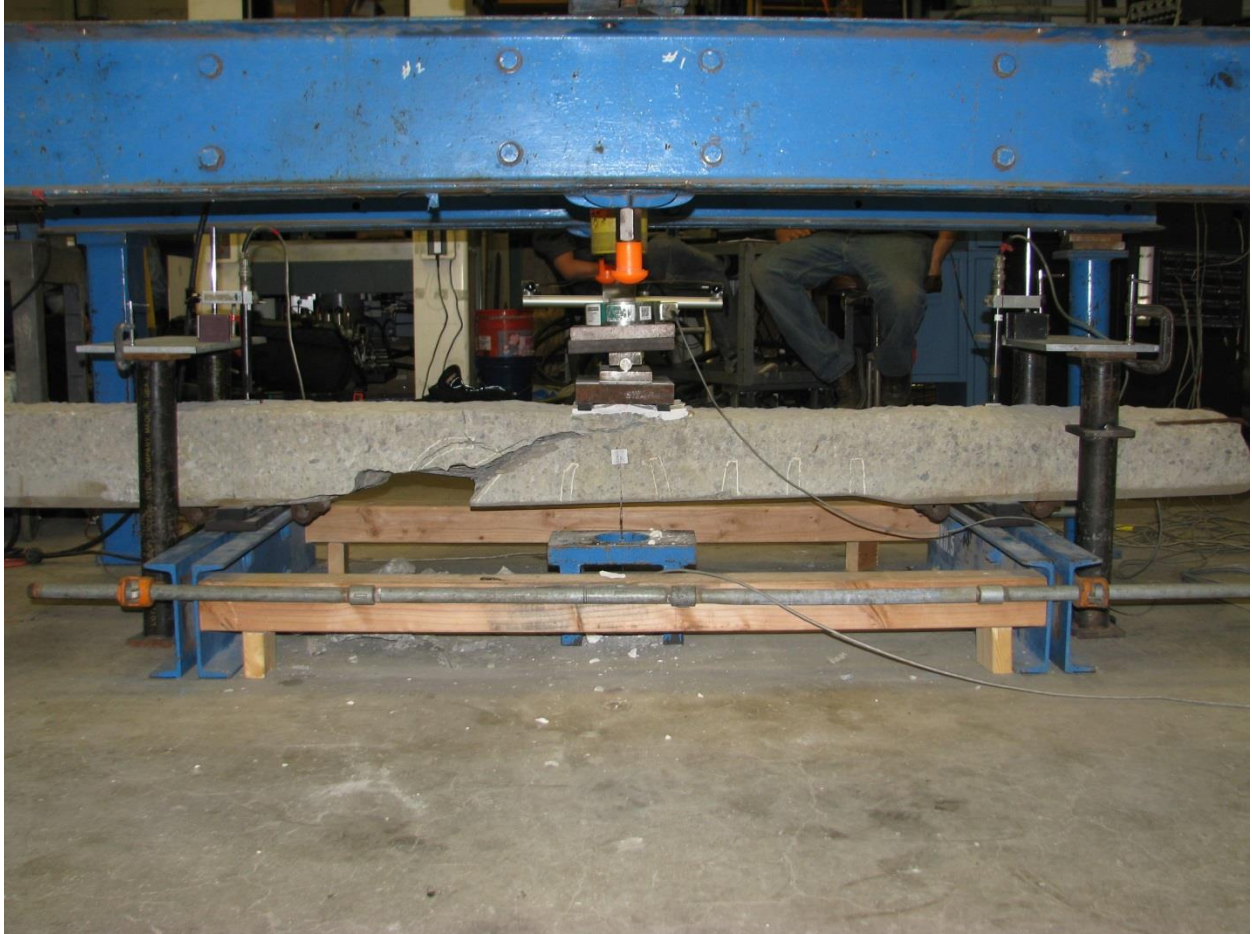
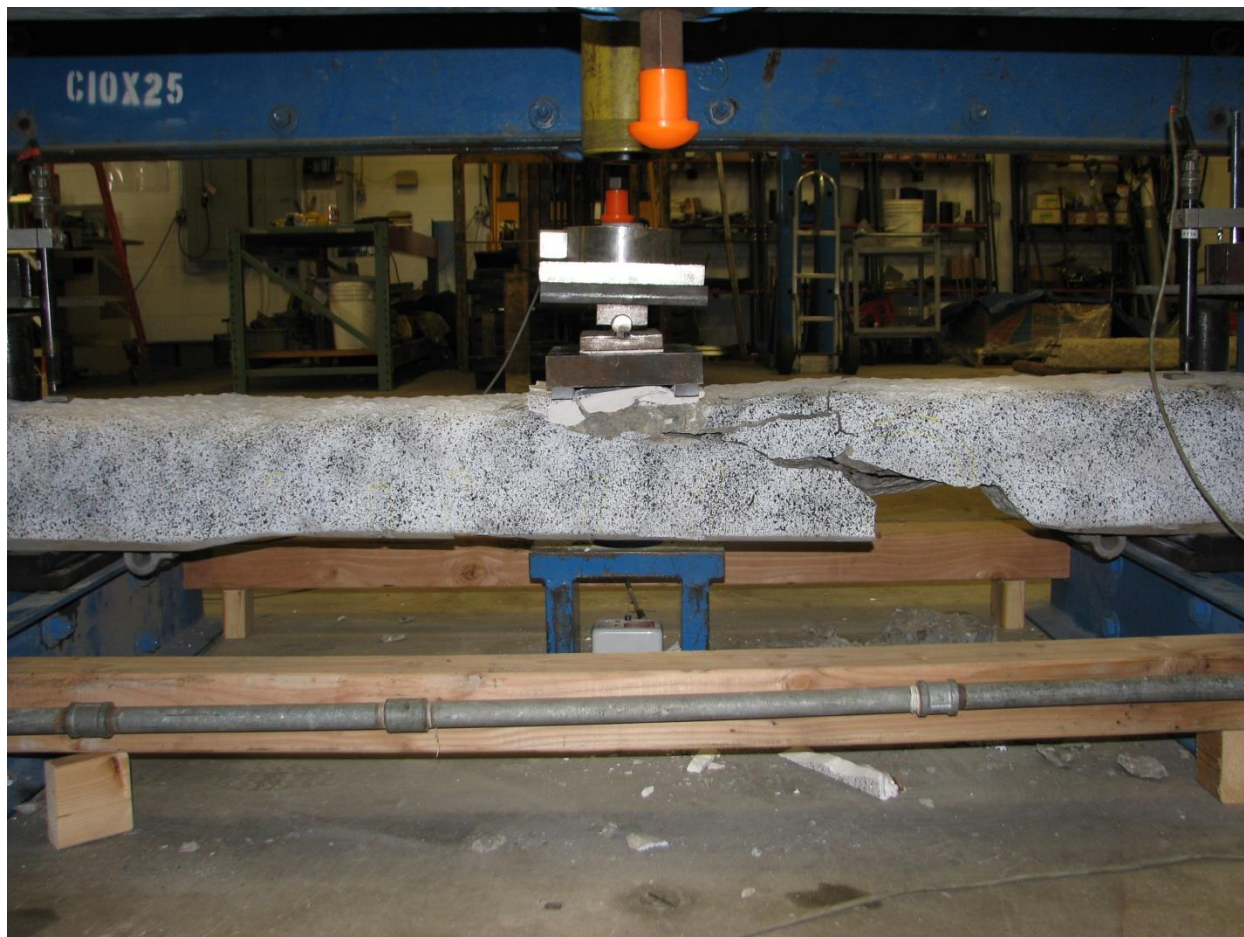
Figure 18. View of east face of New Tie after failure.

Figure 19. View of west face of New Tie after failure.

Figure 20. View of east face of tie N16 after failure.

Figure 21. View of west face of tie N16 after failure.

Figure 22. View of east face of tie S5 after failure.

Figure 23. View of west face of tie S5 after failure.
