NATIONAL TRANSPORTATION SAFETY BOARD

MATERIALS LABORATORY FACTUAL REPORT

Report No. 14-052

Place : New York (Bronx), New York
Date : July 18, 2013
Vehicle : CSX freight train
NTSB No. : DCA13FR009
Investigator : Cy Gura, RPH-10

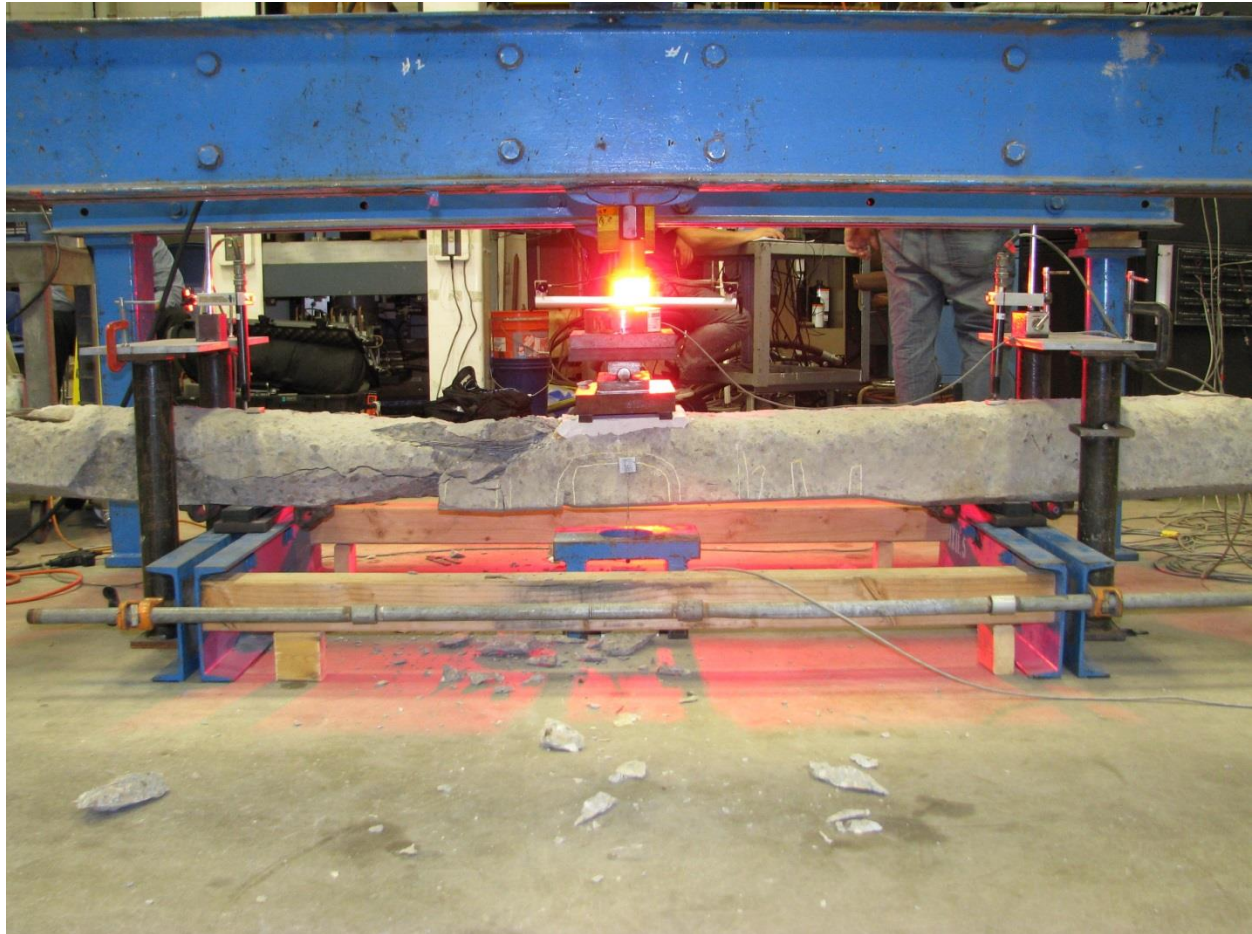
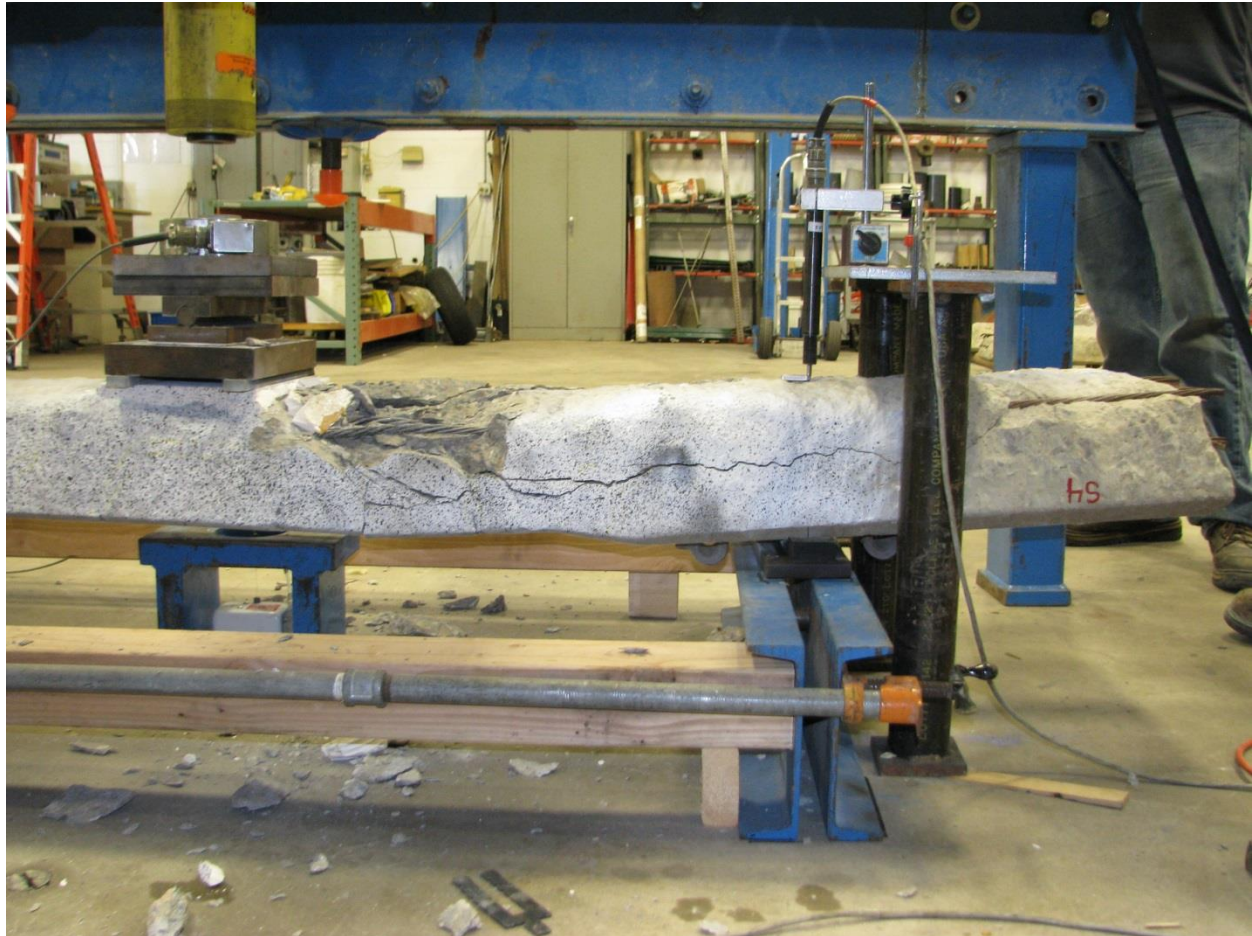
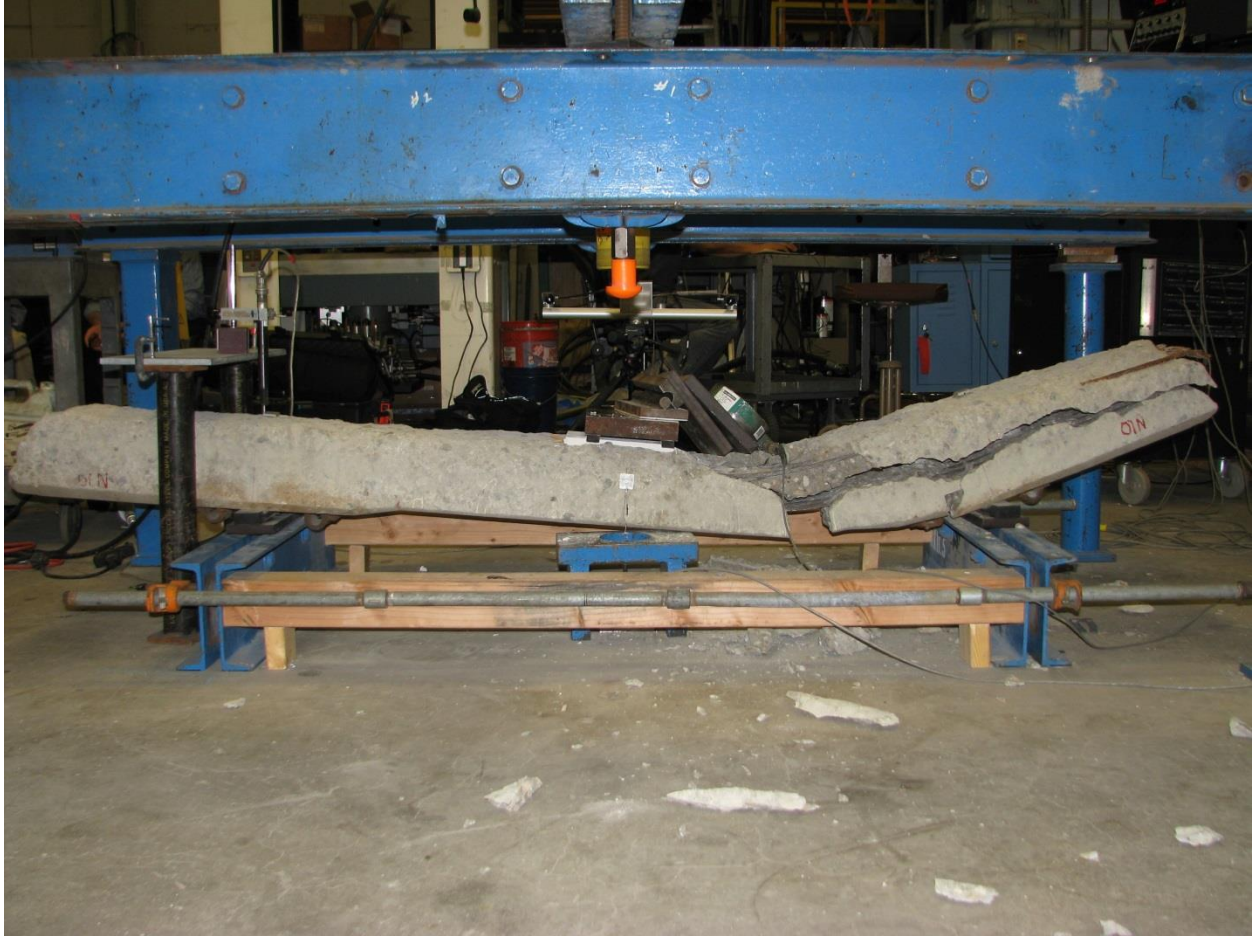
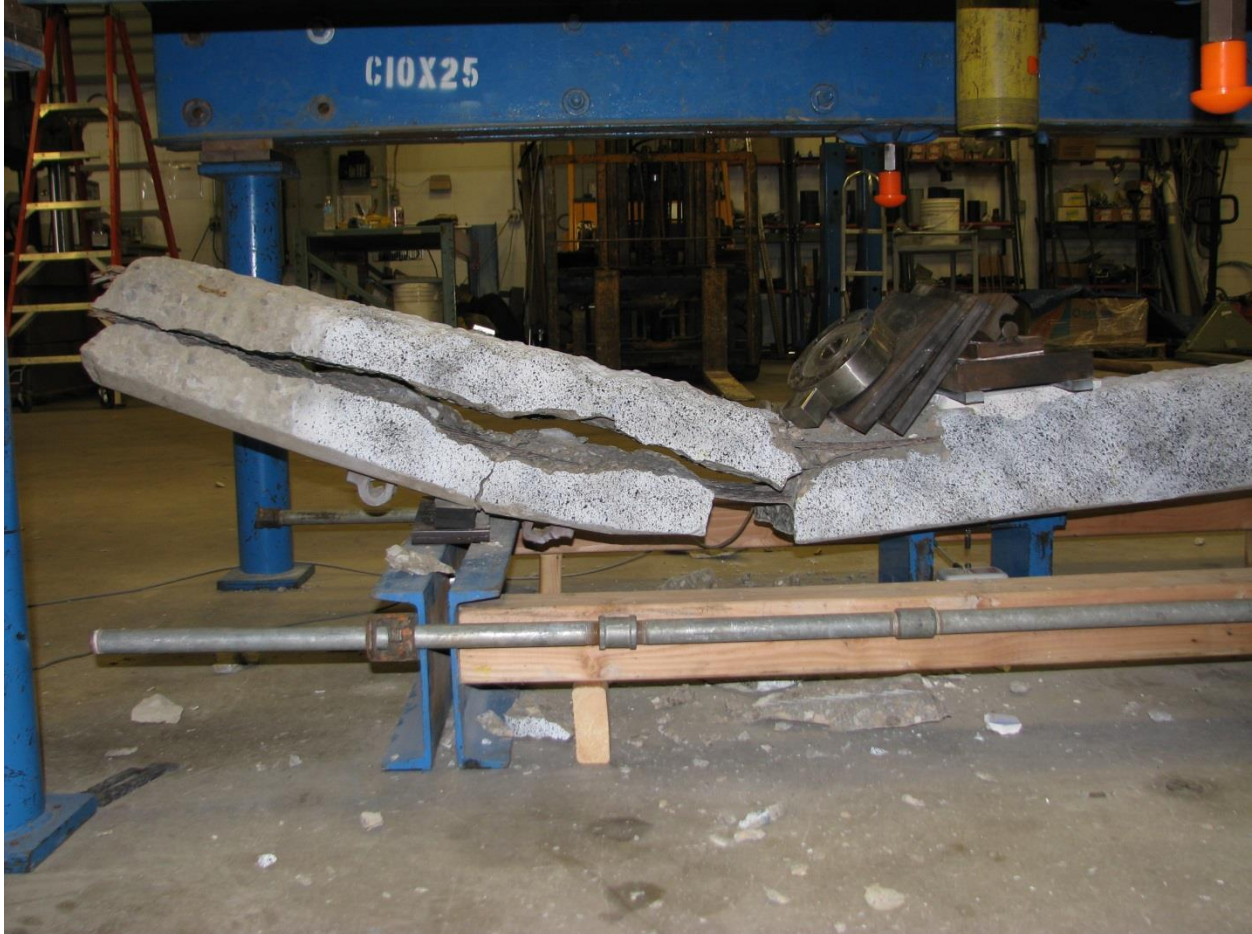
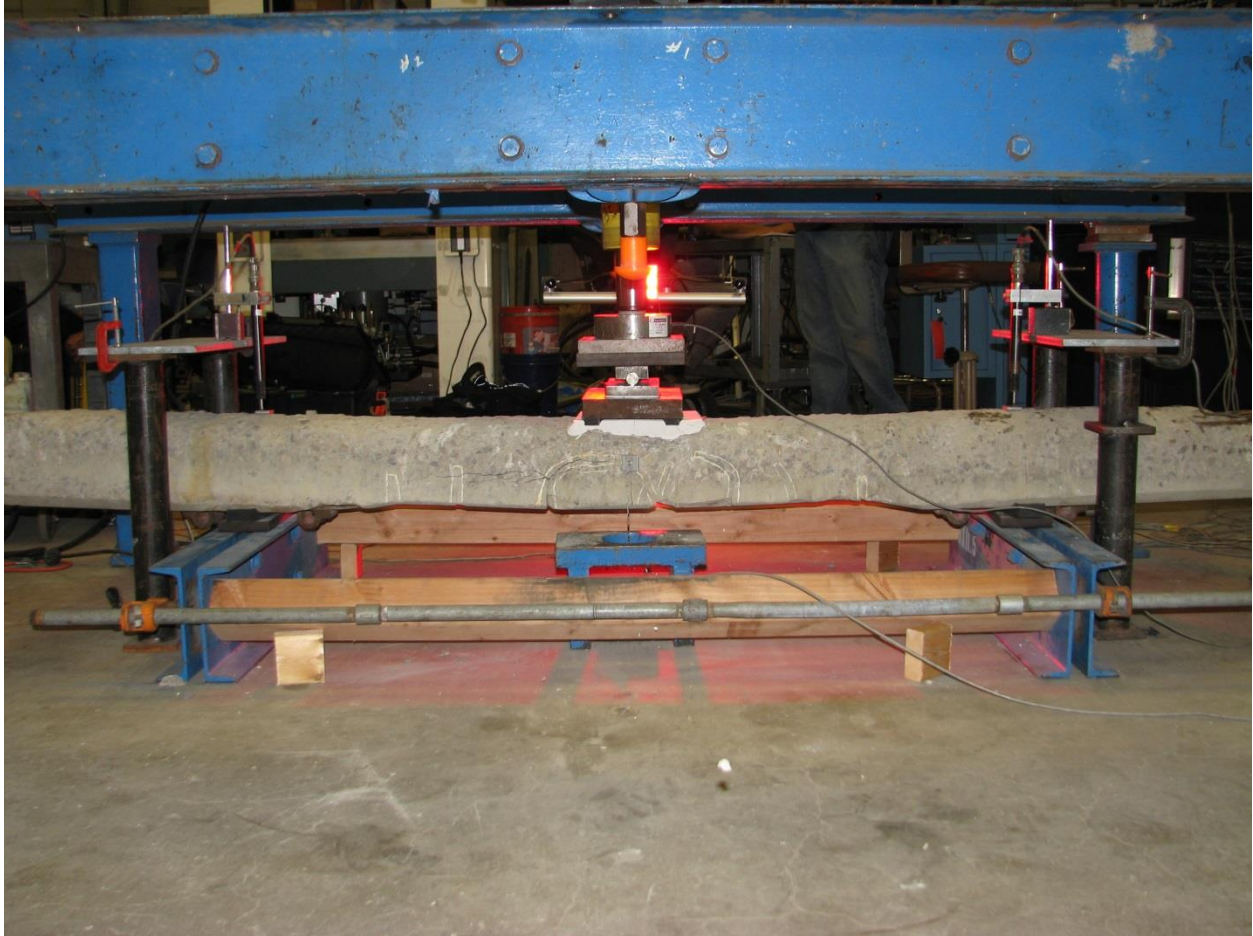
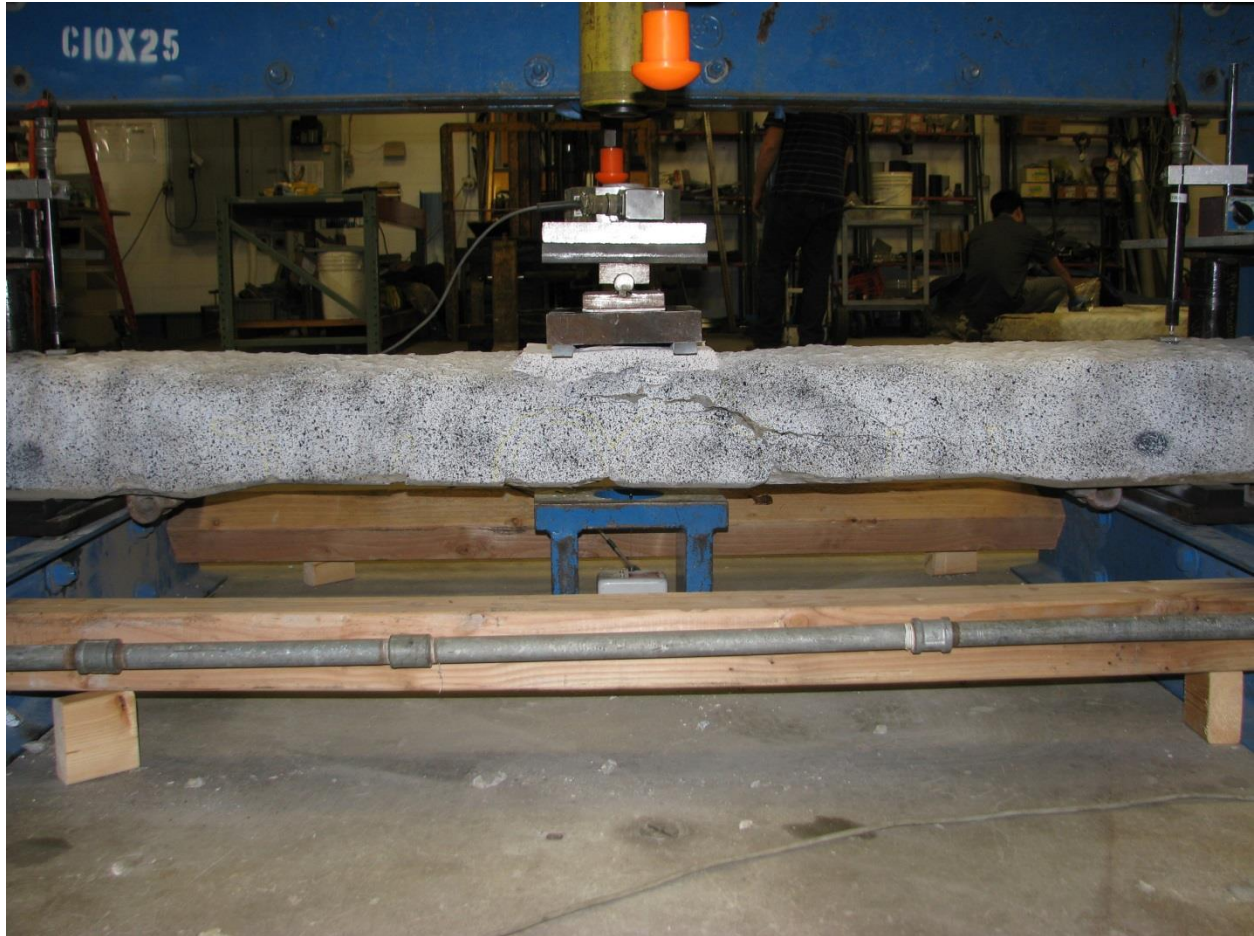
Figure 24. View of east face of tie S4 after failure.

Figure 25. View of west face of tie S4 after failure.

Figure 26. View of east face of tie N10 after failure.

Figure 27. View of west face of tie N10 after failure.

Figure 28. View of east face of tie S3 after failure.

Figure 29. View of west face of tie S3 after failure.

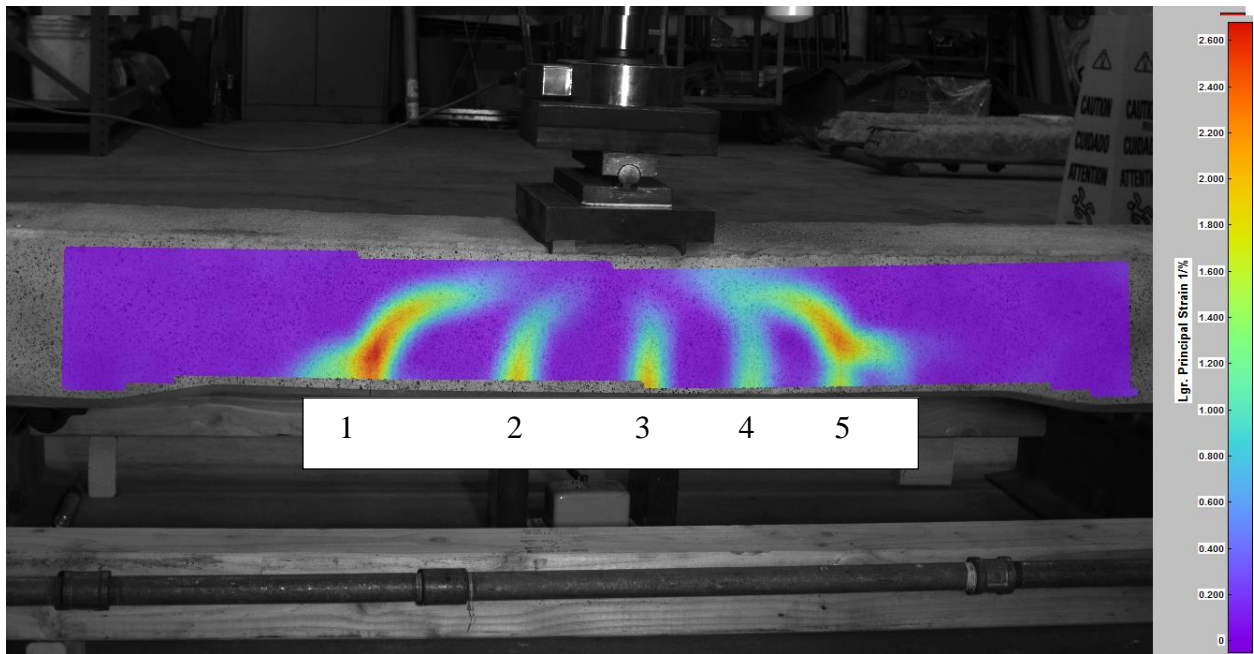
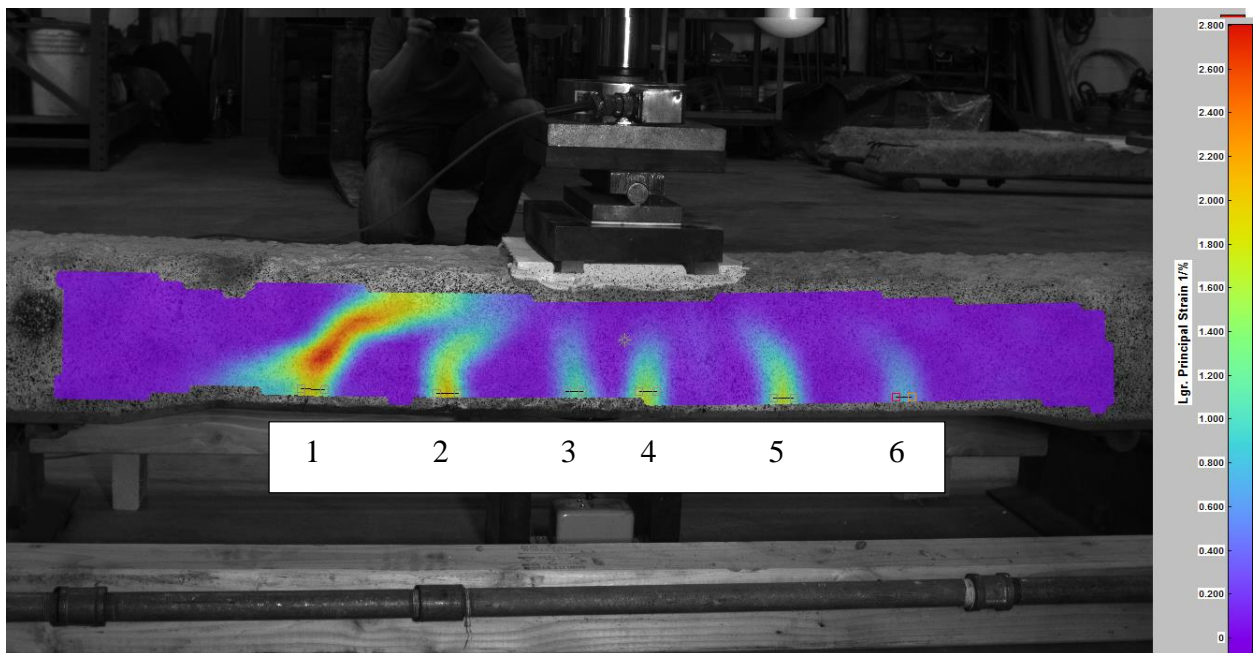
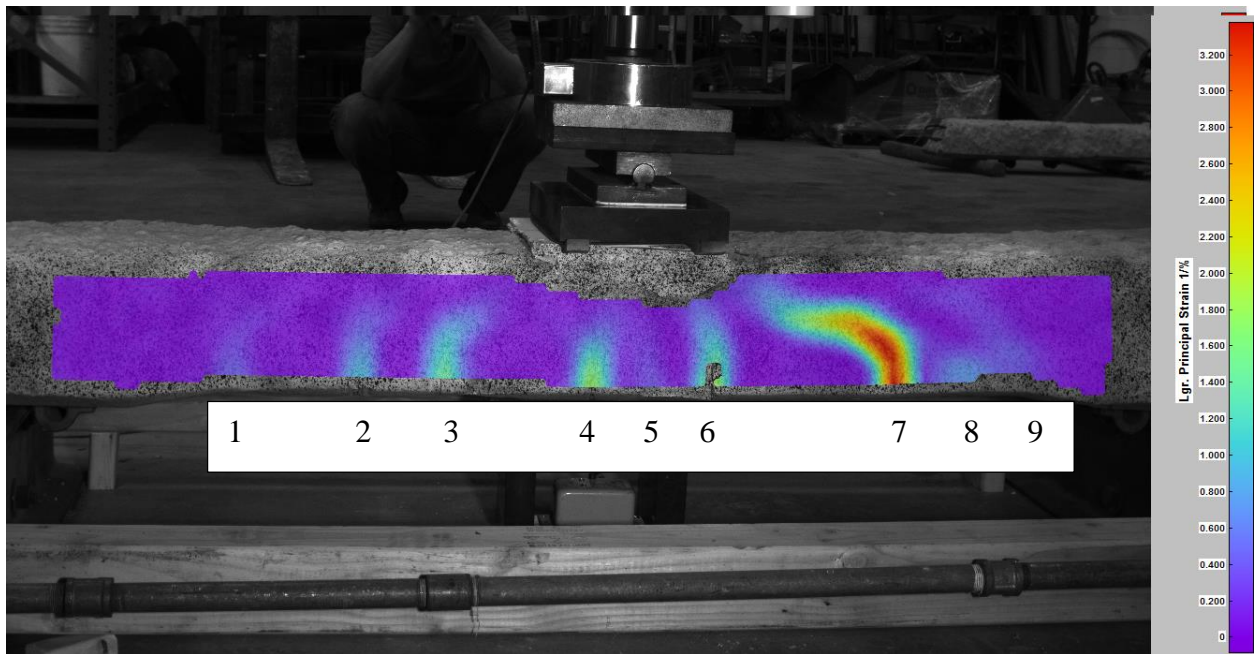
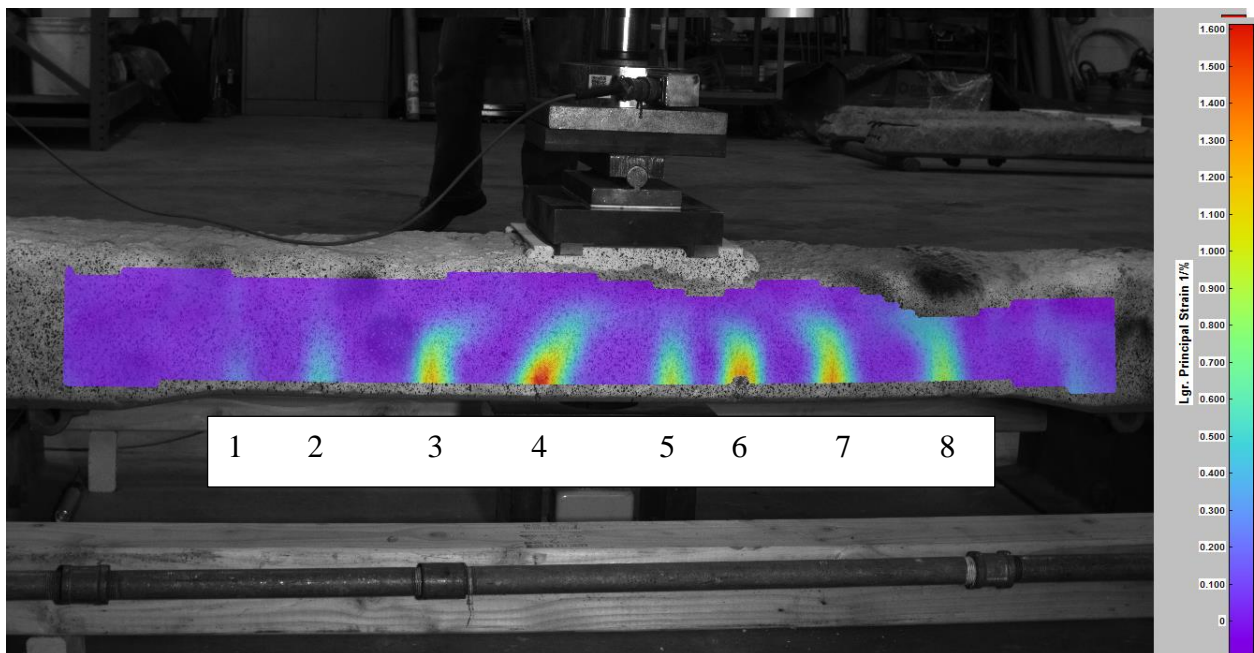
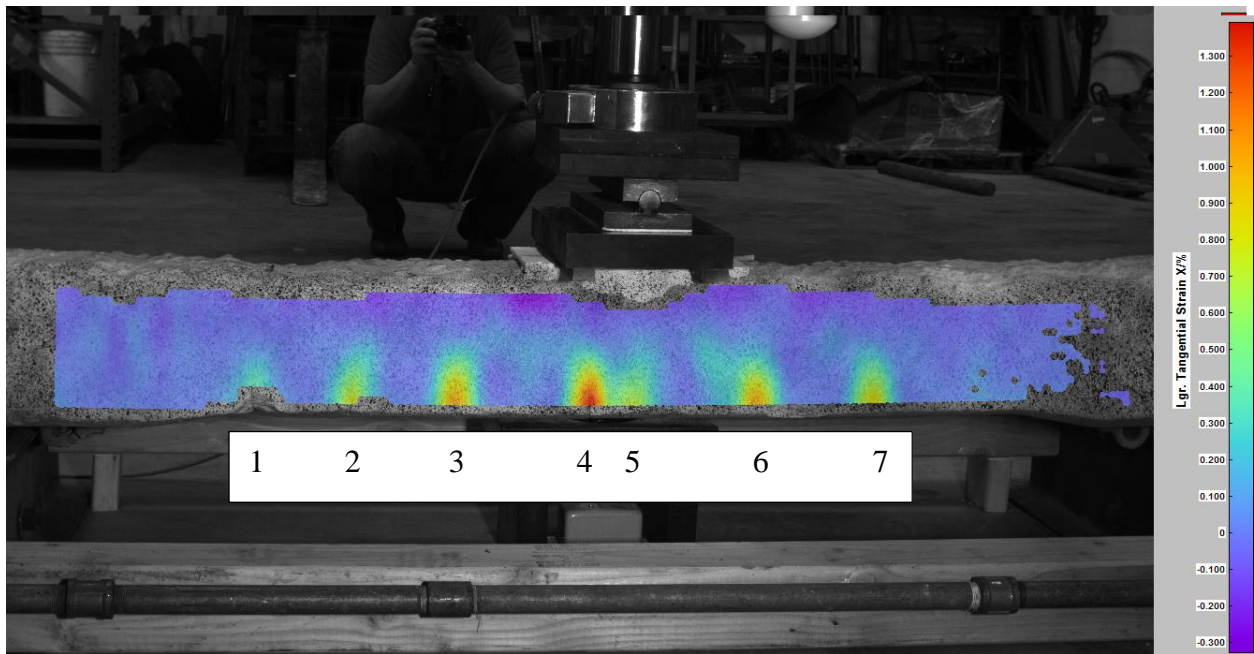
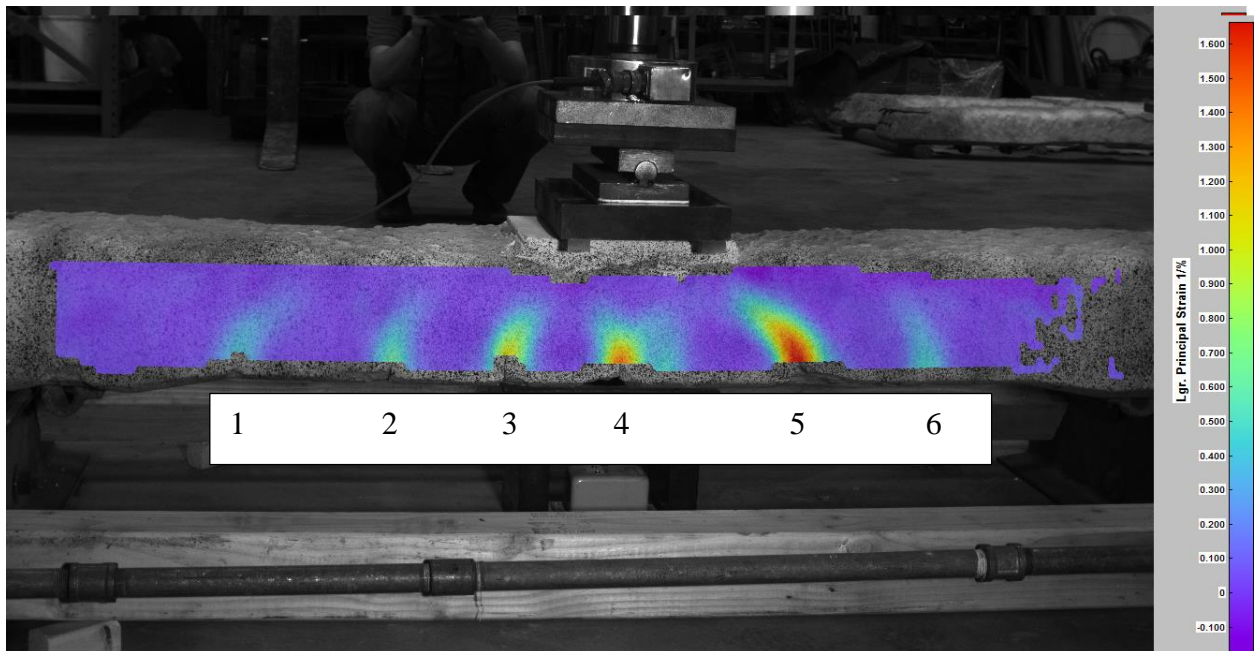
Strain maps showing principal strains of the optically-scanned face of the tested specimens at a time corresponding to immediately before failure are provided in Figures 30 through 35. Strain maps immediately after the New Tie specimen was loaded to 14.4 kips and immediately before the conclusion of the 3 minute period when the load was held at 14.4 kip are provided in Figures 36 and 37. Although no cracks could be visually observed after the initial loading and unloading regimen for the New Tie, the strain maps presented in Figures 36 and 37 suggest some initial cracking may have occurred, as suggested by strain concentrations in the figures. However, correlation between cracking implied by strain maps in Figures 36 and 37 and strain mapping immediately before failure of the New Tie (Figure 30) does not result in precise matching of discrete crack locations.

Figure 30. Principal strain map immediately before failure of New Tie.

Figure 31. Principal strain map immediately before failure of Tie N16.

Figure 32. Principal strain map immediately before failure of tie S5.

Figure 33. Principal strain map immediately before failure of tie S4.

Figure 34. Principal strain map immediately before failure of tie N10.

Figure 35. Principal strain map immediately before failure of tie S3.

All crack locations indicated by DIC system strain measurements are shown in Figures 30 through 35 and are numbered consequentially from left to right. Virtual gauges were designated at these locations to estimate the load at which each crack formed or existing cracks started to open up during loading to failure of the specimens. The indicated strains at cracks for each specimen are plotted in Figures 40 through 51. Based on a review of these strain data, the estimated loads to initiate cracking, or to cause opening of existing cracks are provided in Table 2. The “step” numbers cited in Table 2 are DIC measurement numbers, which also correspond to time steps in the electronically provided strain movies and raw data for each virtual gage. Due to the noted variability in the strain measurements, particularly in the low strain ranges associated with crack opening loads, the provided crack opening loads and step numbers in Table 2 should be considered accurate to approximately +/-3 kips.

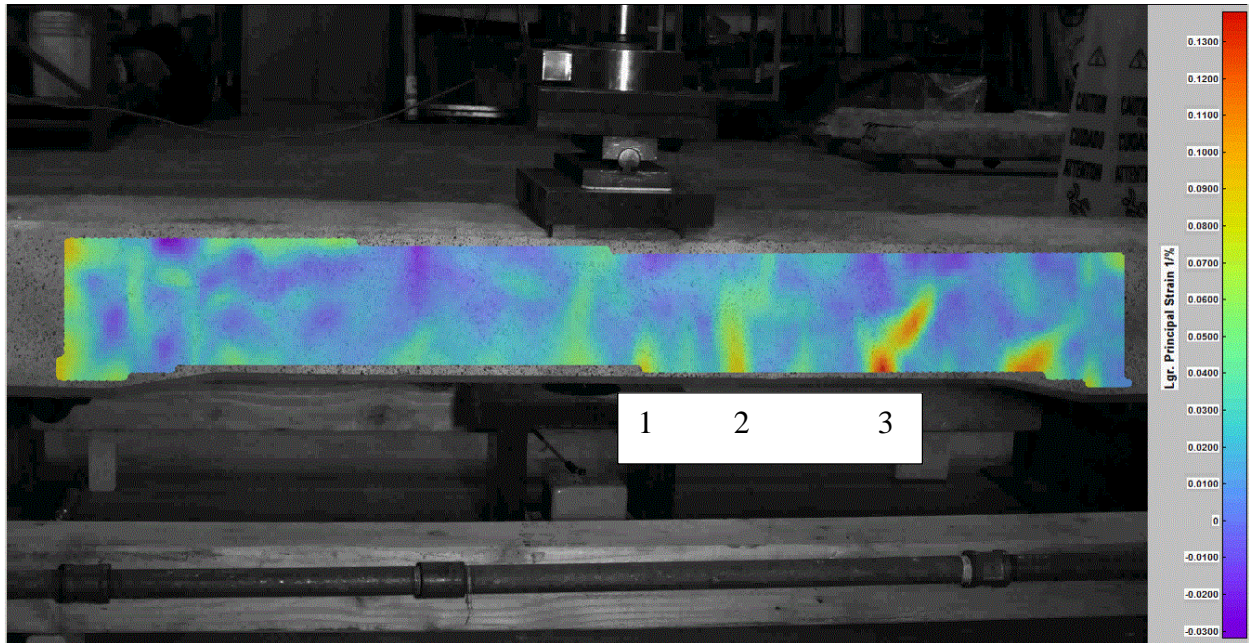
Figure 36. Strain map measured using DIC on New Tie when the applied load first reached the target load of 14.4 kips (actual measured load is 14.55 kips).

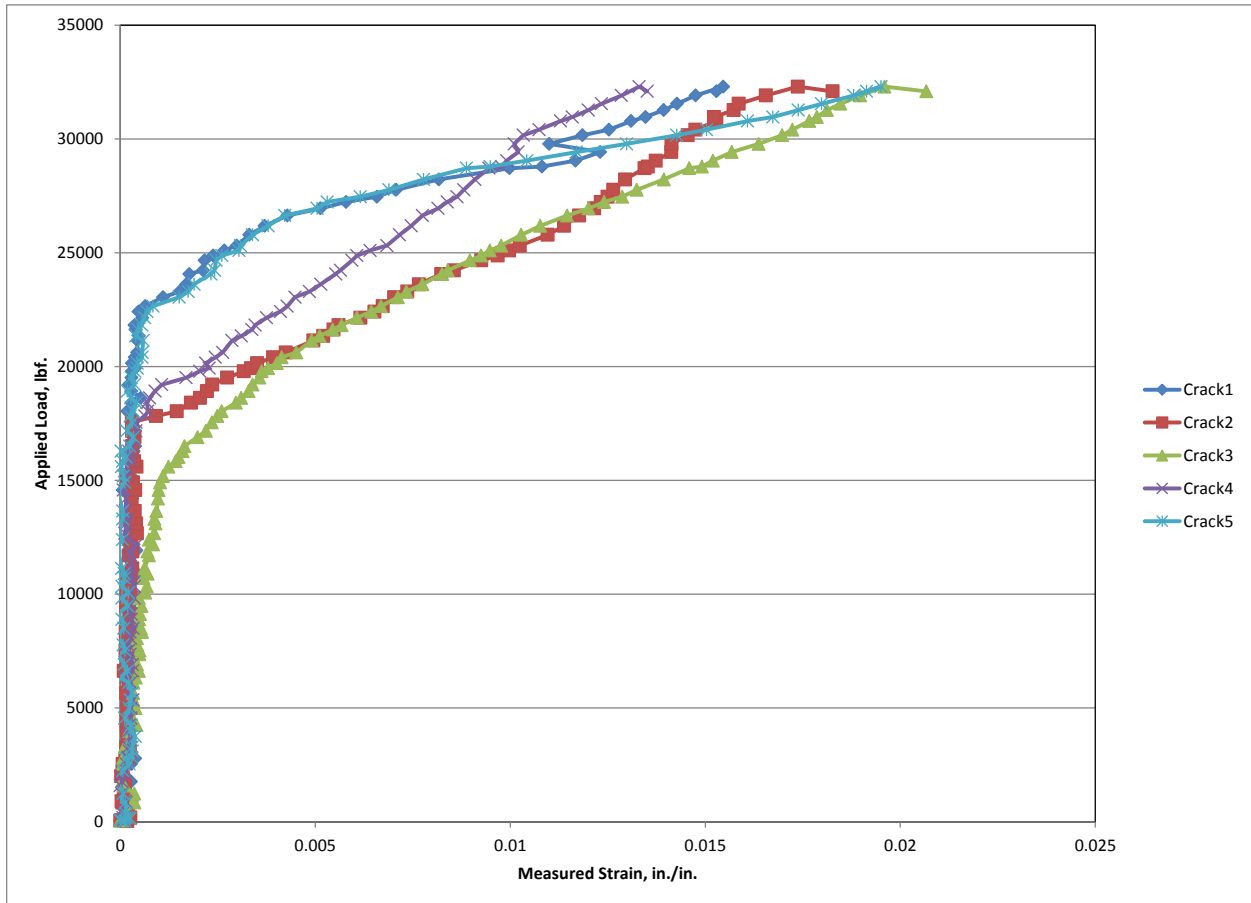
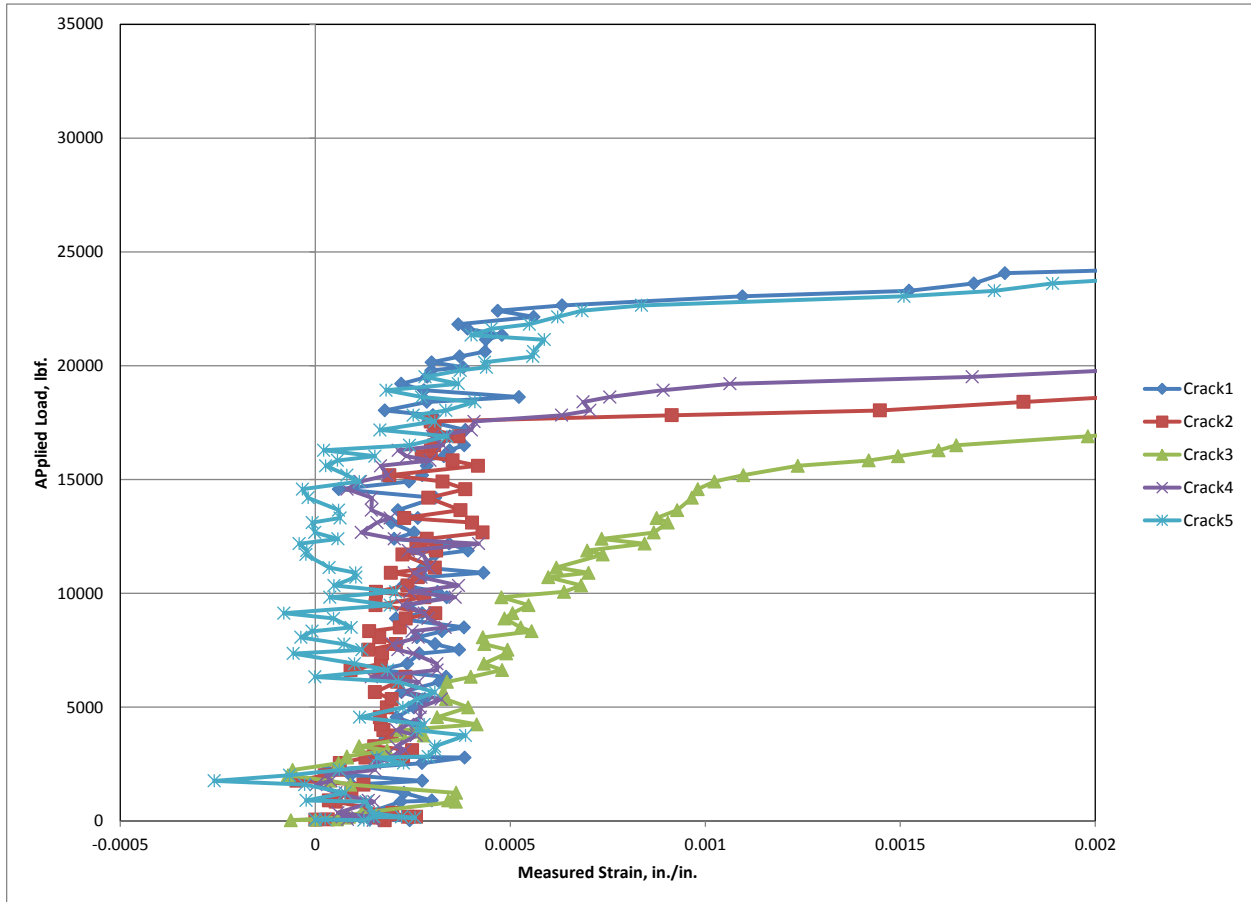
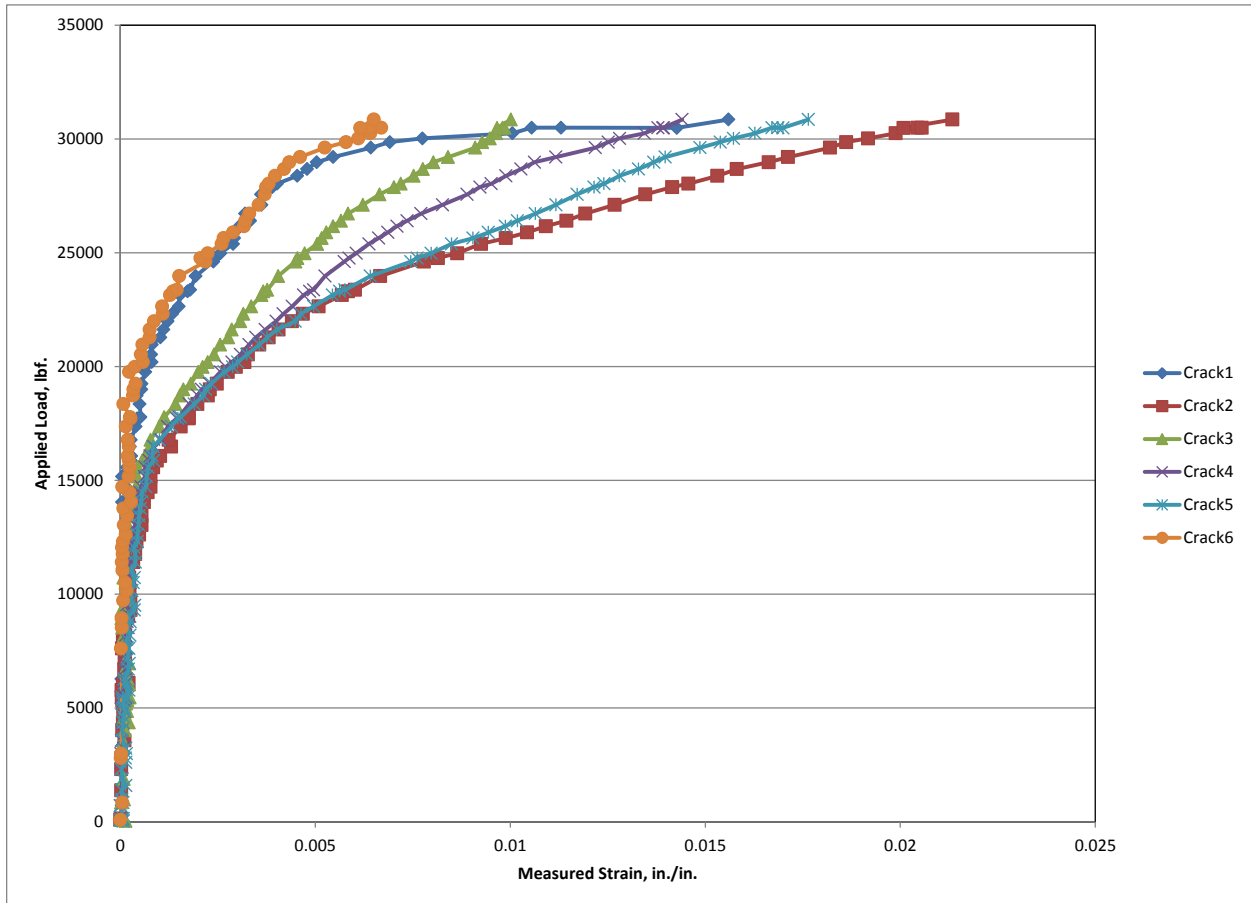
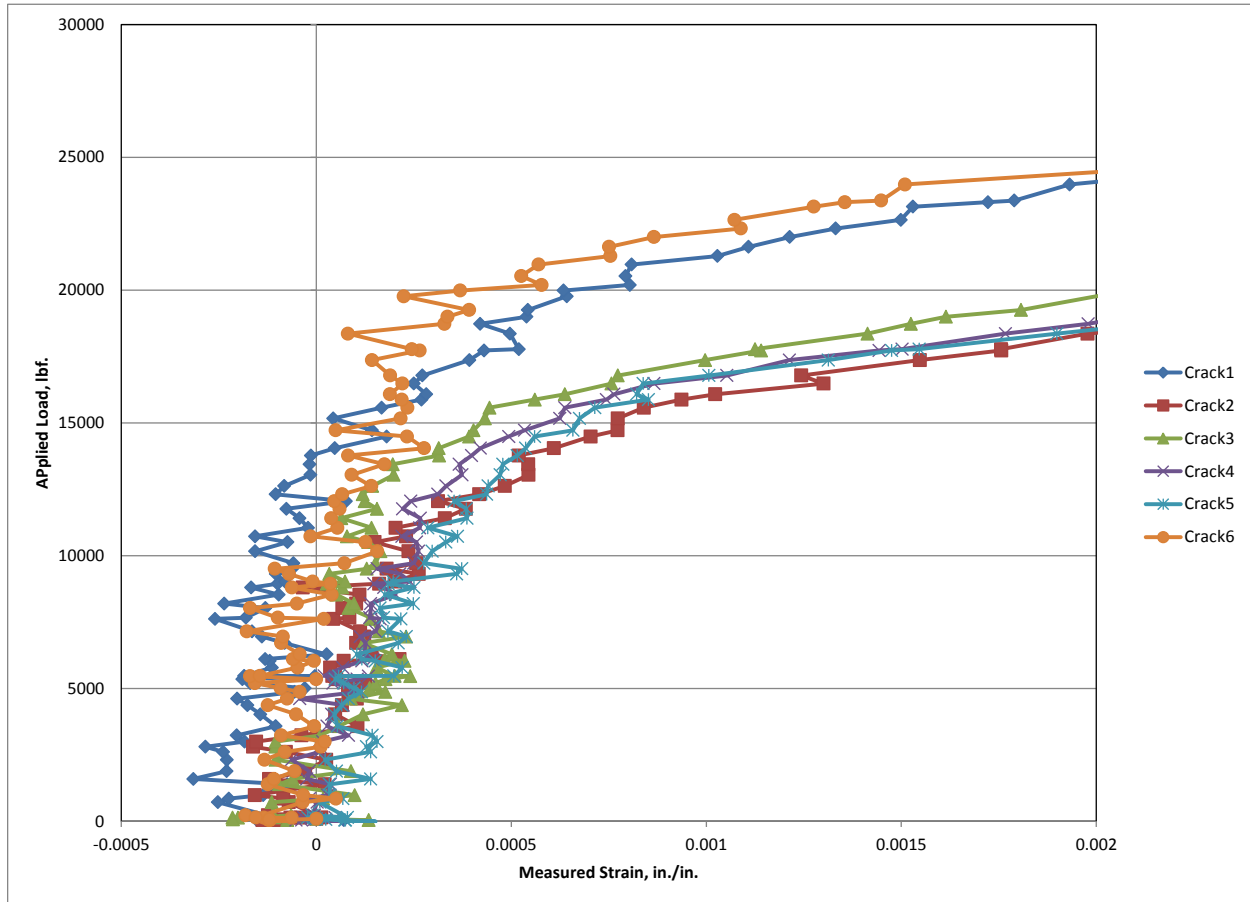
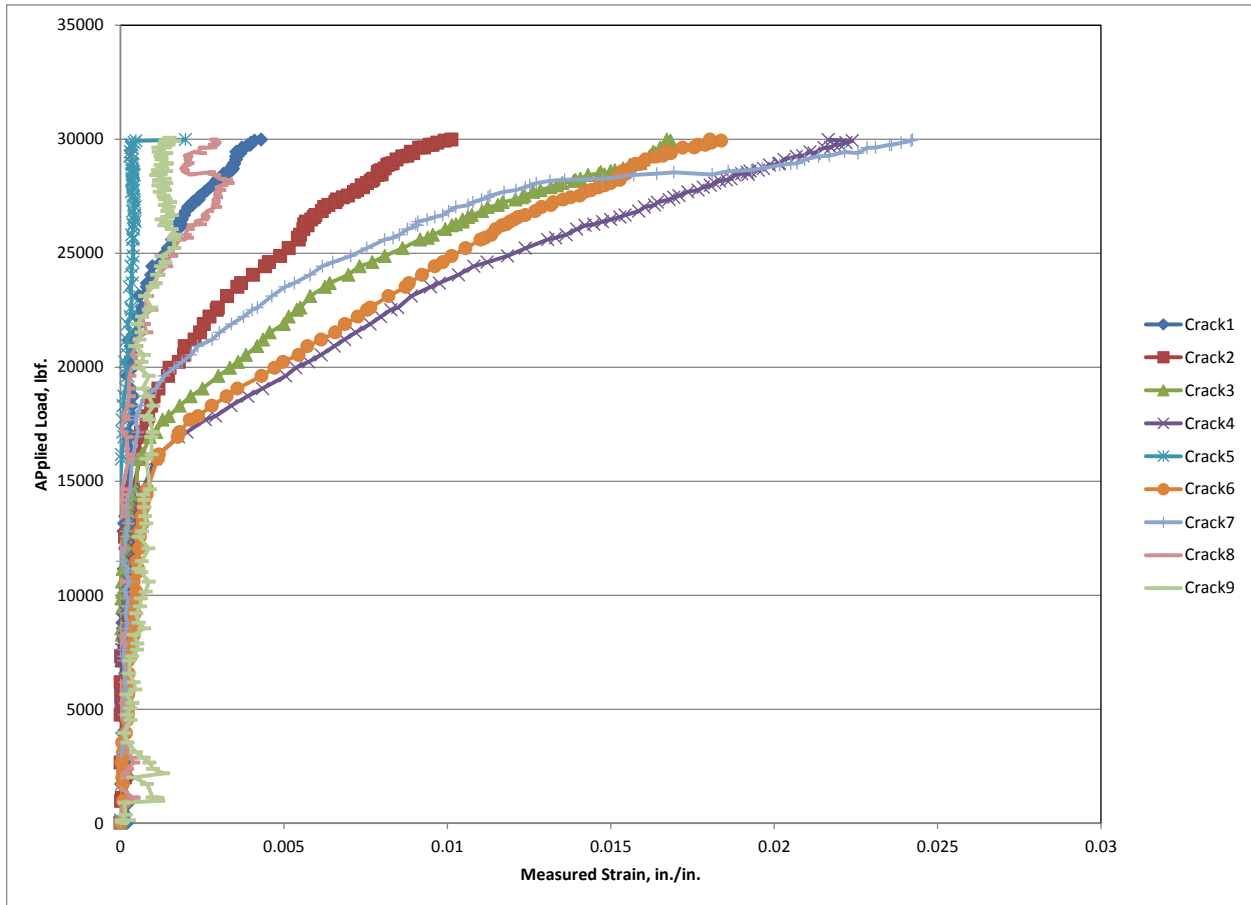
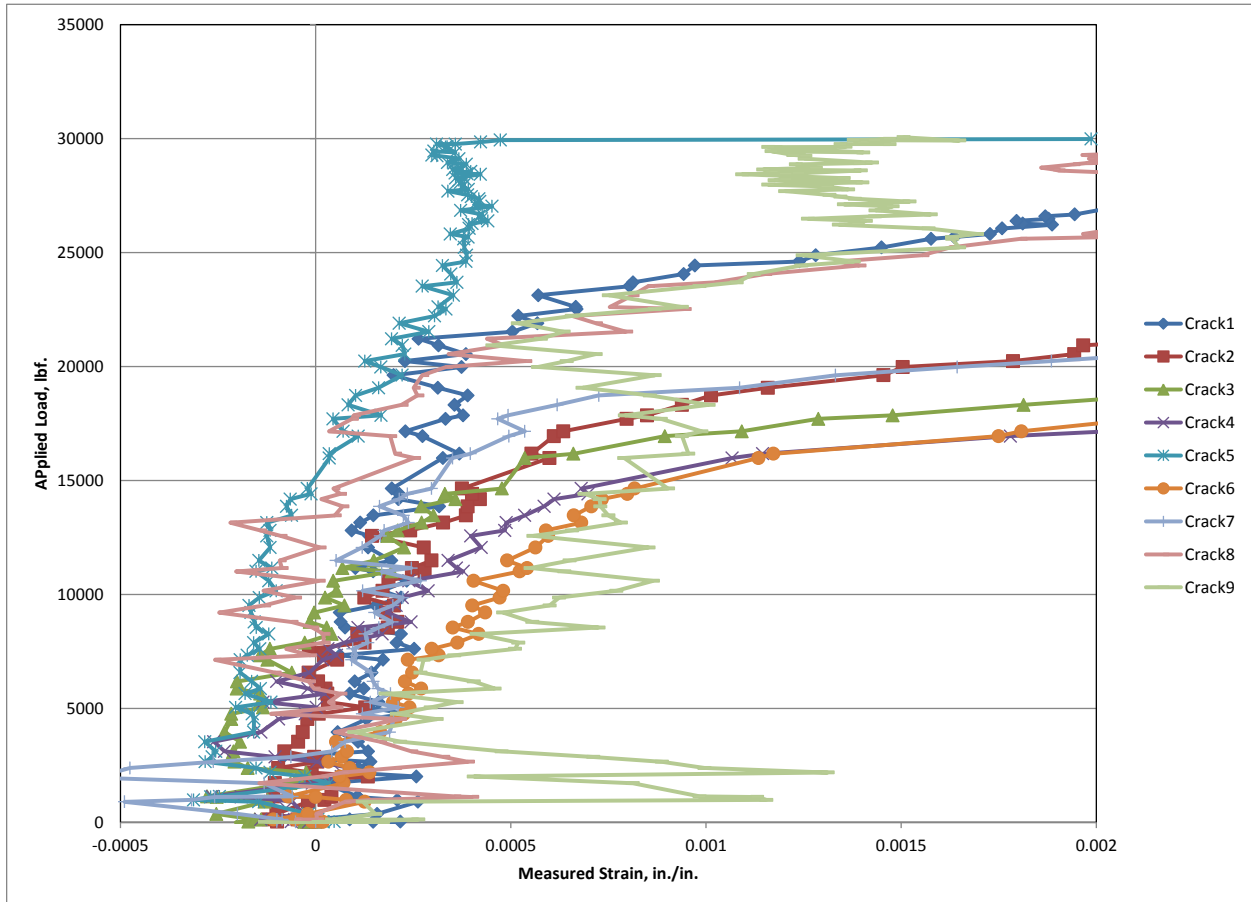
Figure 40. Virtual gage measurements across cracks indicated on the New Tie strain map in Figure 30.

Figure 41. Virtual gage measurements across cracks indicated on the New Tie strain map in Figure 30 zoomed to a lower strain range.

Figure 42. Virtual gage measurements across cracks indicated on Tie N16 strain map in Figure 31.

Figure 43. Virtual gage measurements across cracks indicated on Tie N16 strain map in Figure 31 zoomed to a lower strain range.

Figure 44. Virtual gage measurements across cracks indicated on Tie S5 strain map in Figure 32.

Figure 45. Virtual gage measurements across cracks indicated on Tie S5 strain map in Figure 32 zoomed to a lower strain range.
