NATIONAL TRANSPORTATION SAFETY BOARD

MATERIALS LABORATORY FACTUAL REPORT

Report No. 14-052

Place : New York (Bronx), New York
Date : July 18, 2013
Vehicle : CSX freight train
NTSB No. : DCA13FR009
Investigator : Cy Gura, RPH-10

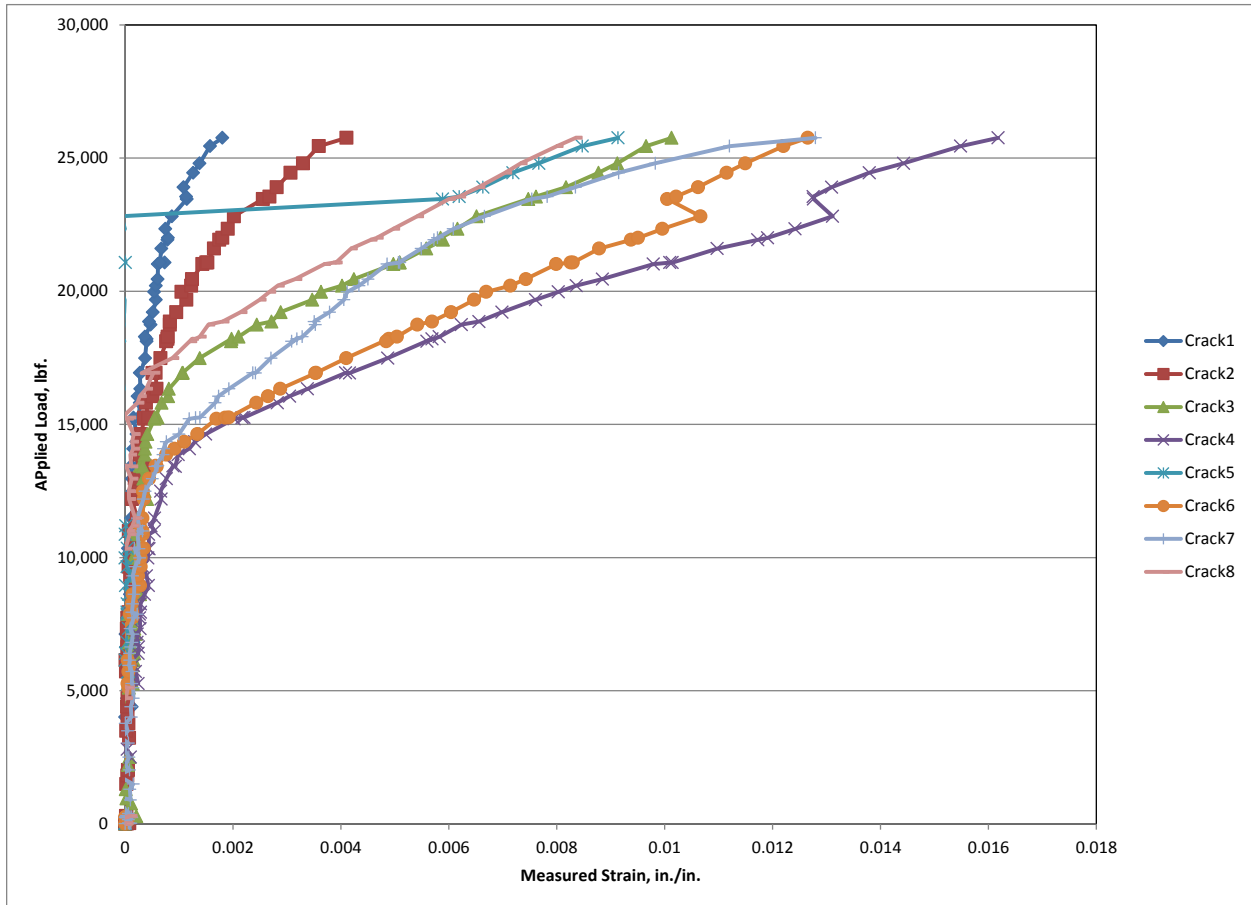
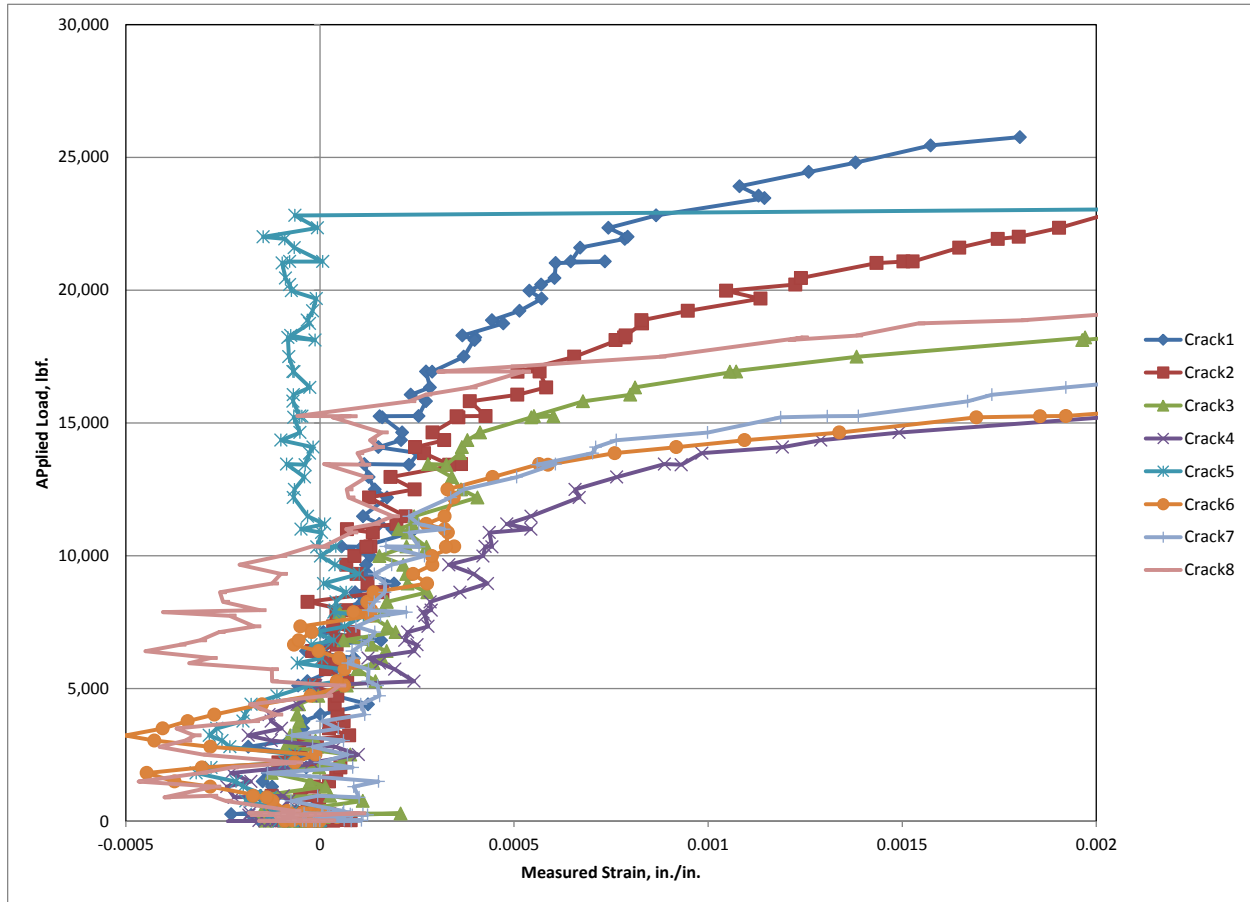
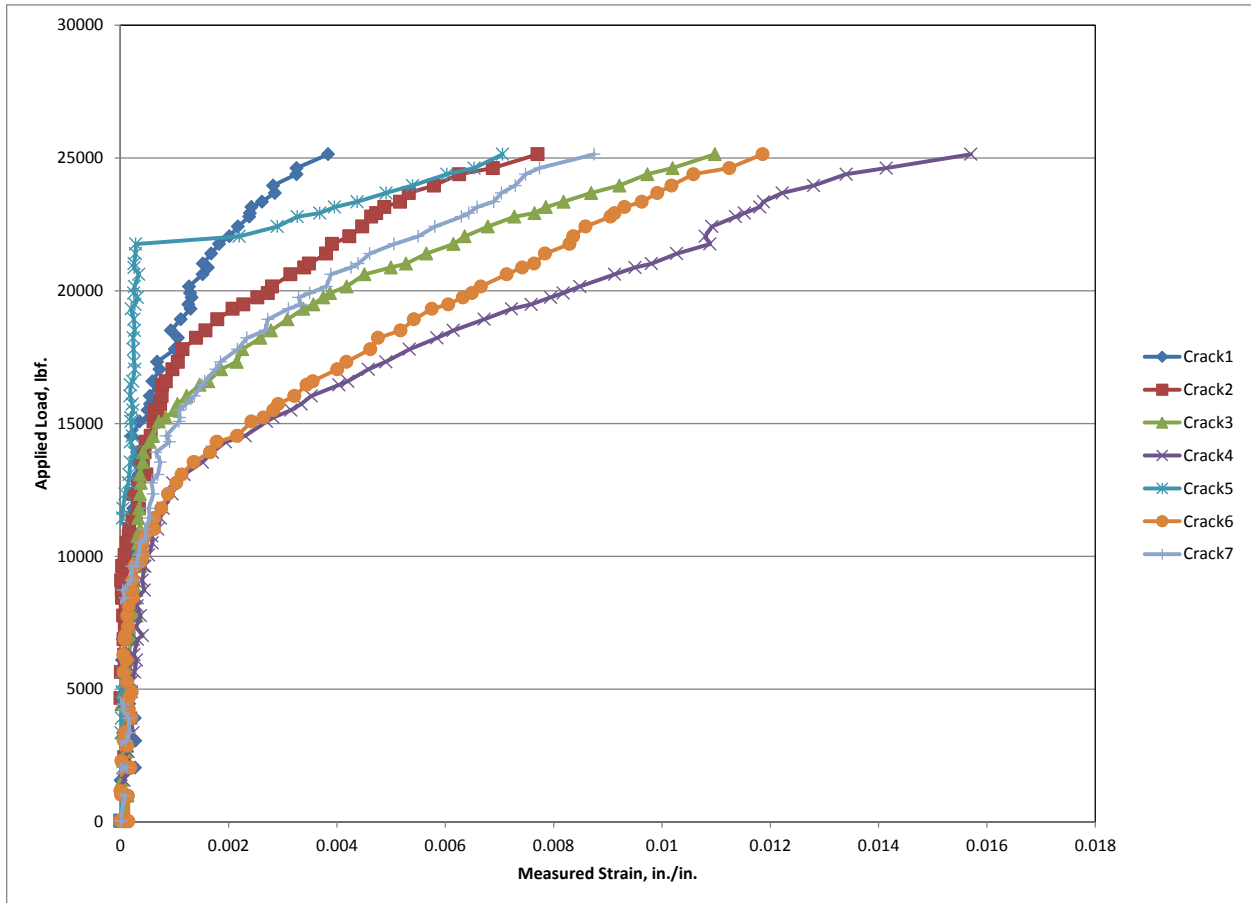
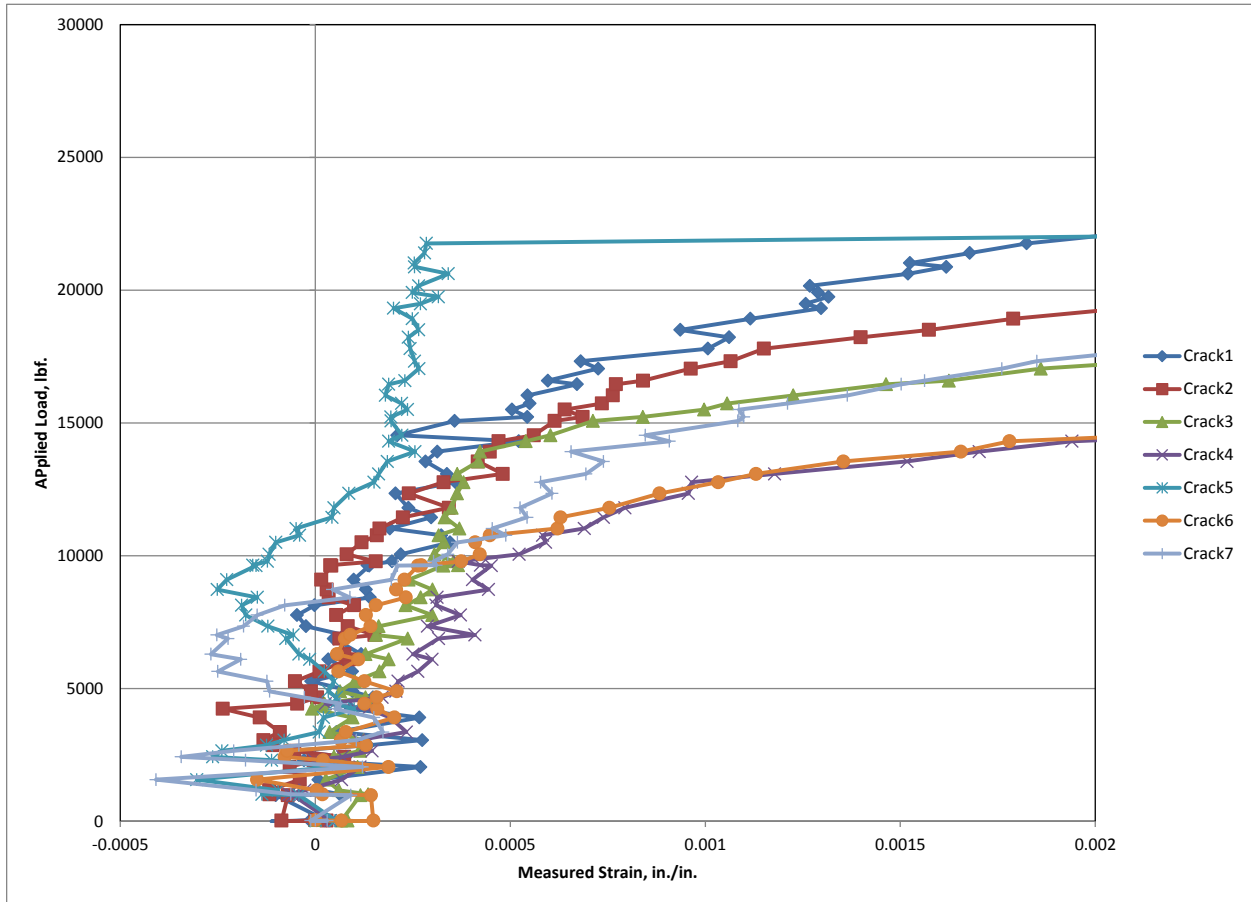
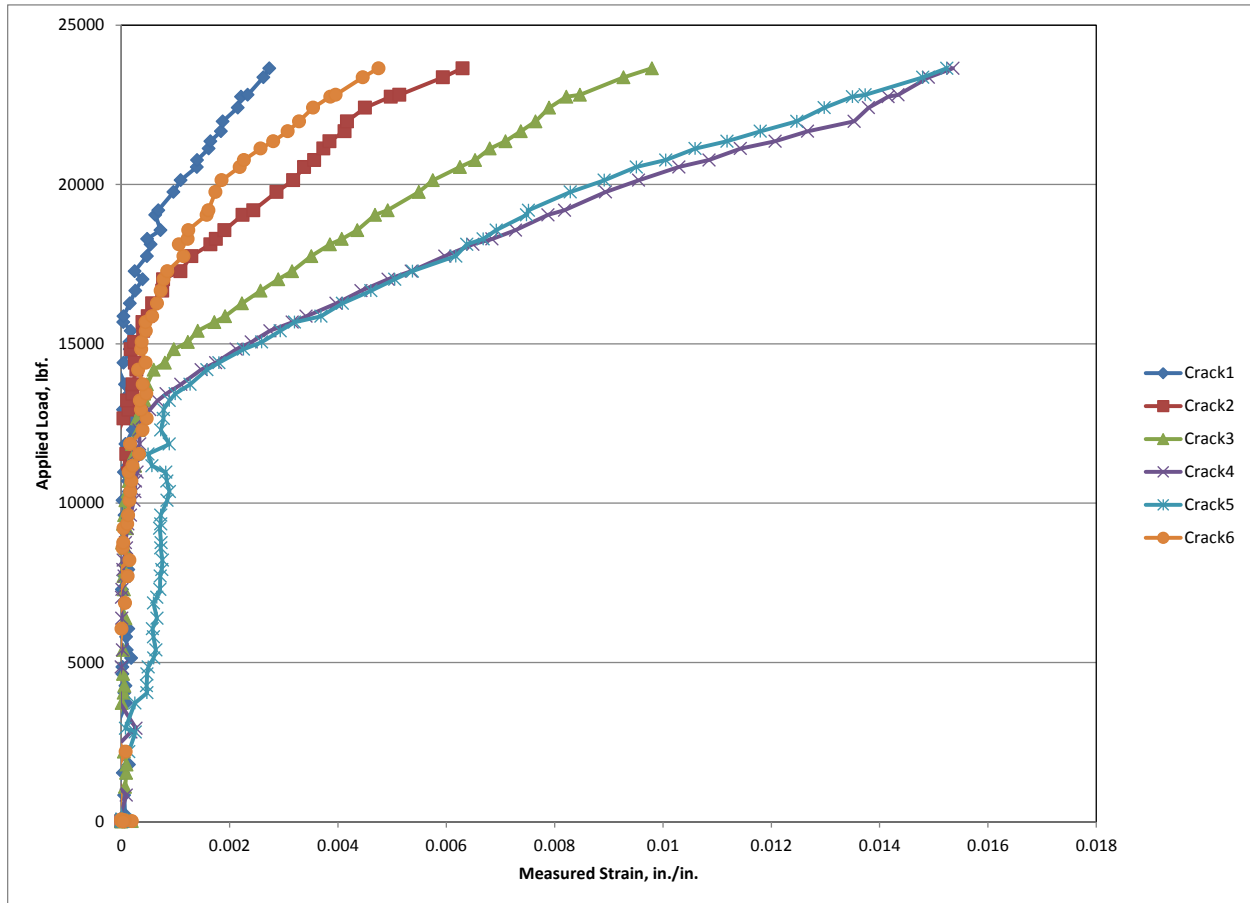
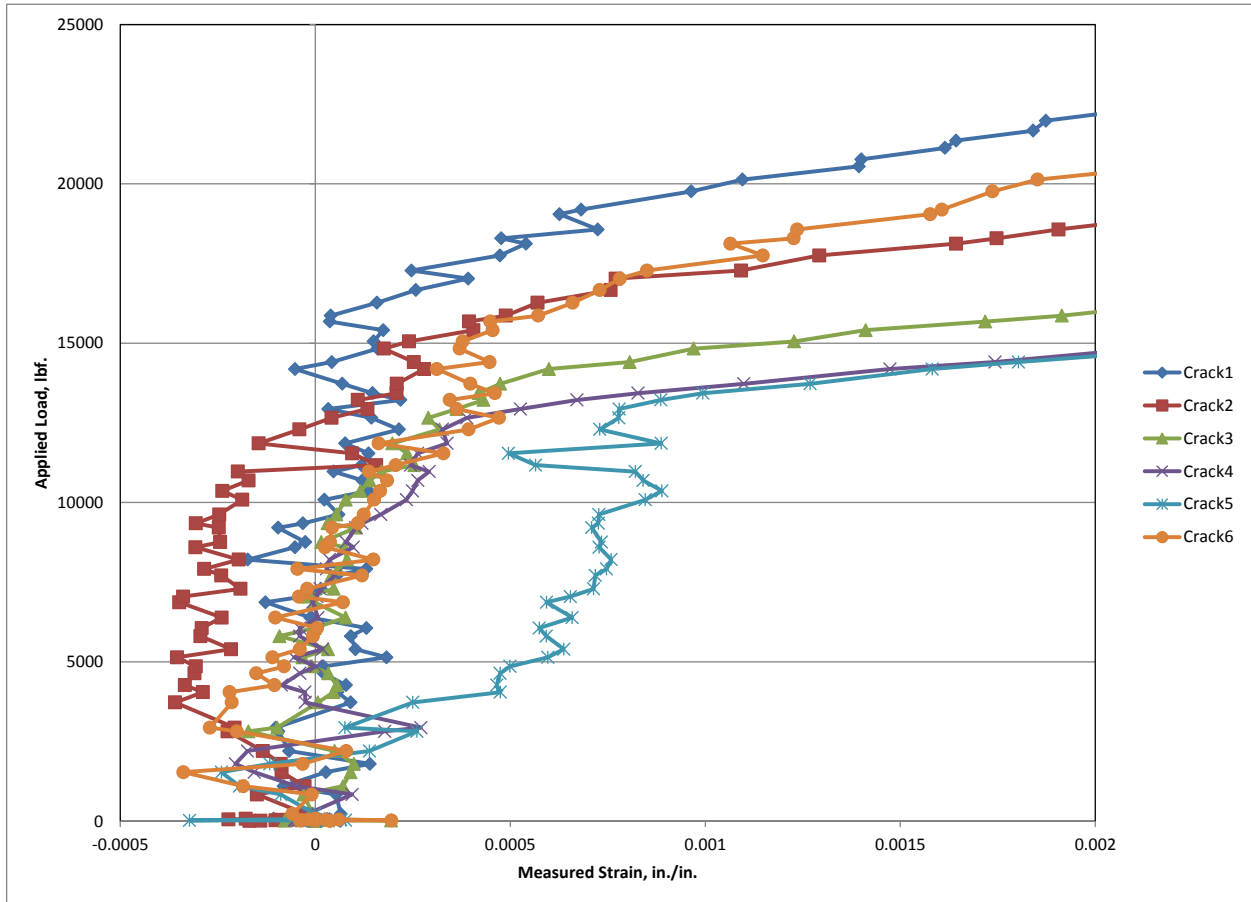
Figure 46. Virtual gage measurements across cracks indicated on Tie S4 strain map in Figure 33.

Figure 47. Virtual gage measurements across cracks indicated on Tie S4 strain map in Figure 33 zoomed to a lower strain range.

Figure 48. Virtual gage measurements across cracks indicated on Tie N10 strain map in Figure 34.

Figure 49. Virtual gage measurements across cracks indicated on Tie N10 strain map in Figure 34 zoomed to a lower strain range.

Figure 50. Virtual gage measurements across cracks indicated on Tie S3 strain map in Figure 35.

Figure 51. Virtual gage measurements across cracks indicated on Tie S3 strain map in Figure 35 zoomed to a lower strain range.

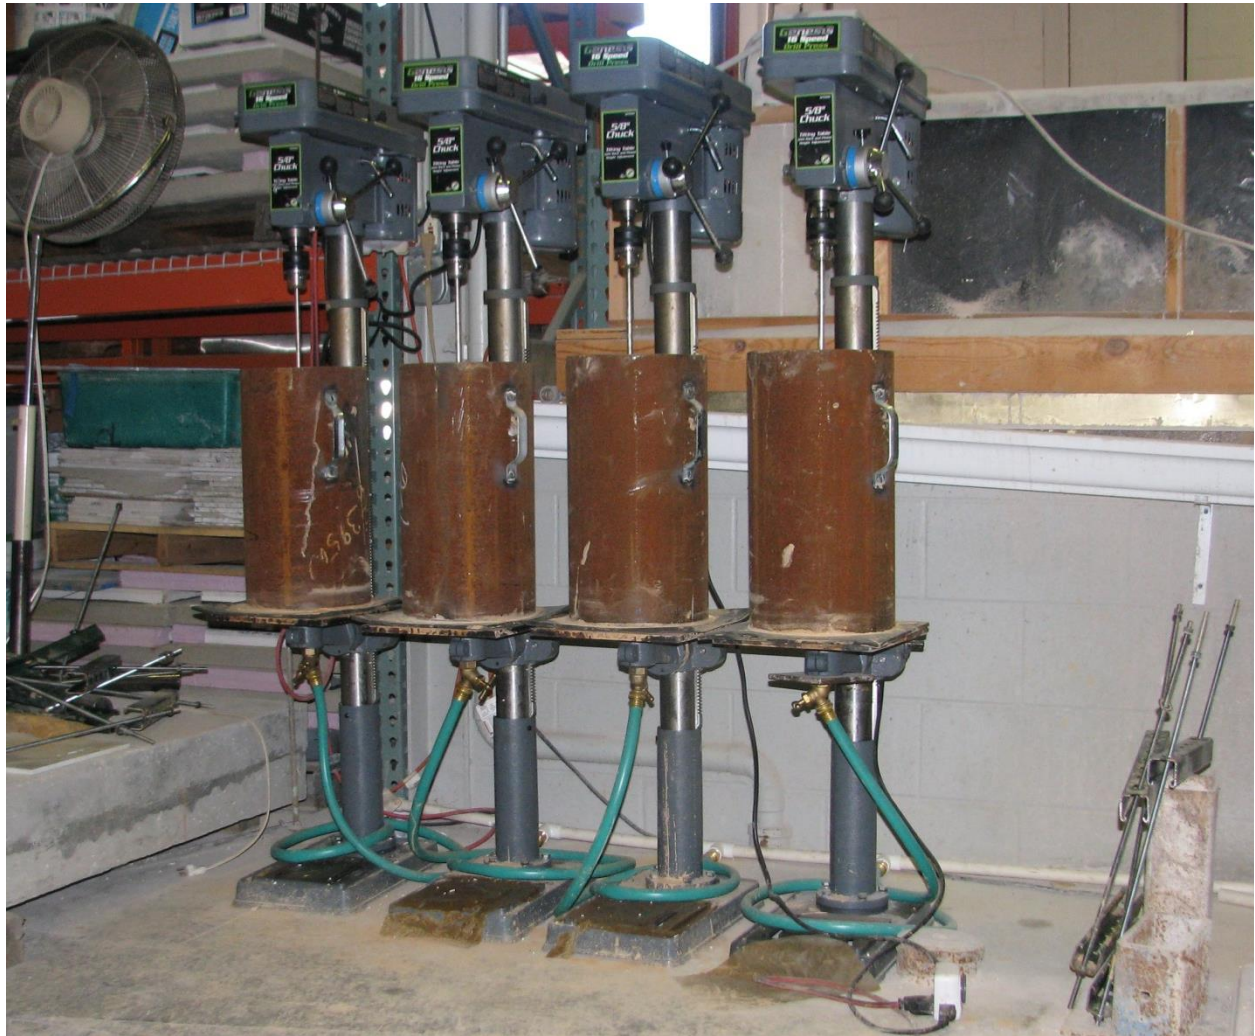
Figure 52. Abrasion test set-up.

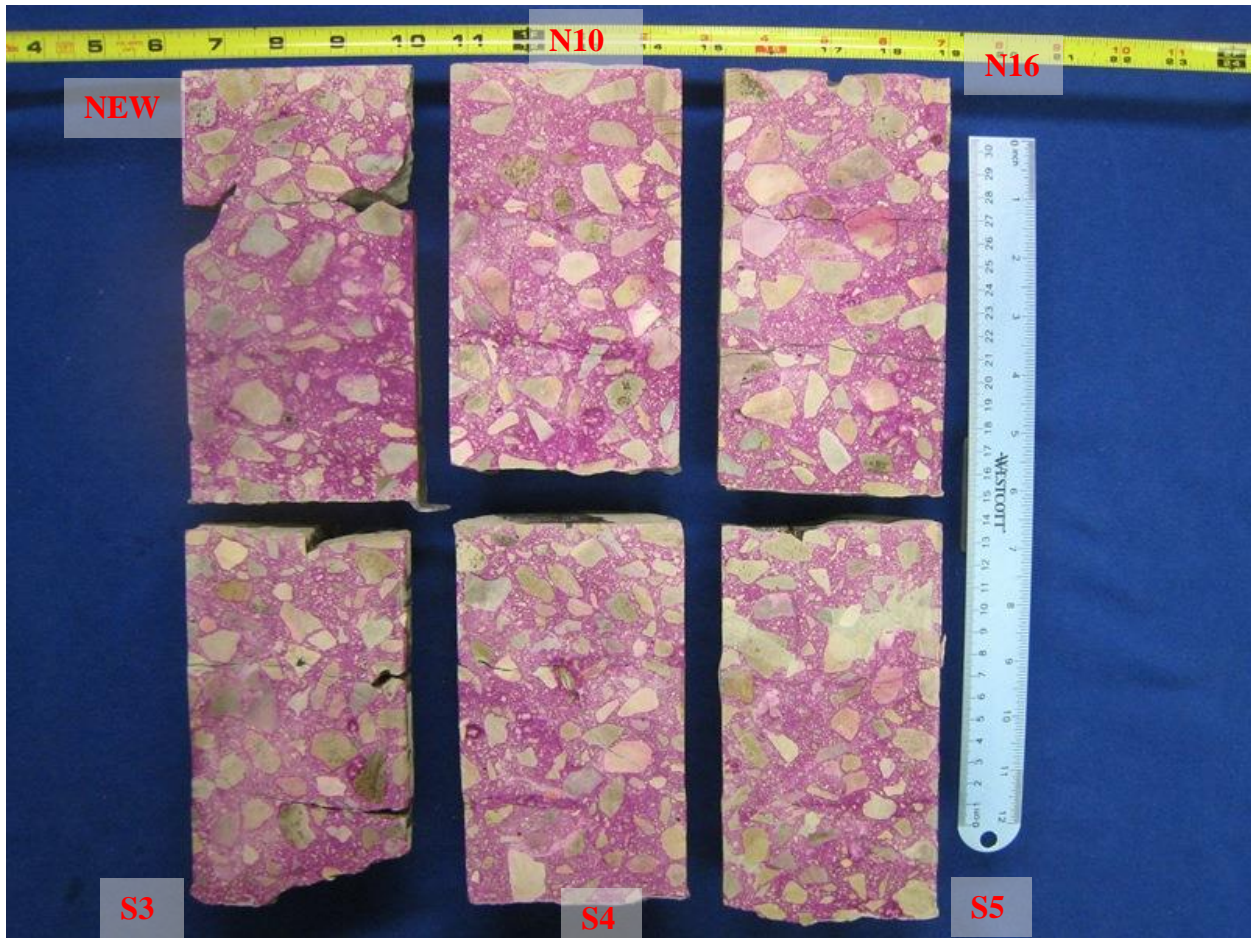
Figure 8. Saw-cut sections stained with phenolphthalein pH indicator solution. Only surficial carbonation was detected.

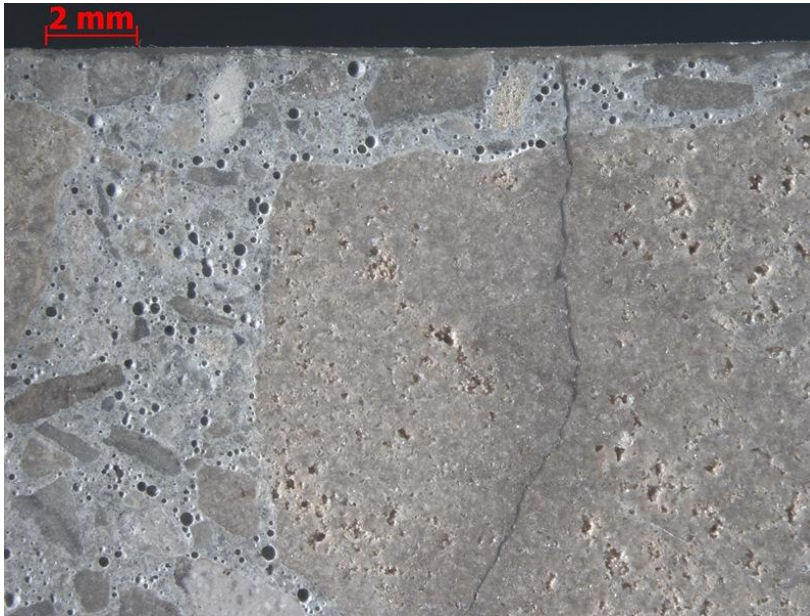
Figure 9. Core NEW. Close-up view showing vertical crack passing through a coarse aggregate particle, and example of air-void system in the near-top region. Epoxy was applied to the crack surfaces to reassemble the core.

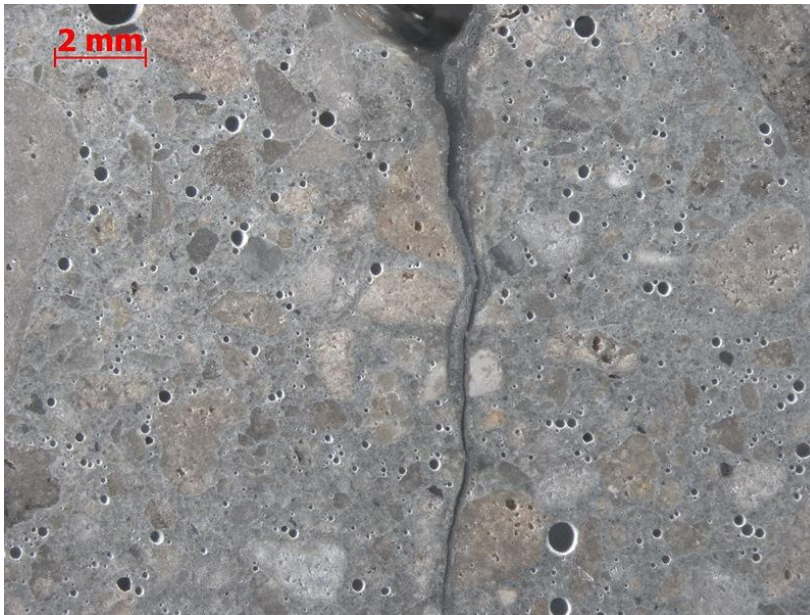
Figure 10. Core S3. Close-up view showing a vertical crack, and example of air-void system in near-top region. Epoxy was applied to the crack surfaces to reassemble the core.

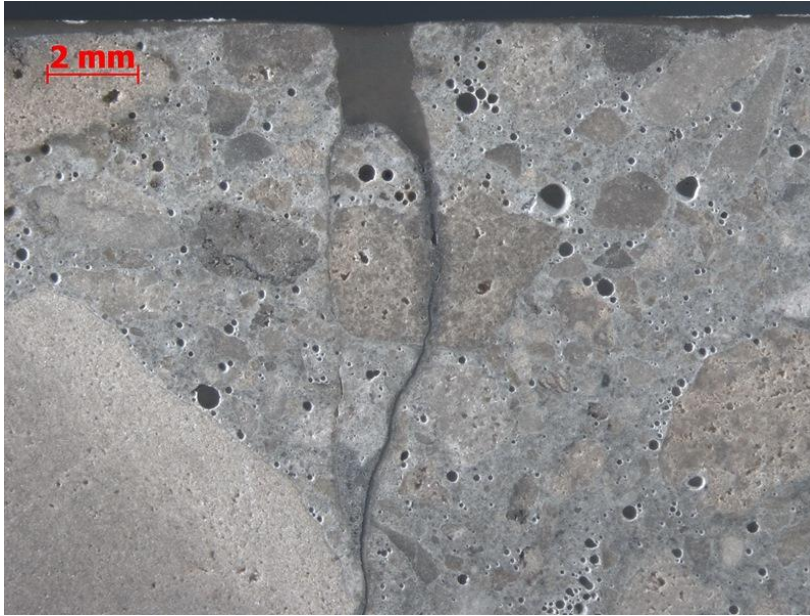
Figure 11. Core S4. Close-up view showing a vertical crack passing through a coarse aggregate particle, and example of air-void system in the near-top region. Epoxy was applied to the top surface to preserve the texture.

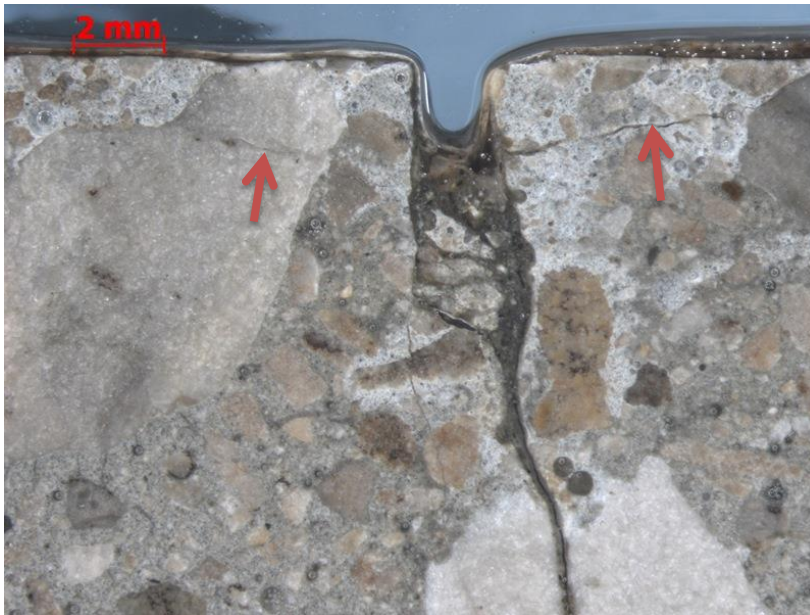
Figure 12. Core S5. Close-up view of near-top region showing a vertical crack and sub-horizontal cracks (red arrow). The vertical crack passes through a coarse aggregate particle. Epoxy was applied to the top surface to preserve the texture.

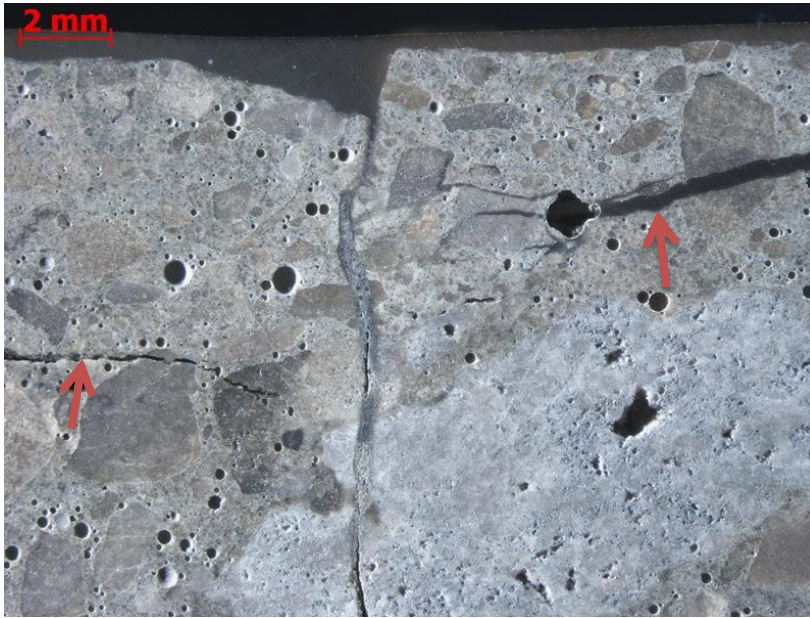
Figure 13. Core N10. Close-up view showing a vertical crack that passes through a coarse aggregate particle, and example of air-void system in the near-top region. Red arrows show discontinuous sub- horizontal cracks. Epoxy was applied to top surface to preserve the texture.

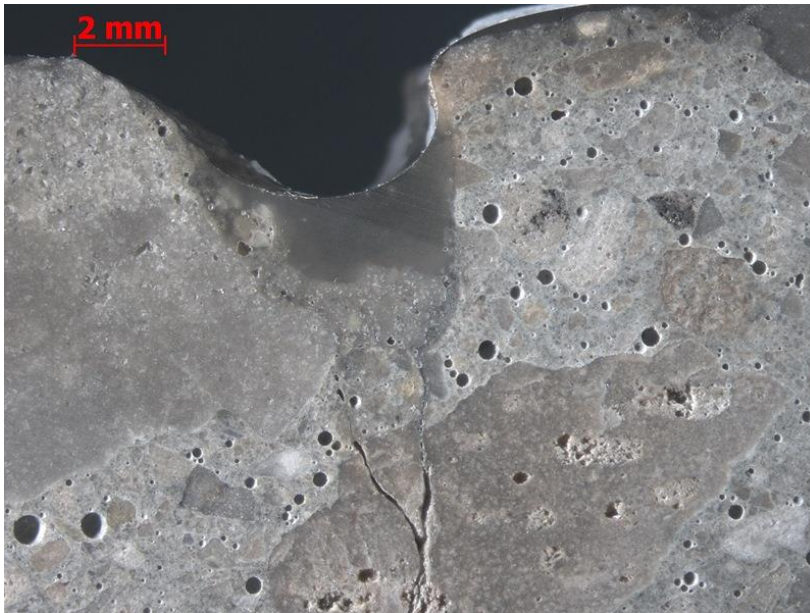
Figure 14. Core N16. Close-up view showing a vertical crack passing through a coarse aggregate particle, and example of air-void system in near-top region. Epoxy was applied to top surface to preserve the texture.

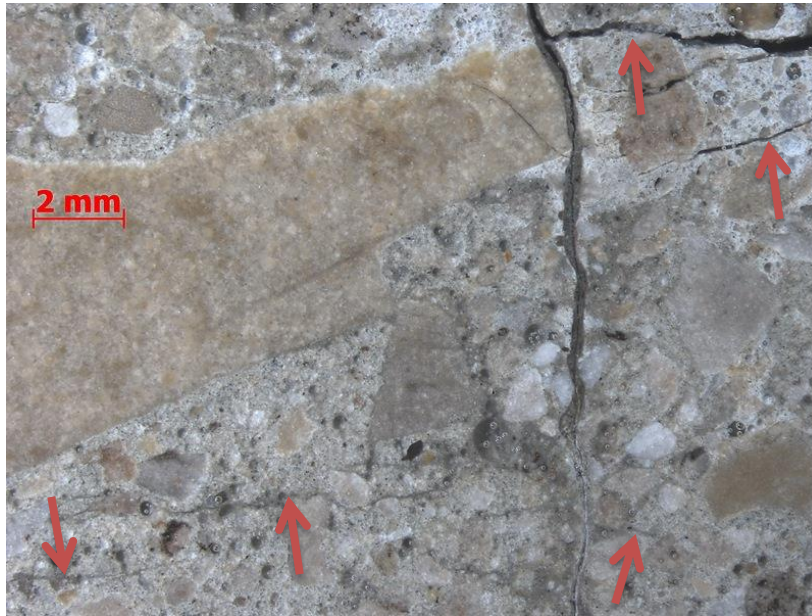
Figure 15. Core N10. Region at depth interval from 0.2 to 0.7 inch. Arrows show sub-horizontal cracks in the near-top region.

- The vertical and sub-horizontal cracks located near the top surface of the ties removed from service appear to have formed after the concrete had gained significant strength and paste-to-aggregate bond. Features consistent with early age, plastic-stage cracks were not observed. Vertical cracks in cores from all of the in-service ties contained a crack-filling material composed of angular mineral and rock

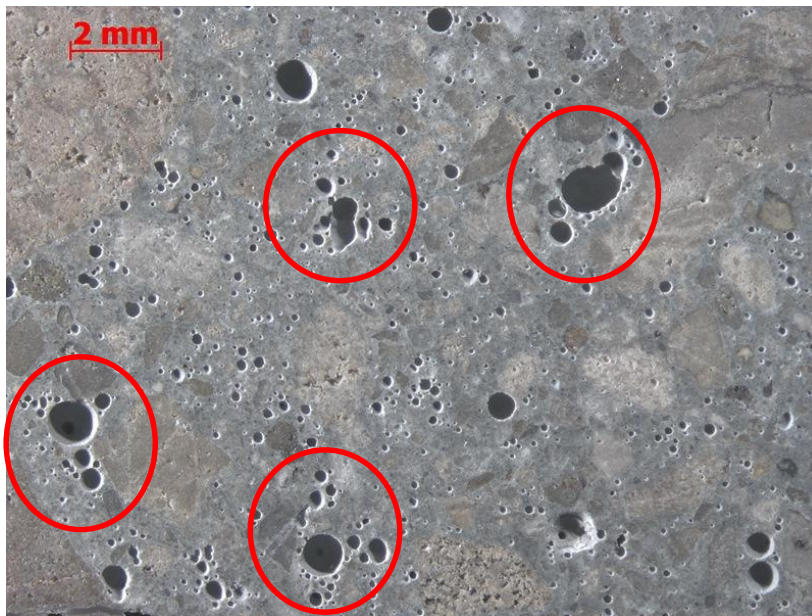
Figure 16. Core S4. A region at depth of approximately 5 inch. Examples of small air clusters are circled.

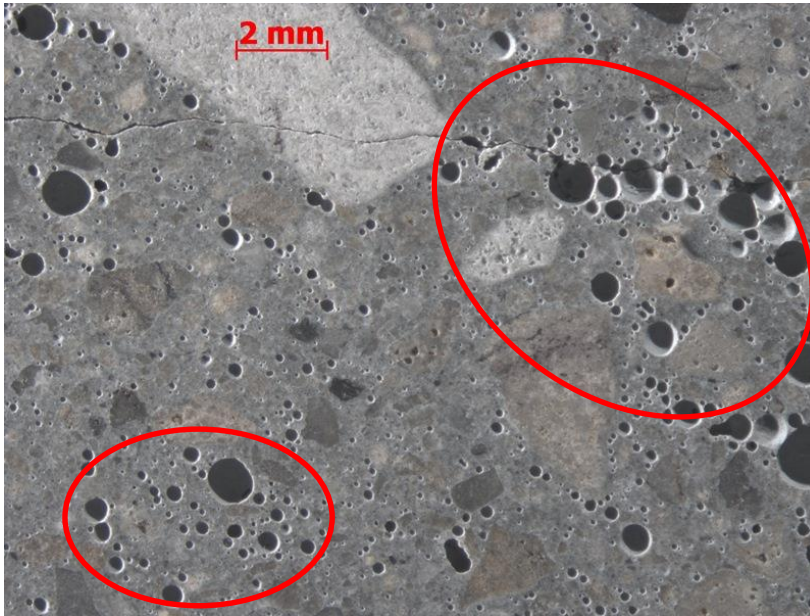
Figure 17. Core S5. Region at depth interval from 1.6 to 2.4 inches. Larger clusters of air voids are circled. The crack is a portion of the vertical crack.

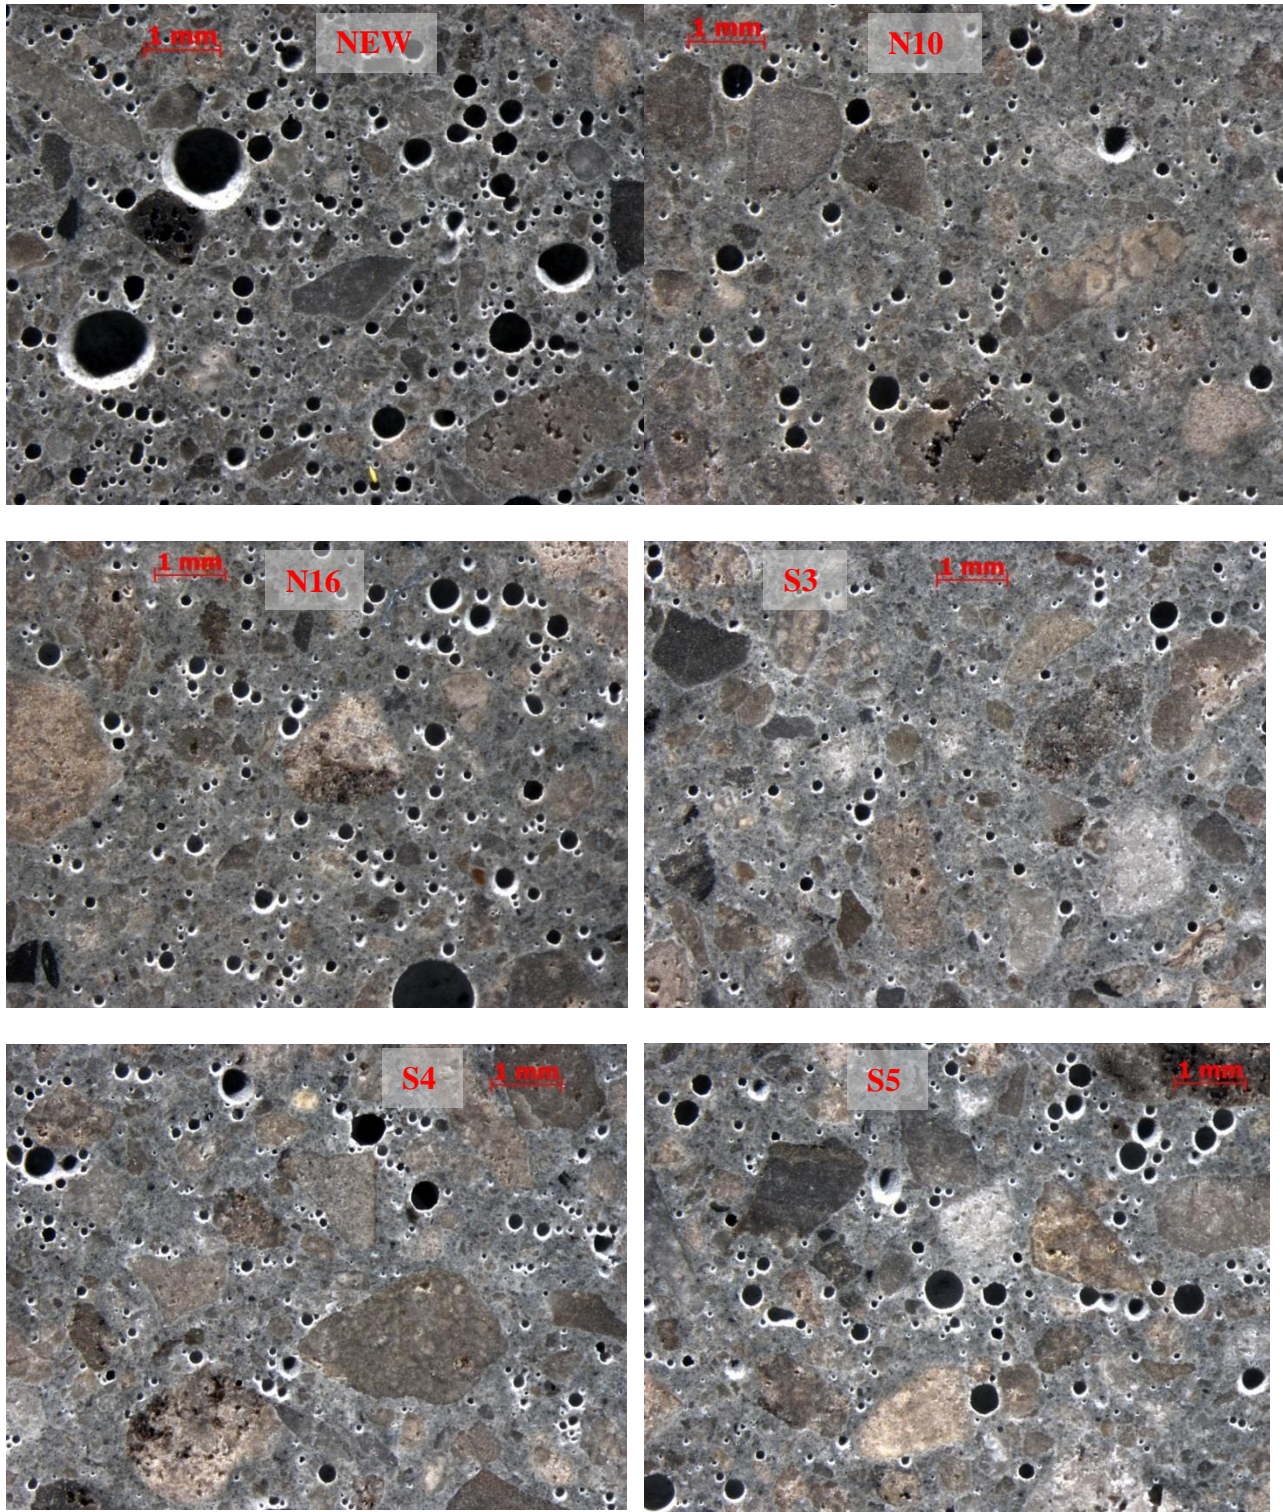
Figure 18. Typical appearance of the air-void systems in the indicated concrete cores.

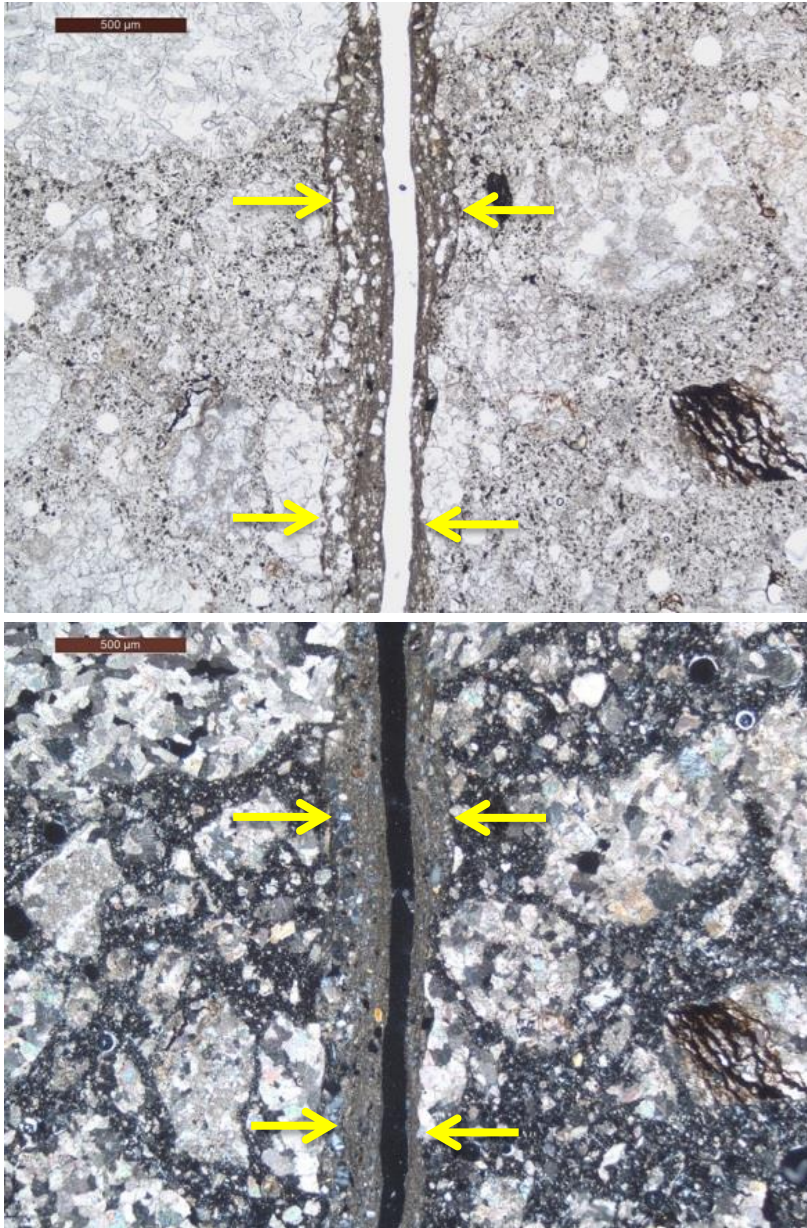
Figure 19. Core S3. Region 1 inch below the top surface is shown. Arrows show a crack-filling material. No significant carbonation was observed on the crack surface. Upper photo, plane-polarized light. Lower photo, cross-polarized light.

particles dispersed in a very fine-grained matrix. The mineral and rock particles are not constituents of the tie concrete, suggesting that the source of the crack-filling material is external to the concrete.

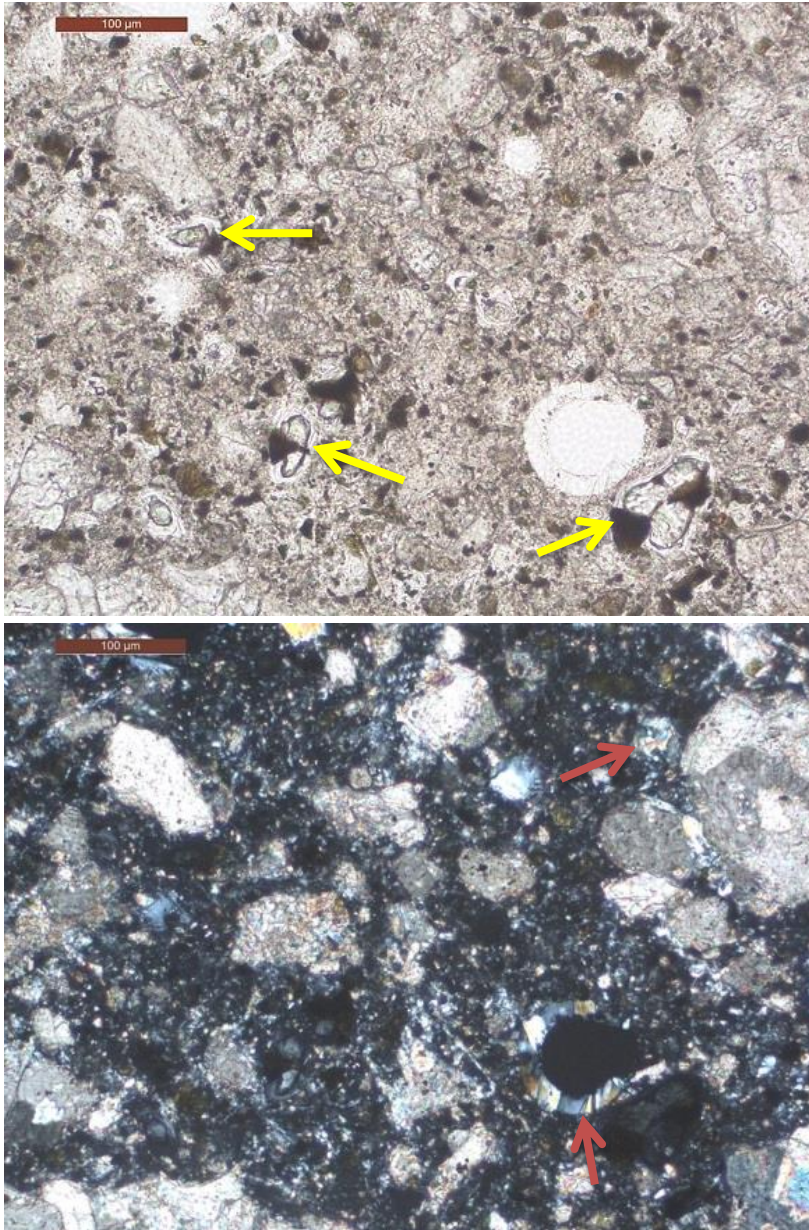
Figure 20. Core NEW. Yellow arrows show examples of residual portland cement particles in the paste. Cement-sized fragmental carbonate particles are frequently observed (bottom photo, bright pink-yellow). Red arrows show examples of secondary portlandite (calcium hydroxide). Upper photo, plane-polarized light. Lower photo, cross-polarized light.

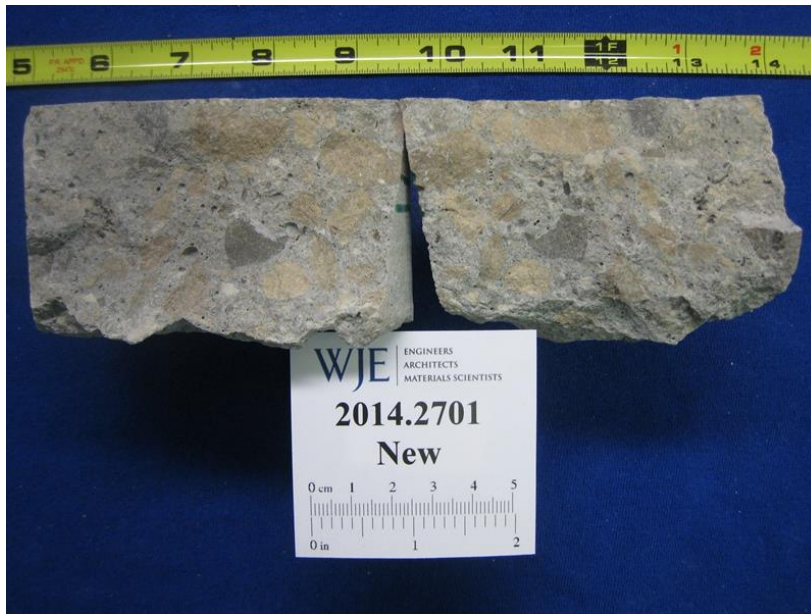
Figure A4. Core NEW, opened fracture surface of the upper segment. The fracture appears to be fresh.

laboratory examinations and the preexisting crack surfaces mainly passed through aggregate particles (Figures A4, A12 and A24).

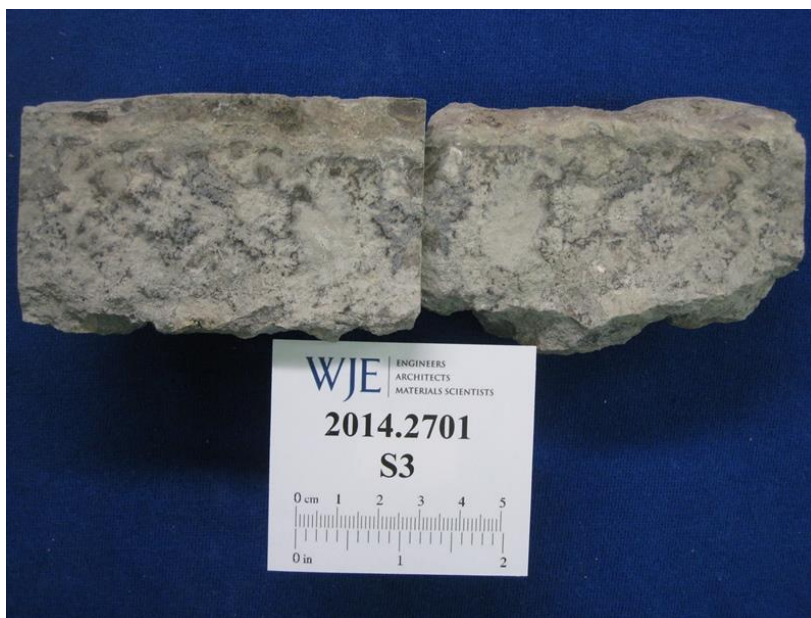
Figure A8. Core S3, fracture surface of the upper segment. Fracture does not appear to be recent.

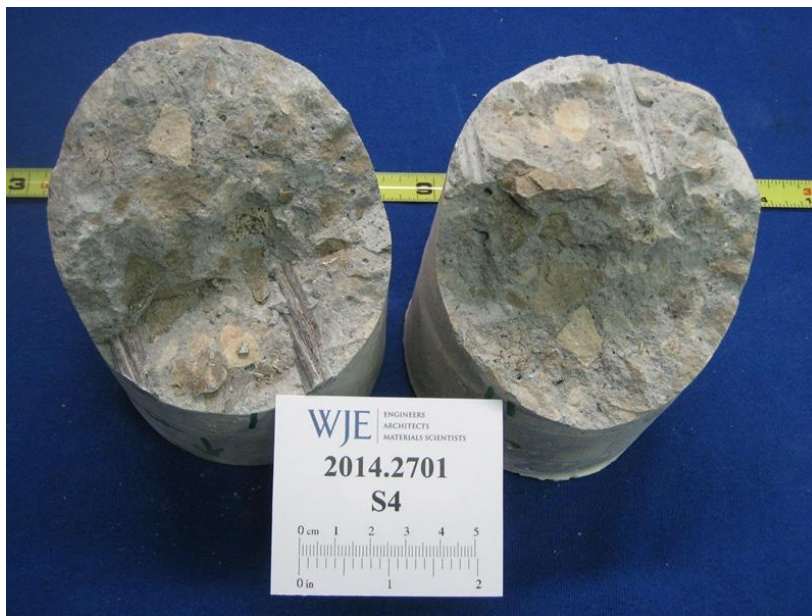
Figure A12. Core S4, matching fracture surface.

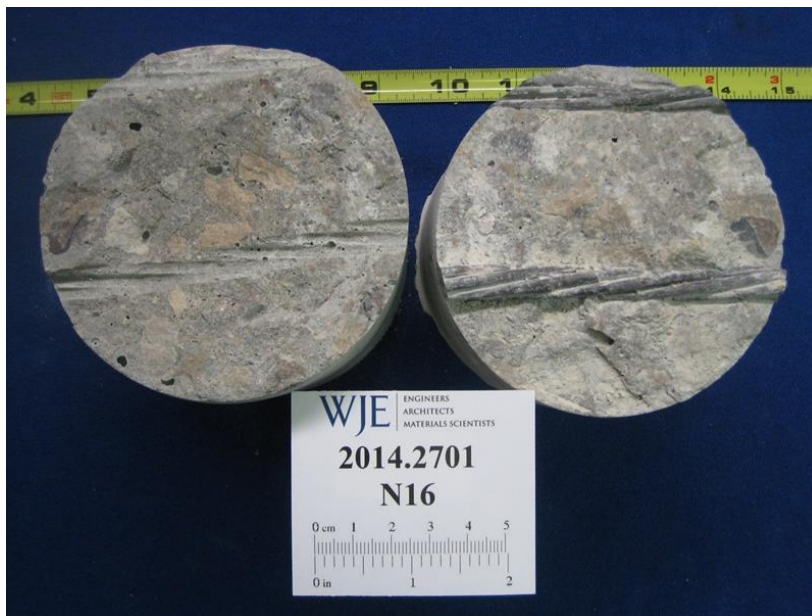
Figure A24. Core N16, fracture surface at reinforcement.
