Collision of New Jersey Transit Passenger Train 1614 at Hoboken Station

Hoboken, New Jersey

Mechanical Group Factual Report

NTSB Accident Number: DCA16MR011  
Date of Accident: September 29, 2016  
Time of Accident: 8:41 a.m. (EDT<sup>1</sup>)  
Type of Trains: NJT Passenger Train 1614  
Railroad Owner: NJT  
Train Operator: NJT  
Fatalities: 1  
Injuries: 110  
Location of Accident: Hoboken, NJ

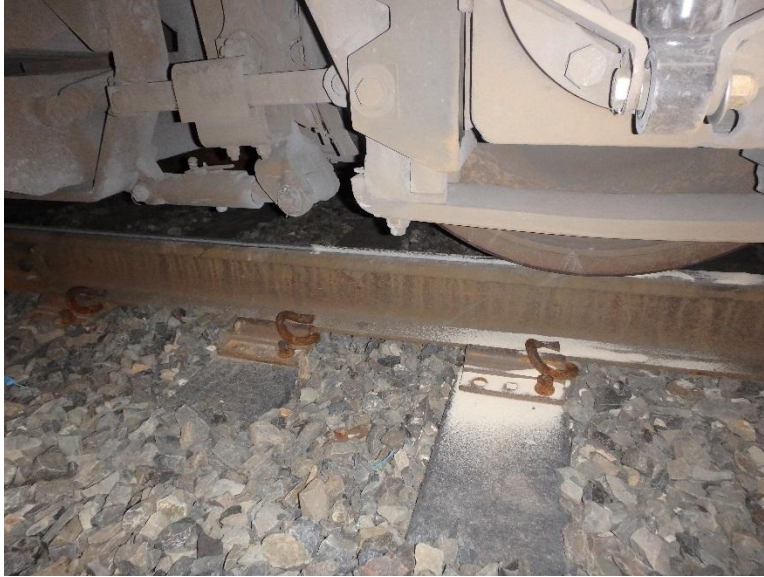
Nothing significant was observed on any undercarriage component that could be observed from where the cars came to rest. Areas obscured by wreckage and debris were evaluated during the recovery operations wherein, no observations of defects were noted. The team observed indications of sand from the sanding system of the rear locomotive at its final point of rest. (See figure 2.)

**Figure 2-Sand on rail and under the front left wheel from locomotive 4214**

The team measured the witness indications of the discharge. There was 25-inches on the rails under each sanding wheel in a way that indicated the train rolled back after the collision.

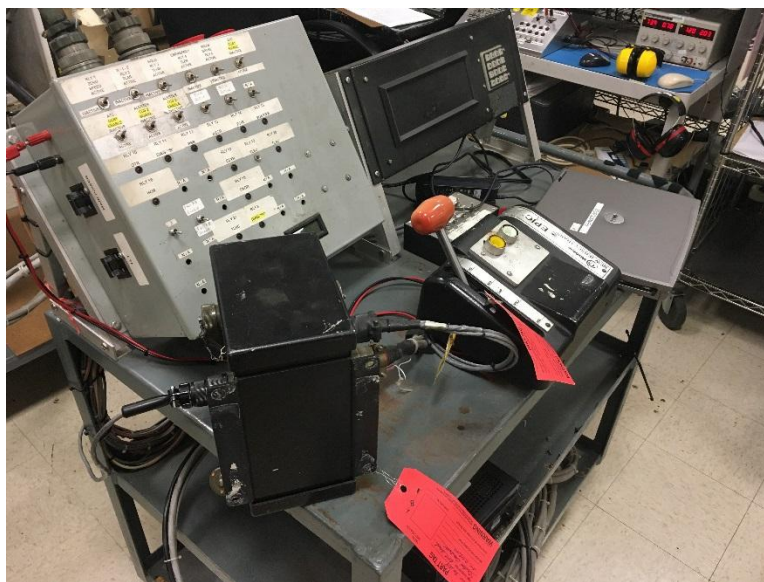
The equipment from the EPIC II brake control system from the accident train was transported to Germantown, Maryland, by NJT in advance of the testing. WABTEC supported the investigation by conducting a full comprehensive qualification test of all five components according to their test procedures, WI1050-WGS Rev B – System test and TP1067 Rev H – LIU test. (See figure 3.) Investigators witnessed all phases of the testing and results. The results of the testing showed that all components were functioning within their tolerances as designed. Copies of the test and the results will be included as appendices to this report.

Figure 3-Photograph of test set up of the EPIC II brake components

In addition to providing all computer-controlled electro-pneumatic service braking, the EPIC II system also features integrated system diagnostics and fault log capture capability. Investigators requested that WABTEC access the BCU from 6036 using a portable test unit and download all system faults. The faults were successfully downloaded. The data showed two faults that occurred on September 29, 2016 at 8:42 a.m.; both faults are attributable to the accident.
