# **National Transportation Safety Board**

Collision of Amtrak Passenger Train P091-03 with CSX Local Train F777-03  
Cayce, South Carolina  
February 4, 2018

RRD18MR003

Mechanical Group Factual Report

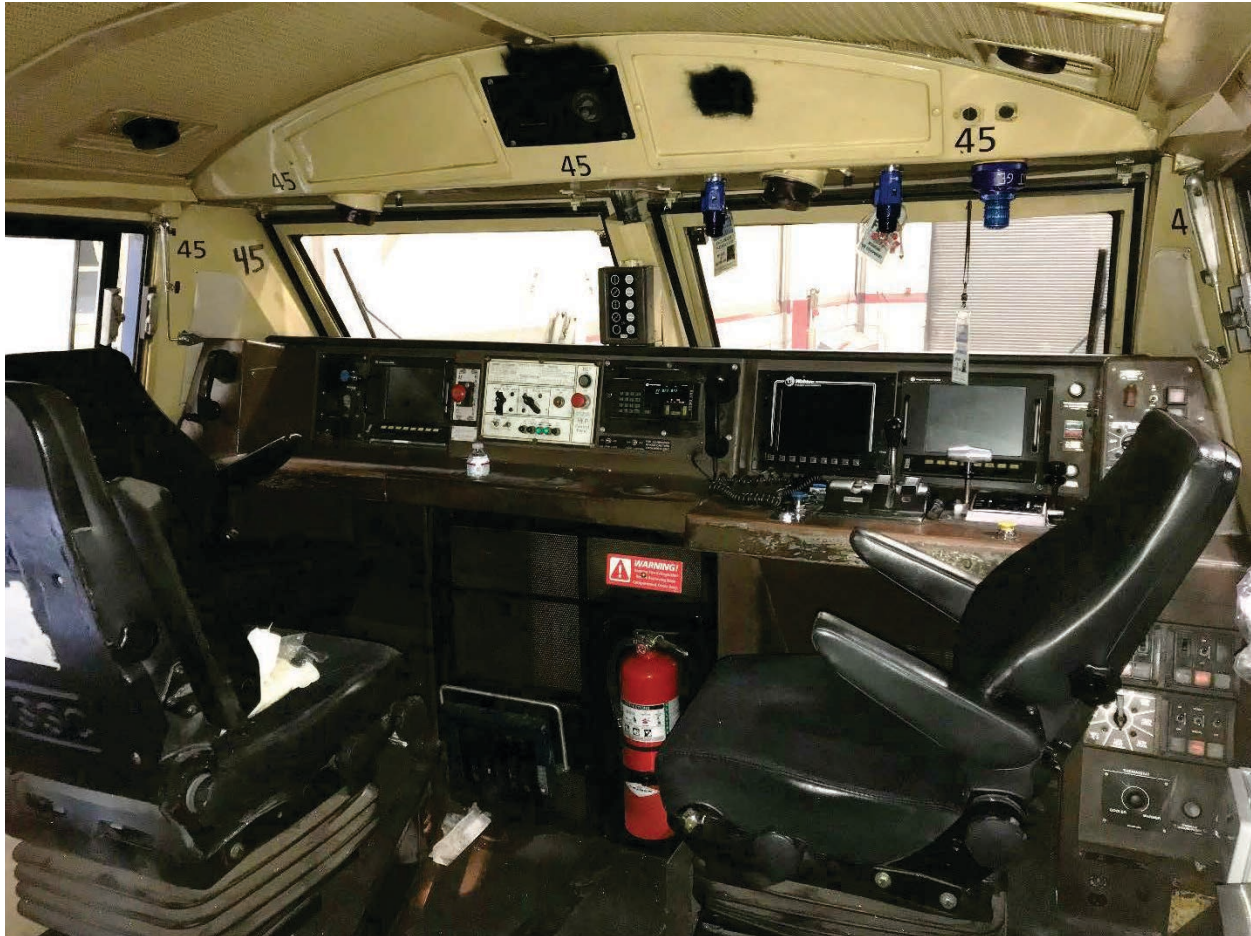
Figure 1-Exemplar photograph of P42-8 operating cab (Amtrak)

The operating cab features an engineer's console that contains all the controls and indicators necessary for the operation of the locomotive, including three full-screen monitors, designated as Integrated Function Display (IFD) as well as an I-ETMS Wabtec monitor. Also located in the operating cab are the windshield and wiper assembly, and the seats for the engineer and assistant engineer.

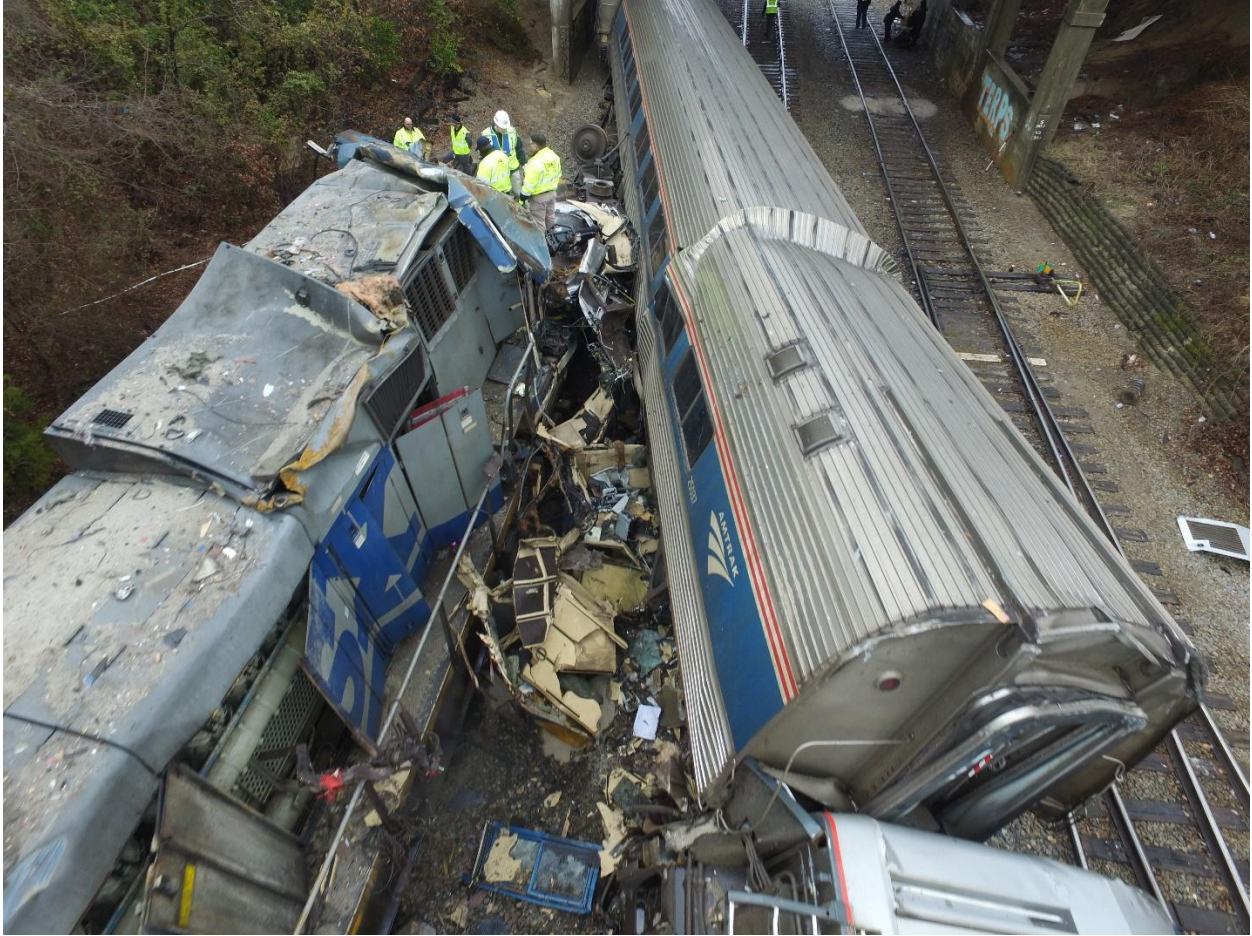
The Amtrak wreckage continued to decelerate for approximately 130 feet beyond the point of collision, shoving the lead coach car into the air as the Amtrak locomotive rolled left. The trucks of the first coach were broken off and came to rest under the car. The lead coach buckled slightly as it lodged into the rear of the Amtrak locomotive. The second coach remained upright but derailed and buckled. The third coach remained on the rail without significant damage.

Figure 3-Photograph showing first passenger coach.

AMTK 25037 (coach) was first inspected in the air and found to have the A end truck and bolster detached from the carbody. The bolster had separated from both the truck and carbody and had taken the A-end right anchor arm and a section of the car's side sill with it. The car structure buckled upward, deforming the center sill, side sills, roof, and floor structure of the car approximately 25' from the A end of the car. Undercar equipment boxes were crushed as the car rode over its A-end truck assembly. There were no notable defects of the truck assemblies, wheels, brakes, couplers, or carbody that appeared to have been present prior to the crash.

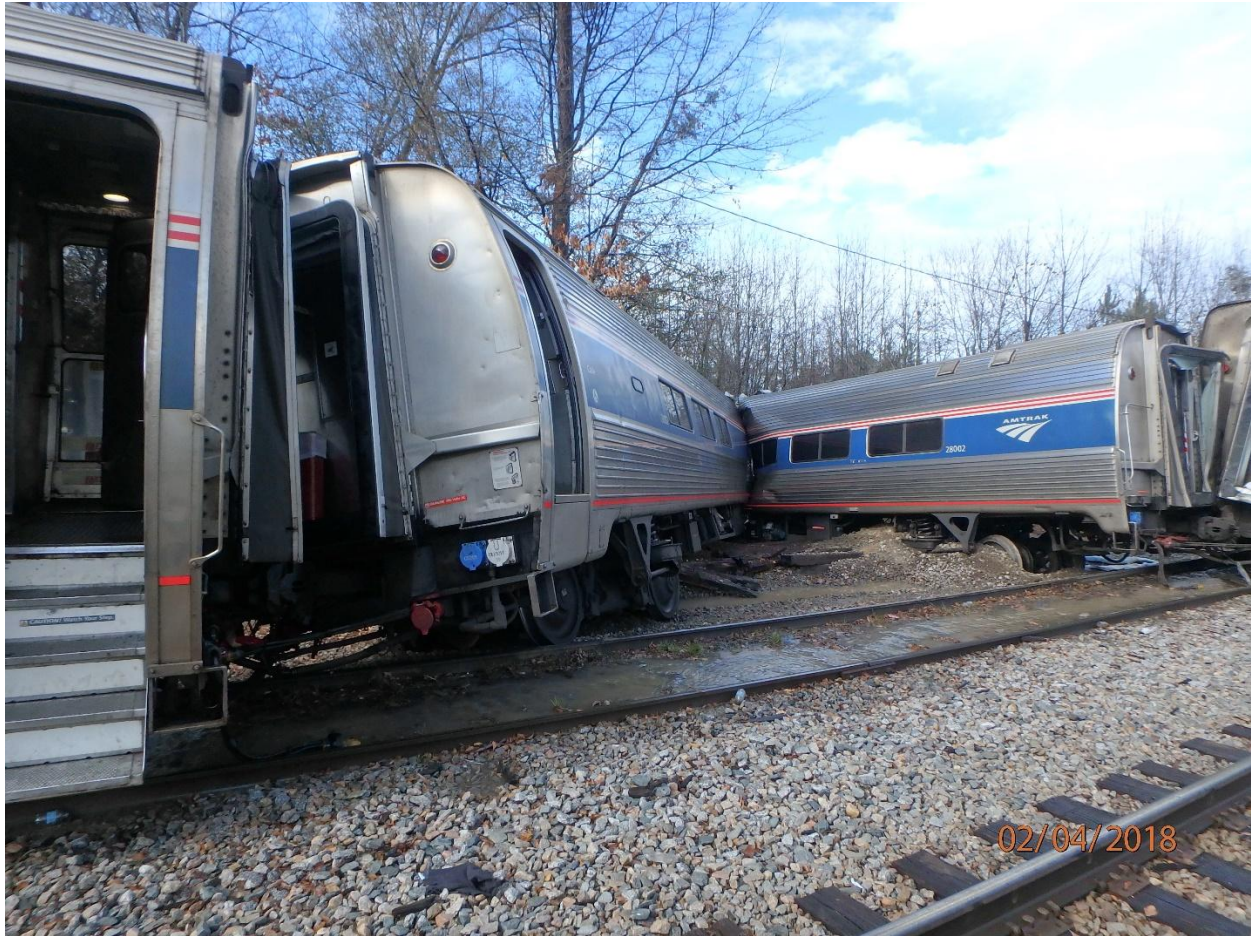
The lounge car was forced off the Silica storage track and bent laterally, shearing open the left side of the car and crumpling the right side.

Figure 4-Photograph of the lounge coach.

AMTK 28002 (lounge) was bent in half and sustained full separation of the left side sill, wall, and roof. The center sill of the car was significantly deformed but remained connected. The right-side sill was crushed at the interior of the bend. Both trucks derailed and had significant damage from the derailment but remained intact and connected to the carbody. The truck and carbody brake components all showed evidence of damage resulting from the derailment. Both couplers remained with the car and intact. There were no notable defects to any of those components that appeared to have been present prior to the crash.

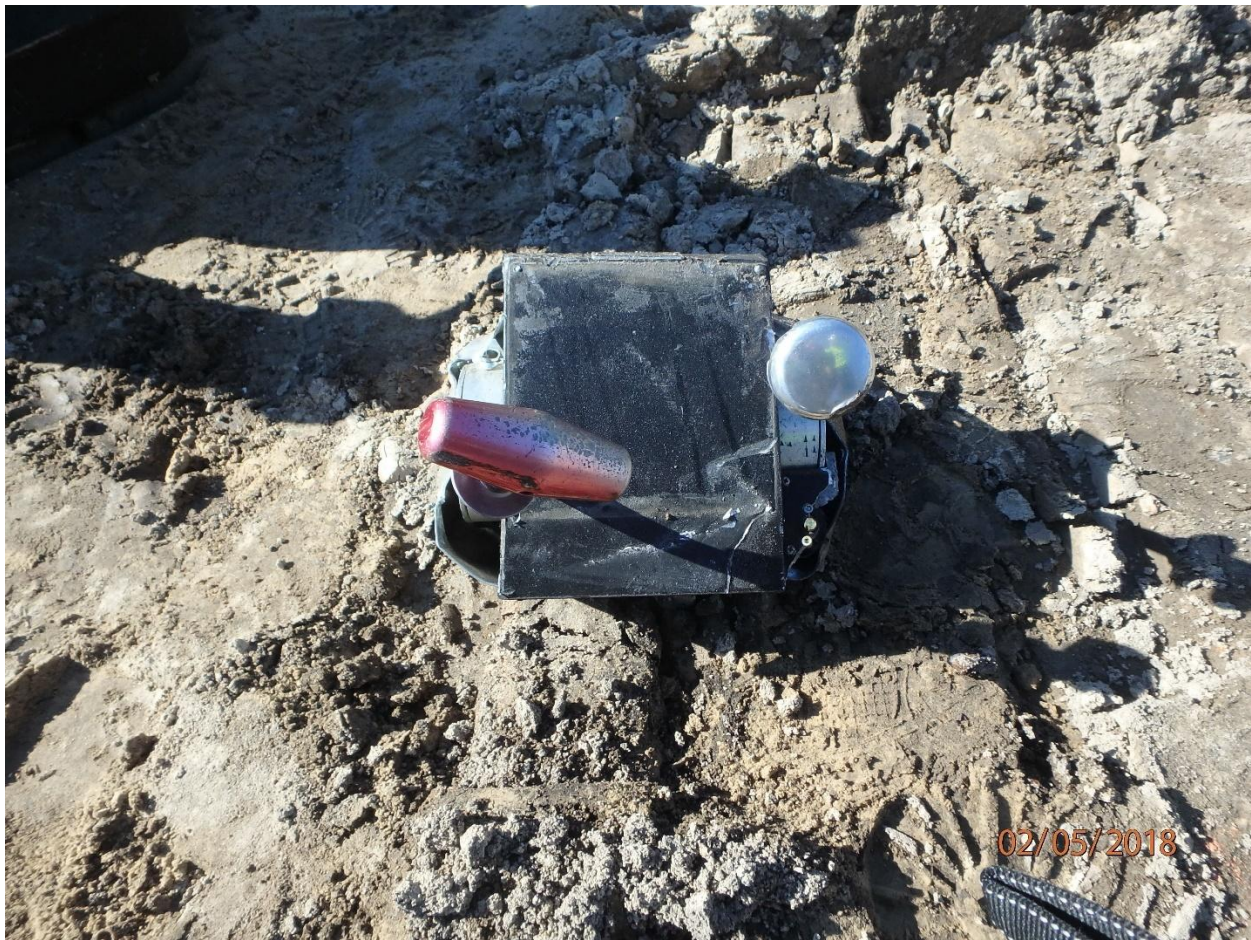
Investigators inspection began on the morning of the 5<sup>th</sup>. Weather conditions were clear and sunny. The initial work was to pull apart the front of the locomotive to locate the engineer's operating console and brake valve controls. During this evolution the artifacts recovered included mostly paperwork items from both cabs of the AMTK47 and CSXT130. Photographs were also taken of various areas of interest. The next step was to pull the CSXT130 south to clear the area. The event recorder and documentation was then removed from the CSXT130. Once removed the AMTK 47 engineer's brake control valve was observed on the top of the CSXT130 fuel tank. Damage to the brake valve resulted in no conclusions to the status of the brake handles at the time of collision.

Figure 5. AMTK 47 brake control valve.

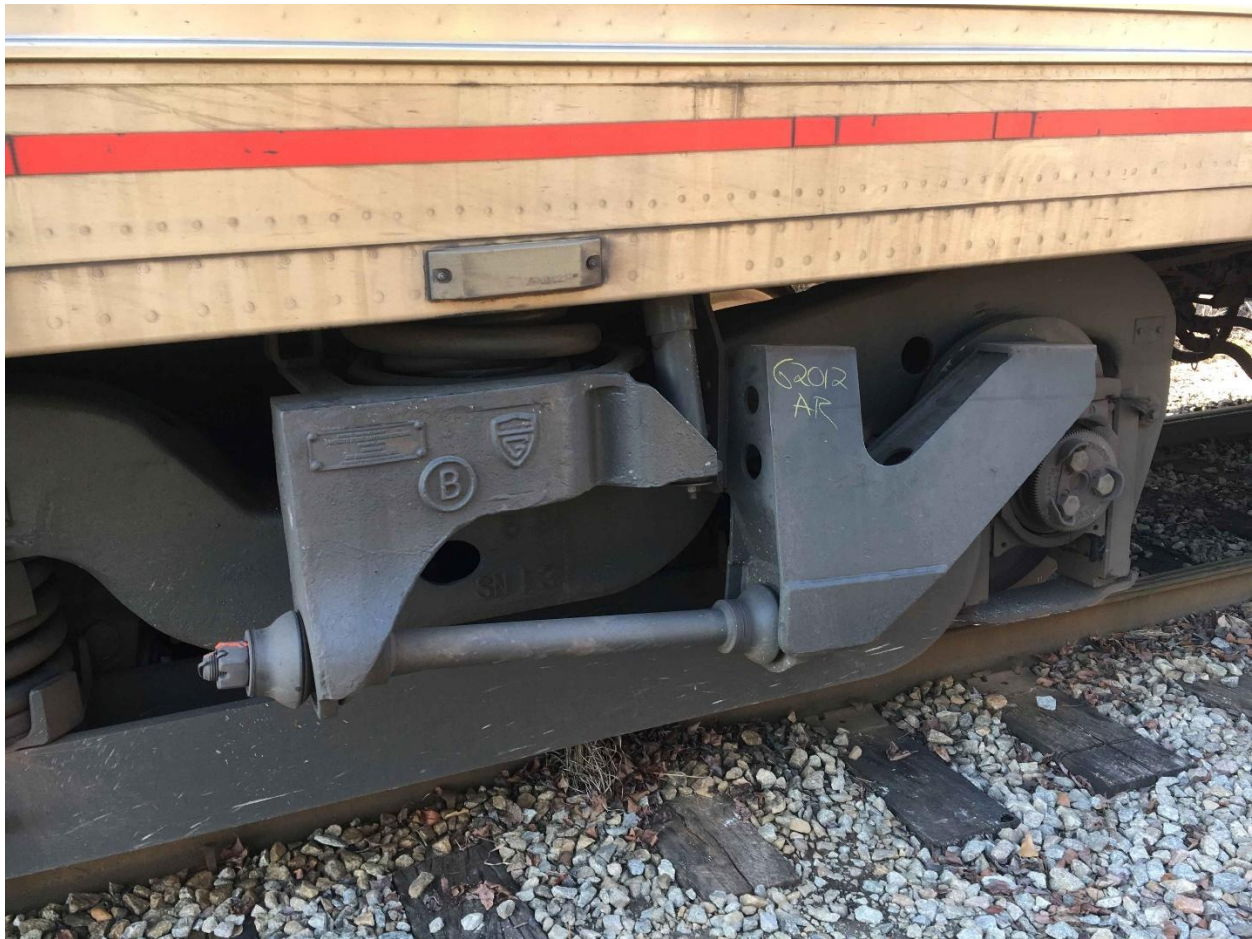
it had collided with AMTK 28002. AMTK 62012 (coach) had damage to the A-End left-side, BL and A-End right-side truck anchor fixture sheared from the side sill. (car body bolts sheared off).

Figure 6. AMTK 62012 Car body truck anchor fixture sheared from side sill (A-End right side).
