**Docket No. SA- 516**

**NATIONAL TRANSPORTATION SAFETY BOARD**

**Meteorological Factual Report  
[DCA96MA070]  
(46 Pages)**

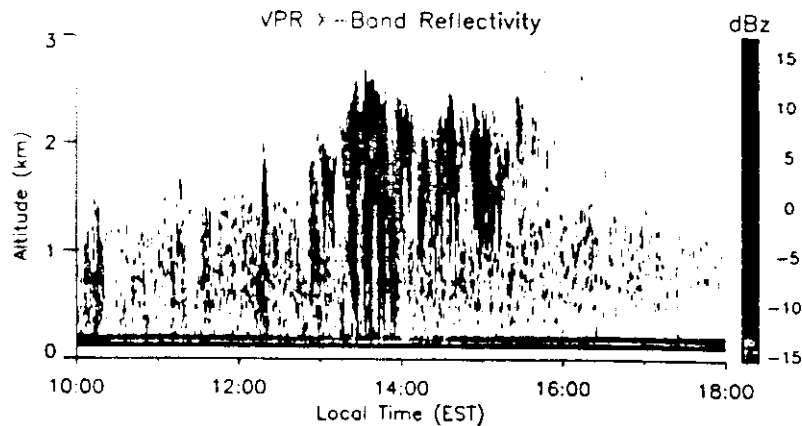
FIG. 3. Time-height pattern of reflectivity measured by the VPR. The resolution of the data in this plot is 30 m in altitude and 30 s in time. The strong echoes from about 1315 to 1530 EST are associated with the plume.

reflectivities in these columns exceed  $10 \text{ dBZ}$ . The stronger echoes are clearly associated with the smoke plume as it passed over the McGill campus.
