## **NATIONAL TRANSPORTATION SAFETY BOARD**

### **Group Chairman's Factual Report**

# **METEOROLOGY**

**WPR12MA034**

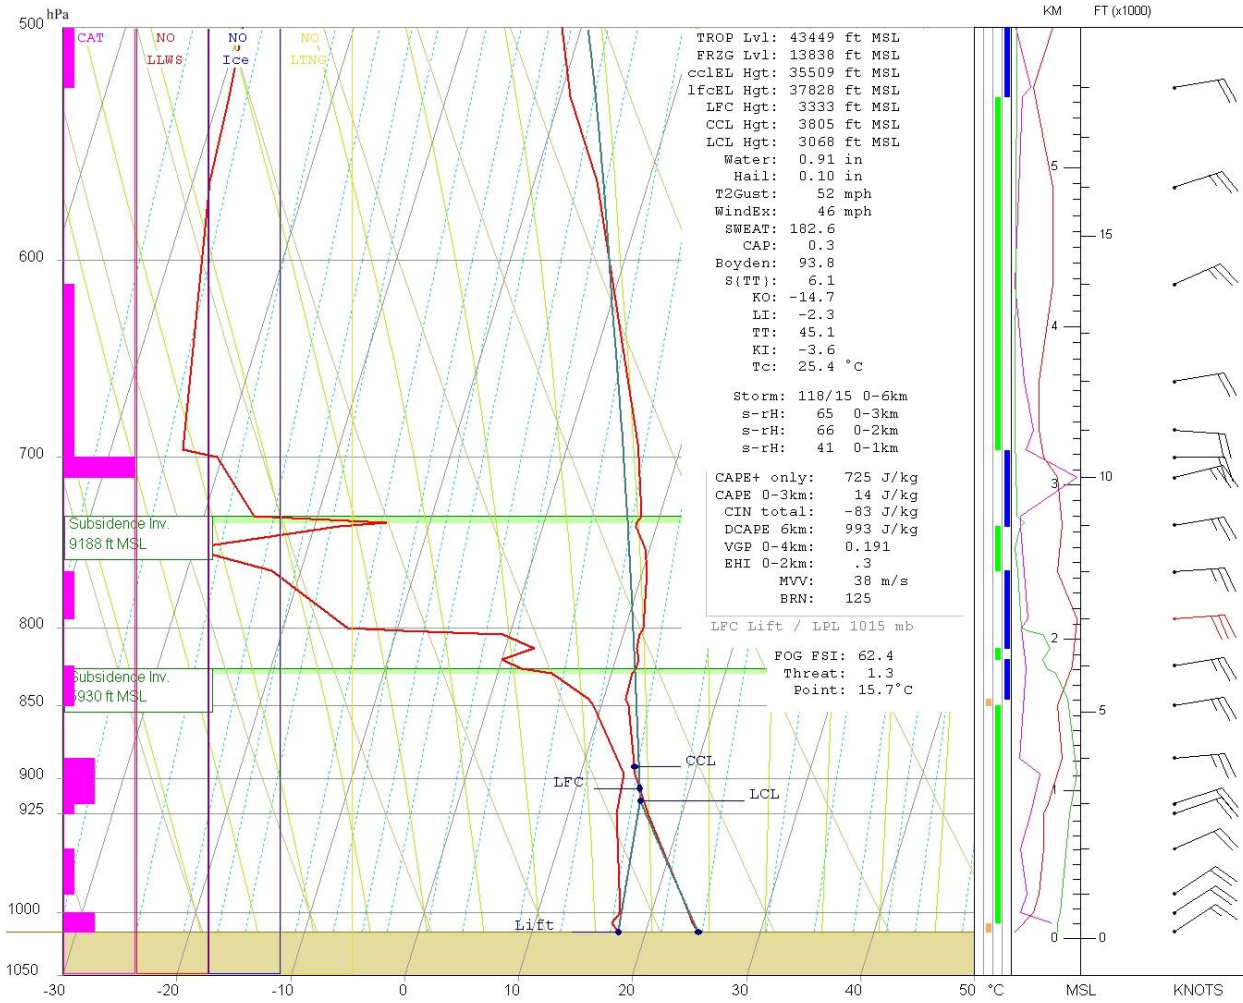
PHLI was located approximately 150 miles west-northwest of the accident site. The PHLI sounding indicated the LCL was at about 3,000 feet, and the lowest 5,000 feet of the atmosphere was, for the most part, conditionally unstable. The RH near the surface was 65 percent, however the RH increased to 94 percent at about 3,600 feet. Above this level, the RH decreased with increasing height. “Most unstable” CAPE for this atmosphere was 725 J/kg. The freezing level was identified as about 13,800 feet. Calculations made by RAOB yielded the potential for scattered clouds as low as 2,000 feet. The PHLI wind profile indicated a surface wind from 055° at 15 knots and the wind magnitudes increased slightly with height. At about 2,800 feet, the wind was from 070° at 22 knots. About this level, the wind veered slightly to a more easterly direction and increased in magnitude with height to 28 knots at about 6,800 feet. Calculations by RAOB indicated no significant turbulence in the lower part of the atmosphere and no areas of significant LLWS were identified.

**Figure 6** – Rawinsonde sounding from PHLI in SkewT/LogP<sup>5</sup> format for 1400 HST, surface to 500 hPa.

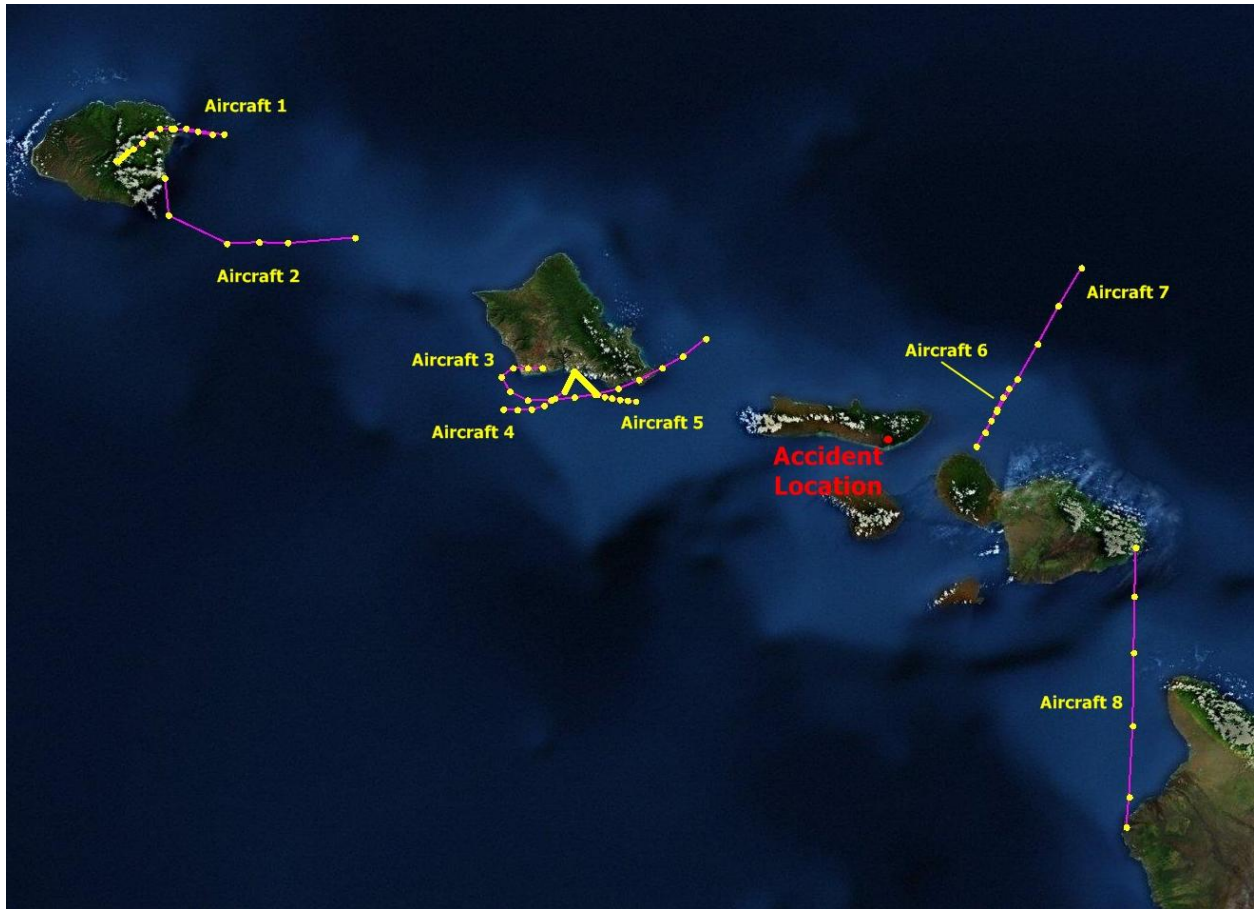
**Figure 10** – Flight paths (pink lines) below about 10,000 feet for AMDAR-reporting aircraft. Yellow dots indicate reporting points.

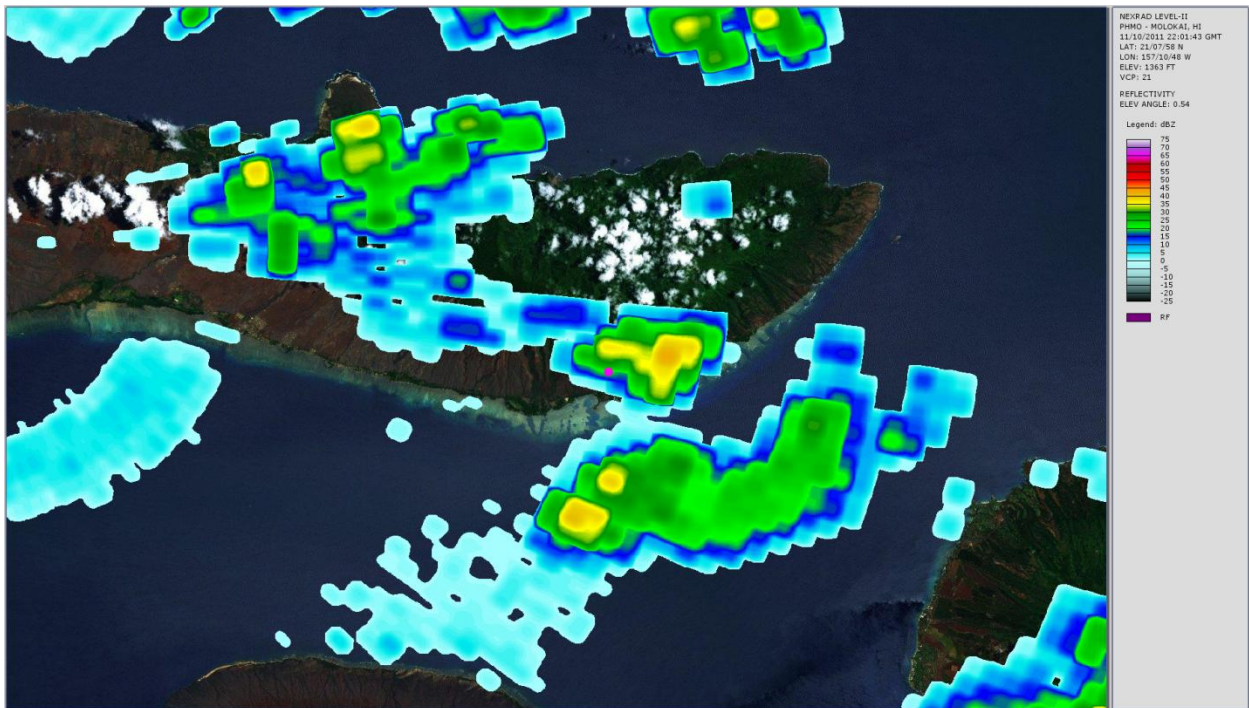
**Figure 12** – PHMO 0.54° elevation base reflectivity image from 1201 HST. Pink dot denotes accident location.

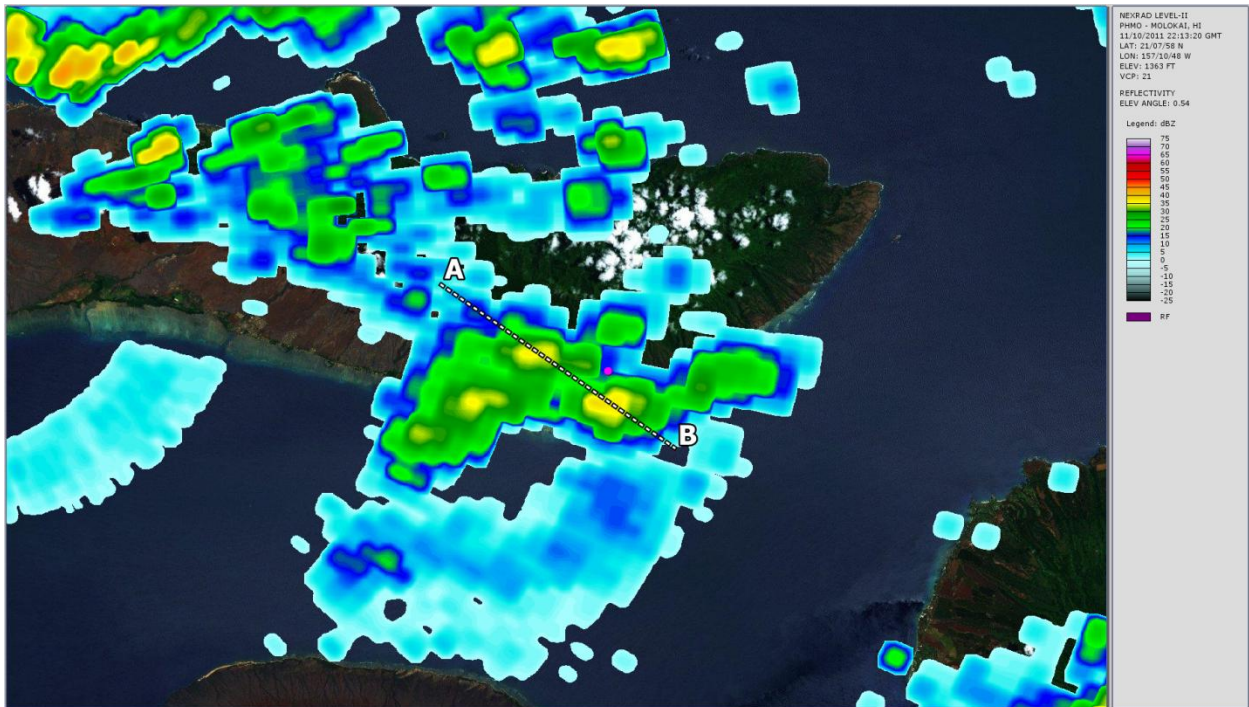
**Figure 14** – PHMO 0.54° elevation base reflectivity image from 1213 HST. Pink dot denotes accident location. Dotted line corresponds to section taken for vertical slice in figure 17.

Vertical cross-sections of the reflectivities were taken for the PHMO radar data at 1207 and 1213 HST are presented in figures 16 and 17, and the boundaries of these cross-sections can be found in figures 13 and 14, respectively. The vertical cross-sections indicate that the stronger values of reflectivity were limited in depth to below about 5,000 feet, and the lightest of reflectivity values (~ 0 dBZ) did not extend far above 9,000 feet msl.

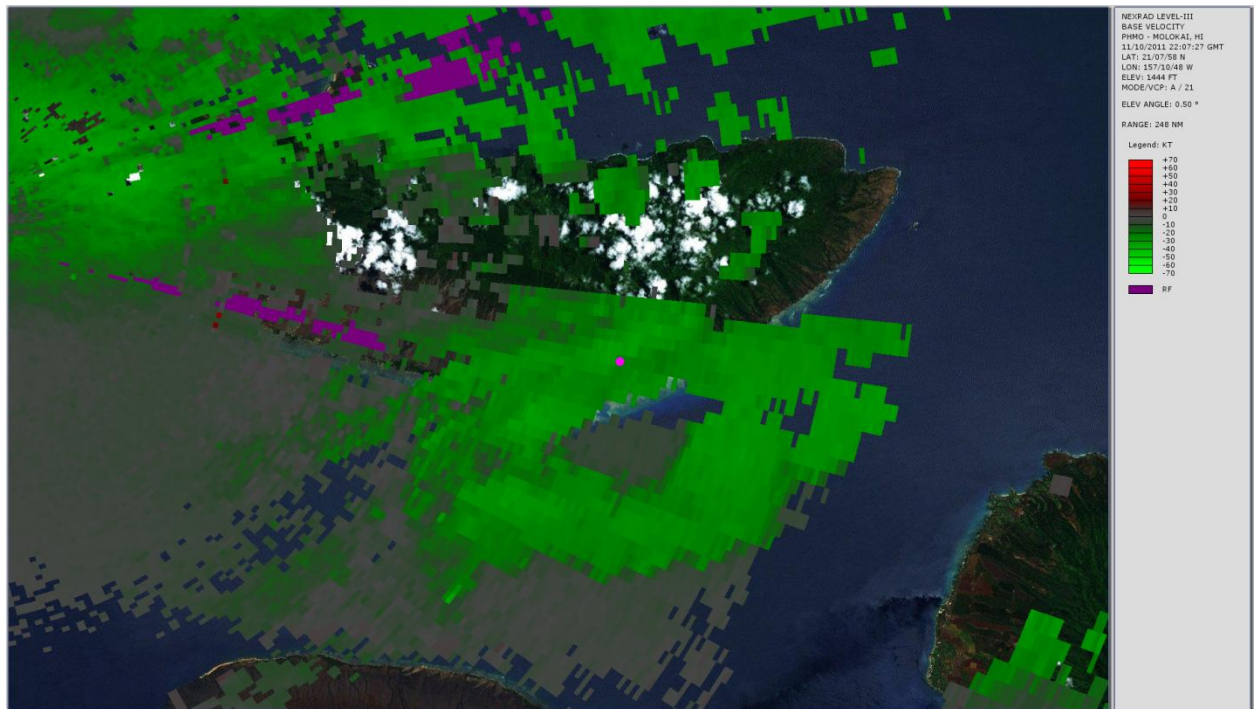
**Figure 18** – PHMO 0.50° elevation base velocity image from 1207 HST. Pink dot denotes accident location.

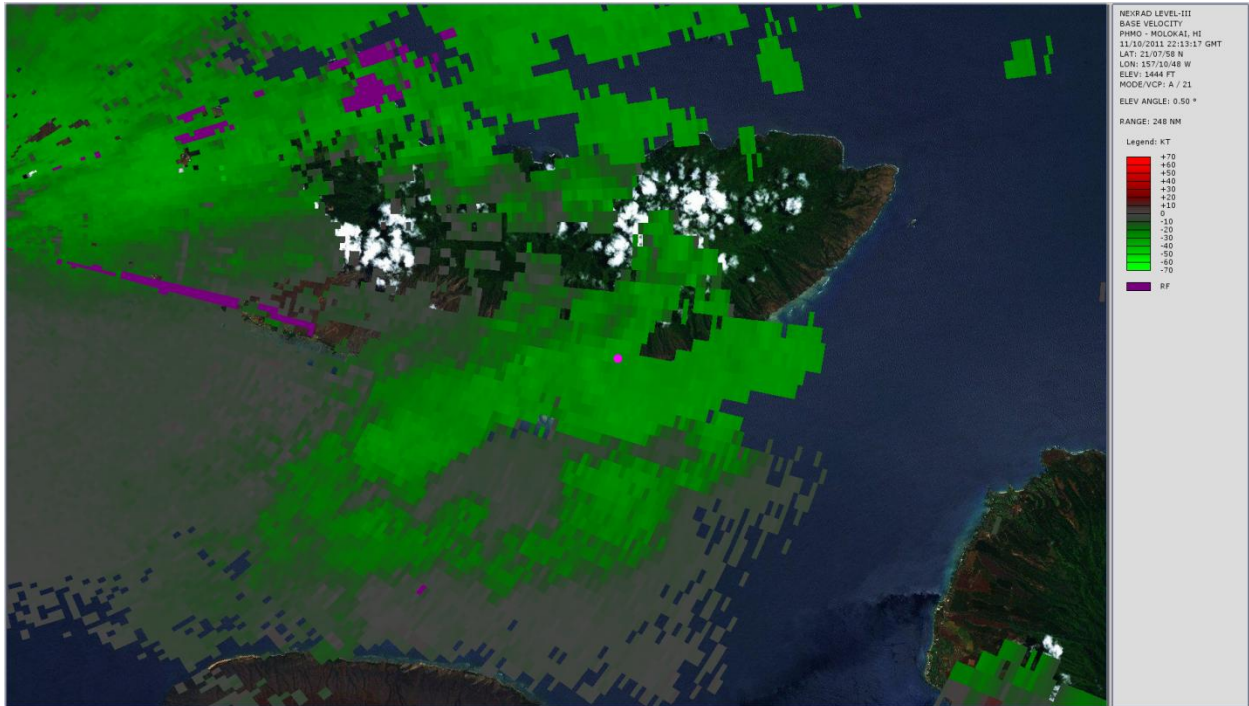
**Figure 19** – PHMO 0.50° elevation base velocity image from 1213 HST. Pink dot denotes accident location.

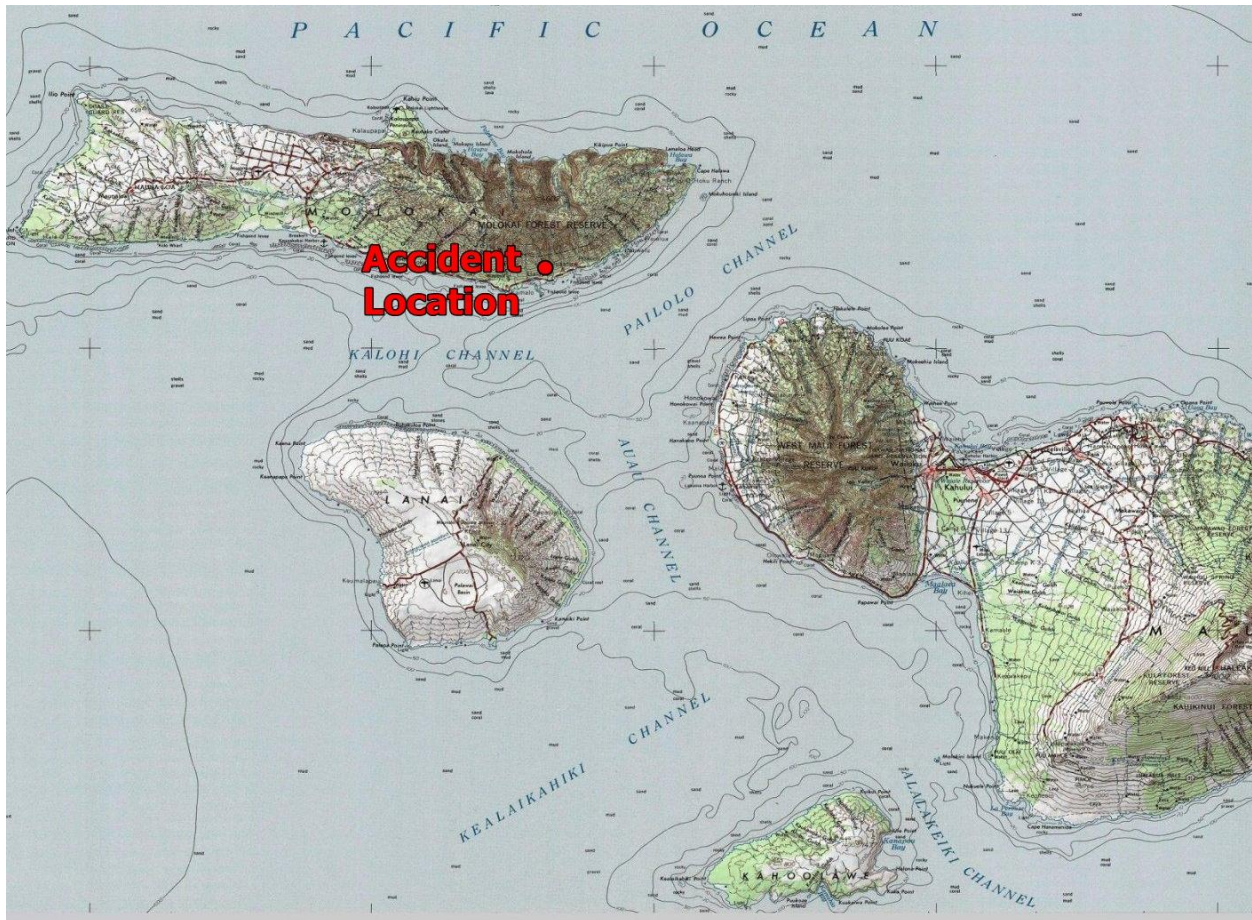
**Figure 23** – Map of the Hawaiian Islands immediately surrounding the accident location that identifies the marine channels by name.
