National Transportation Safety Board
Office of Aviation Safety
Washington, D.C. 20594-2000
April 10, 2006

METEOROLOGY FACTUAL REPORT

DCA06MA009

Location: Chicago-Midway Airport, Chicago, Illinois
Date: December 8, 2005
Time: 1914 Central Standard Time (0114Z December 9, 2005)
Aircraft: Southwest Airlines flight 1248, Boeing 737-7H4, registration: N471WN

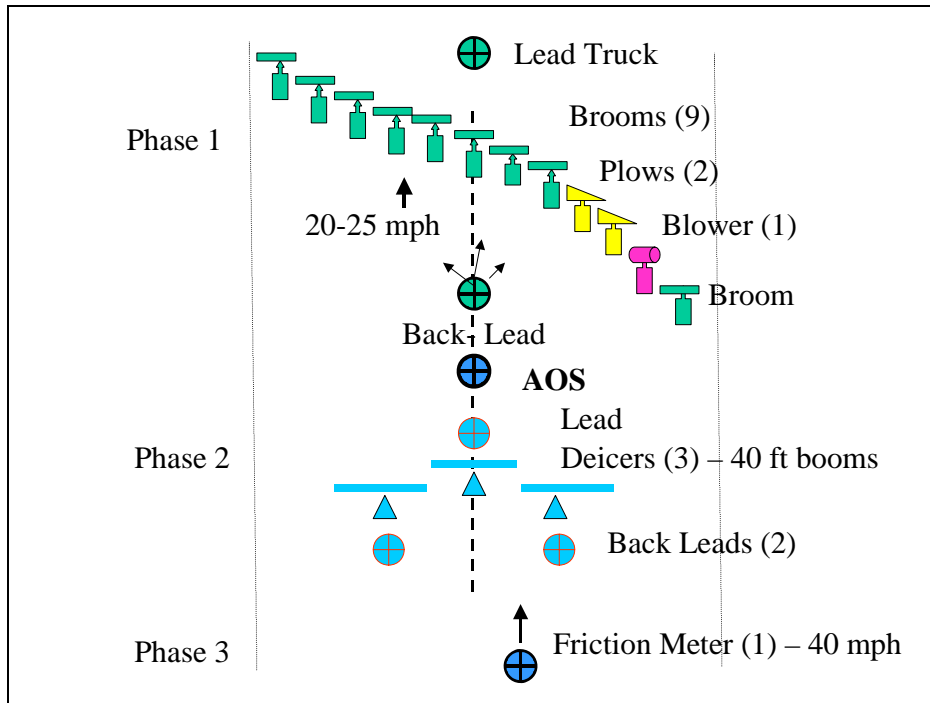
Figure 16 – typical runway plowing diagram

Phase 3 would follow a few minutes behind the deicing procedure when an unobstructed run down the runway could be accomplished by the vehicle to obtain the MU-meter reading. The friction measuring run is performed at 40 mph approximately 10 feet off the centerline of the runway (to approximate the main gear braking) and would begin approximately 500 feet from the beginning of the runway and end within 500 feet of the end of the runway, due to braking concerns and decelerations. The entire runway length is broomed, plowed, and deiced. A typical runway clearing took approximately 10-minutes to perform with a friction test taken after each runway treatment and the MU values recorded by the operator, radioed to the Operations Center and the Operations liaison in the control tower, and logged.

After a typical runway clearing, the brooms would move to a ramp or clear area to clean the “heads” by vibrating or shaking them, which would take approximately 5-minutes. After a heavy wet snow or after extensive runway runs the brooms would move to a ramp or clear area and have ground crews totally clean the brooms by compressed air, washed, and then vibrated. This more extensive cleaning process takes approximately 30 to 45-minutes to accomplish. At 0044Z the brooms were at the ramp undergoing one such broom cleaning process, and were unavailable for any runway treatment.

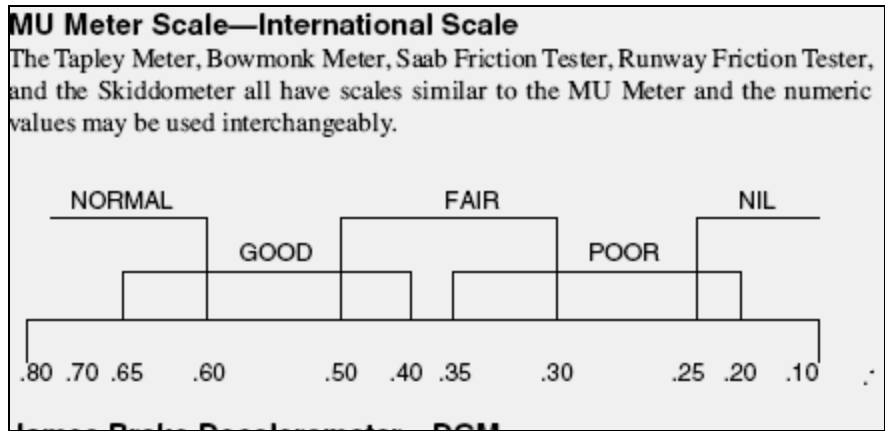
Figure 17 – Southwest Airlines MU-Meter Scale/Braking Action

Southwest Airlines Flight Operations Manual (FOM) section 3.23.2, states that for frozen contaminants on runway surfaces, a MU-meter value of .40 or less is the level at which aircraft braking performance and directional control begin to deteriorate. The manual also includes the International MU-meter scale for use in approximating runway condition under 3.23.3 (figure 17).
