NATIONAL TRANSPORTATION SAFETY BOARD

Group Chairman's Factual Report

METEOROLOGY

DCA13MA133

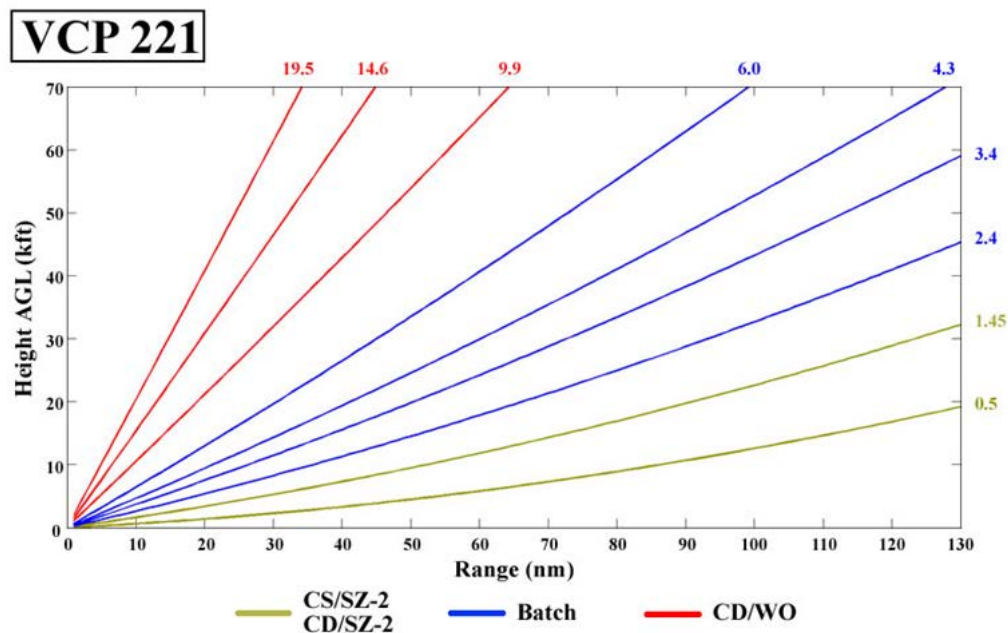
Figure 12 - WSR-88D VCP-221 scanning strategy

The WSR-88D operates in several different scanning modes, identified as Mode A for precipitation and Mode B for the clear air mode. Mode A is the precipitation scan and has multiple scanning strategies depending on the expected conditions. During the period of the accident the radar was being operated in the non-severe convective mode where the radar makes 9 elevation scans from 0.50° to 19.5° every five minutes. This particular scanning strategy is documented as volume coverage pattern 221 (VCP-221). This mode is typically used by the NWS during periods of widespread precipitation with embedded convection, and allows for improved low-level vertical resolution of the storms. Figure 12 depicts the different elevation angles in this VCP, and the approximate height and width of the radar beam with distance from the radar site.

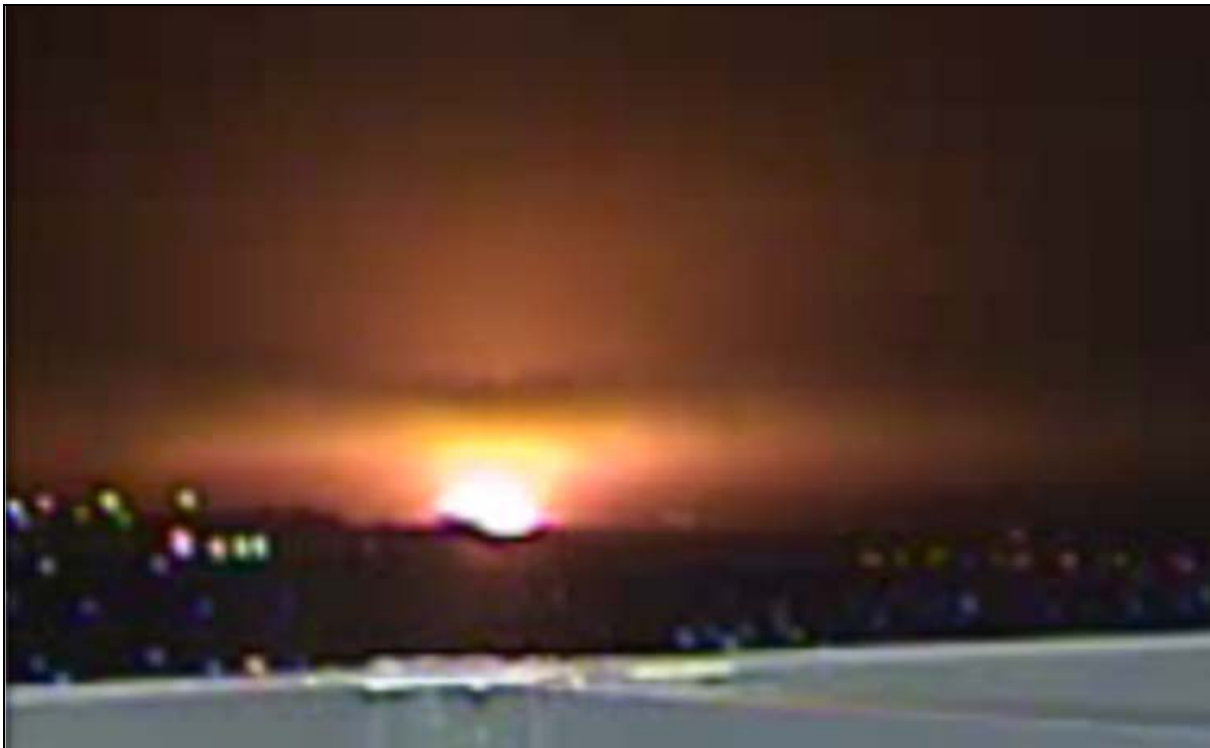
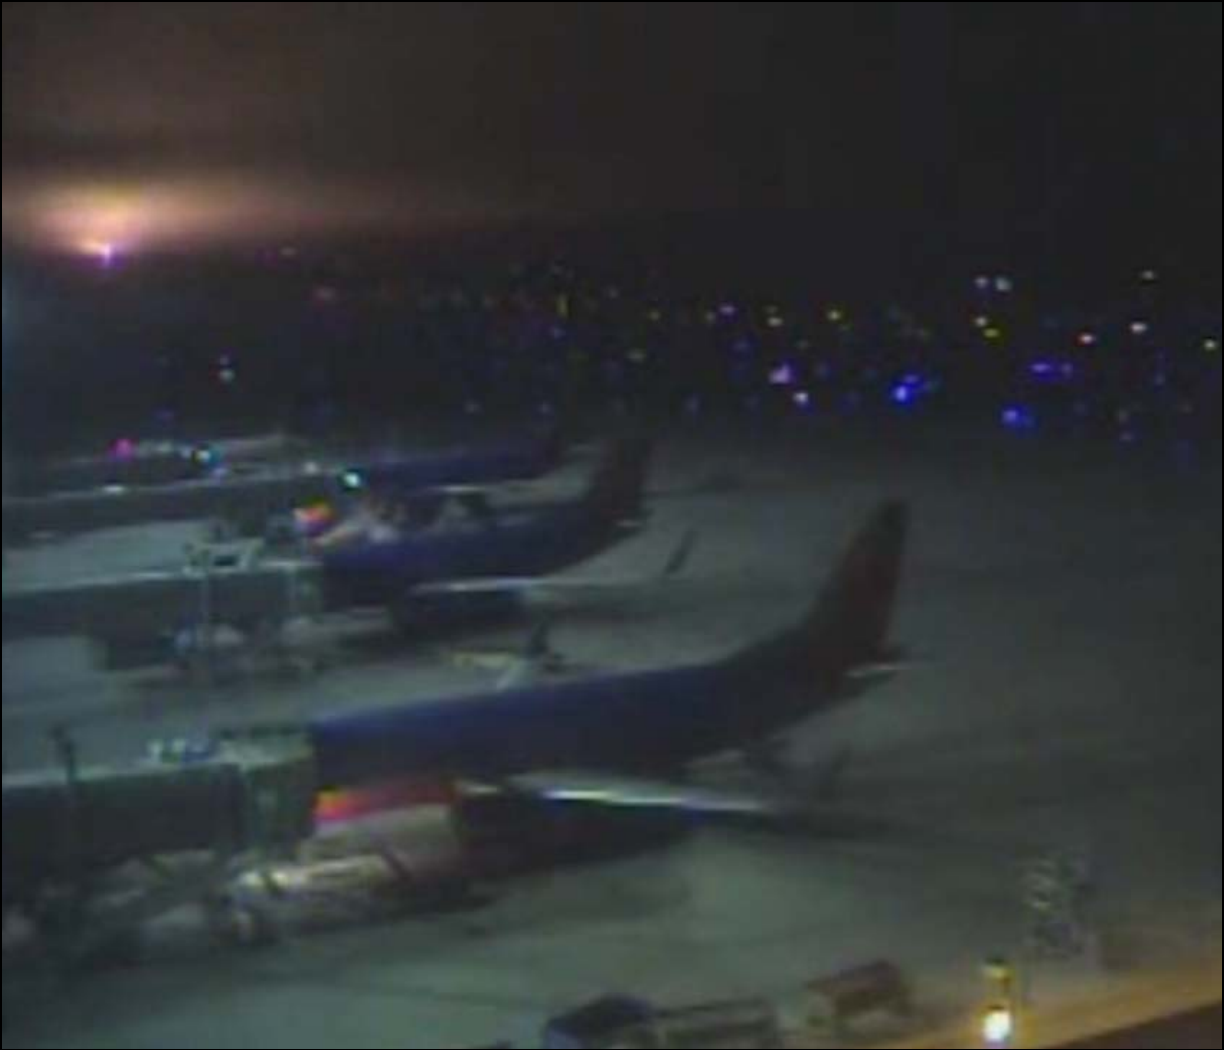
Several video images were captured on security cameras of the accident and obtained by the NTSB. Of significance on the images is the observation of the UPS flight 1354's descent through a band of clouds at low altitude or low on the horizon given the rising terrain in the area. The airplane's lights are observed prior to the airplane's impact with the terrain. The resultant fireball momentarily illuminates a band of stratus clouds over the accident site, which is north of the airport. Still frames of the video images are included as figures 20 and 21. These images show a layer of stratiform clouds immediately north of the airport and over the approach path of runway 18.

Figure 20 - Security camera video image at time of accident

Figure 21- Security camera capture of accident
