## **NATIONAL TRANSPORTATION SAFETY BOARD**

**Group Chairman's Factual Report**

**METEOROLOGY**

**DCA15FA085**

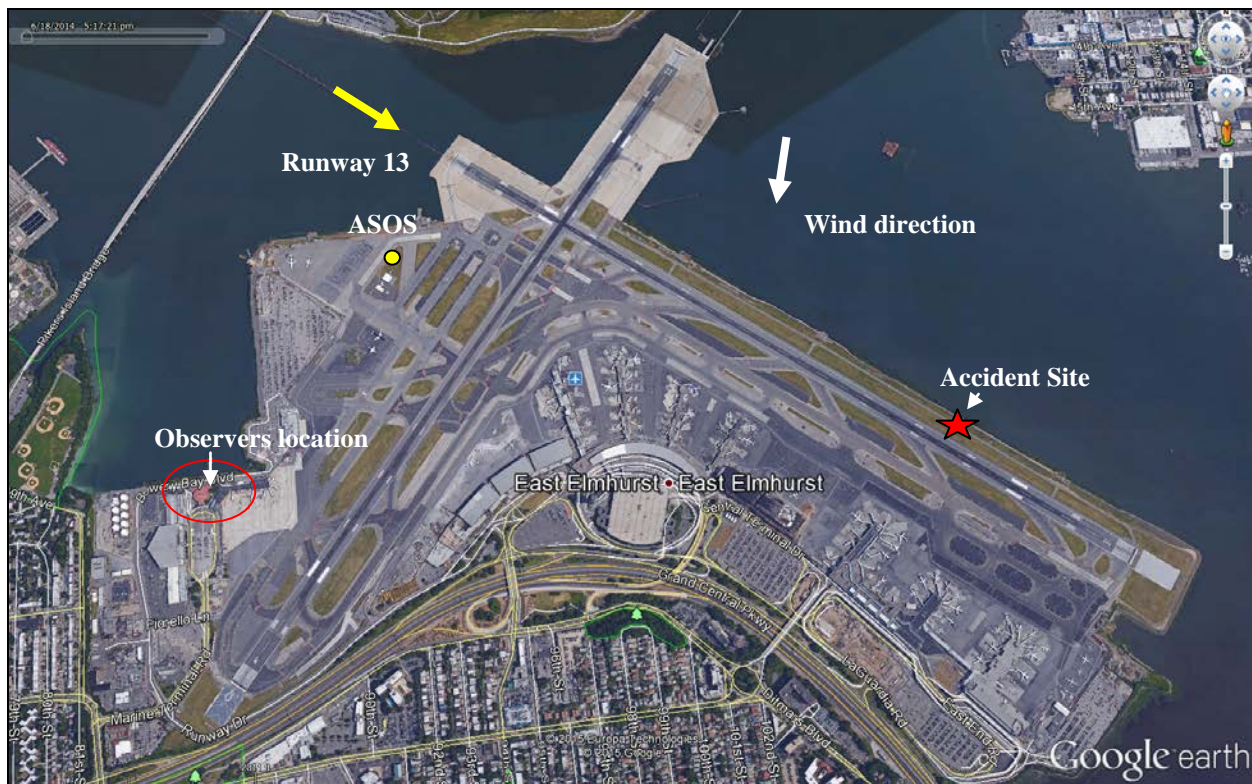
Figure 8 - KLGA Airport showing ASOS and observers location

Figure 8 is a Google Earth image of the La Guardia Airport with the approximate locations of the ASOS, weather observer's office location, runway 13, the accident site, and general wind direction. The ASOS primary sensor location was located approximately 0.2 miles southwest of the touchdown zone of runway 13. The weather observer's location was located on the second floor of the old Marine Air Terminal approximately 0.6 miles southwest of runway 13 and immediately north of the touchdown zone of runway 4, where the primary runway visual range (RVR) system was located.

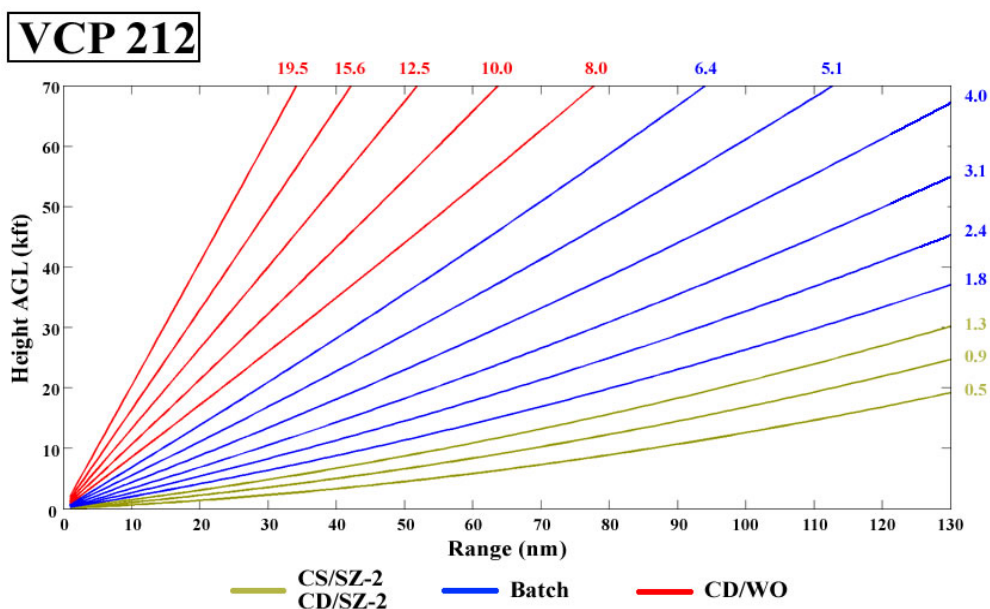
Figure 14- VCP-212 scanning mode

During the period surrounding the accident the KOKX WSR-88D radar was operating in the precipitation mode volume coverage pattern 212 (VCP-212), where the radar makes 14 different elevation scans from 0.5° to 19.5° every in 4 ½ minutes. This mode is typically used by the NWS during periods when rapidly evolving wide spread severe convection is expected, and allows for improved low-level vertical resolution of the storms. The following chart provides an indication of the different elevation angles in this VCP, and the approximate height and width of the radar beam with distance from the radar site.
