## **NATIONAL TRANSPORTATION SAFETY BOARD**

### **Group Chairman's Factual Report**

# **METEOROLOGY**

CEN17FA168

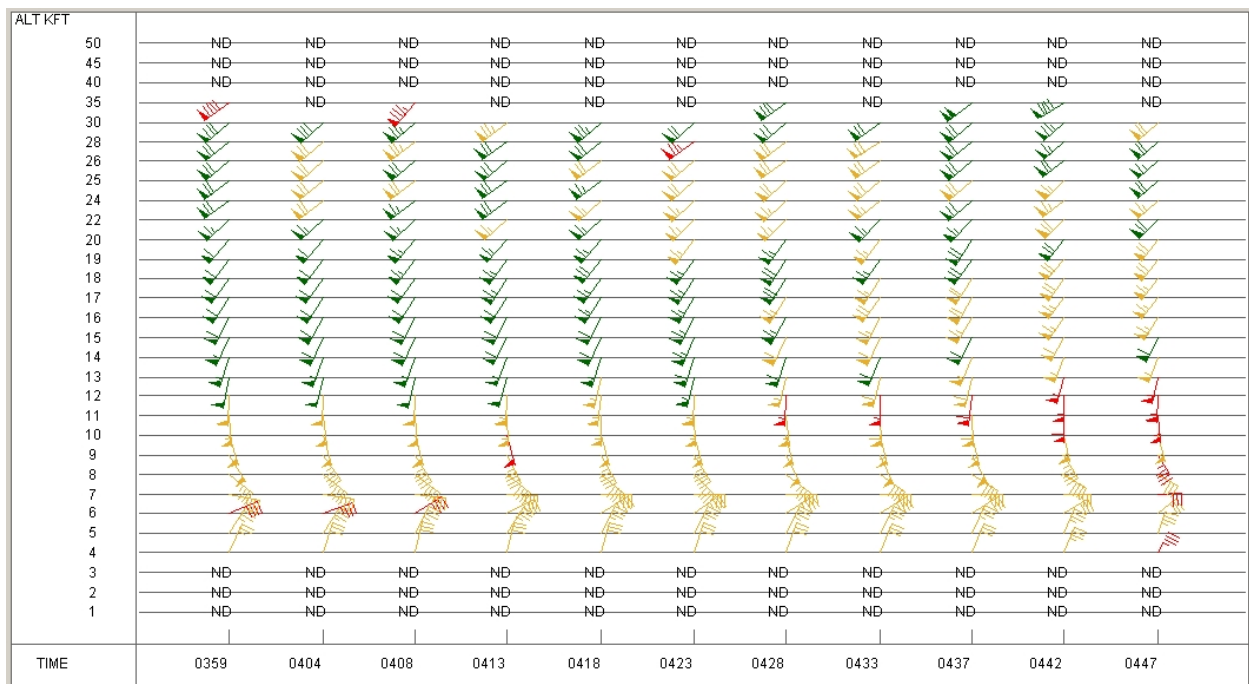
**Figure 5** – KAMA VAD wind profile for the times leading up to the accident time. Time is in UTC on April 29, 2017, and height is in 1,000's of feet above msl.

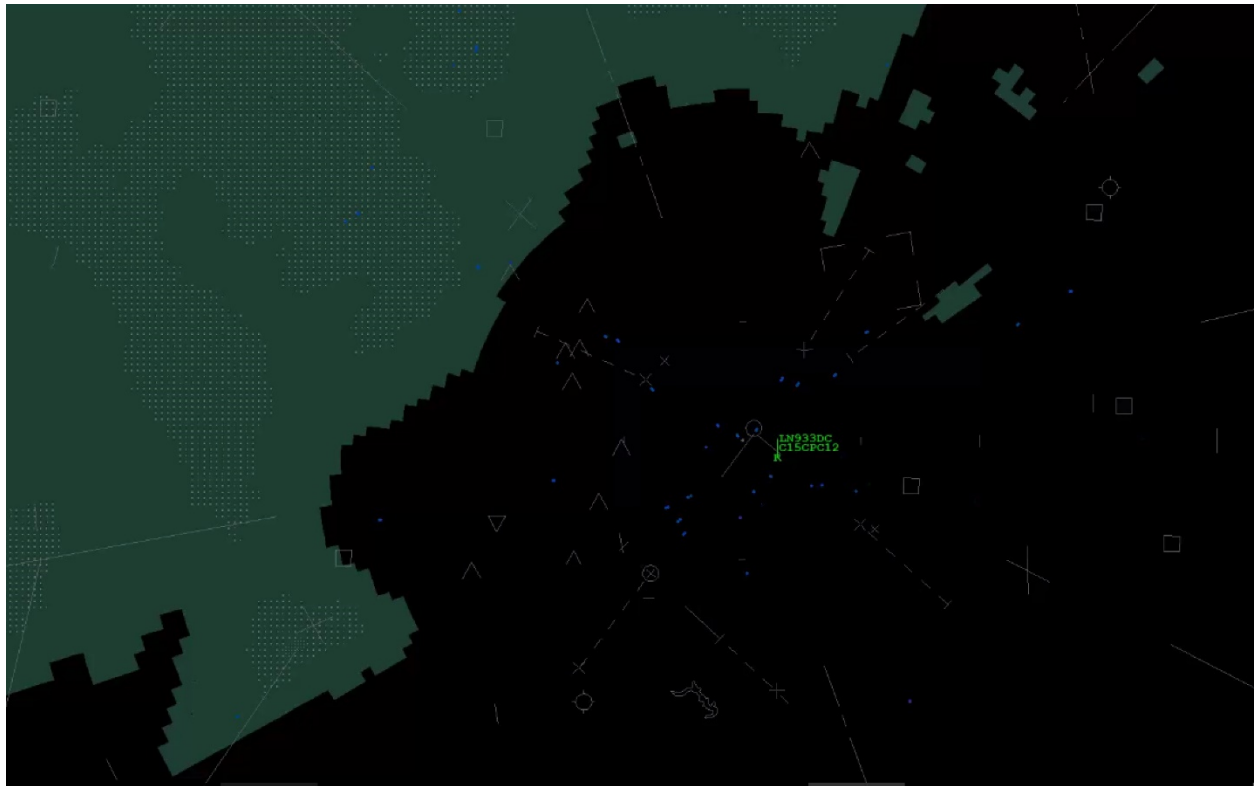
Weather radar data obtained from the Standard Terminal Automation Replacement System (STARS) at the Amarillo Terminal Radar Approach Control (TRACON) were provided by the Federal Aviation Administration (FAA), and replayed by the NTSB using a separate playback program. Figure 6 depicts the STARS weather presentation at about 2348 CDT. Figure 7 describes how different radar levels are presented in the STARS display. Figure 6 presents a slightly different color shading (green/blue), however the solid color/dots are consistent.

**Figure 6** – Amarillo TRACON STARS weather depiction from about 2348 CDT.

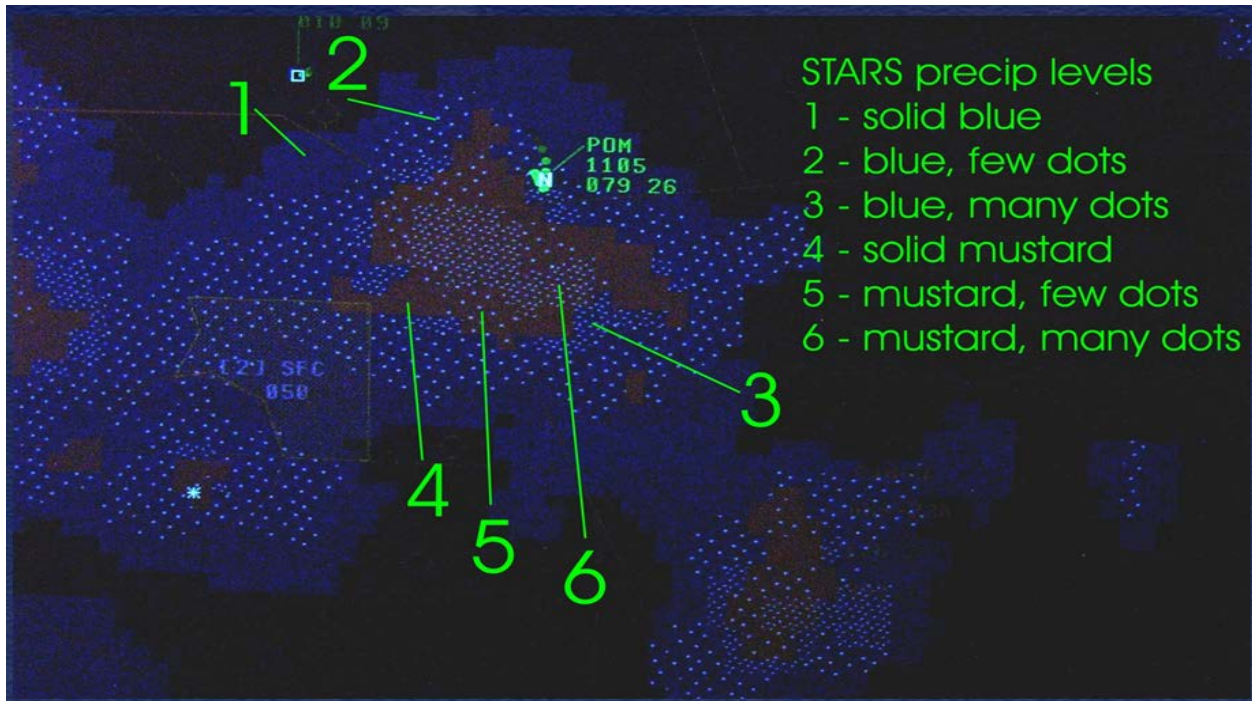
**Figure 7** – Example of weather radar presentation in STARS.

According to the FAA the dBZ thresholds for the color scale (levels) presented in the STARS display are as follows:

- Level 1: 18 < 30 dBZ
- Level 2: 30 < 41 dBZ
- Level 3: 41 < 46 dBZ
- Level 4: 46 < 50 dBZ
- Level 5: 50 < 57 dBZ
- Level 6: 57+ dBZ
