NATIONAL TRANSPORTATION SAFETY BOARD

Group Chairman's Factual Report

METEOROLOGY

CEN15MA290

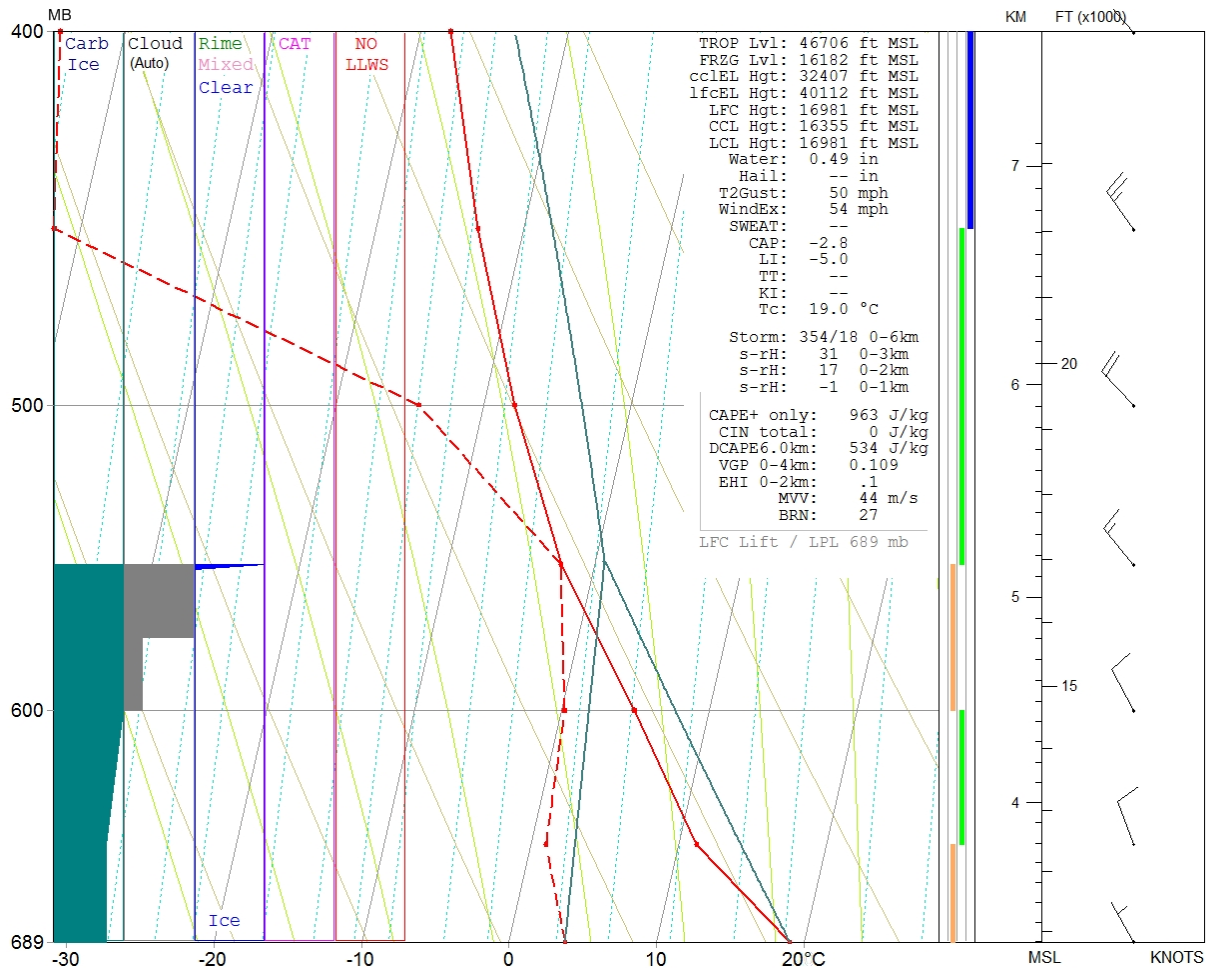
Figure 13 – 1200 MDT NAM sounding

The 1200 MDT NAM sounding indicated a relatively dry vertical environment from the surface through 15,000 feet msl with several layers of conditional instability through 22,000 feet msl. This environment would have been conducive of cloud formation as indicated by RAOB from 14,000 feet through 17,000 feet. No icing was indicated by RAOB. With cumulus clouds, rain showers, and thunderstorms possible given the environment and observations from around the accident time, the NAM sounding indicated the strongest wind speeds possible with a microburst, outflow boundary, or gust front would have likely been 50 mph as indicated by the T2Gust parameter or 54 mph as indicated by the WindEx parameter.

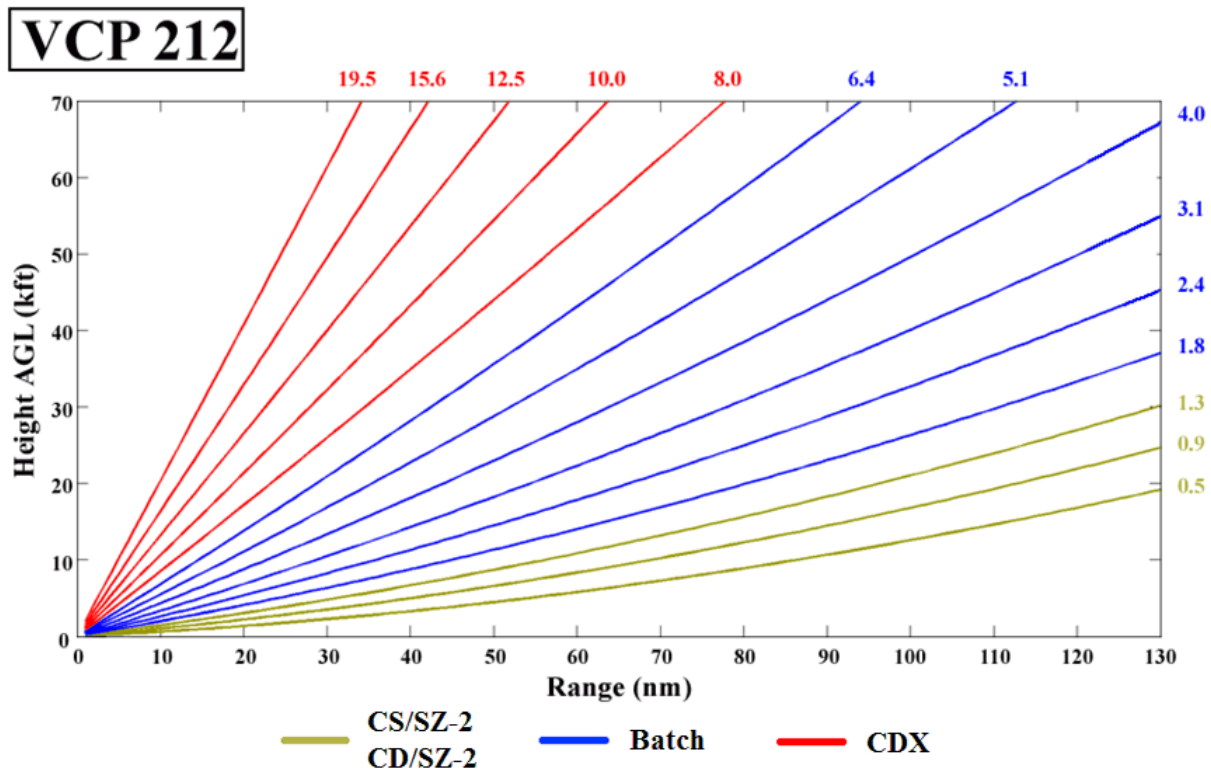
VCP-212 Precipitation Mode Scan Strategy

The WSR-88D operates in several different scanning modes, identified as Mode A and Mode B. Mode A is the precipitation scan and has three common scanning strategies. The most common is where the radar makes 14 elevation scans from 0.5° to 19.5° every four and a half minutes. This particular scanning strategy is documented as volume coverage pattern 212 (VCP-212). Mode B is the clear-air mode, where the radar makes 5 elevation scans during a ten minute period. During the period surrounding the accident, the KFTG WSR-88D radar was operating in the precipitation mode (Mode A, VCP-212). The following chart provides an indication of the different elevation angles in this VCP, and the approximate height and width of the radar beam with distance from the radar site.

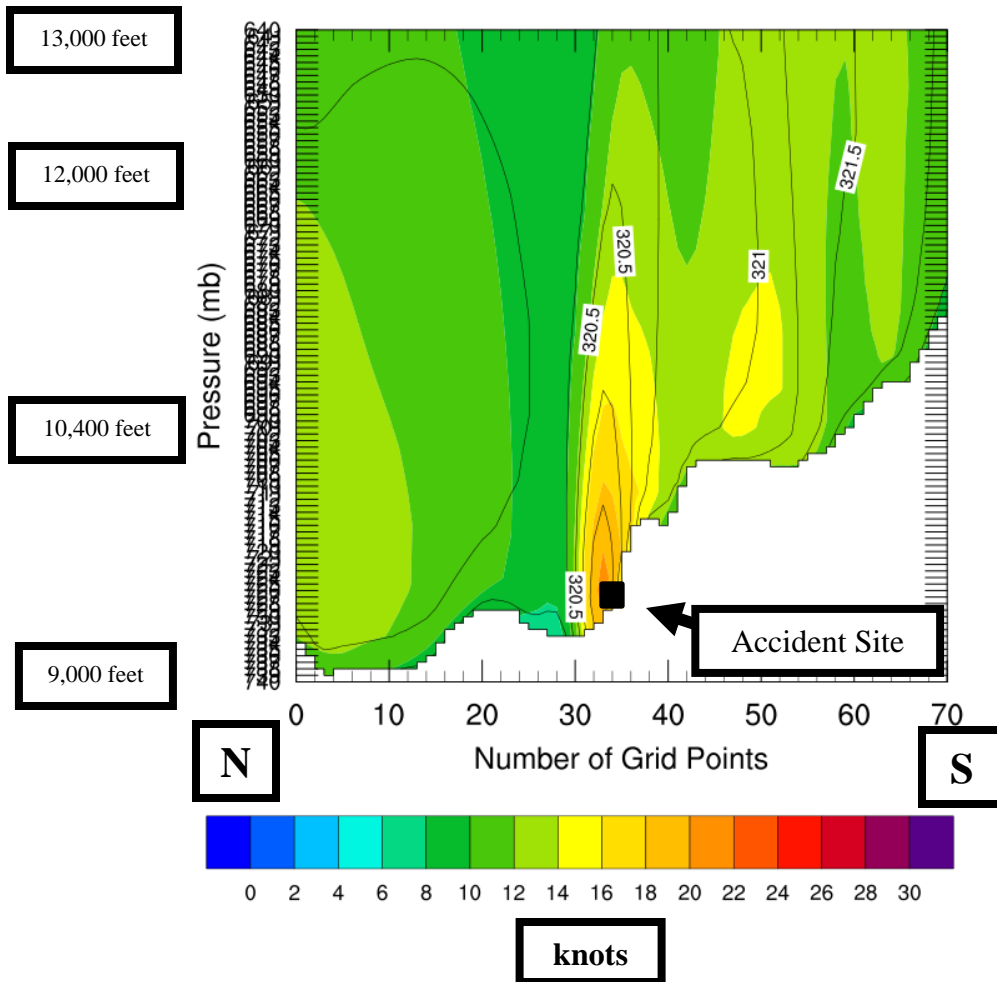
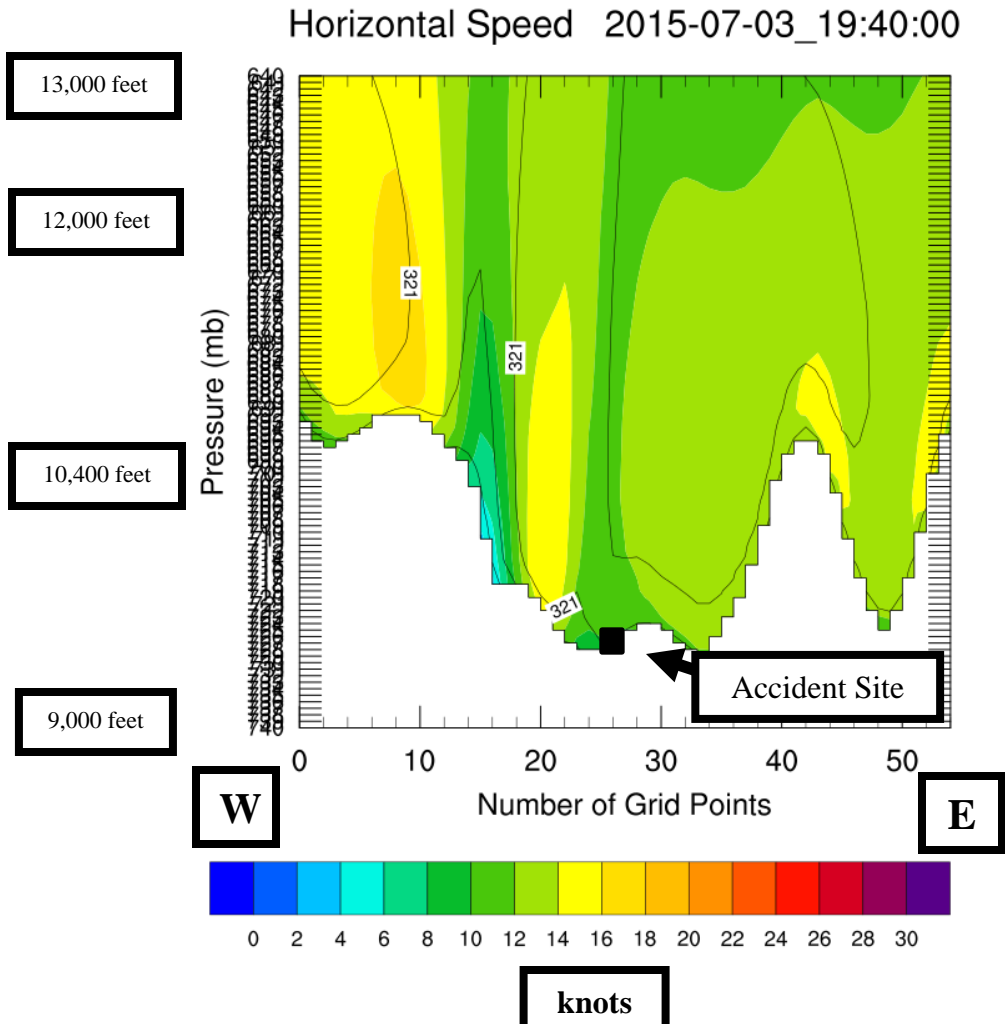
Figure 30 – WRF cross section from 1340 MDT of horizontal speed in knots and potential temperature in kelvin from north to south across the terrain with the approximate accident site marked

Figure 31 – WRF cross section from 1400 MDT of horizontal speed in knots and potential temperature in kelvin from north to south across the terrain with the approximate accident site marked

Figure 32 – WRF cross section from 1420 MDT of horizontal speed in knots and potential temperature in kelvin from north to south across the terrain with the approximate accident site marked

Figure 33 – WRF cross section from 1340 MDT of horizontal speed in knots and potential temperature in kelvin from west to east across the terrain with the approximate accident site marked

Figure 34 – WRF cross section from 1400 MDT of horizontal speed in knots and potential temperature in kelvin from west to east across the terrain with the approximate accident site marked

Figure 35 – WRF cross section from 1420 MDT of horizontal speed in knots and potential temperature in kelvin from west to east across the terrain with the approximate accident site marked

A Weather Research and Forecasting Model (WRF) simulation was run to simulate the weather conditions surrounding the accident site at the accident time. WRF ARW (Advanced Research WRF core) version 3.2.1.5 was run with 3 domains with horizontal grid spacing of 8 km, 1.6 km, and 320 m over the accident site. Other WRF simulation parameters included: 55 vertical levels, the Kain-Fritsch cumulus parameterization scheme used on the outer domain, a Lin et al. microphysics scheme, a Yonsei University boundary layer scheme, Noah land surface physics, and the Dudhia scheme used for the long and short wave radiation. The terrain (in feet) used in domain 3 is shown in figure 29 along with the location of the cross sections used figures 30 through 43 with the location of the accident site marked.

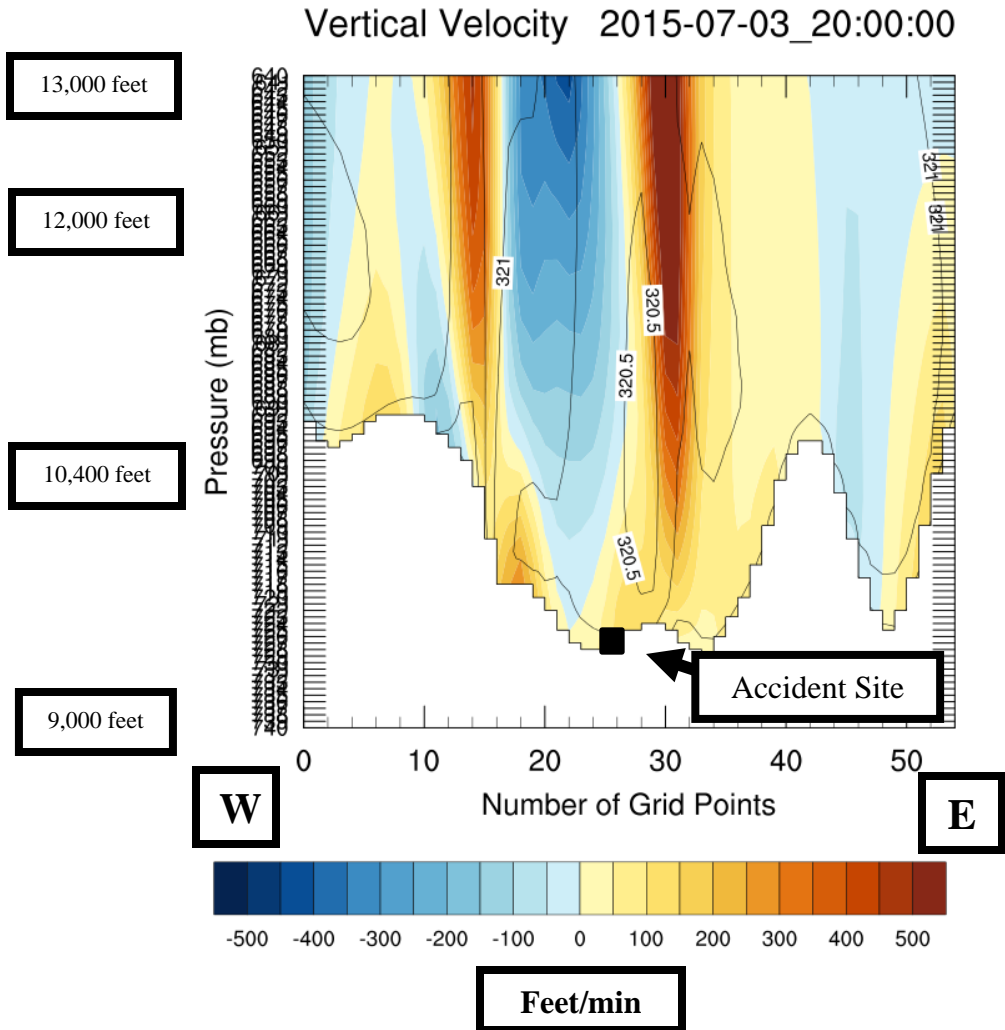
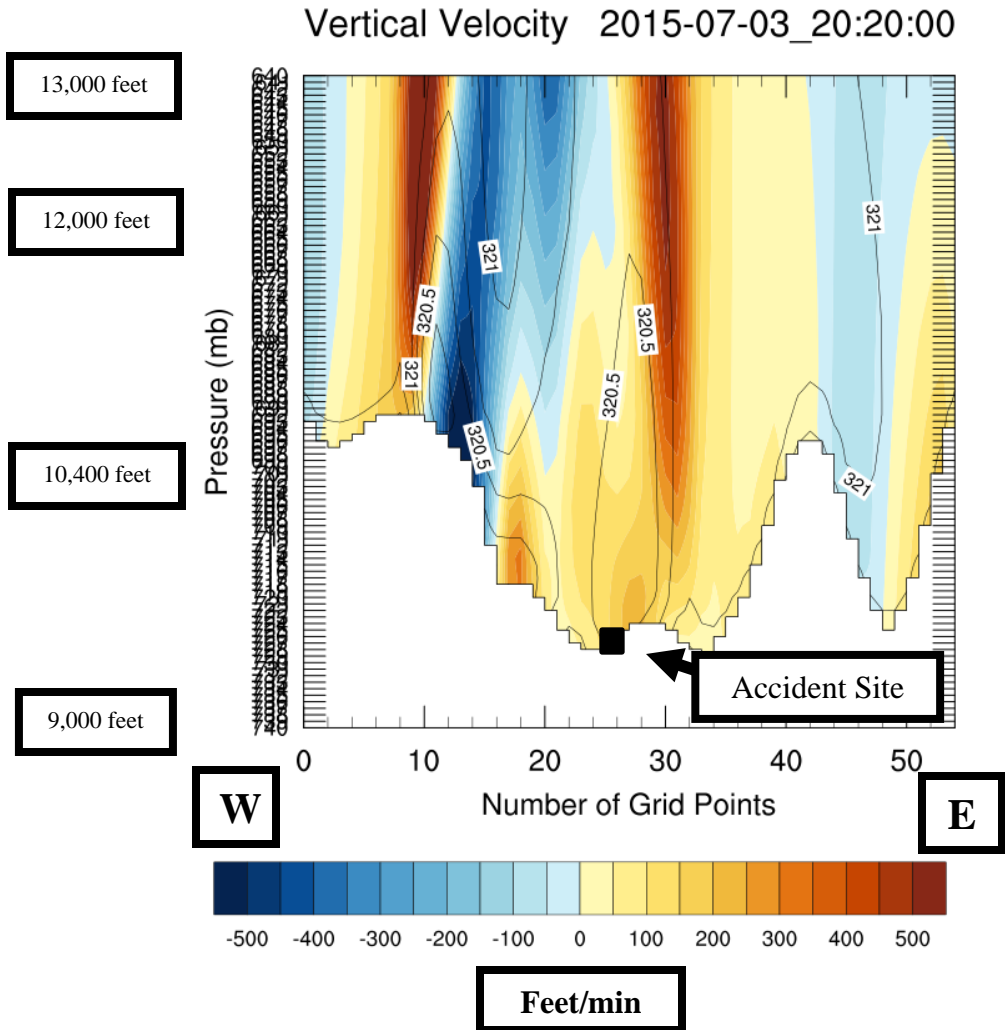
There was also a corresponding downdraft just west of the accident site on figures 40 and 41, associated with an increase in relative humidity (figures 42 and 43) at the surface, as well as the relative humidity increasing in height over the strong updraft and downdraft areas. Attachments 6 and 7 show the vertical velocity values between 1300 and 1450 MDT on the north to south and west to east cross sections, with attachment 8 showing the relative humidity values on the west to east cross section between 1300 and 1450 MDT. Attachments 4 through 8 showed environmental conditions very similar to the conditions described in sections 3.0 and 6.4 with rain showers in and around the accident site at the accident time with a corresponding wind speed increase.

Figure 40 – WRF cross section from 1400 MDT of vertical speed in feet per minute and potential temperature in kelvin from west to east across the terrain with the approximate accident site marked

Figure 41 – WRF cross section from 1420 MDT of vertical speed in feet per minute and potential temperature in kelvin from west to east across the terrain with the approximate accident site marked

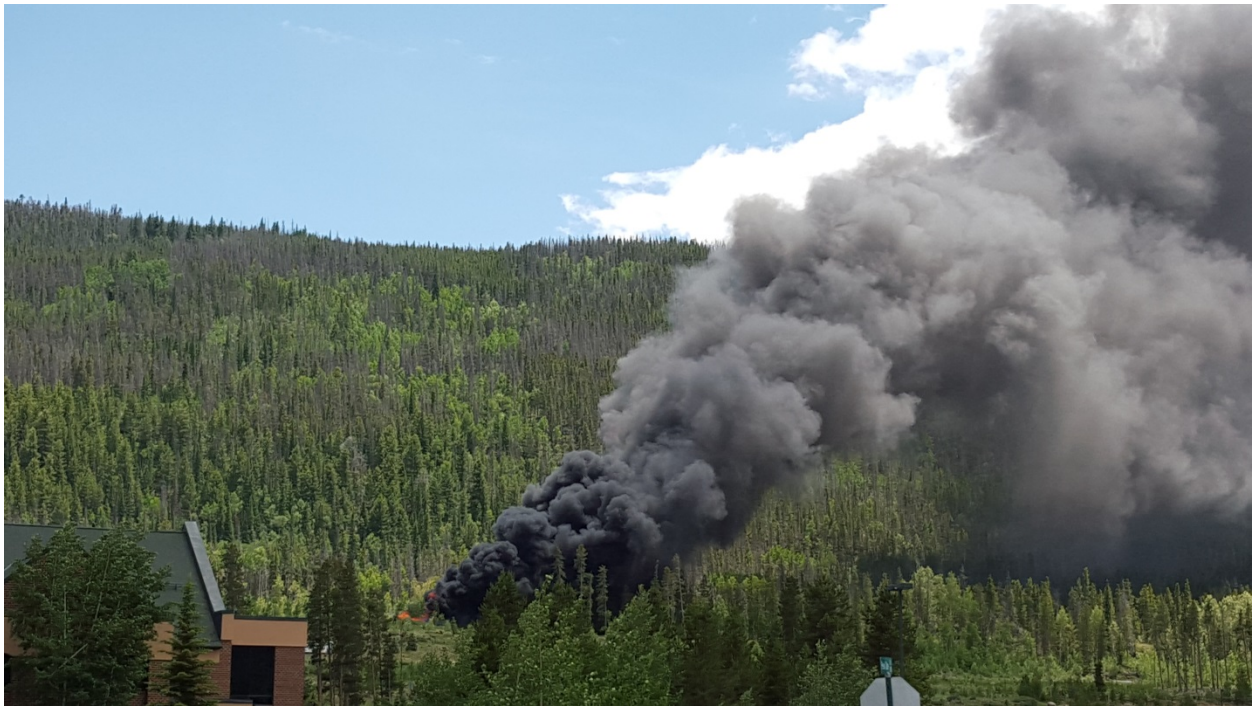
A witness a quarter mile north-northwest of the accident site (located at the Frisco recycling center) took several pictures of the accident site after the accident time. Figure 44 is one of these images with the smoke plume blowing away from the accident site toward the southwest to west. The southwesterly to westerly oriented smoke plume was a different wind direction than observed from the wind sock at the helipad as the accident flight departed. The helipad wind sock was rated to 15 knots, with the wind sock fluctuating between below horizontal to above horizontal before, during, and after the accident time (figure 45).²⁰ The wind sock conditions were captured in security video taken from the ambulance bay and helipad areas. The wind sock wind speeds are similar to the conditions described in sections 3.0, 4.0, and 16.0.

Figure 44 – Witness image taken after the accident time a quarter mile north-northwest of the accident site
