NATIONAL TRANSPORTATION SAFETY BOARD

Group Chairman's Factual Report

METEOROLOGY

DCA15MA029

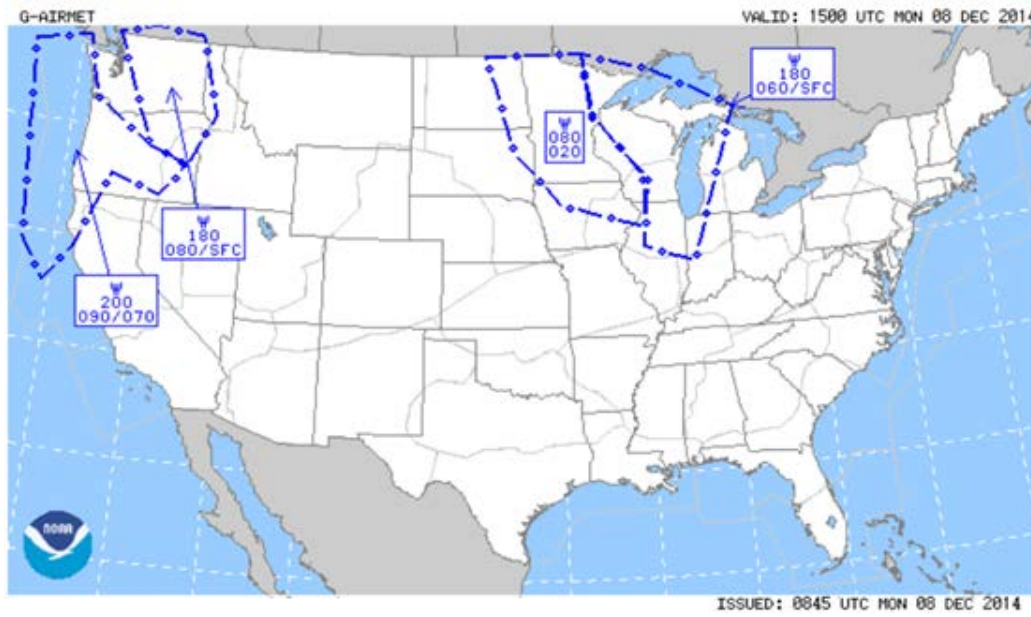
The following graphic of G-AIRMETs were issued for the period by the AWC and are included as figure 21 through 23:
