NTSB Docket Item
DCA-05-MR-009
Metrolink Derailment
Glendale, California
January 26, 2005

Metrolink Derailment Sketches

METROLINK COLLISION
 DCA-05 MR-0009
 1/26/05 - GLENDALE, CA
 DWN BY P.D. HALL
 NOT TO SCALE

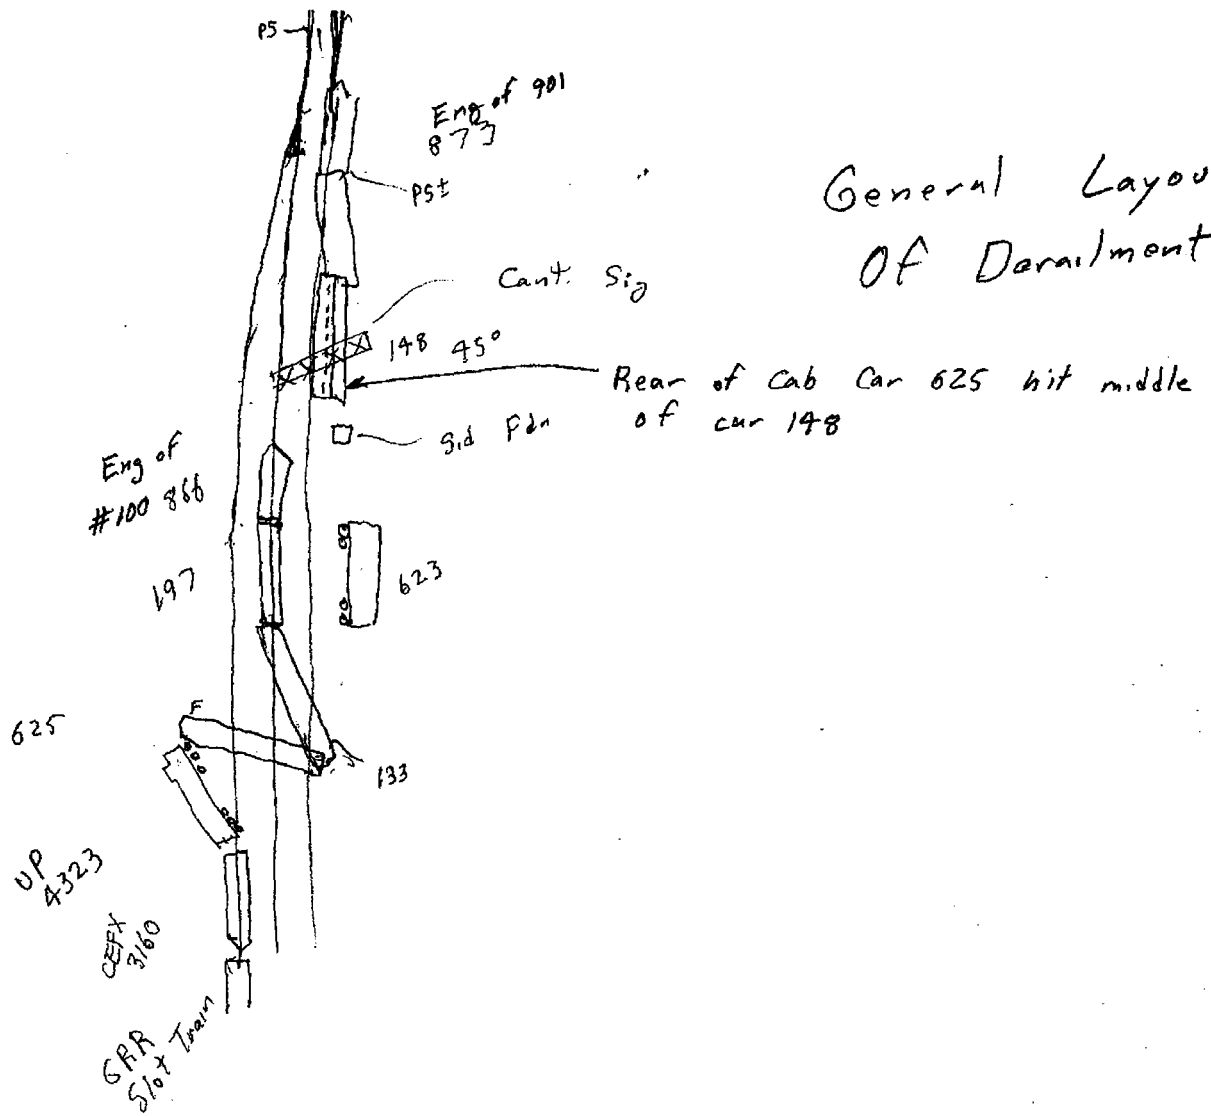
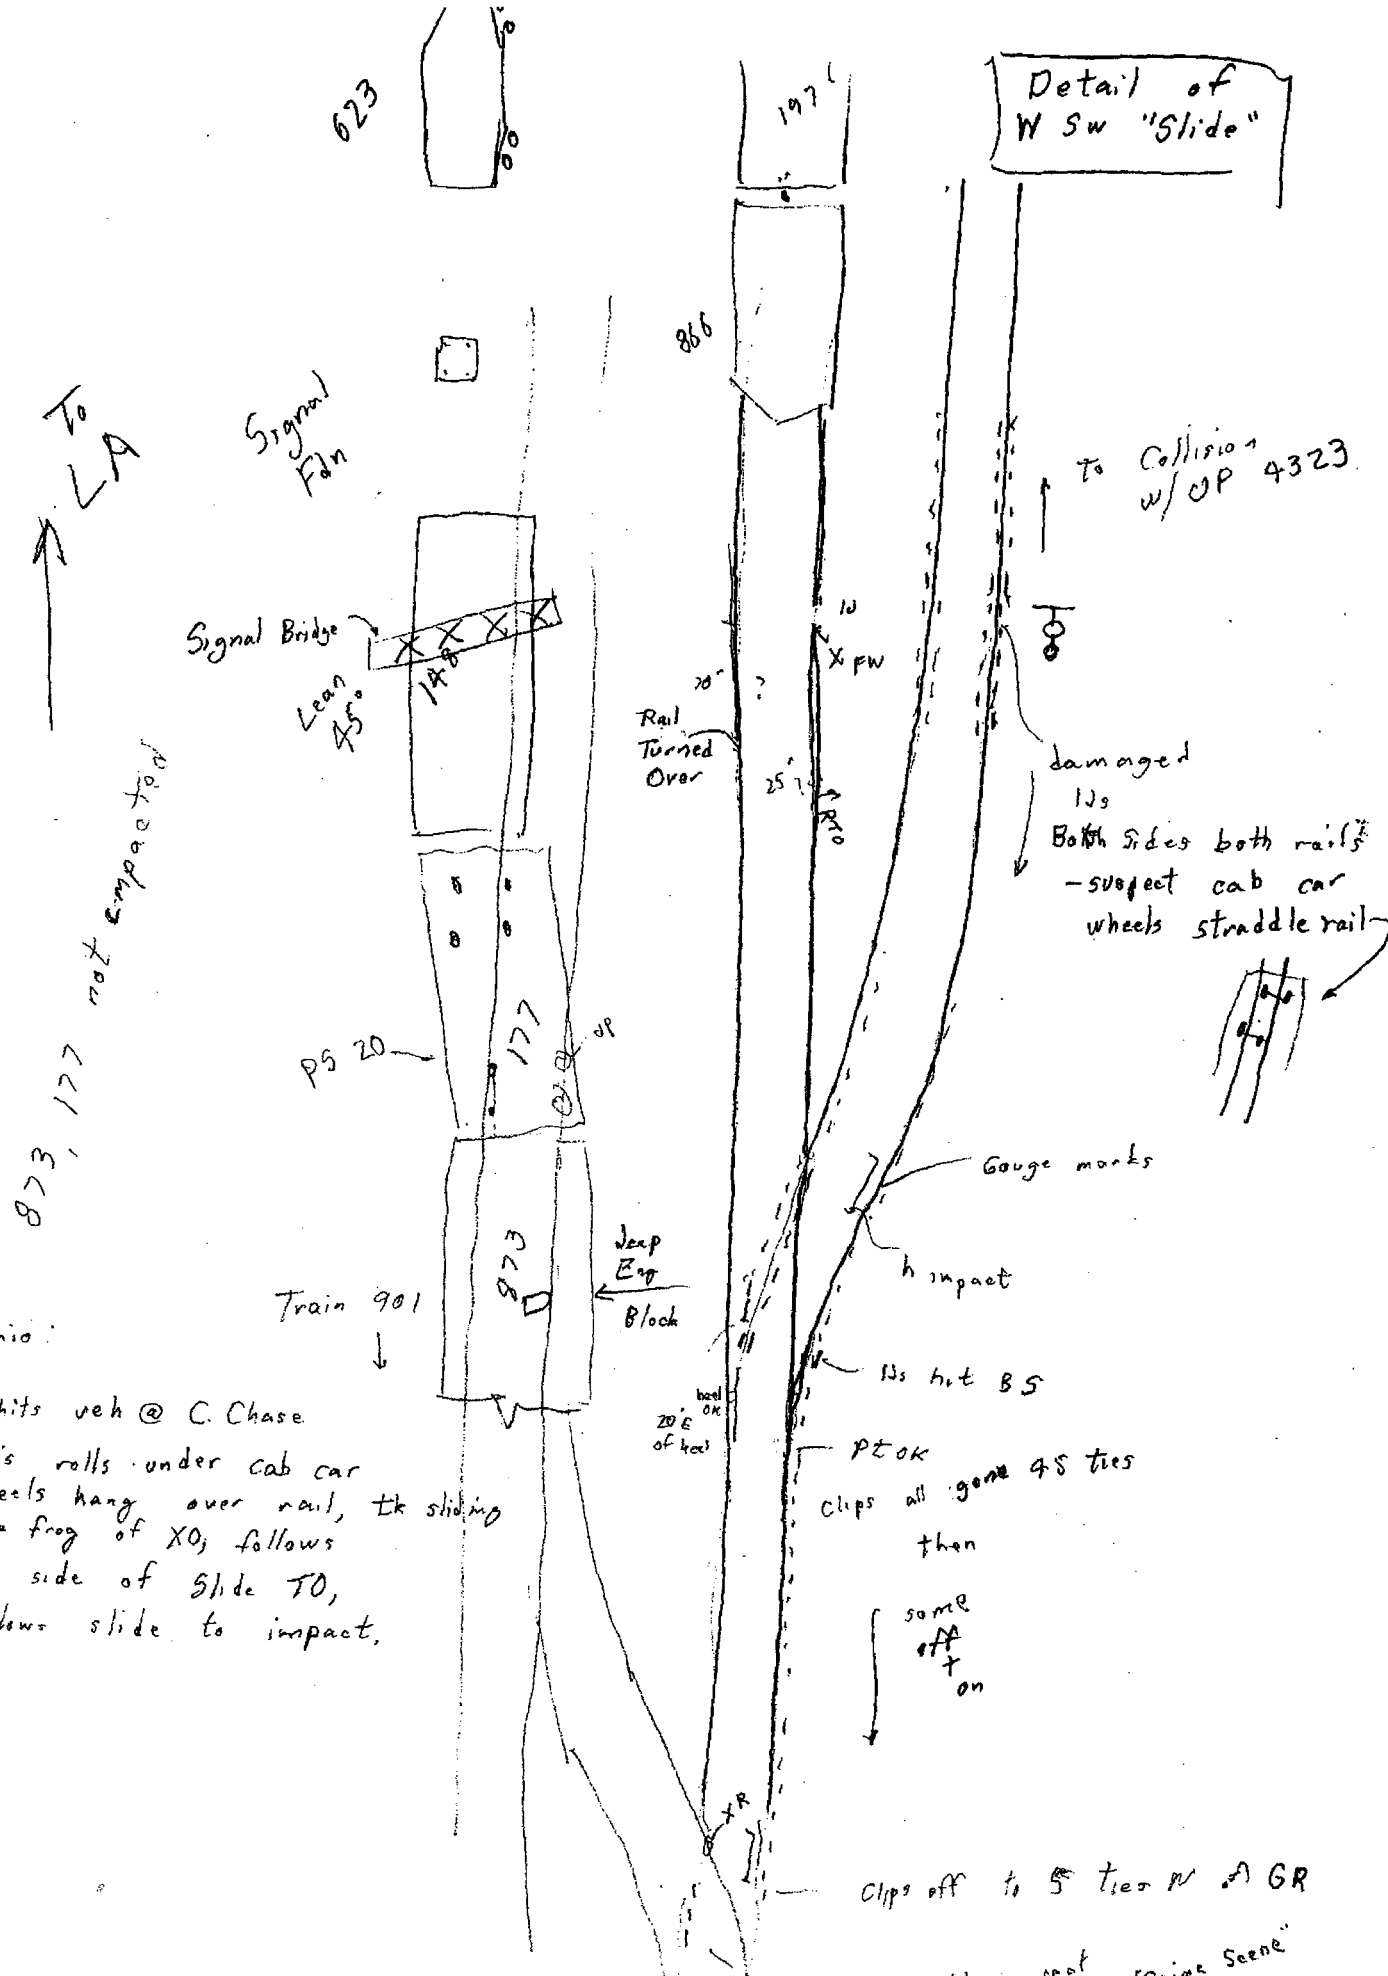
Detail of W SW "Slide"

To LA ↑
 873, 177 not impacted

To Collision w/ CP 4323 ↑

damaged N's
 Both sides both rails
 - suspect cab car wheels straddle rail

Scenario:

100 hits veh @ C. Chase
 debris rolls under cab car
 wheels hang over rail, tk sliding
 thru frog of XO, follows
 TO side of slide TO,
 follows slide to impact,

Clips off to 5 ties W of GR
