## SERVICE BULLETIN 13-12-19

**Subject:** Fuel Tank Attach Modification

**Affected Models:** All RV-12 Fuel Tanks shipped prior to December 19, 2013  
All SLSA RV-12 serial numbers 12019 and below.

**Required Action:** Install T-01220 Doublers and Upgrade T-1205 attach hardware.

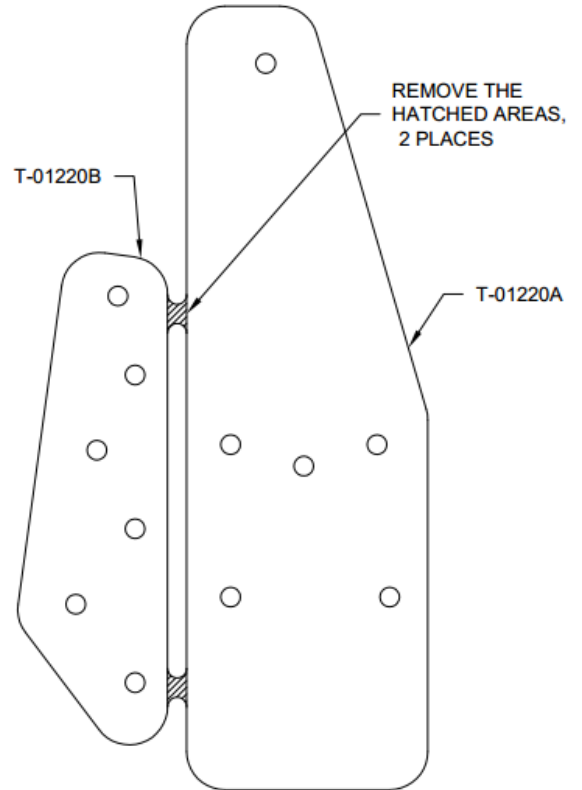
**FIGURE 1:** SEPARATING THE DOUBLERS

**Step 4:** Separate T-01220 Doubler into A & B parts as shown in Figure 1.

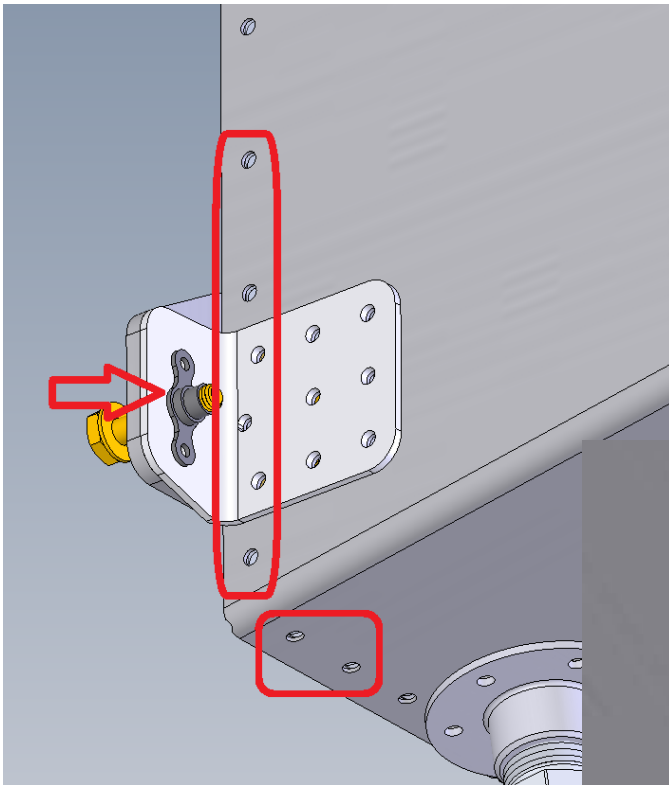
**FIGURE 2:** REMOVING INBOARD RIVETS AND NUTPLATES

**Step 5:** Remove the two K-1000-3 nutplates attached to the T-1205 Fwd Tank Bracket and save them for reinstallation later (Reuse of the old nutplates is beneficial. Since they have already had a bolt inserted, the prevailing torque of the locking feature will be lower which reduces the risk of over torquing and fracturing the frangible bolt). Removal of the rivets common to the doublers and other rivets depicted will greatly help with the removal process of the existing sealant. See Figures 2 and 3. See KAI Chapter 5 for further information on removing rivets.

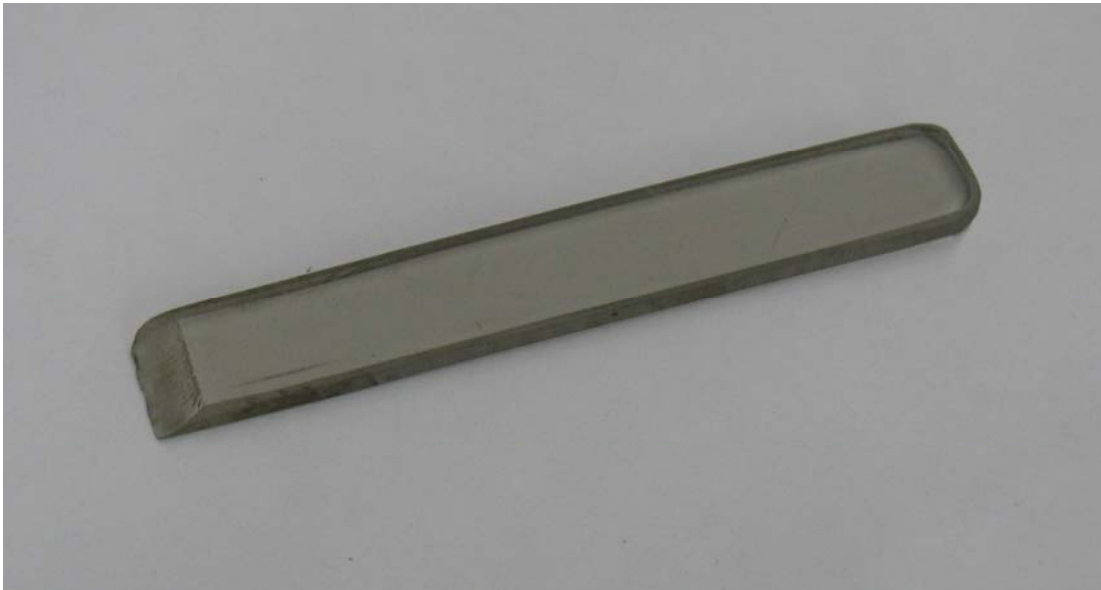
**FIGURE 4: SEALANT  
REMOVAL TOOL**

Step 7: Remove sealant within the contact area of each doubler. A hard plastic scraper about 1/2" wide is useful for sealant removal. See Figure 4. A Polysulfide Stripper (such as PolyGone 300AG available from Van's Aircraft) can be used to soften the sealant for easier removal. If used, be sure to remove all sealant softened by the stripper.

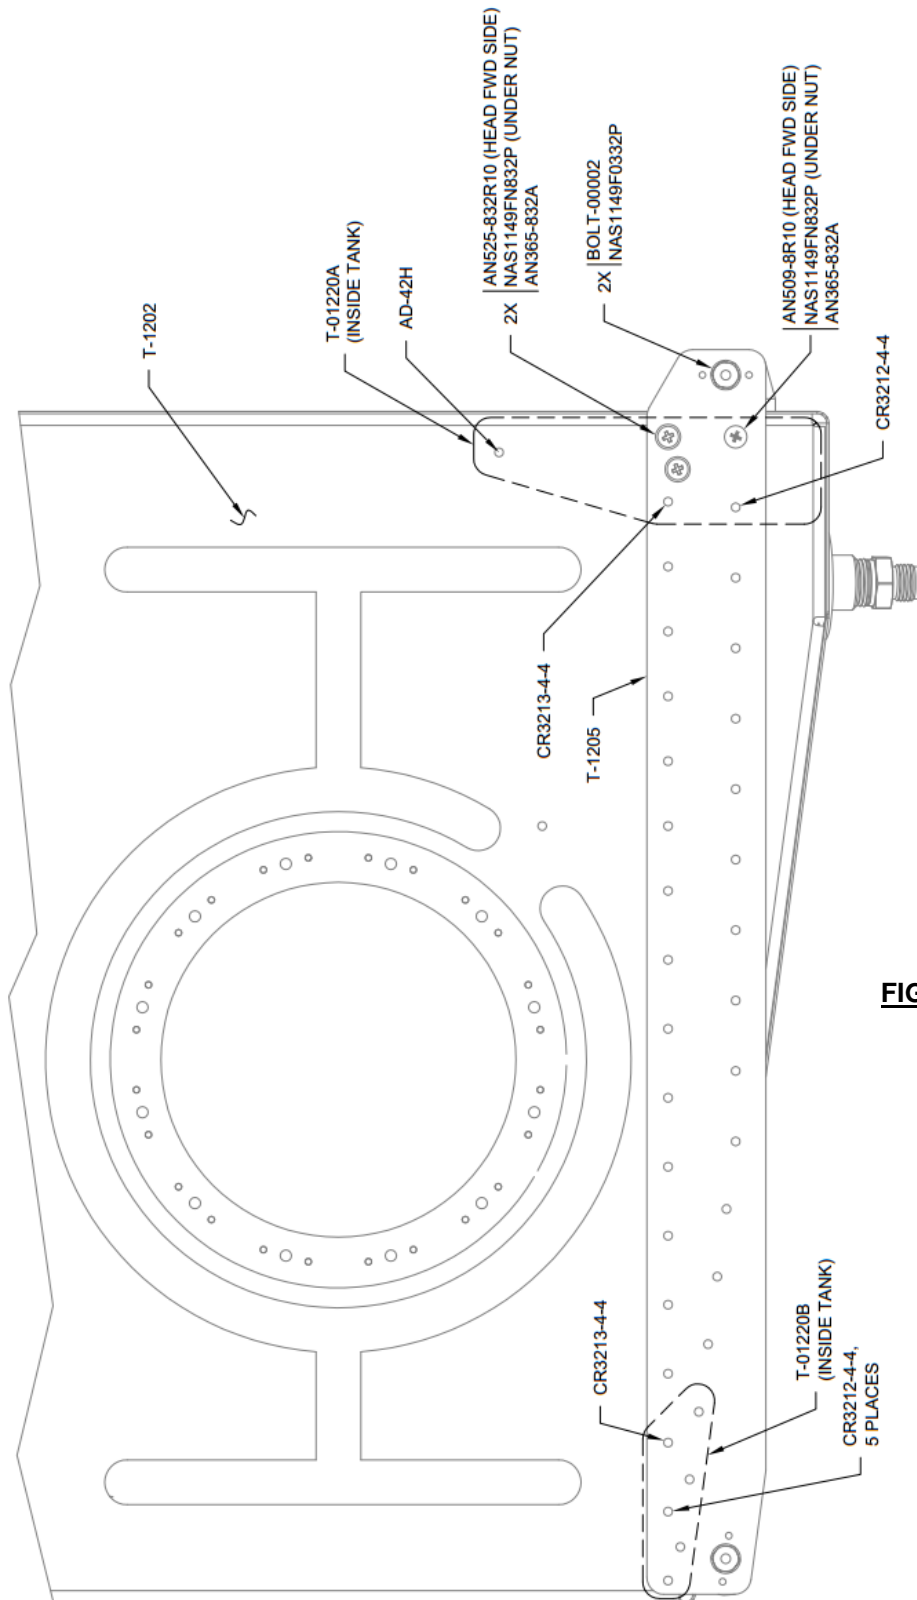
**FIGURE 5: INSTALLING THE DOUBLERS**

Step 8: Test fit the doublers inside the tank. Radius the edges of the doublers to fit against the bend radii in the T-1202 Fwd Tank Bulkhead. See Figure 5.

Step 13: Add a very thin layer of sealant covering the face of the doublers that will lay against the T-1202 Fwd Tank Bulkhead. Using the hardware callouts shown in Figure 5 rivet the doublers to the tank structure using tank sealant. Refer to Section 5 for installation of Cherry Max rivets.

Step 14: Install the screws common to the inboard doubler as shown in Figure 5.
