NATIONAL TRANSPORTATION SAFETY BOARD

MODELING GROUP STUDY

Report No. 07-115

Place : Minneapolis, Minnesota
Date : August 1, 2007
Vehicle : I-35W bridge
NTSB No. : HWY07MH024
Investigator : Gary Van Etten

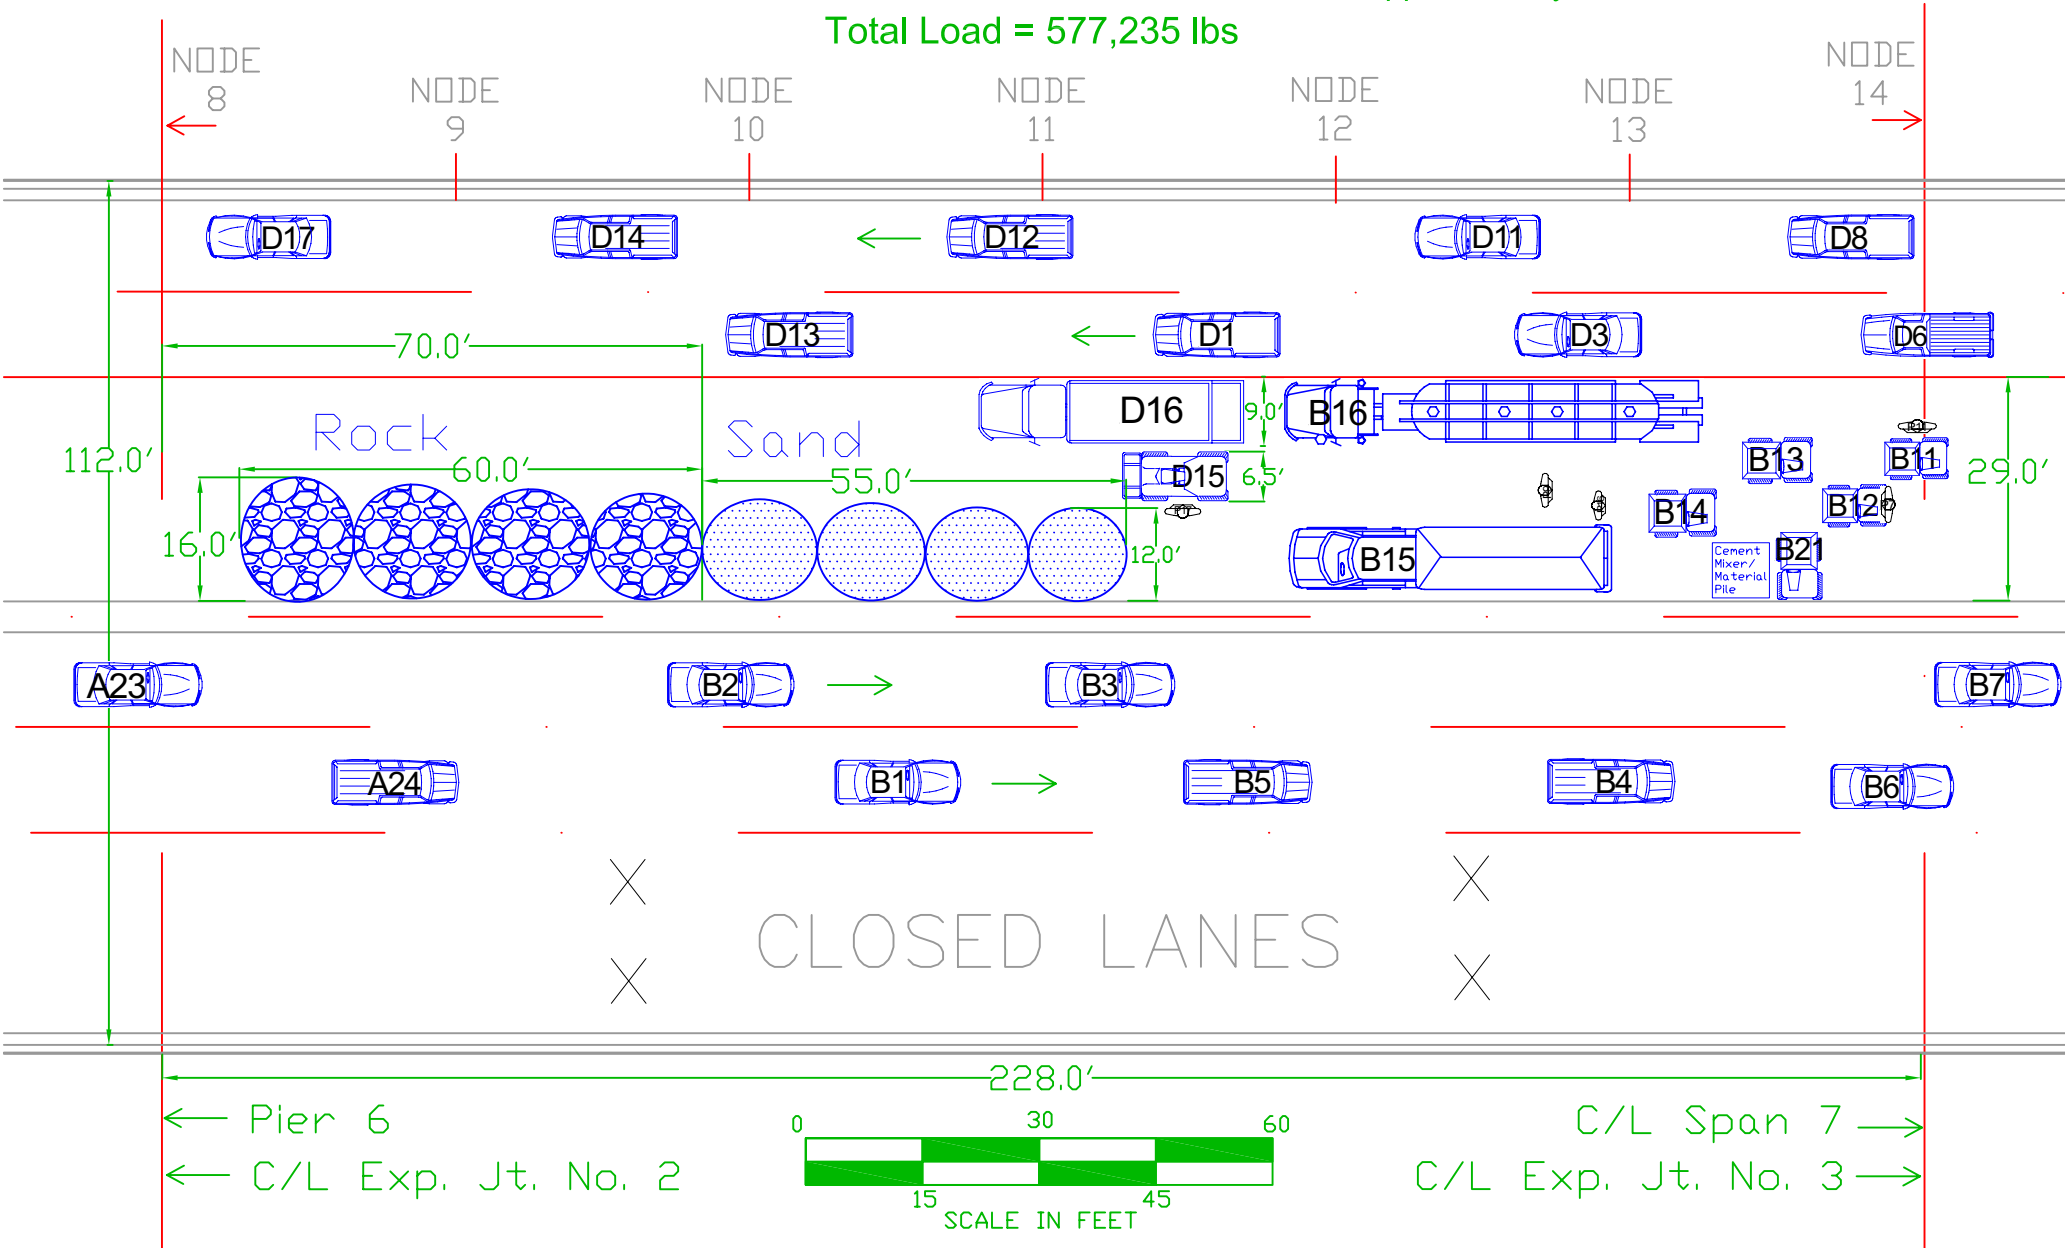
Figure 2 – Construction Staging Area

Construction Material Staging on Center Span Truss

4 Loads of Rock (184,380 lbs) 4 Loads of Sand (198,820 lbs) = 383,200 lbs

3 Loaded Commercial Construction Vehicles, Water Truck D16 (48,200 lbs), Cement Tanker B16 (72,780 lbs), and Concrete Mixer B15 (51,400 lbs) = 172,380 lbs

1 Skidsteer and 5 Scootcretes with associated material and workers = approximately 21,655 lbs

Total Load = 577,235 lbs

Construction vehicles and materials associated with the resurfacing activity were located in the left two southbound lanes on the main span, as shown in Figure 2. The construction vehicles are included with the other vehicles in Tables 1 and 2.

Four loads of coarse aggregate (gravel) and four loads of fine aggregate (sand) were located in the leftmost southbound lane just north of pier 6, as shown in Figure 2. Delivery records indicated that the weight of the coarse aggregate was 184,380 pounds, and the weight of the fine aggregate was 198,820 pounds. The sizes and shapes of the aggregate piles at the time of the accident were estimated with information from three different sources, as described below.

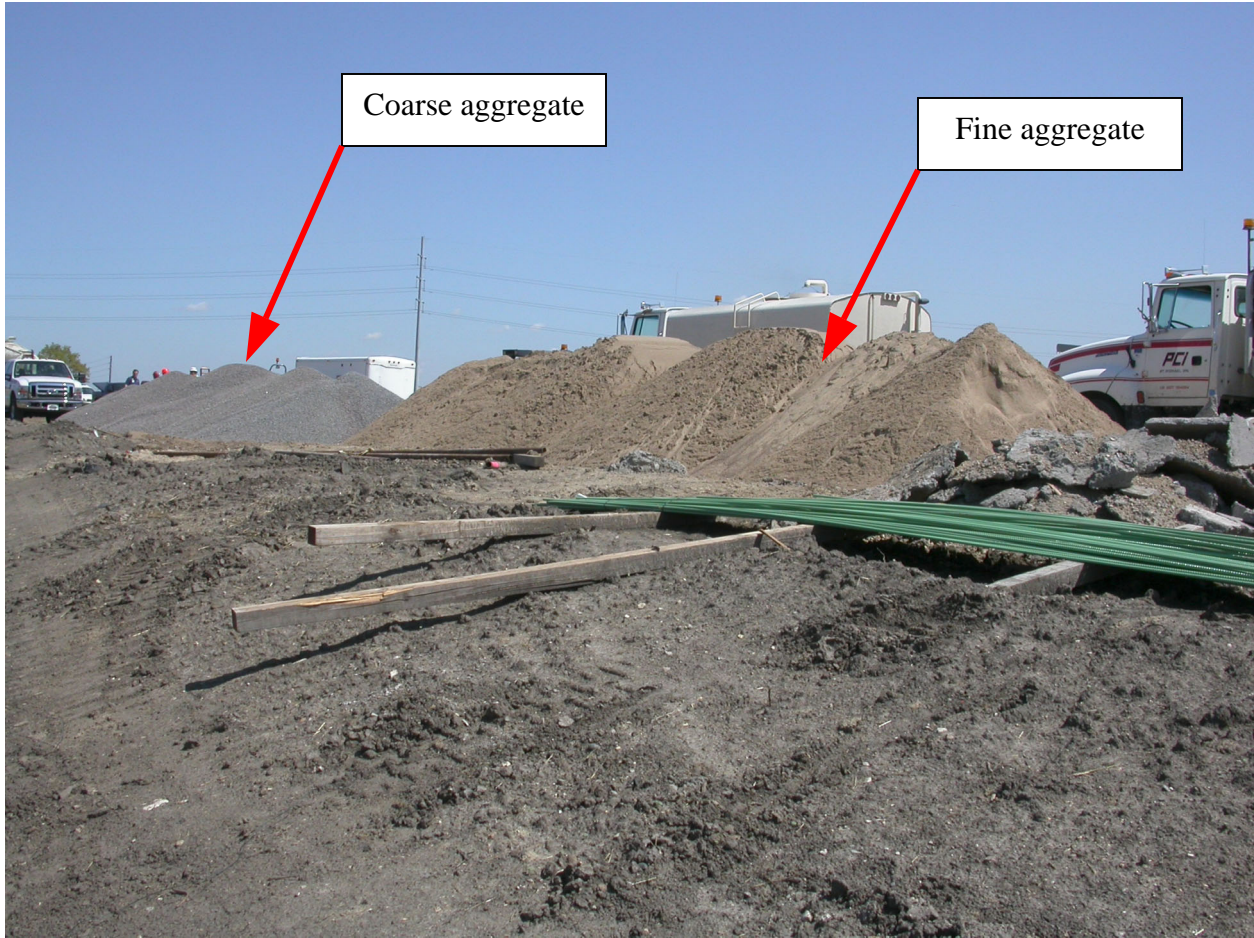
Figure 3. Piles of aggregate delivered to another job site. The quantities of coarse and fine aggregate were similar to the quantities placed on the bridge on the day of the accident. The coarse aggregate pile was approximately 16 feet wide, 60 feet long, and 5 feet tall (at its peak), while the fine aggregate pile was approximately 14 feet wide, 51 feet long, and 6 feet tall (at its peak).

2. Measurements were taken on piles of aggregate from a delivery to another job site of a similar quantity of coarse and fine aggregate. See Figure 3. The coarse aggregate pile was approximately 16 feet wide, 60 feet long, and 5 feet tall (at its peak), while the fine aggregate pile was approximately 14 feet wide, 51 feet long, and 6 feet tall (at its peak).

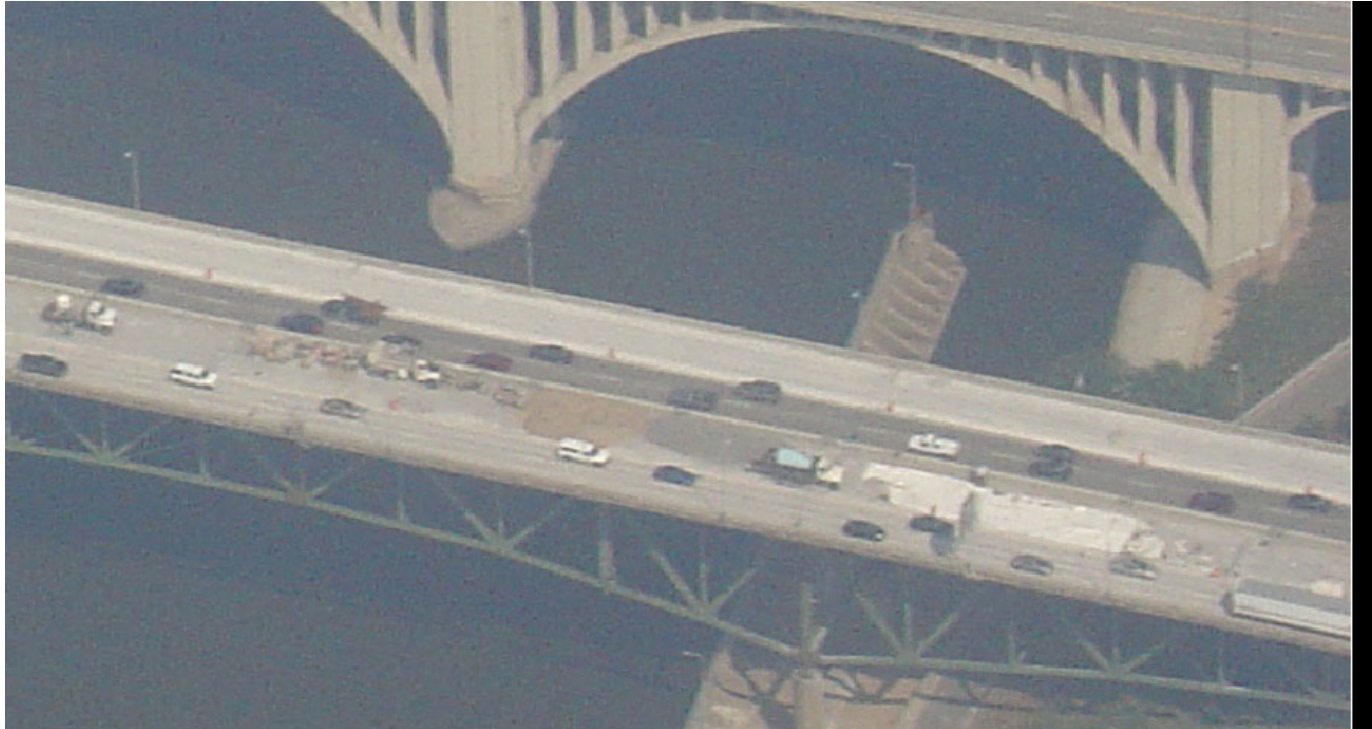
Figure 4. Photograph showing the locations of the aggregate piles on the bridge on August 1, 2007 at 15:47:58 Central Daylight Time.

3. A photograph taken from a commercial airline flight at 15:48 Central Daylight Time showed the coarse and fine aggregate piles on the bridge, as indicated in Figure 4. Photogrammetry was used to measure the locations of points on the boundaries of the piles, as indicated in Figure 5. The photogrammetric measurements were made using known dimensions from the design drawings and measurements taken from a scaled post-accident photograph of the bridge deck. Figure 6 compares the boundaries of the aggregate piles in the photograph with the boundaries as reported by the construction workers.

The construction workers indicated that the aggregate piles were pushed up against the barrier along the center of the bridge after the photograph was taken in order to clear space for the passage of construction vehicles. The photograph shows the boundary between the coarse and fine aggregate piles approximately 70 feet north of pier 6, and it is assumed that the position of this boundary did not change. The construction workers indicated that the aggregate piles were somewhat tapered, being wider to the south and more compressed to the north in order to allow for construction vehicle traffic. It was also assumed that the final sizes of the aggregate piles were similar to those measured at the other job site. The approximate size of the coarse aggregate pile was taken to be 60 feet long and about 16 feet wide at the south end and 14 feet wide at the north end. The fine aggregate pile was taken to be 55 feet long and about 14 feet wide at the south end and 12 feet wide at the north end. The coarse aggregate was therefore assumed to extend from 10 feet to 70 feet north of pier 6, and the fine aggregate was assumed to extend from 70 to 125 feet north of pier 6, as shown in Figure 2. The weights and positions of the aggregate (and other assorted construction materials) are also indicated in Table 3, giving x and y positions for the four corners enclosing each item.

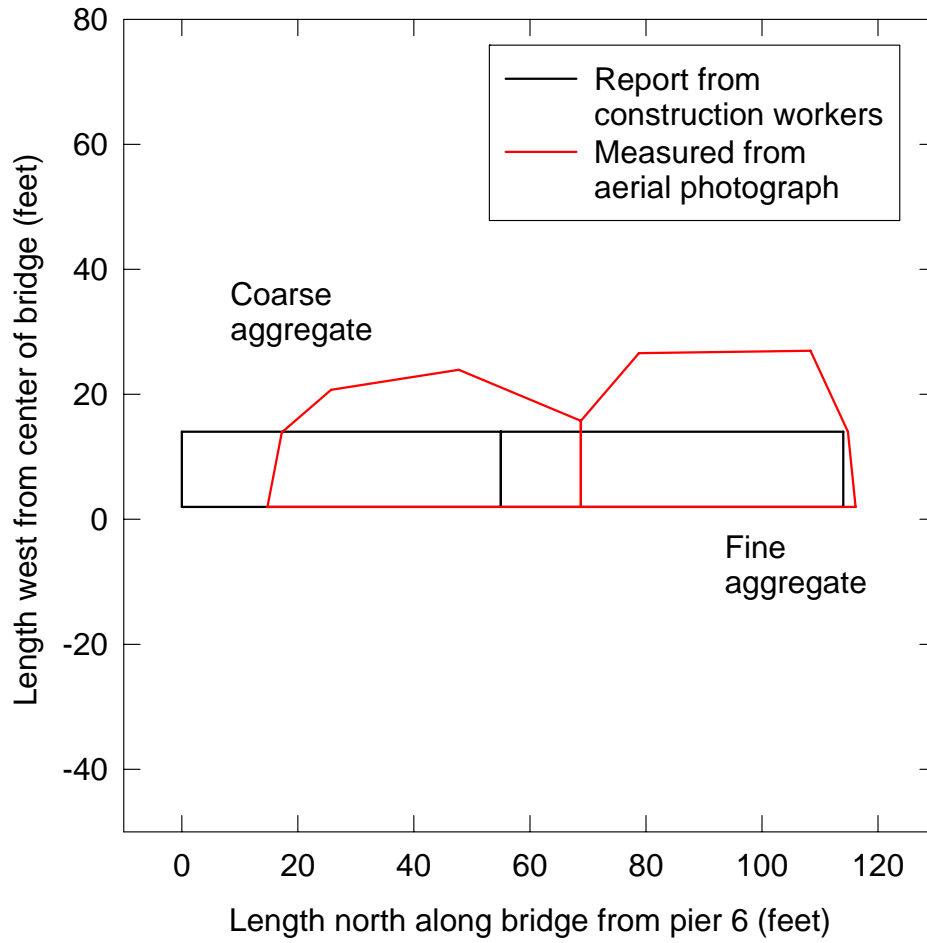
Figure 6. Locations of the coarse and fine aggregate piles as reported by construction workers and as measured from the aerial photograph in Figure 4.

1. Construction workers involved in the resurfacing activity reported that the aggregate was located between Pier 6 and the centerline of Span 7 and that it was pushed into the inside leftmost closed southbound lane, giving the aggregate piles a width of approximately 12 feet. It was estimated that the coarse aggregate

extended north from pier 6 approximately 55 feet and the fine aggregate extended another 59 feet farther north from the end of the coarse aggregate pile.
