**MOTOR CARRIER FACTORS GROUP CHAIRMAN'S
FACTUAL REPORT**

HWY15MH006

**NATIONAL TRANSPORTATION SAFETY BOARD
OFFICE OF HIGHWAY SAFETY
WASHINGTON, D.C.**

Location: Oxnard, Ventura County, California
Vehicle #1: 2005 Ford F450 Pick-up towing a 2000 Tandem Axle Utility Trailer
Operator #1: Harvest Management LLC
Vehicle #2: Metrolink Commuter Train
Date: February 24, 2015
Time: 5:44 a.m. PST
NTSB #: **HWY15MH006**

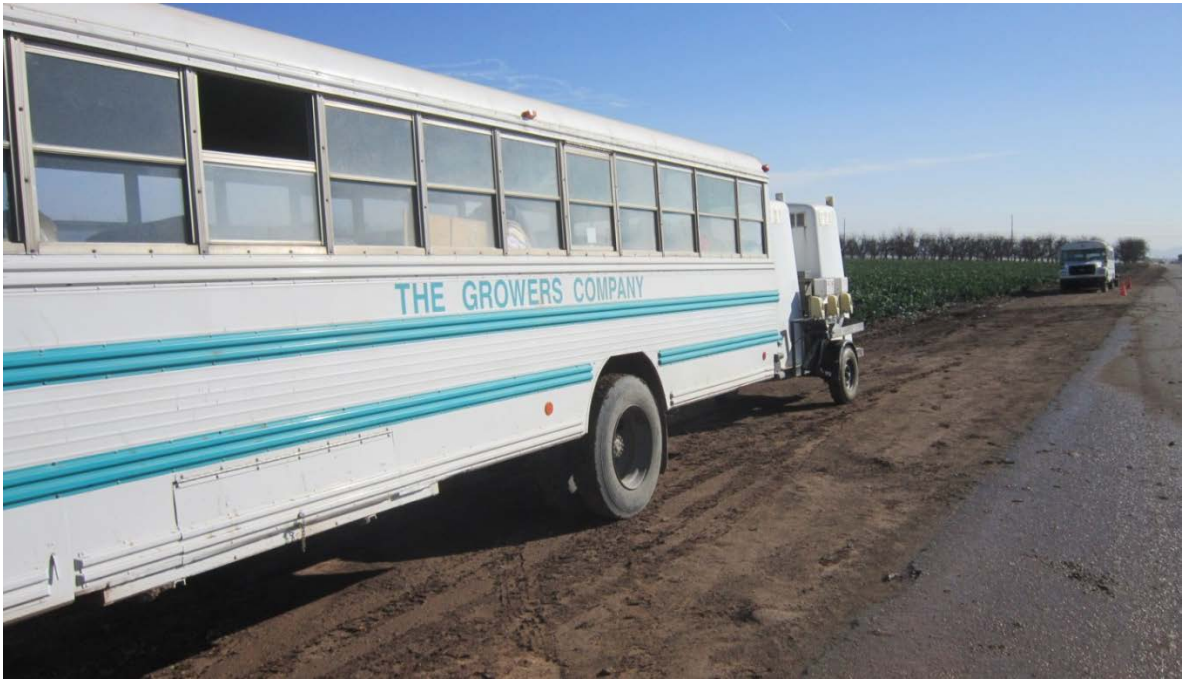
Figure 1. A sample bus used by The Growers Company for migrant worker transport

The carrier's business model consists of a complex structure managing agriculture, trucks, equipment, and labor. The scope of the carrier's business is to manage all aspects of crops that have been contracted in Arizona and California. This includes production from seed to market. On a daily basis, the carrier transports migrant workers from the Mexican Border to various job sites in Arizona or California. See **Figure 1** for more details.

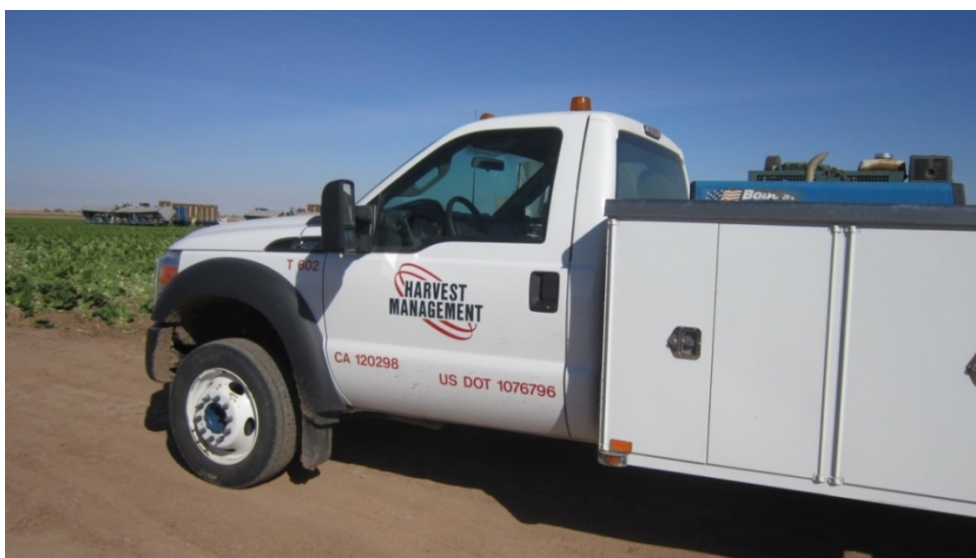
Figure 5. Exemplar mechanic truck and mechanic on-call for all repairs.

All of the work stations in Arizona and California are staffed by a company mechanic. Mechanics assigned to a job site are responsible for all of the machinery involved in the field operation. This would include repairs to the tractor-trailers, straight trucks, farm tractors, conveyor belts and all related production equipment. **Figure 5** depicts a Ford F450 that was similar to the one operated by the accident driver at the time of crash. The accident driver had similar duties and responsibilities as the mechanic depicted in this photo.
