**MOTOR CARRIER FACTORS GROUP CHAIRMAN'S  
FACTUAL REPORT**

**Biloxi, Mississippi**

**HWY17MH010**

**NATIONAL TRANSPORTATION SAFETY BOARD  
OFFICE OF HIGHWAY SAFETY  
WASHINGTON, D.C.**

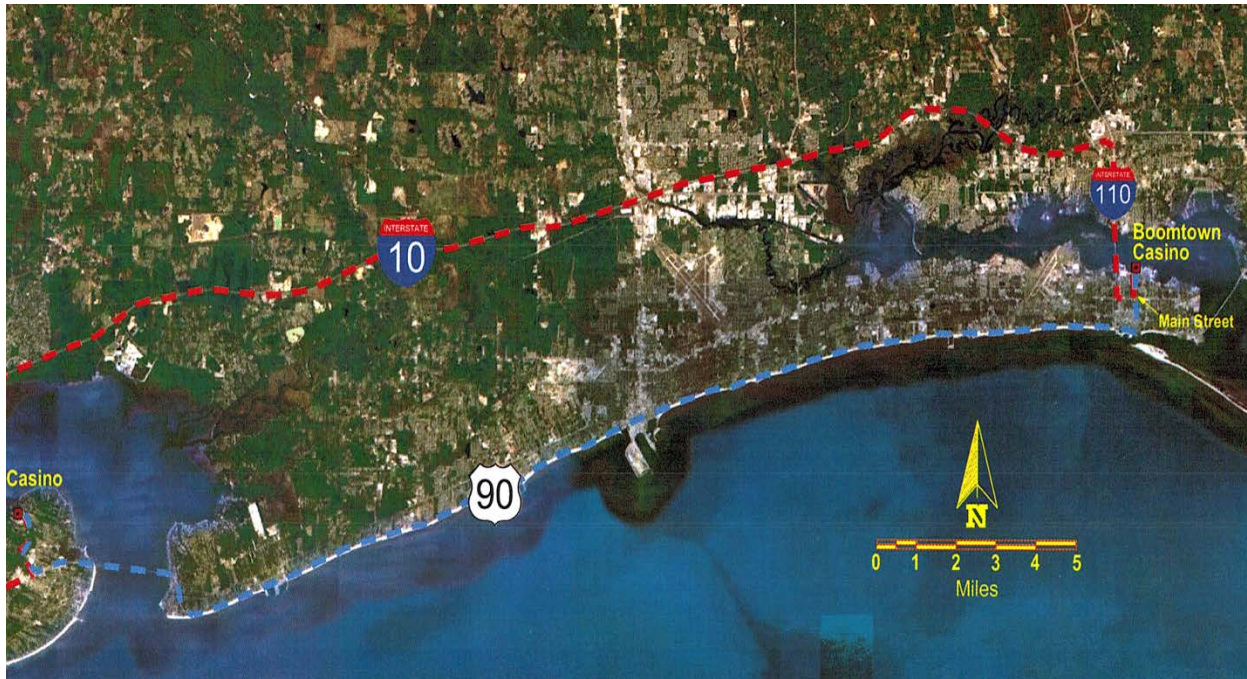
Figure 1. Google map of routes to Boomtown Casino in Biloxi, MS.

The red line shows the route using Interstates 10 and 110. The blue line shows the “scenic route” using US 90.

The driver stated the GPS unit routed the motorcoach along US-90 and to turn left onto Main Street in downtown Biloxi. A Garmin DEZL 570MT GPS was recovered by the Biloxi Police Department from the motorcoach. The device was downloaded normally using manufacturers and forensic software. Accident related data was found on the device. For further information, see the Recorders Group Chairman’s report in the docket for this investigation.

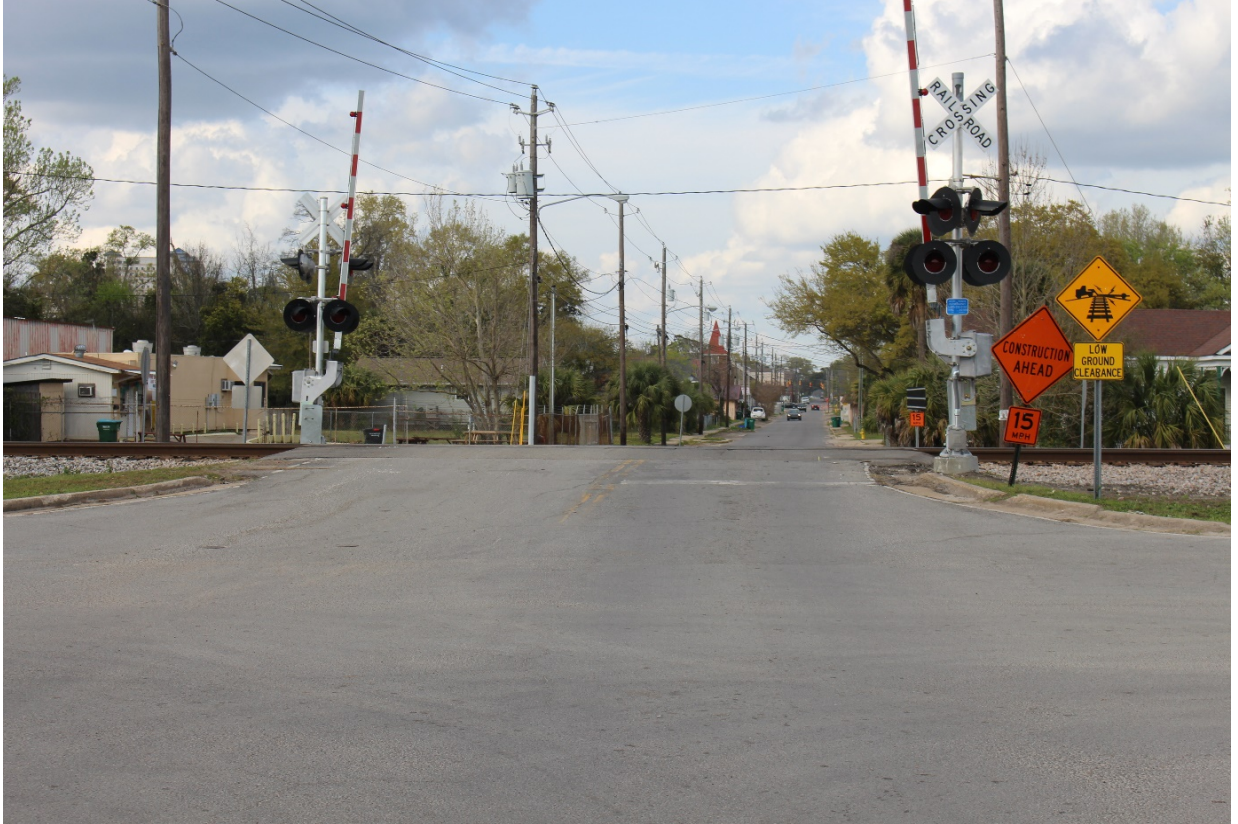
The Main Street railroad crossing was equipped A Grade Crossing (Crossbuck) sign, in conjunction with the flashing-light signal assembly and mechanical gates. The crossing also displayed a highway warning sign marked “Low Ground Clearance” with a graphic of a “low boy” trailer striking the tracks. A second highway warning sign stated, “Construction ahead 15 mph”

Photo # 1 View of Main Street Crossing Northbound from the Motorcoach View.

See Photo # 1 For additional information refer to the Highway Group Chairman factual report in the docket for this investigation.
