NATIONAL TRANSPORTATION SAFETY BOARD

Vehicle Recorder Division

Multiple Electronic Devices

Specialist's Factual Report
by Bill Tuccio, Ph.D.

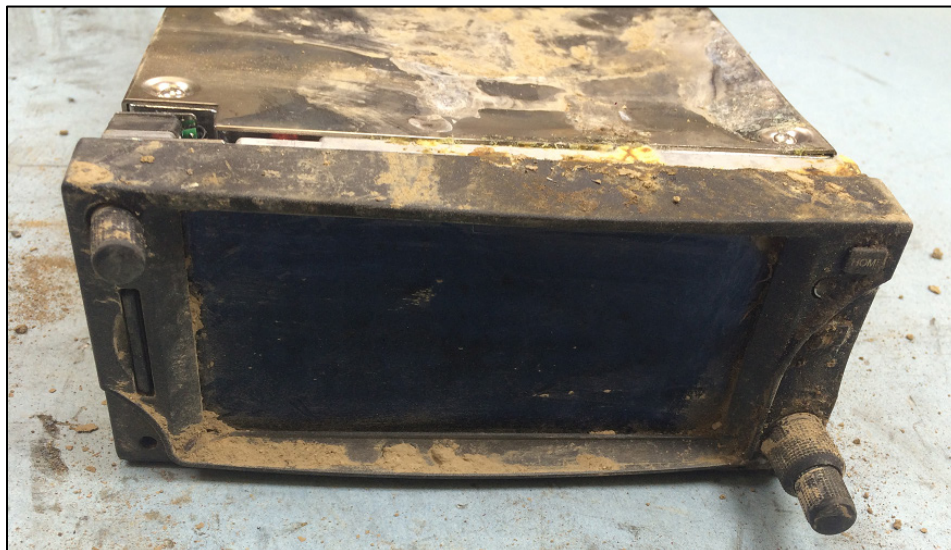
Regarding the Garmin GTN 650 (figure 1), the device does not record any historical data and only retains last communication and navigation frequency information in non-volatile memory. This information was deemed non-pertinent to this investigation and no effort was made to recover the last frequency information.

Figure 1. Garmin GTN 650.

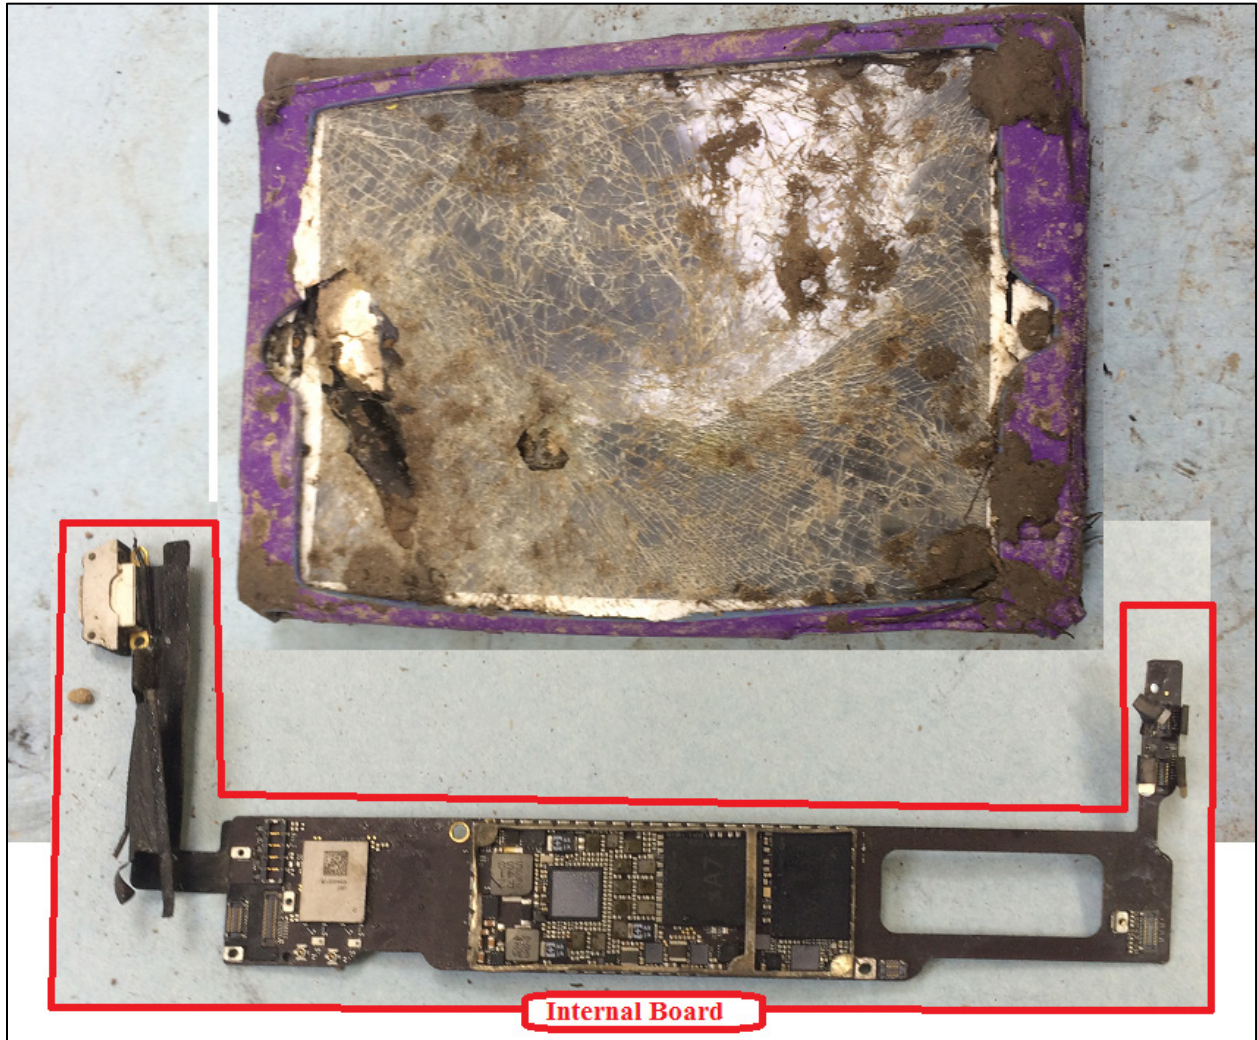
Regarding the iPad Mini (serial number F4KLV1WJFCM9, figure 2), the internal board was removed from the unit and installed in an operable unit; however, the unit would not start. No further recovery efforts were attempted.

Figure 2. Apple iPad Mini (serial number F4KLV1WJFCM9) with internal board inset.

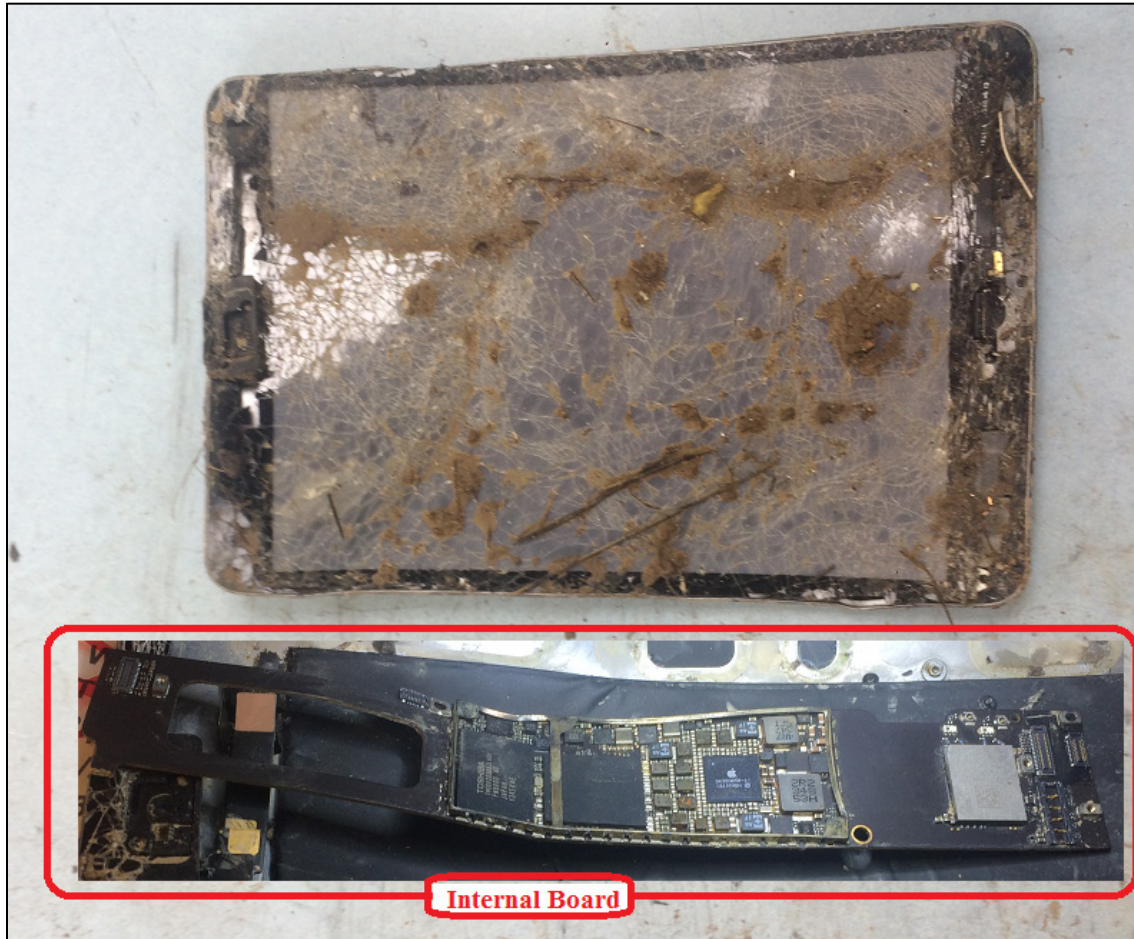
Regarding the iPad Mini (serial number DLXLVAG3FCM7, figure 3), the internal board was damaged and could not be installed in an operable unit. No further recovery efforts were attempted.

Figure 3. Apple iPad Mini (serial number DLXLVAG3FCM7) with internal board inset.

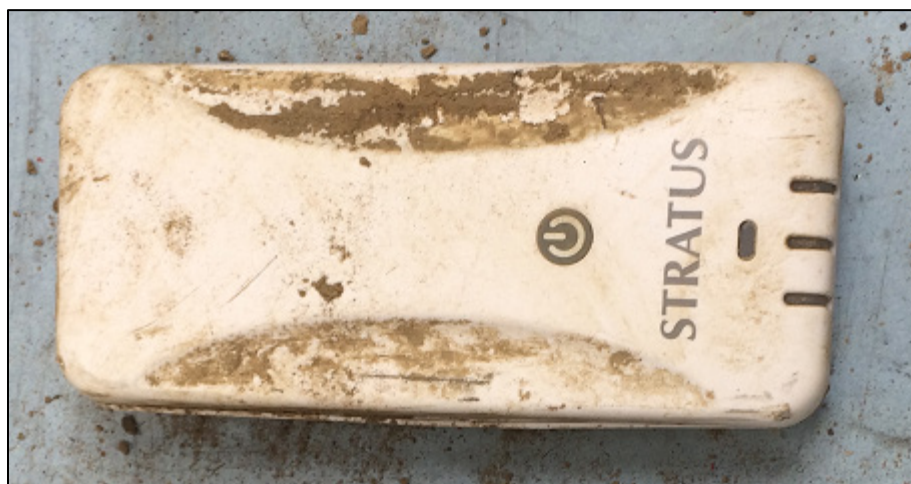
Upon arrival at the Vehicle Recorder Laboratory, an exterior examination revealed the unit had sustained minor impact damage, as shown in figure 4. An internal inspection revealed minor damage to the internal components, as shown in figure 5. When power was applied to the unit, it would not start. The unit was repaired and data logs downloaded using the ForeFlight application.

Figure 4. Appareo Stratus 2 as received.

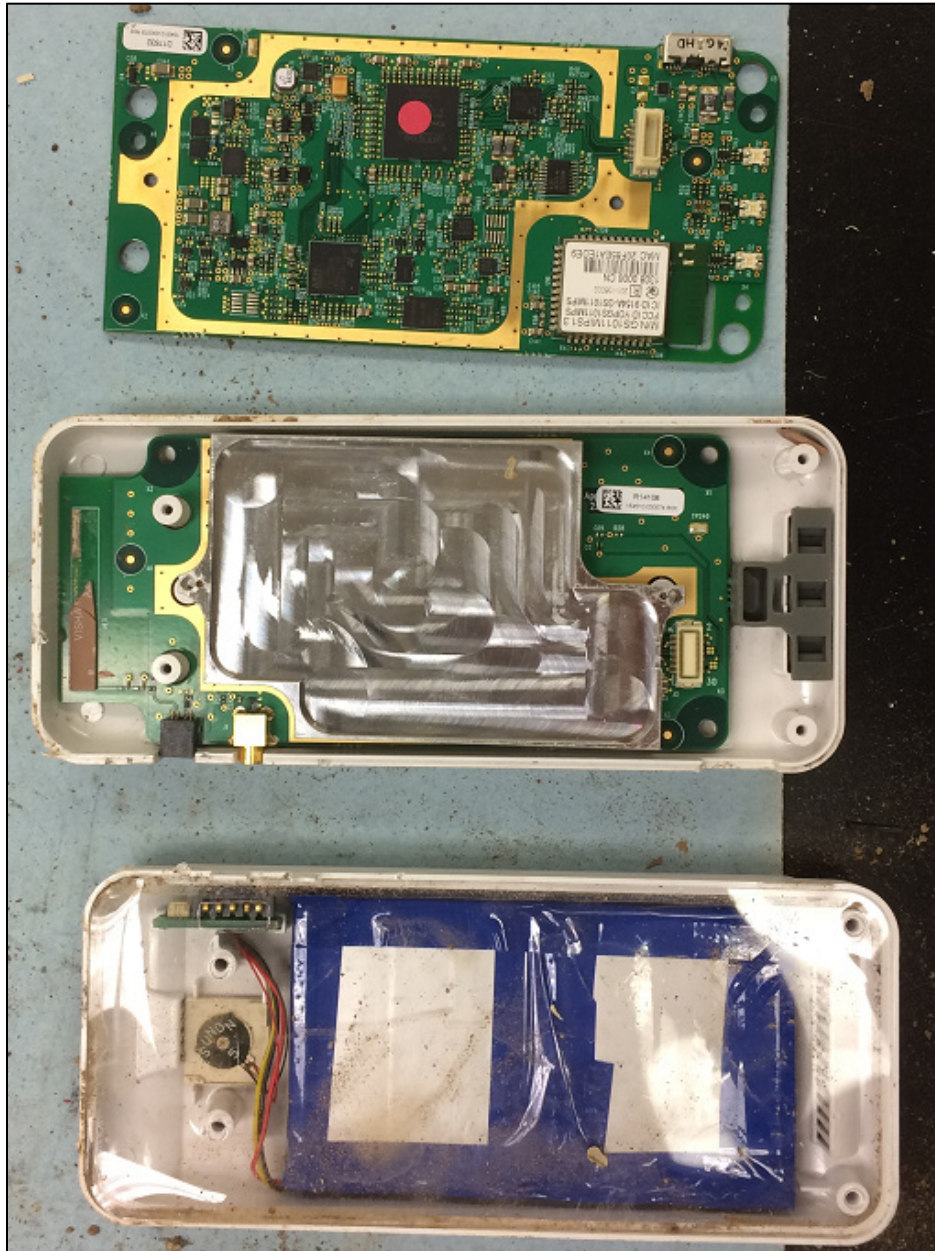
Figure 5. Appareo Stratus 2 internal components.

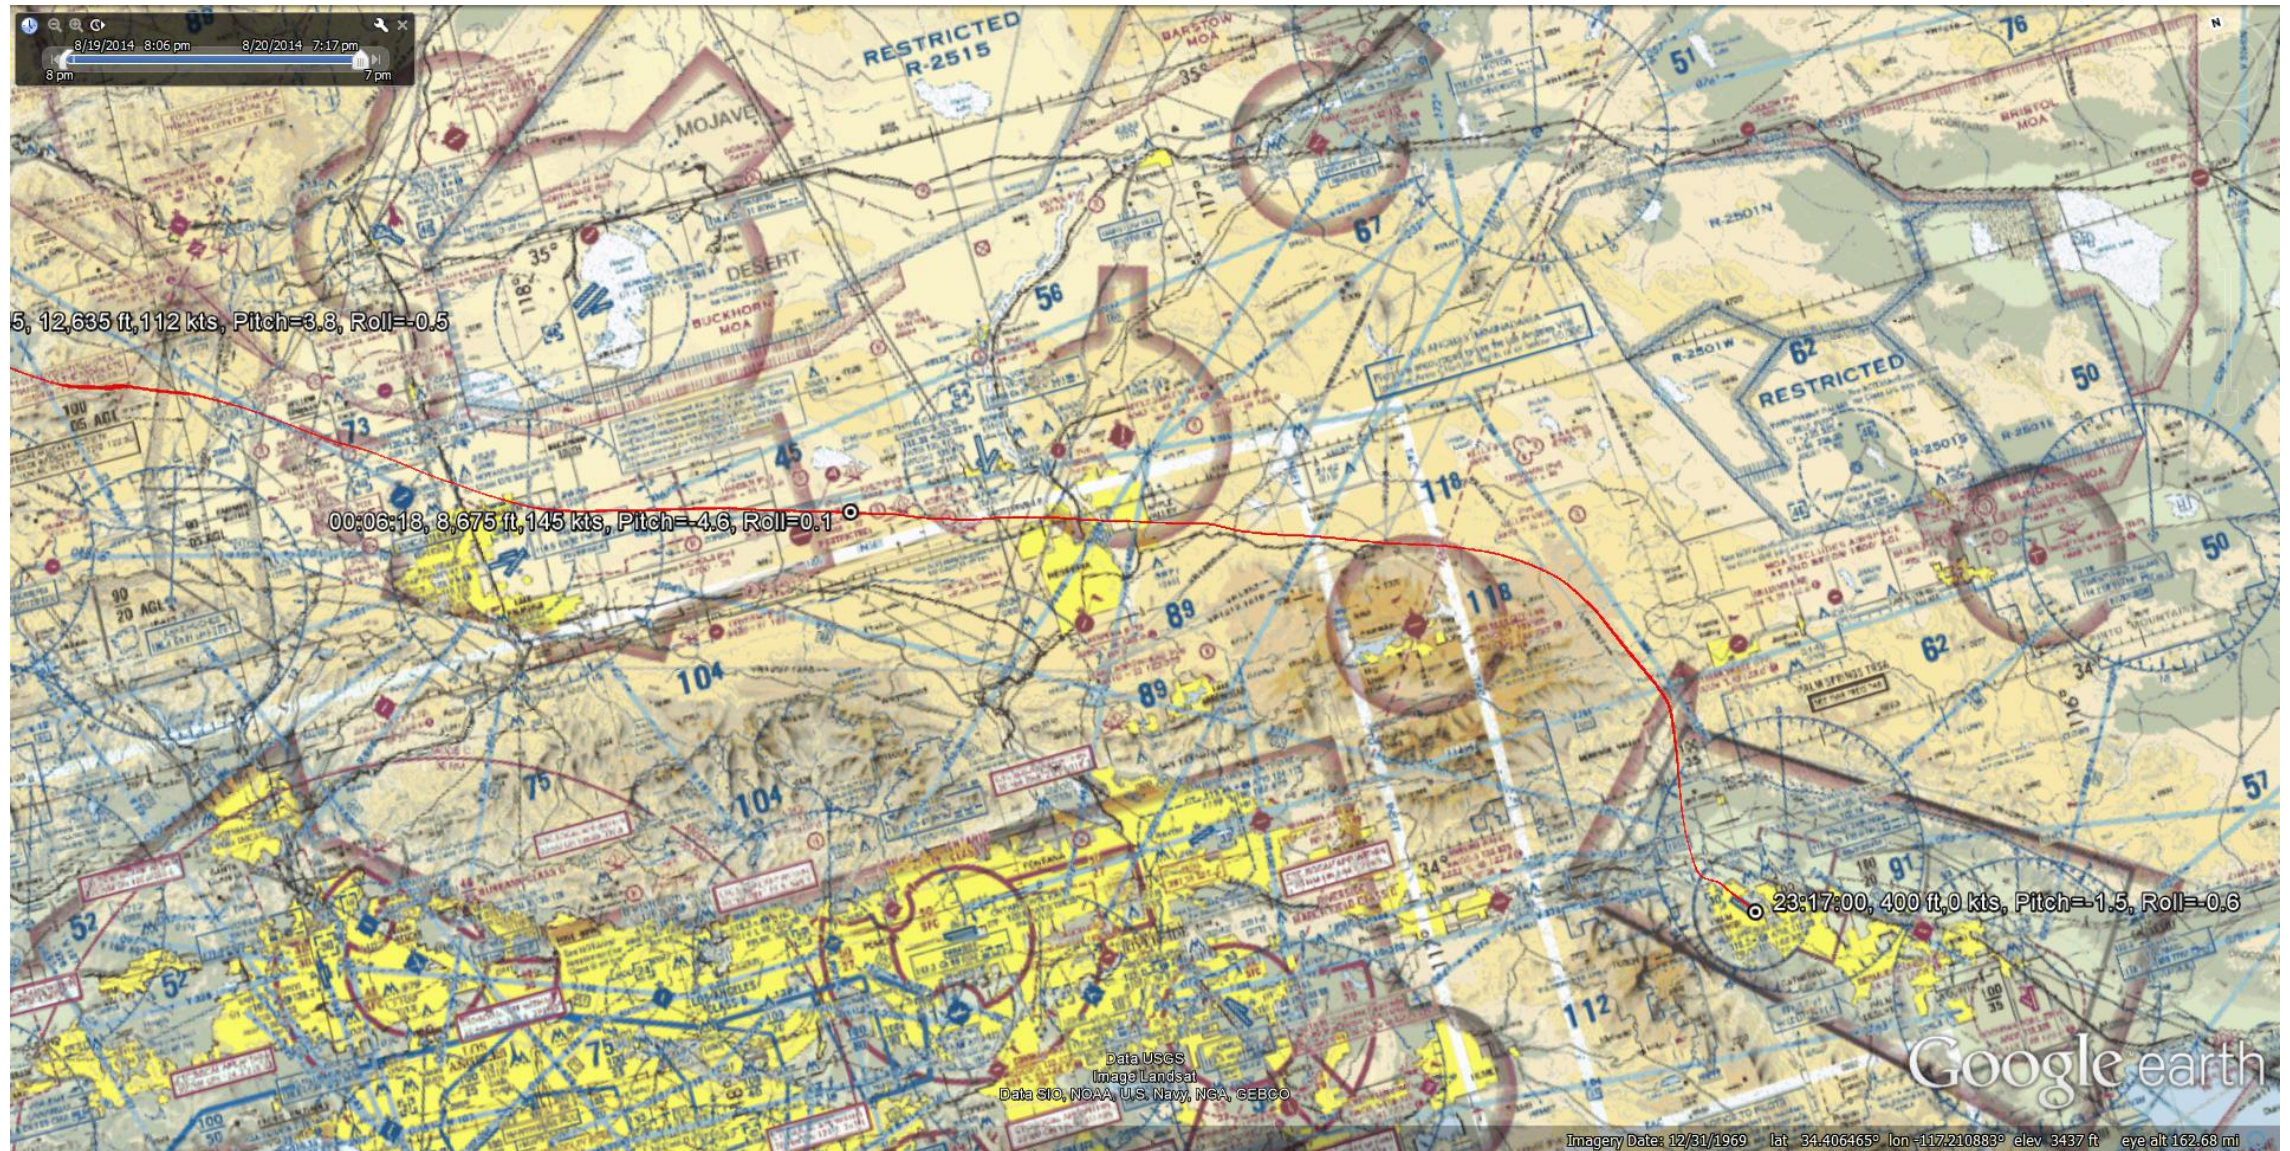
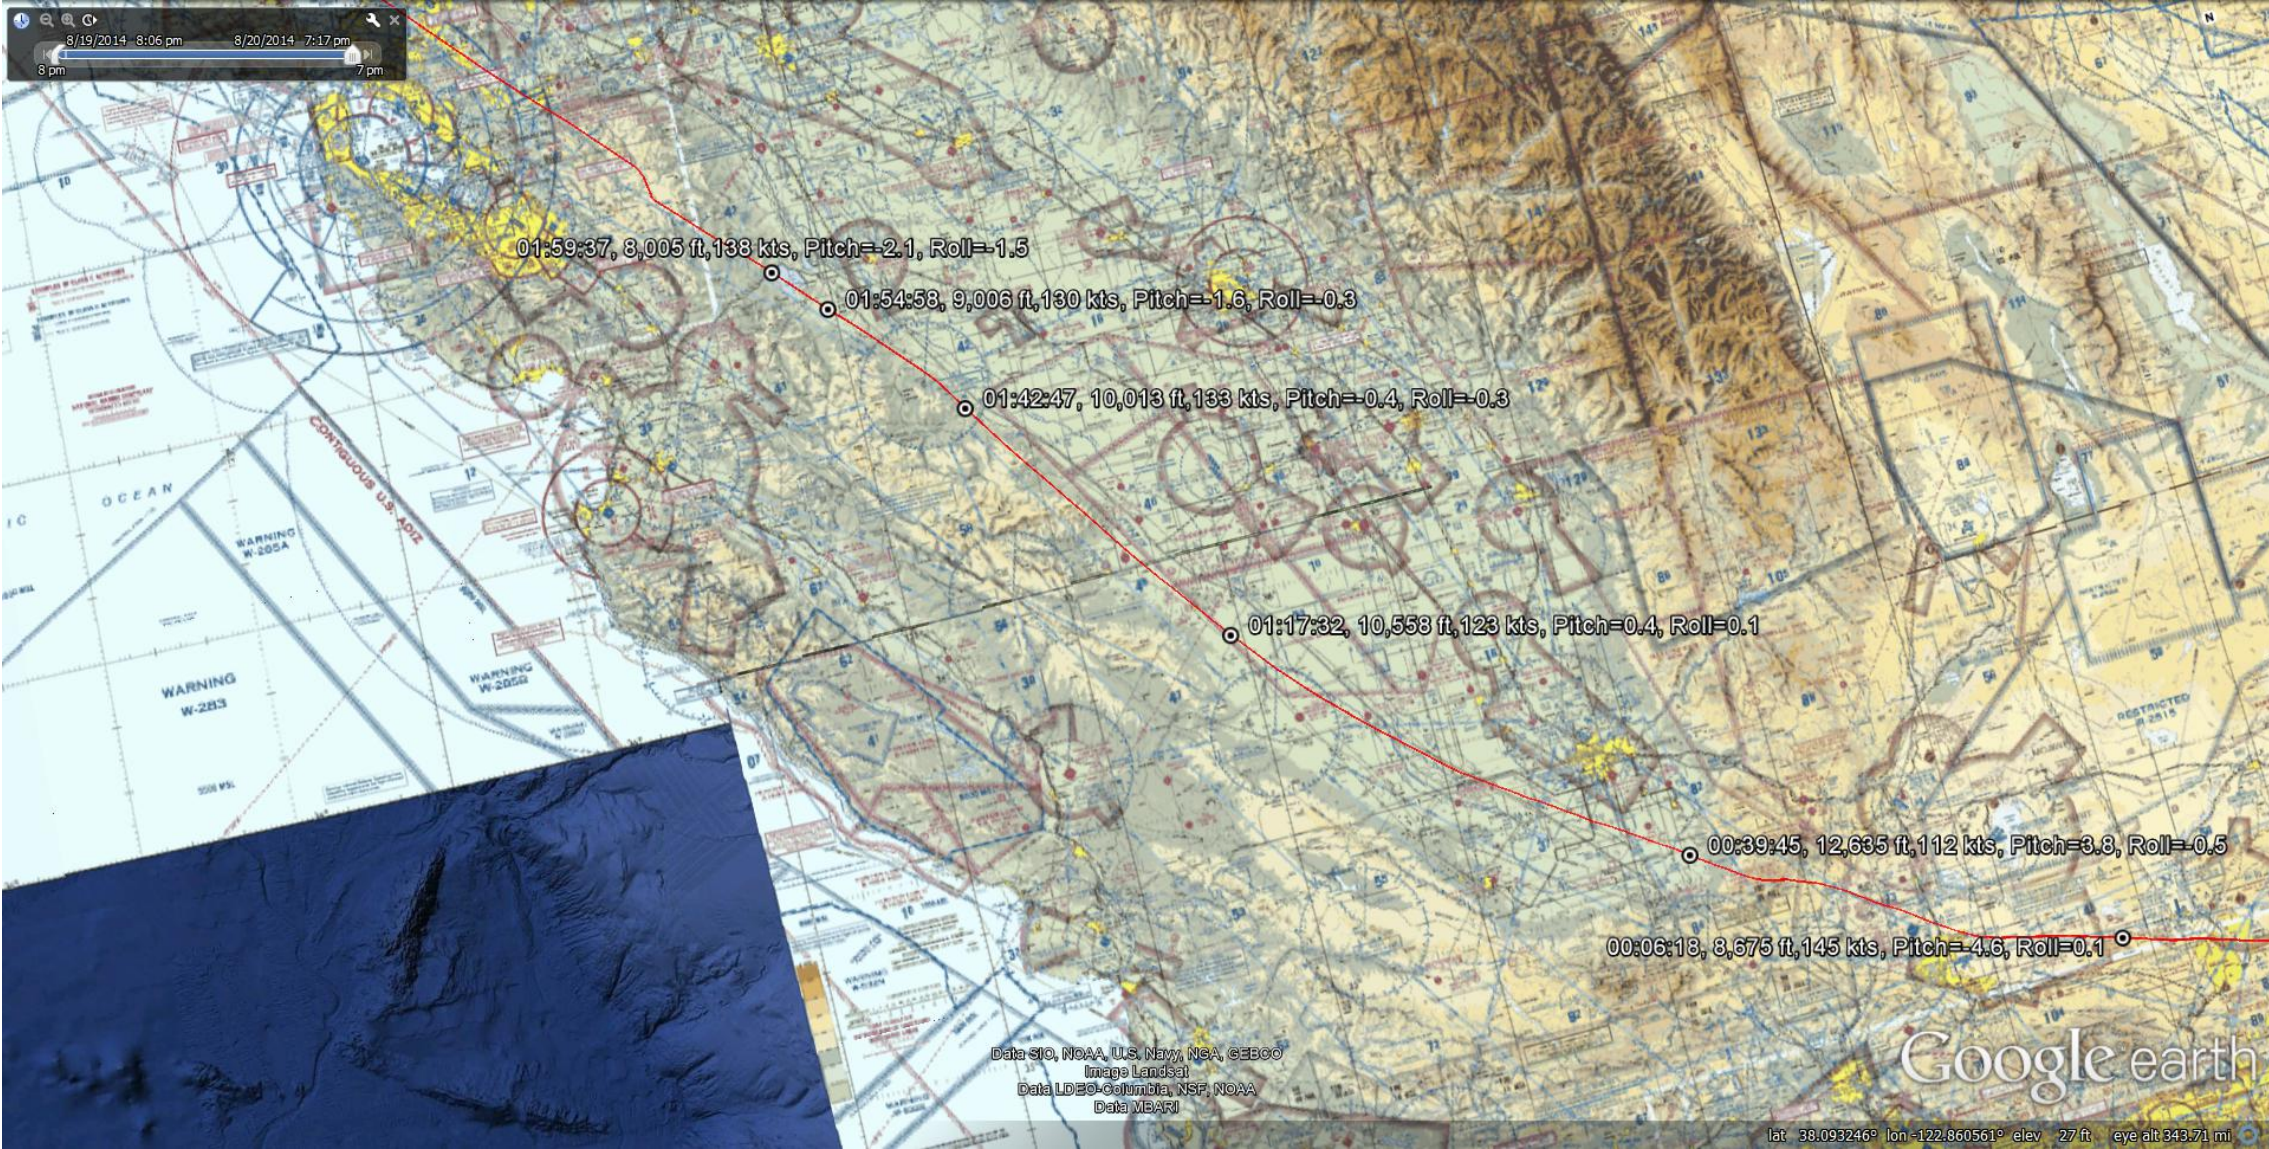
Figures 8 through 10 show the enroute flight path overlaid on an aviation sectional chart.

Figure 8. First portion of recording, aviation sectional chart overlay, select points.

Figure 9. Enroute portion of accident flight, select points.

Figure 10. Arrival portion of recording, select points.

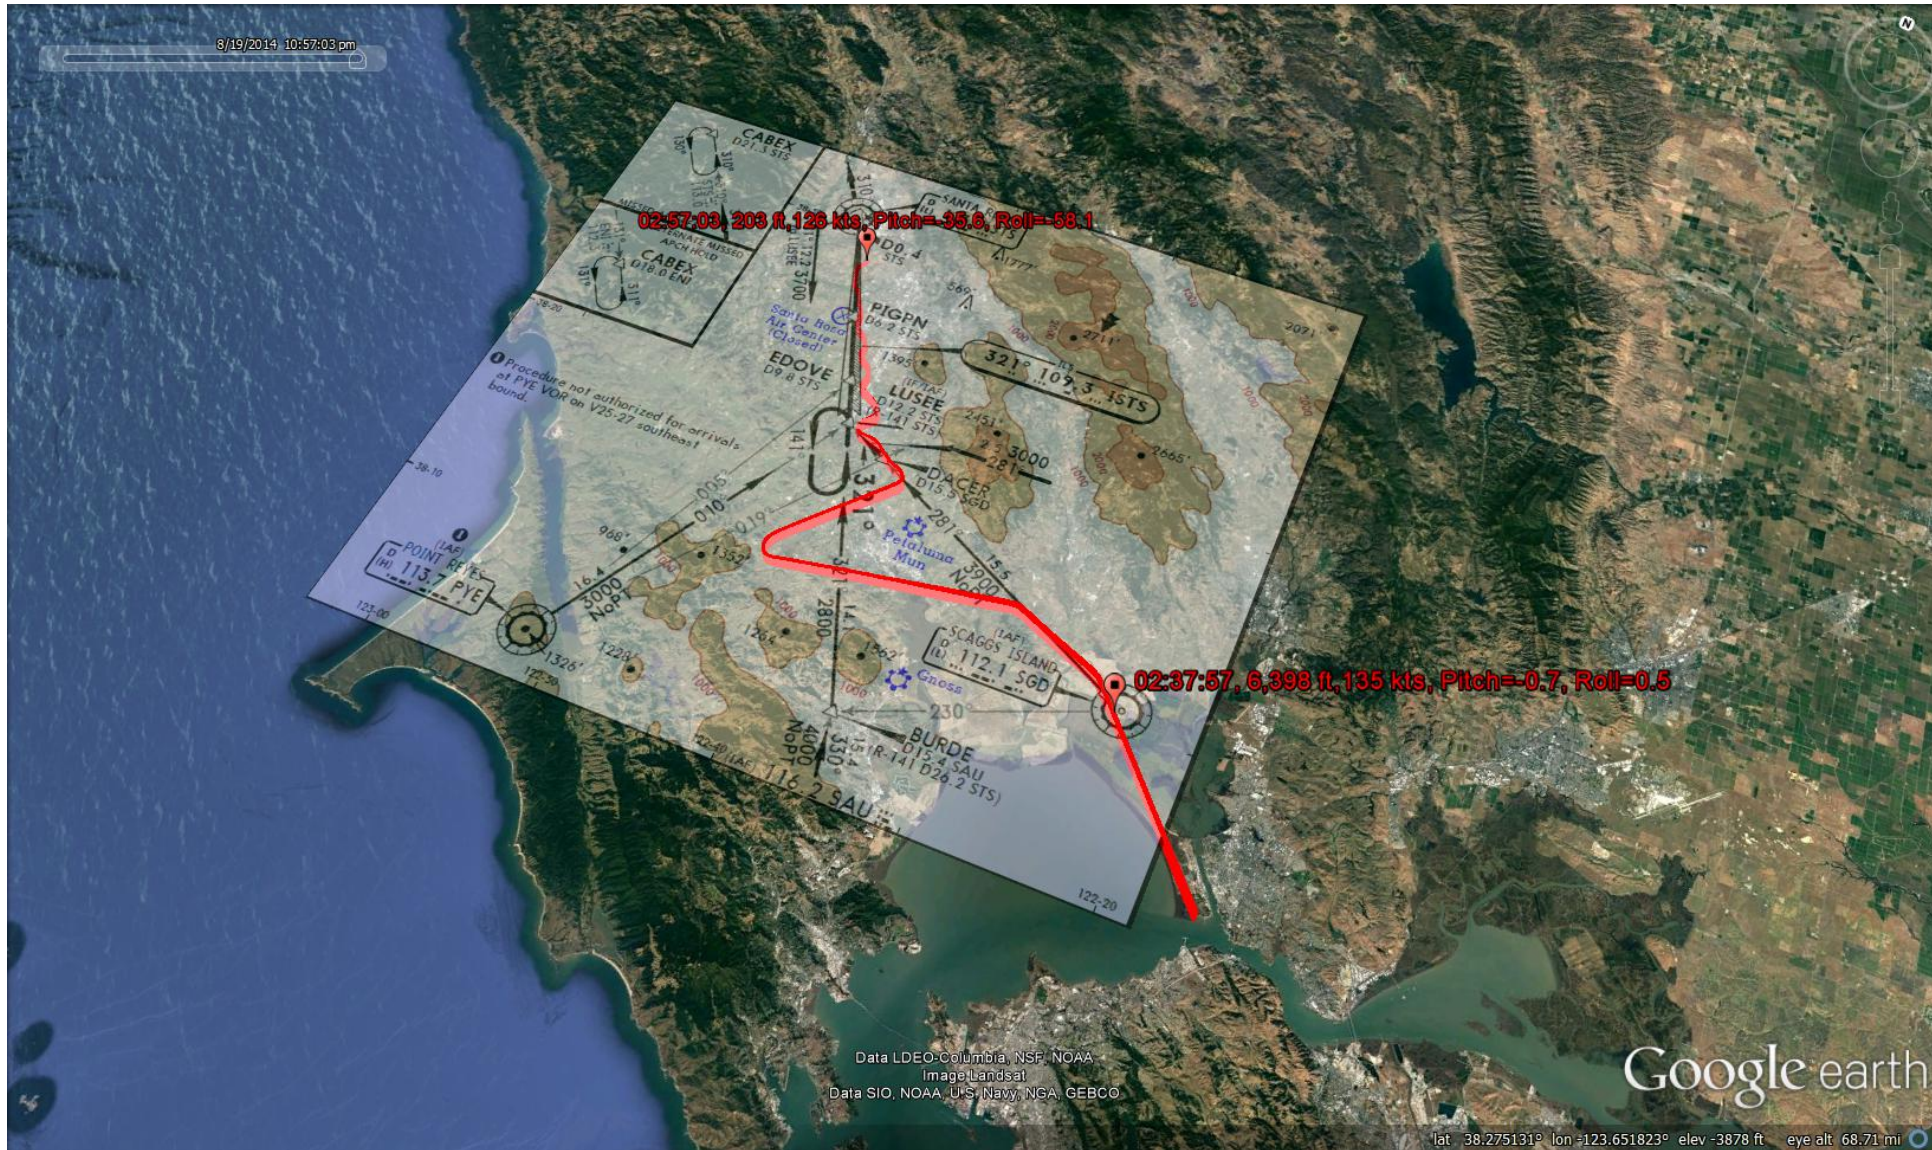
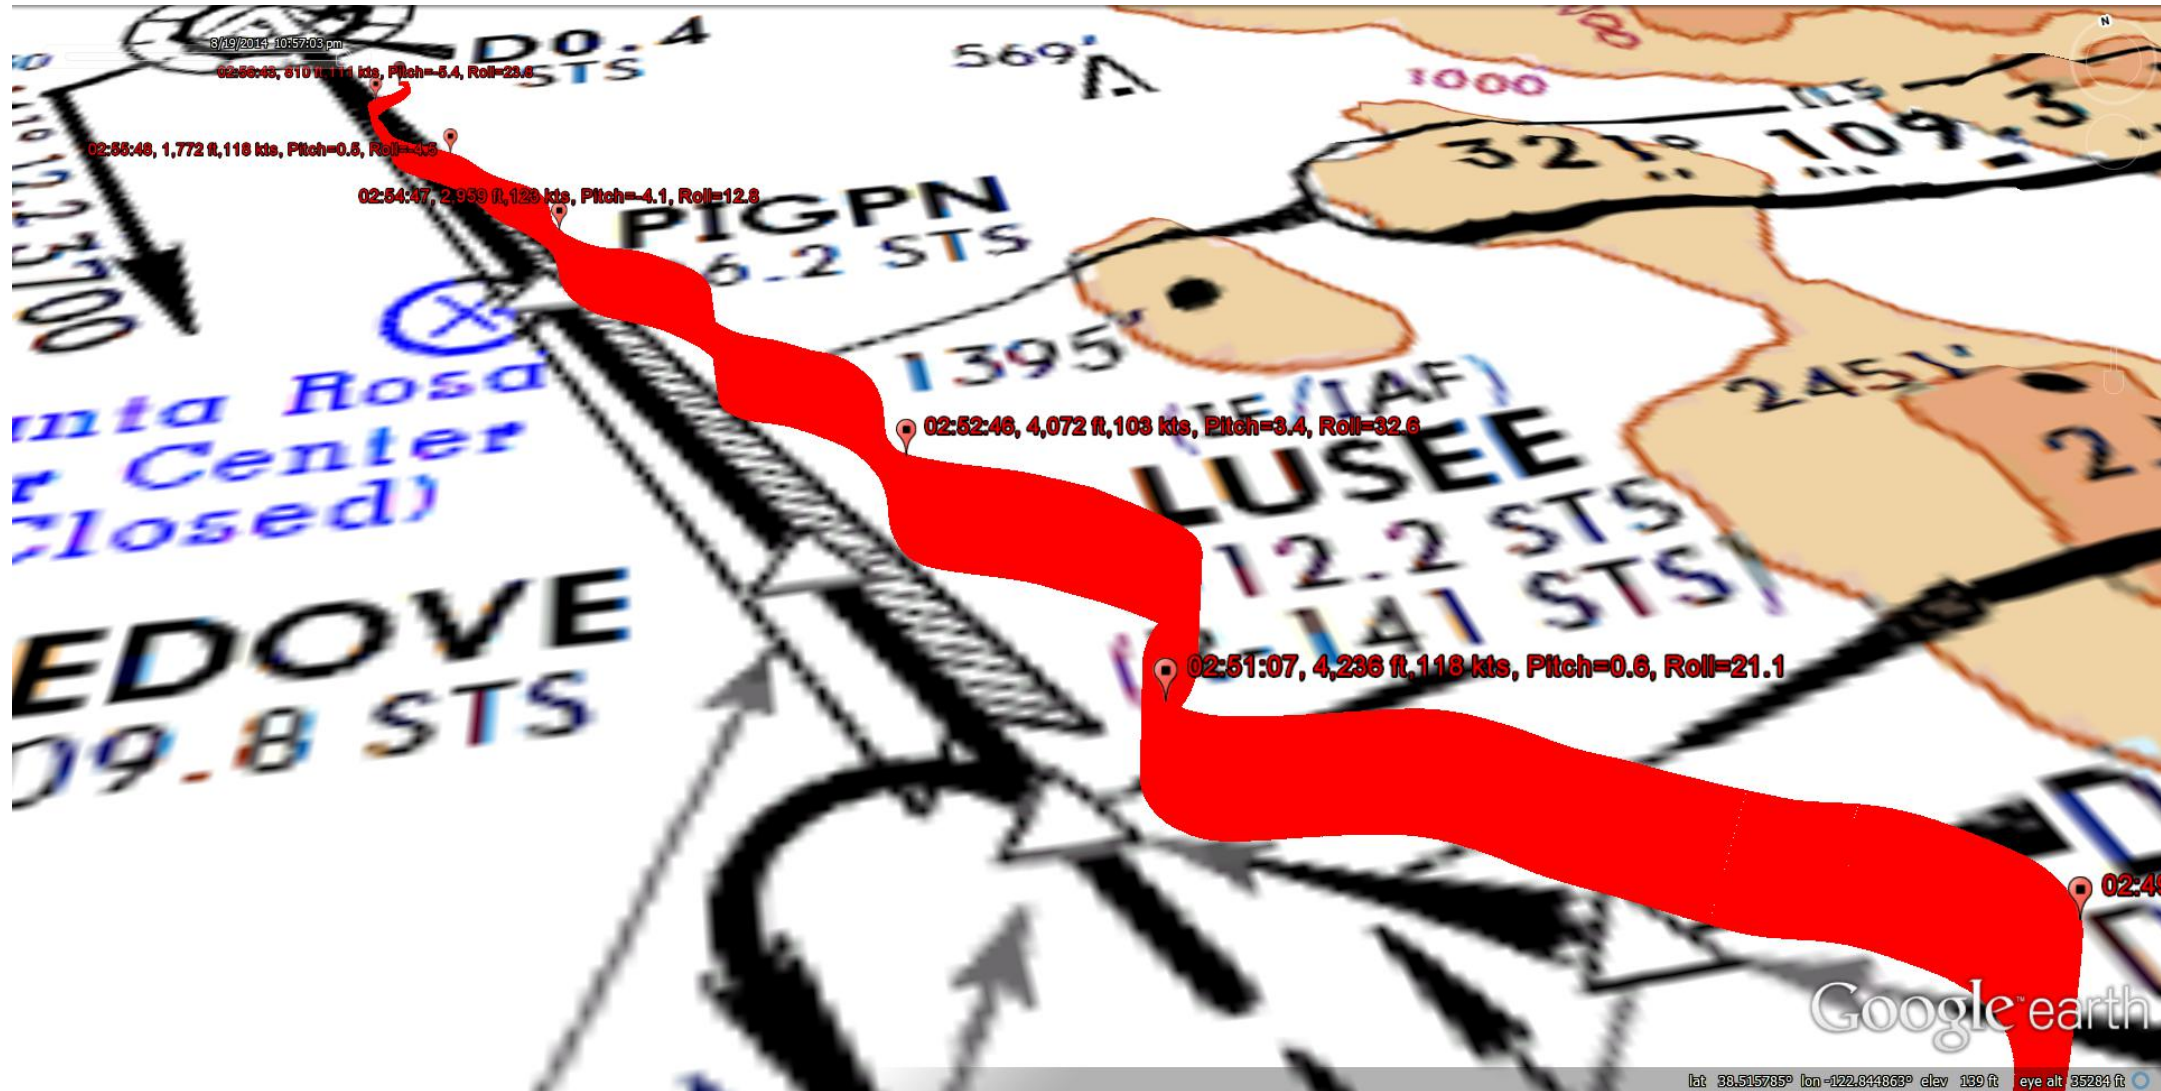
Collectively, figures 11 through 16 show the flight path overlaid on the ILS 32 instrument approach chart, as follows (narrative values are approximate):

- At 02:37:57 UTC, the aircraft passed the SGD VOR at about 6,400 feet.
- Between 02:37:57 UTC and 02:40:44 UTC, the aircraft path was consistent with the 281° feeder route from SGD to DACER intersection (with a minimum published altitude of 3,900 feet). On this segment the recorded GPS altitude was 6,500 feet.

- At 02:40:44 UTC, the aircraft path turned towards the southwest.
- At 02:45:52 UTC, at a GPS altitude of 4,800 feet, the aircraft path turned towards the northeast.

- At 02:49:11 UTC, at a GPS altitude of 4,900 feet, the aircraft path turned towards the west and the path was consistent with the feeder route from SGD to DACER to LUSEE.

- At 02:51:07 UTC, at a GPS altitude of 4,200 feet, the aircraft passed near the LUSEE intersection (the minimum published altitude at LUSEE was 3,000 feet).

- At 02:52:46 UTC, at a GPS altitude of 4,000 feet, the aircraft passed near the EDOVE intersection (the minimum published altitude at EDOVE was 2,700 feet).

- At 02:54:47 UTC, at a GPS altitude of 3,000 feet, the aircraft passed near the PIGPN intersection (the ILS intercept altitude published at PIGPN was 2,000 feet).

- At 02:55:48 UTC, at a GPS altitude of 1,700 feet, the aircraft crossed the localizer tracking slightly west of the localizer.
- At 02:56:43 UTC, at a GPS altitude of 810 feet, the aircraft crossed the localizer, tracking east of the localizer.

- The last recorded point was 02:57:03 UTC at a GPS altitude of 203 feet, east of the localizer. AHRS data showed the aircraft in left bank of about 50 degrees with a pitch down attitude (the decision altitude for the approach was 377 feet).

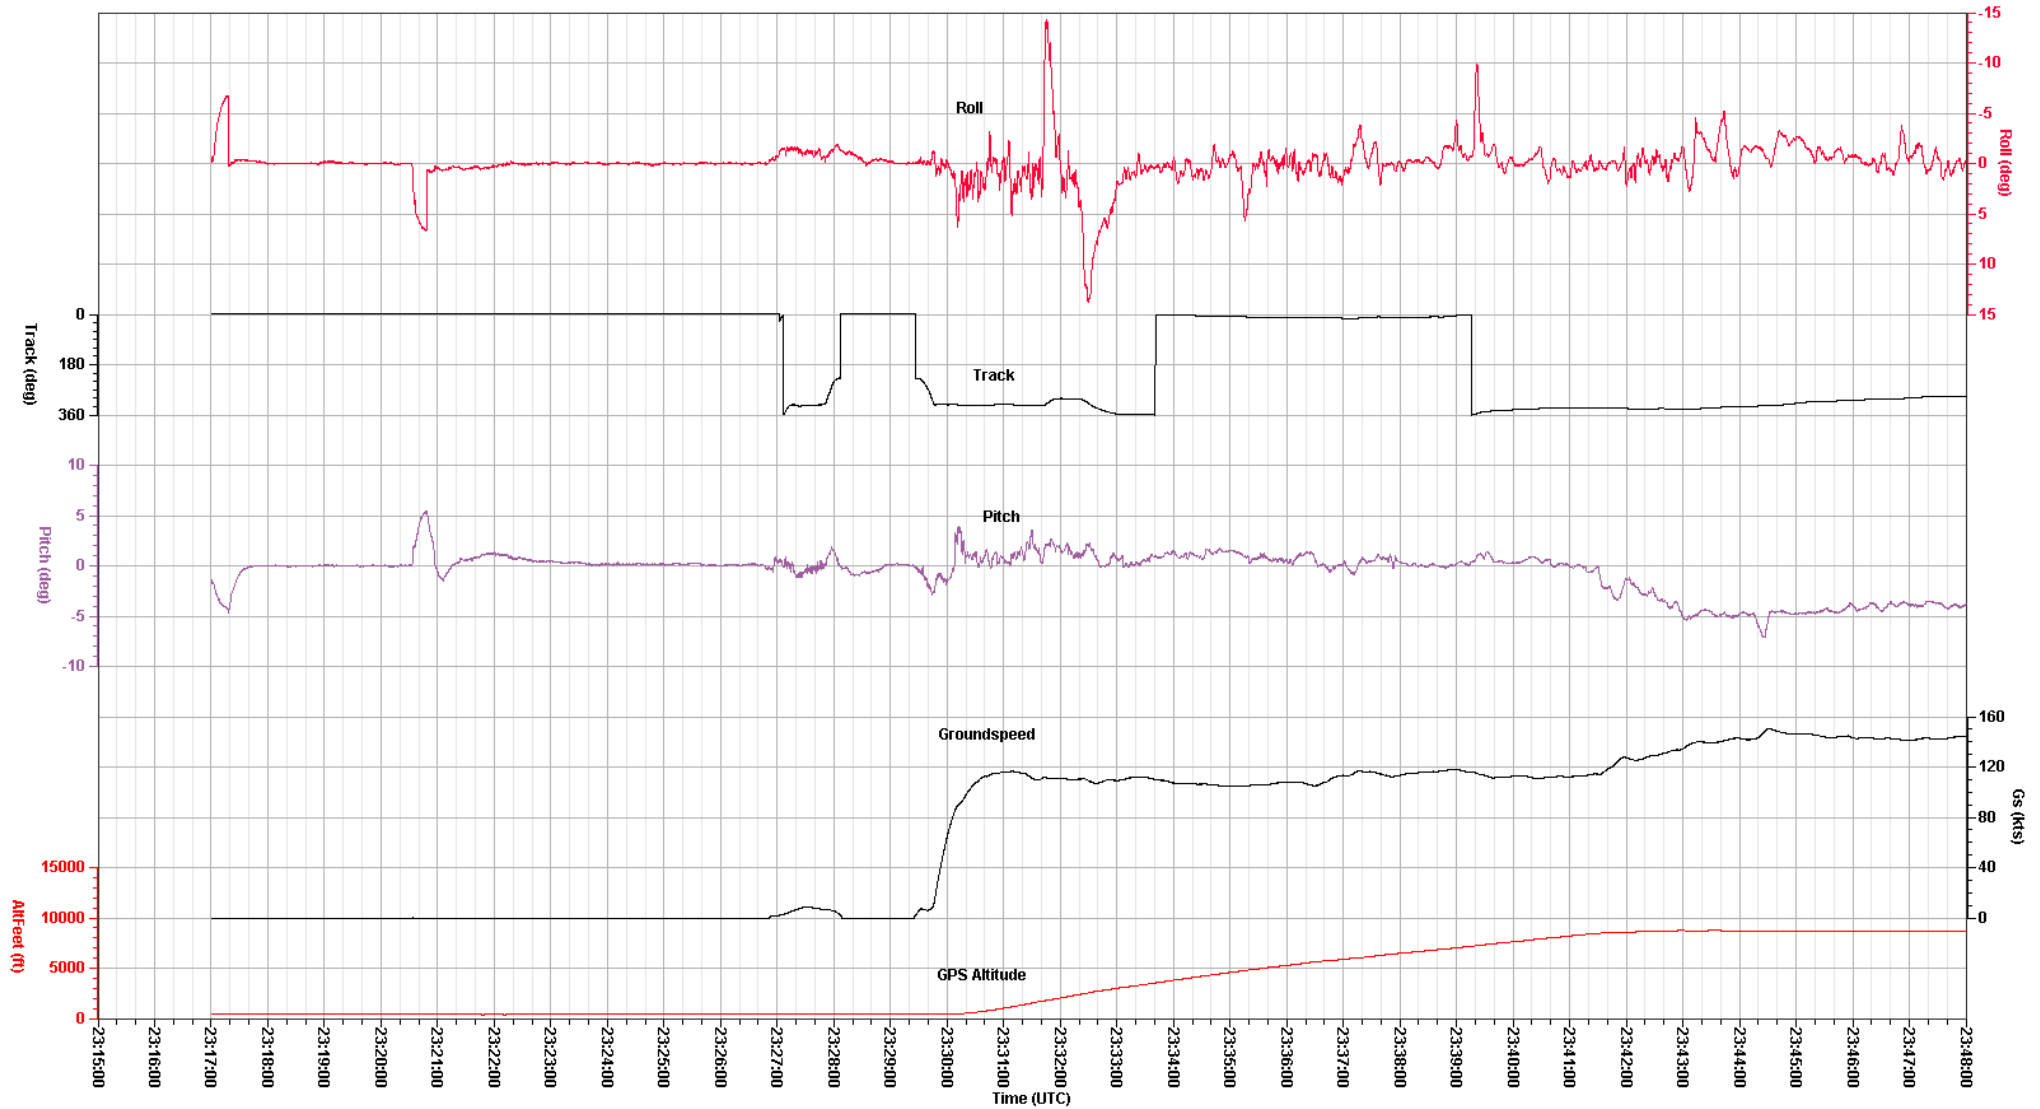
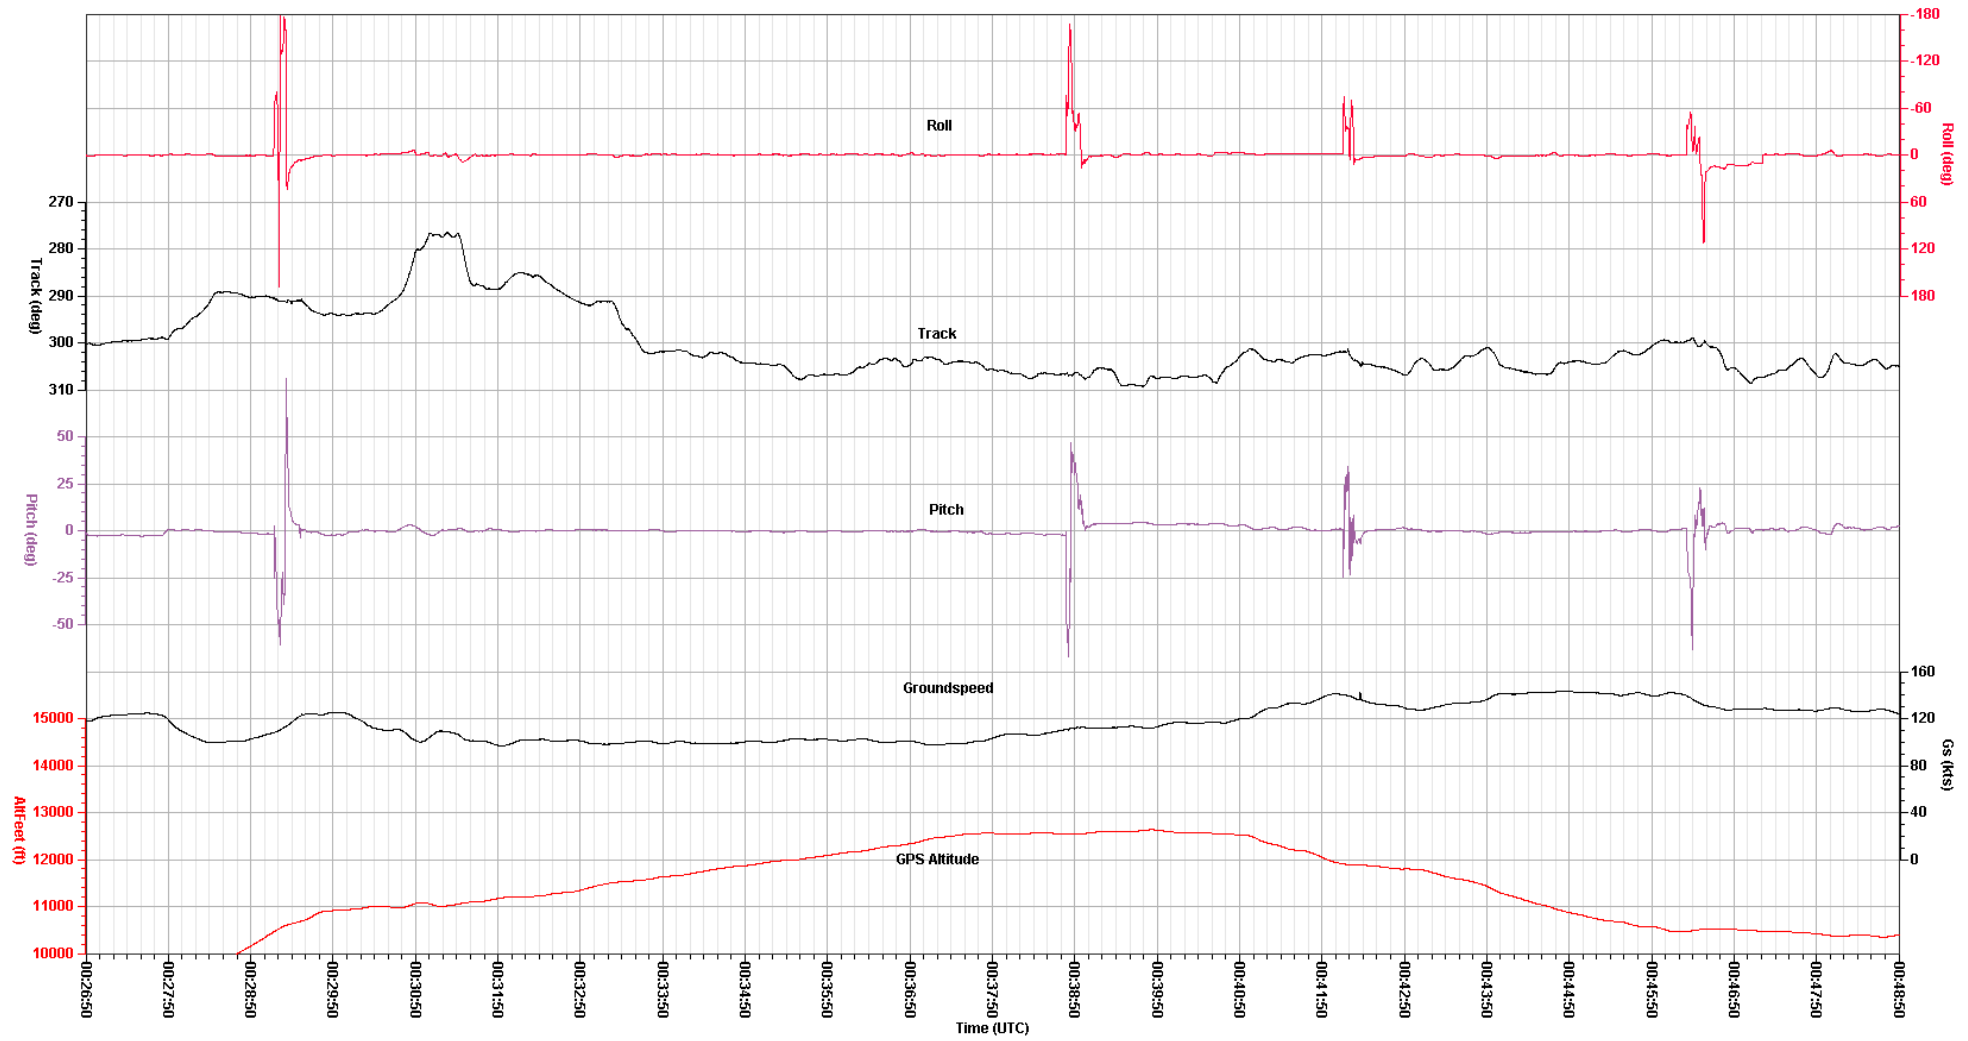
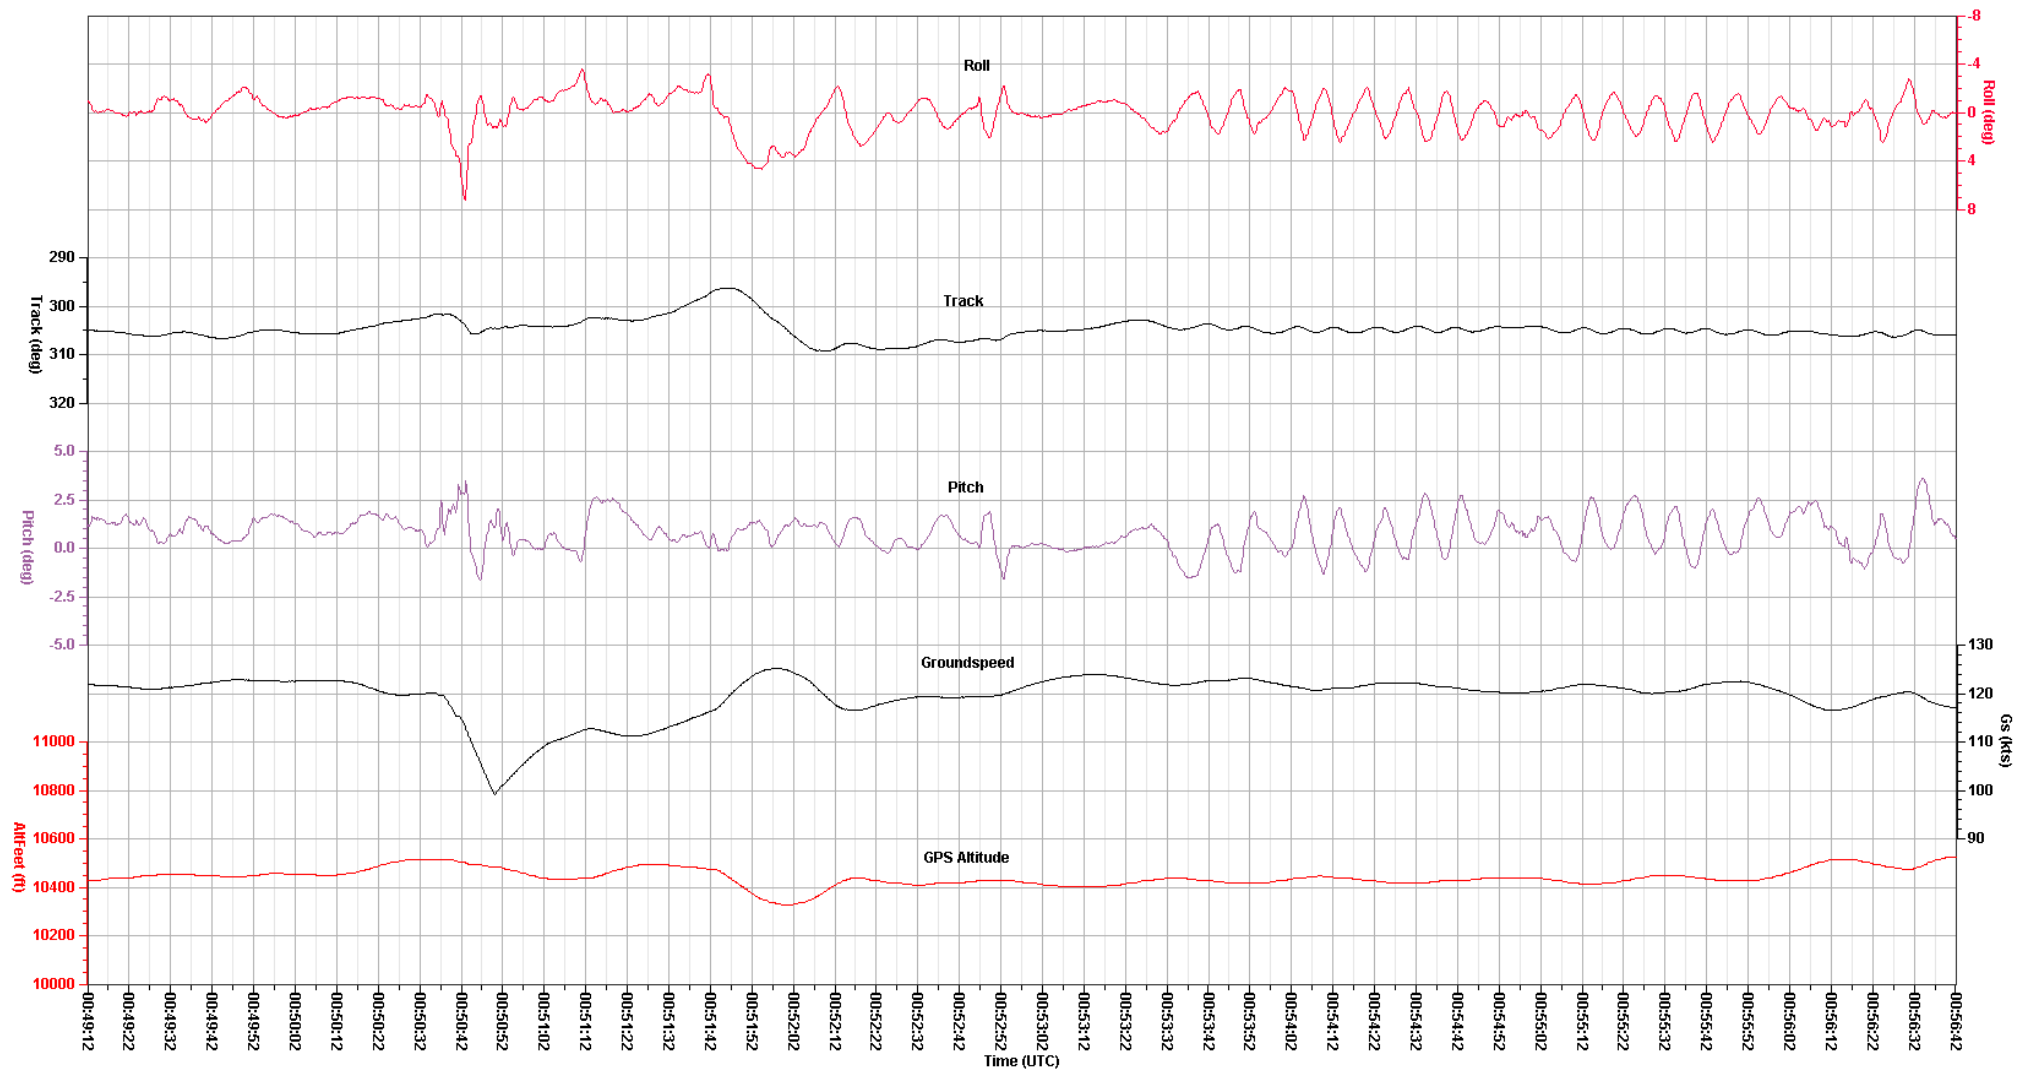
Figures 17 through 21 show plots of the accident flight data, including Stratus 2 recorded groundspeed, track, pitch, and roll. The plots may be summarized as follows (narrative values are approximate):

- In the first 12 minutes after takeoff, until 23:42:23 UTC, the aircraft climbed to a GPS altitude of 8,500 feet.
- For the 43 minutes, until 00:25:28 UTC, the aircraft remained at a GPS altitude of 8,500 feet.
- Between 00:25:28 UTC and 00:37:10 UTC, the aircraft climbed to a GPS altitude of 12,500 feet and remained at this altitude until 00:41:00 UTC.
- By 00:46:32 UTC, the aircraft descended to 10,500 feet and remained at that altitude until 01:35:00 UTC.
 - Note: Between 00:28:02 UTC and 00:47:21 UTC, there were four large excursions of pitch and roll. Given the track, groundspeed, and altitude trends during this same period, it is possible the excursions were an anomaly (for example, the Stratus 2 unit may have been moved from its reference location, disturbing the AHRS accelerometers).

- Between 01:35:00 UTC and 2:07:53 UTC, the aircraft descended from 10,500 feet to 6,500 feet and remained at 6,500 feet until passing the SGD VOR on the approach.

Figure 17. Plot of entire accident flight.

Figure 18. Plot of start of recording.

Figure 19. Plot of pitch and roll excursions enroute.

Figure 20. Plot of groundspeed excursion enroute.

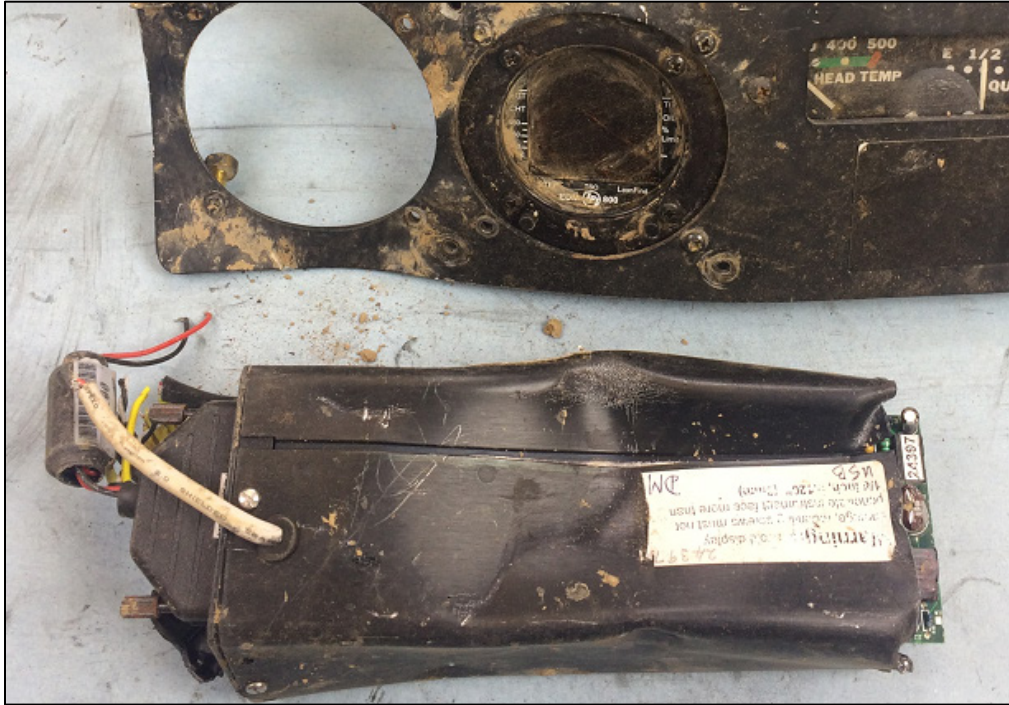
Upon arrival at the NTSB Vehicle Recorder Division, an exterior examination revealed the unit had sustained significant structural damage, as shown in figure 22. The dataplate from the unit is shown in figure 23, with marks next to the letters: C, OT, OP, A, F, and R/M. An internal inspection revealed that non-volatile memory chips containing recorded information were intact, as shown in figure 24.

Figure 22. JPI EDM-800 as received.
