NATIONAL TRANSPORTATION SAFETY BOARD

Electronic Devices

Specialist's Factual Report
by Bill Tuccio, Ph.D.

Location: Ruther Glen, Virginia
Date: May 9, 2014
Aircraft: Eagle C-7
Registration: N3016Z
Operator: Private
NTSB Number: ERA14FA231

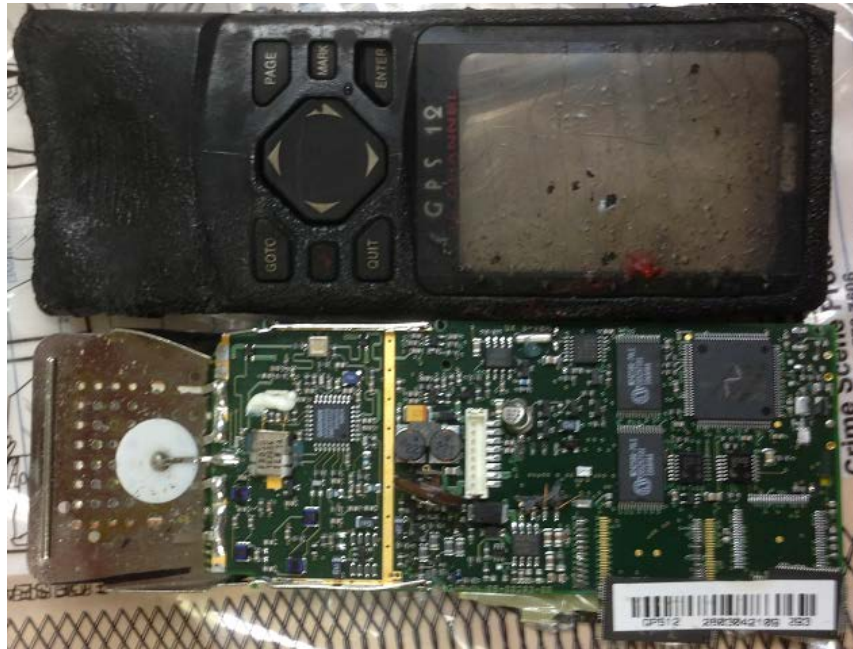
Upon arrival at the Vehicle Recorder Laboratory, an exterior examination revealed both devices had sustained severe fire damage. Figure 1 shows the Garmin GPS 12 and

Figure 1. Garmin GPS 12 as received.

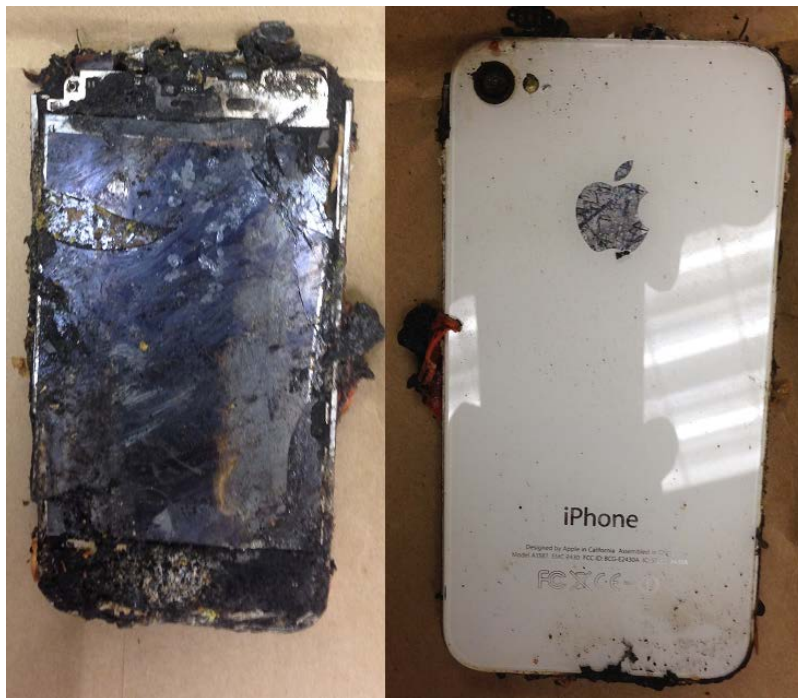
figure 2 shows the Apple iPhone 4S. Internal inspection of both devices revealed internal damage (figure 3 shows the iPhone 4S internal component board). No further recovery attempts were attempted.

Figure 2. Apple iPhone 4S as received.

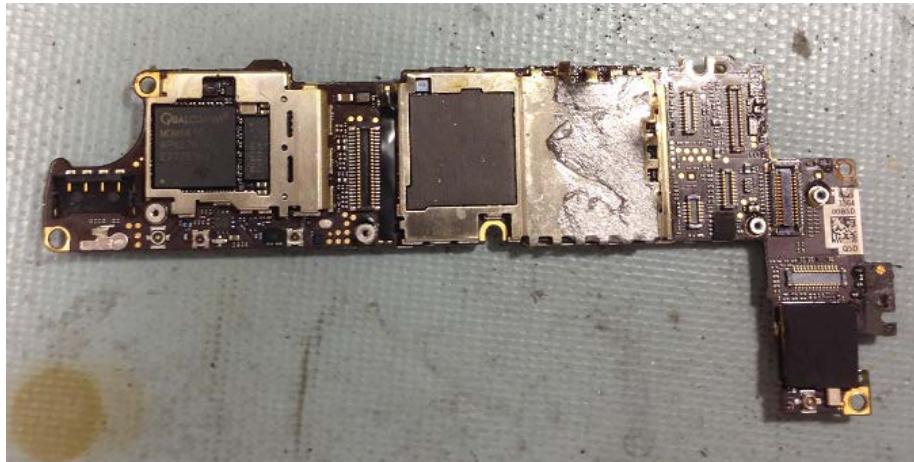
Figure 3. iPhone 4S internal component board.

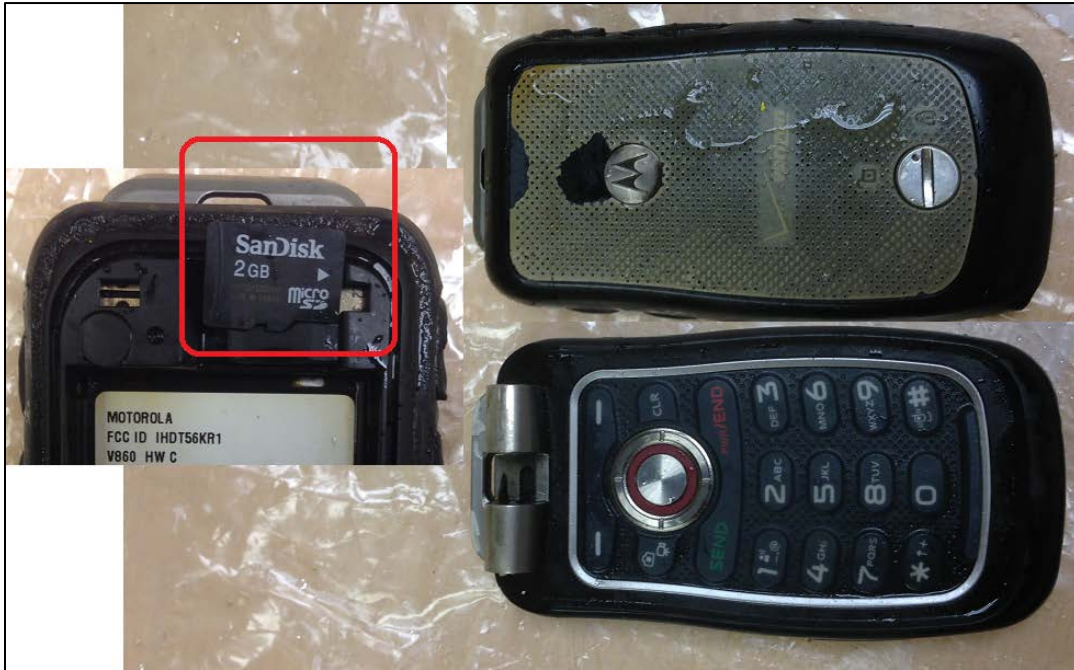
Upon arrival at the Vehicle Recorder Laboratory, an exterior examination revealed the unit had sustained severe structural damage. The screen component of the flip phone was missing; however, the base unit was intact and contained a 2GB microSD card, as shown in figure 4.

Figure 4. Motorola Barrage.

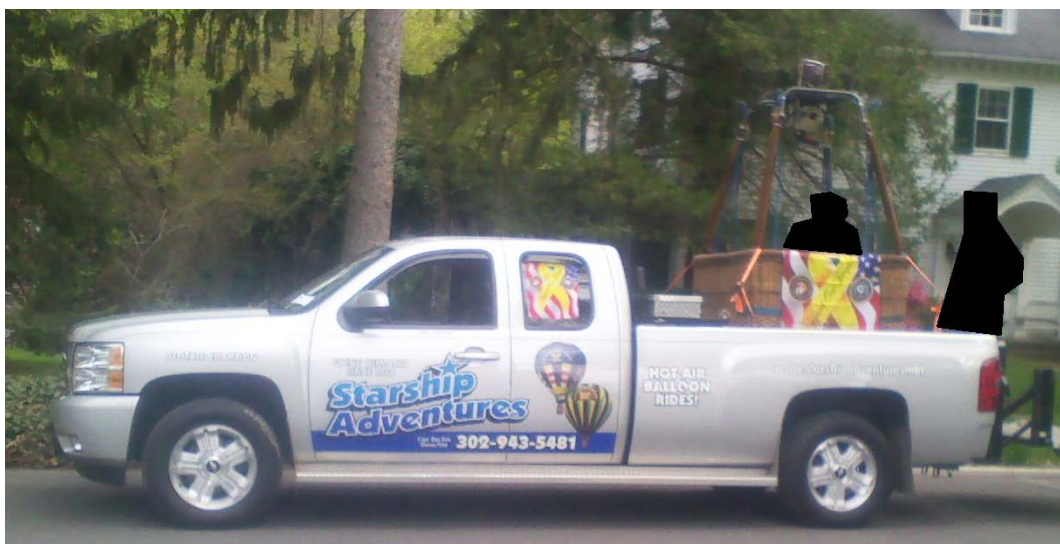
The phone belonged to the accident pilot. Due to damage, only the microSD card was examined for this report. The phone contained 22 still photos and 7 video clips with timestamps between January 2011 and May 3, 2014. Only the May 3, 2014 photo was determined to be pertinent to the investigation and is shown in figure 4. The photo shows a balloon basket in the back of a silver pickup truck. The pickup truck has a logo “Starship Adventures” and a phone number 302-943-5481 printed on the side. The two people in the photo were redacted for the purpose of this report.

Figure 5. Photo timestamped May 3, 2014.

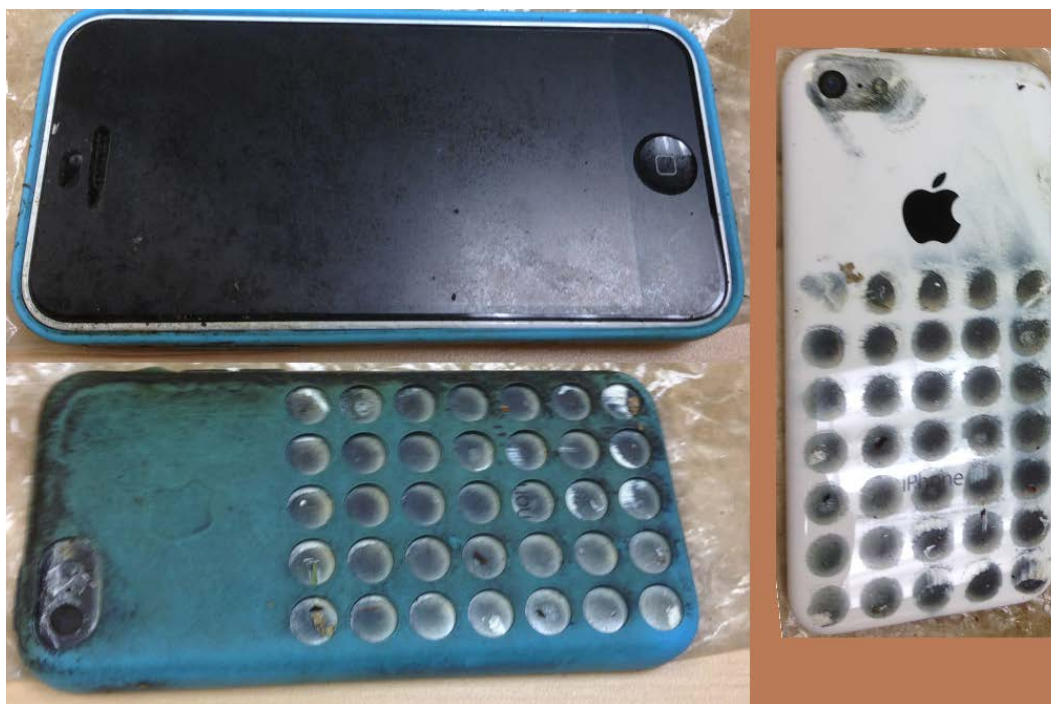
Upon arrival at the Vehicle Recorder Laboratory, an exterior examination revealed the iPhone had been exposed to smoke or fire. Figure 6 shows the unit in the blue case and with the blue case removed; smoke residue is evidenced on the device. The device started normally and was password protected. The IIC provided the correct password and information was downloaded from the phone normally.

Figure 6. Apple iPhone 5C in case and with case removed.

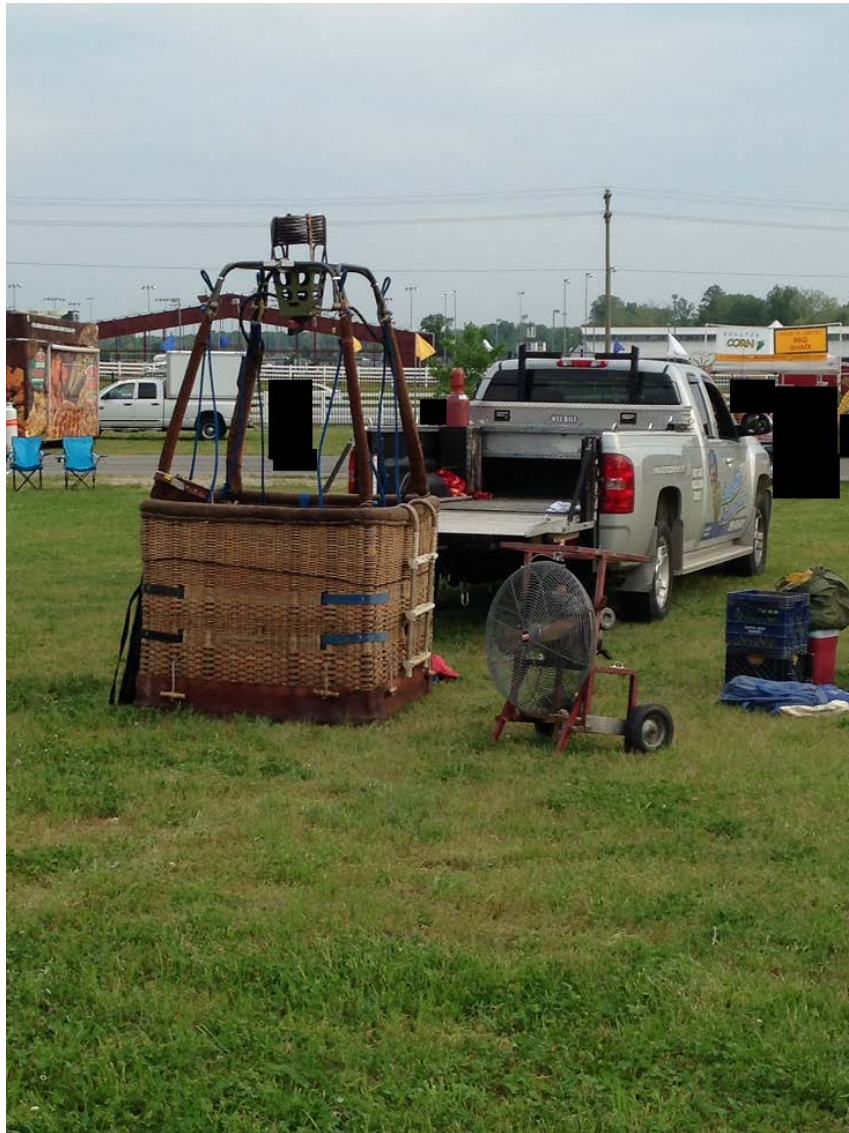
Figure 7 shows a photograph (5253576.jpg) of a balloon basket in front of the truck shown in figure 5; the photo was taken on May 9, 2014, at 18:38:24 EDT. An inflator fan is shown to the right of the basket. Above the basket is one burner assembly. People in the photo were redacted for the purpose of this report.

Figure 7. Photo 5253576.jpg taken 5/9/2014 at 18:38:24 EDT.

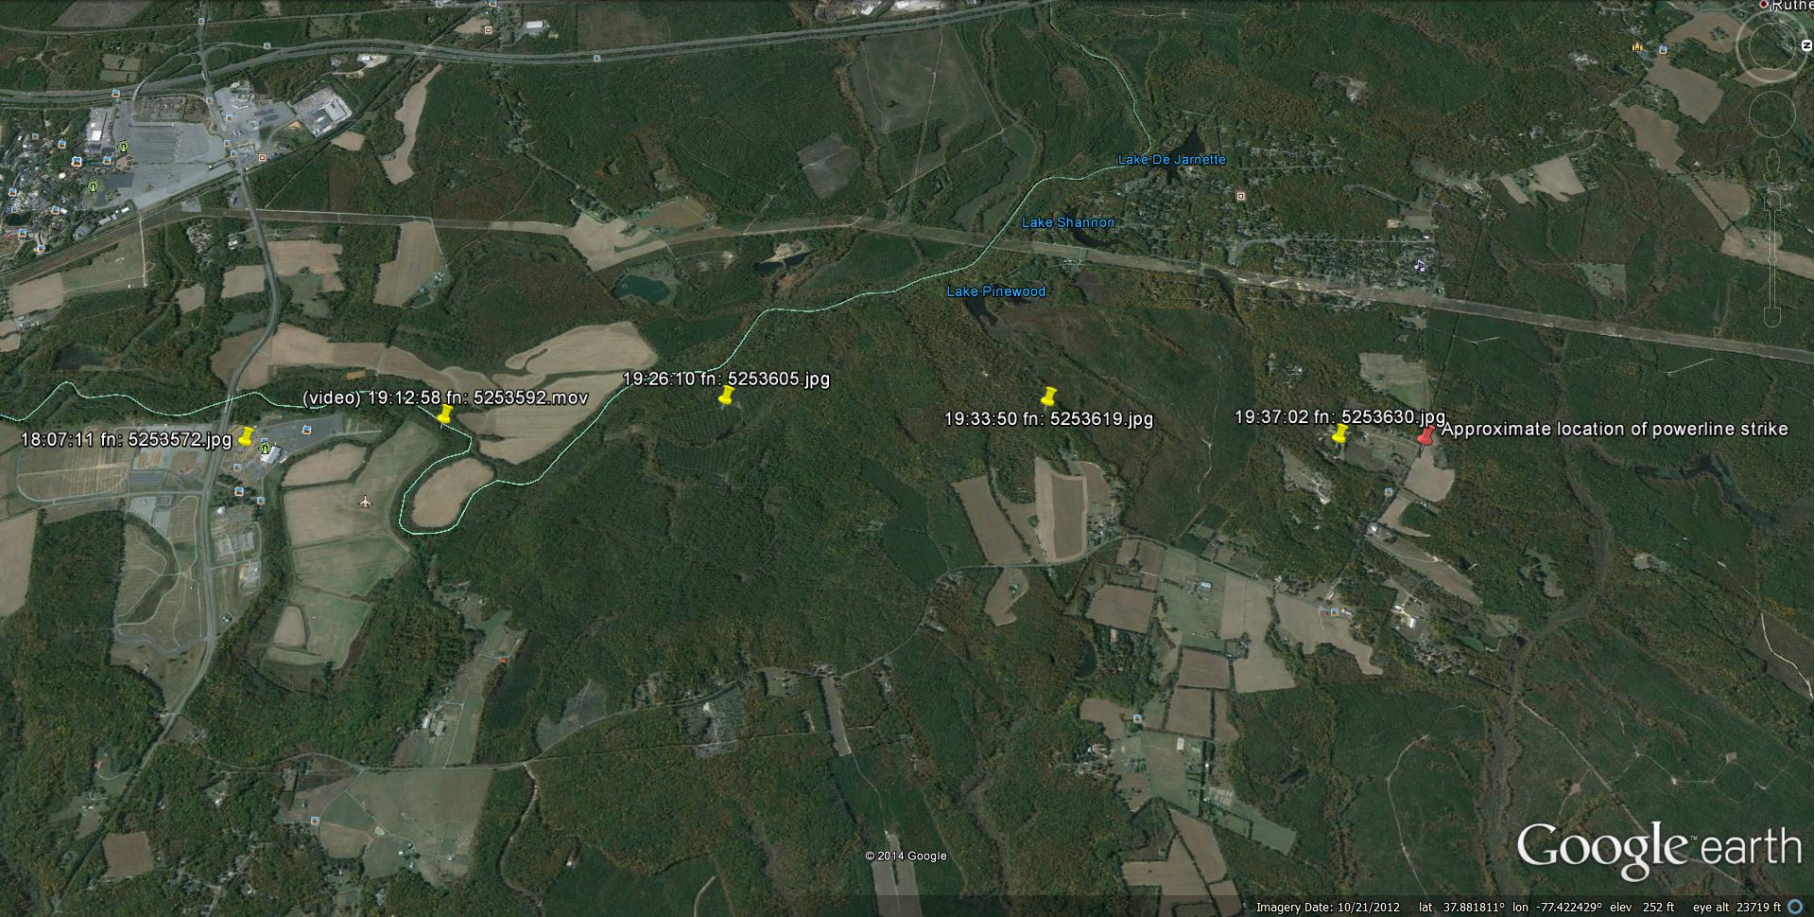
Each photograph and video contained metadata of the date, time, latitude, and longitude of the photo. Table 1 shows the metadata for all the photos and videos. Figure 8 shows select points on a Google Earth overlay. Note the weather and features shown in Google Earth are from satellite imagery at an earlier date and may not reflect the weather and features at the time of the accident.

Figure 8. Select points from iPhone 5C photo/video metadata on May 9, 2014.
