NATIONAL TRANSPORTATION SAFETY BOARD

Vehicle Recorder Division

Multiple Electronic Devices

Specialist's Factual Report
by Bill Tuccio, Ph.D.

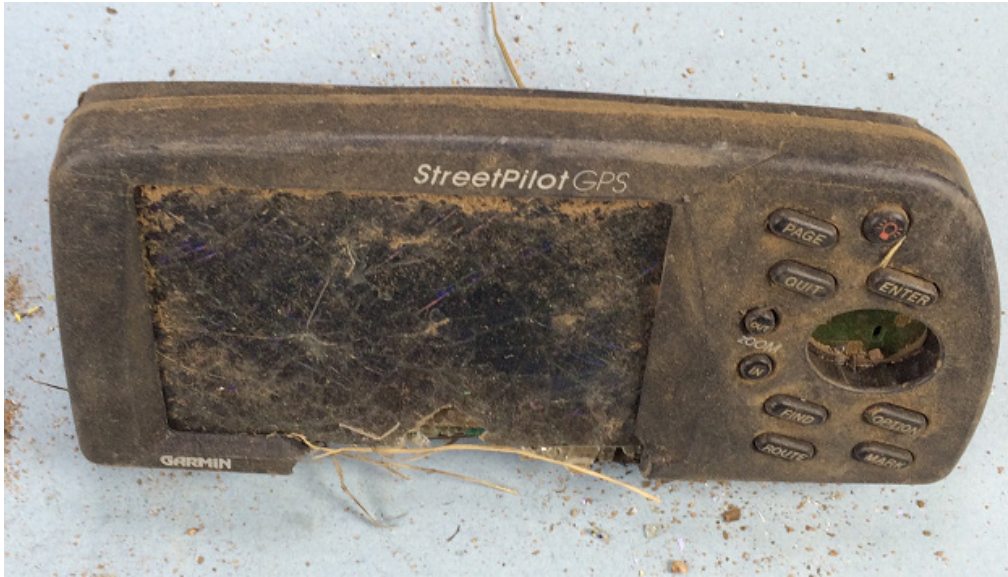
Figure 1. Garmin StreetPilot as received.

Upon arrival at the Vehicle Recorder Division, an exterior examination revealed the device had sustained significant impact damage, as shown in figure 1. An internal inspection revealed no significant damage to electronic components, as shown in figure 2. The unit was repaired and downloaded using the manufacturer's software.

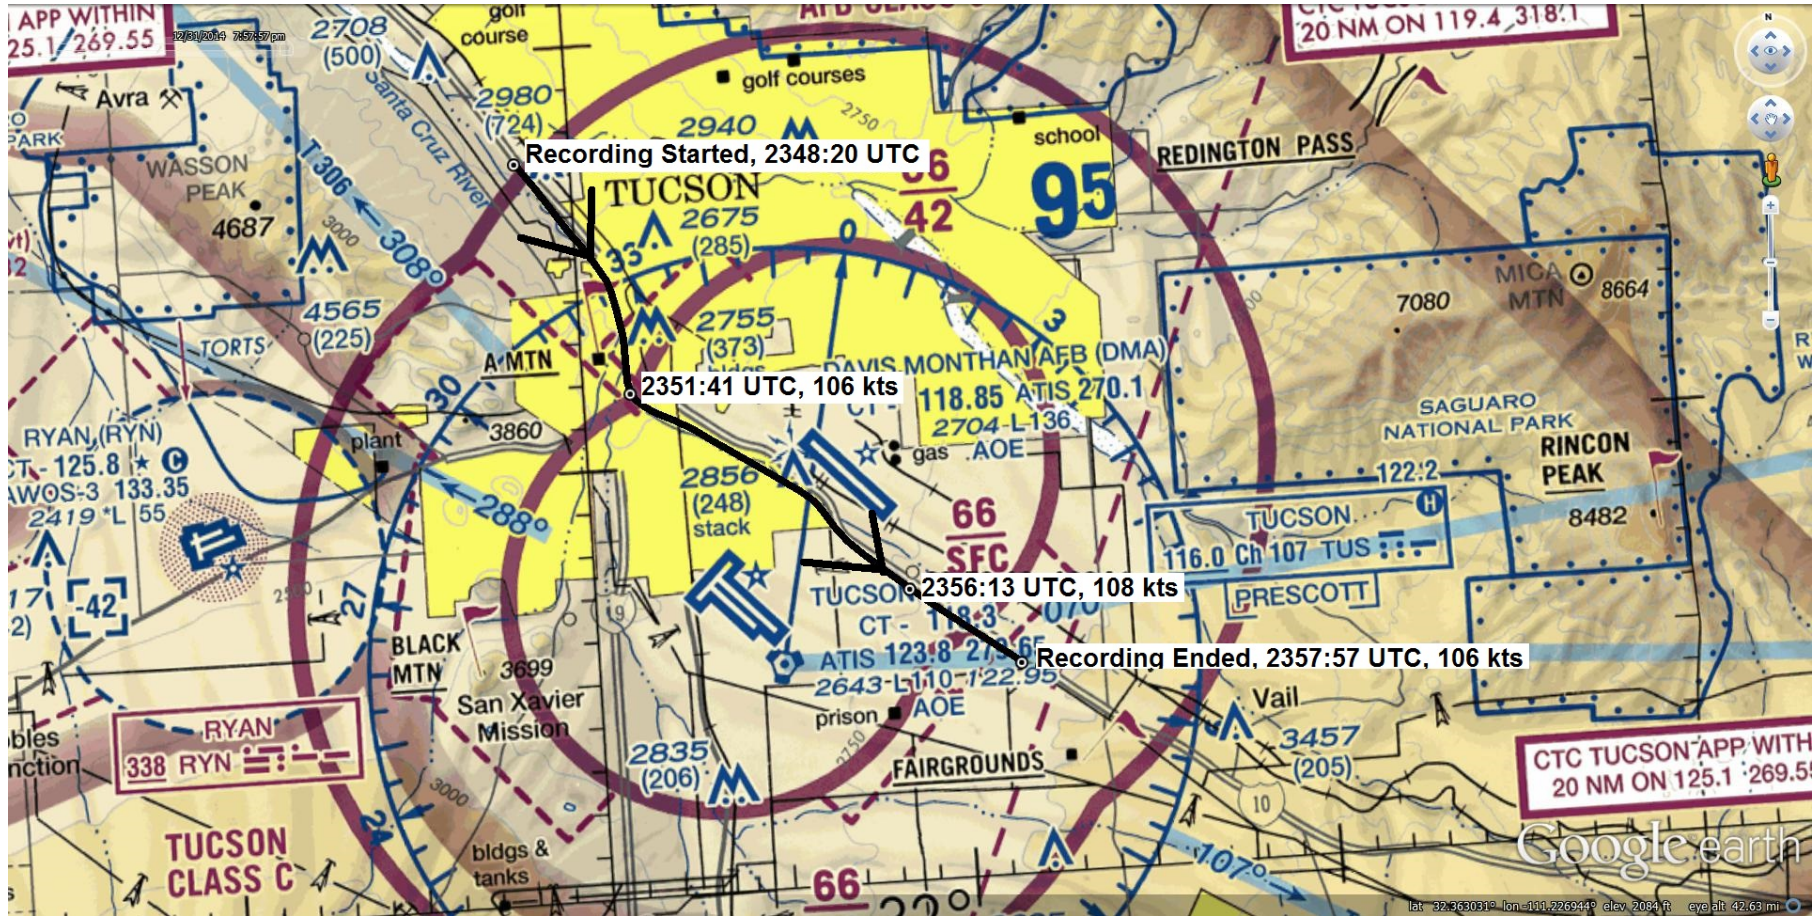
Figure 3. Overlay of accident flight recording.

Figure 3 is a graphical overlay of the accident flight, generated using Google Earth and an aviation sectional chart.

The recording began at 2348:20 UTC, when the helicopter was northwest of Tuscon International Airport (TUS). The track followed Interstate Highway I-10 southeast bound, passed TUS. The recording ended shortly after the helicopter passed TUS, at 2357:57 UTC.

Tabular data used to generate figure 3 are included as attachment 1. This attachment is provided in electronic comma-delimited (.CSV) format.
