## **NATIONAL TRANSPORTATION SAFETY BOARD**

# **ACCIDENT SITE EXAMINATION SUMMARY**

**WPR15MA243AB**

On August 16, 2015, about 1100 Pacific daylight time, two airplanes, a Cessna 172, N1285U, and an experimental Sabreliner, (Sabre 60), N442RM, collided midair approximately 1 mile northeast of Brown Field Municipal Airport (SDM), San Diego, California. The two pilots and two mission specialists aboard the Sabreliner were fatally injured. The pilot of the Cessna, the sole occupant of the airplane, was fatally injured. The Sabreliner was being operated as a public aircraft flight by the U.S. Department of Defense in support of the U.S. Navy. The Sabreliner was registered to BAE Systems Technology Solutions & Services, Inc. The Cessna was registered to Plus One Flyers, Inc., of San Diego, California, and operated by the pilot as a personal flight under the provisions of 14 Code of Federal Regulations Part 91. Both airplanes were destroyed. Visual meteorological conditions prevailed at SDM. Both airplanes departed SDM earlier that day and a mission flight plan was on file for the Sabreliner; no flight plan was filed for the Cessna 172. A controller in the SDM air traffic control towe

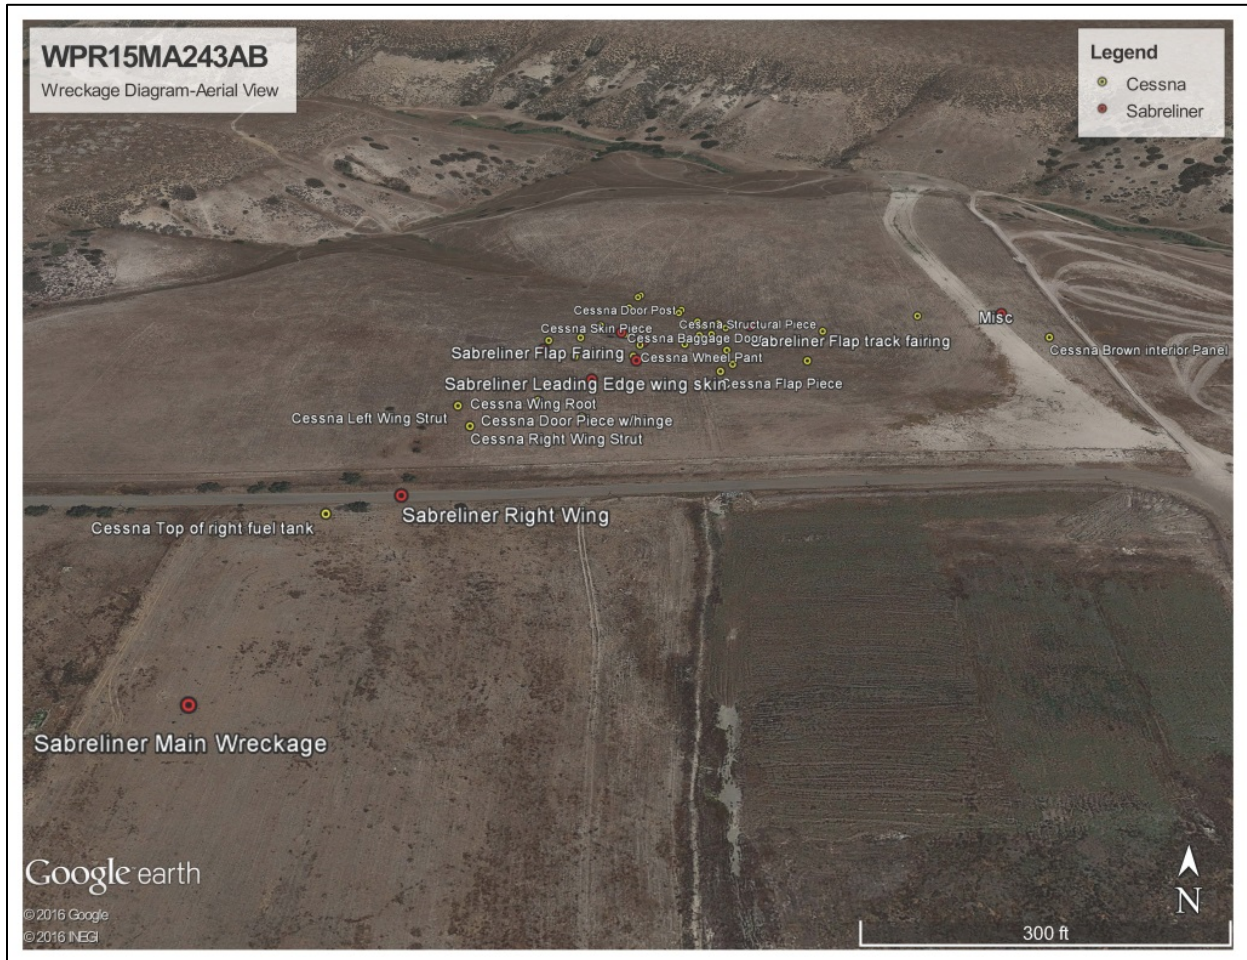
Figure 2-Aerial View of Accident Site

The accident site consisted of two debris fields. The Cessna's debris field was located about 400 feet northeast of the Sabreliner's debris field. The Cessna's debris field was about 1,200 feet in length at a magnetic heading of 055 degrees, and contained parts from the Sabreliner.

The Cessna's debris field was about 1,200 feet in length at a magnetic heading of 055 degrees, and contained parts from the Sabreliner. The Cessna was highly fragmented throughout its debris field.

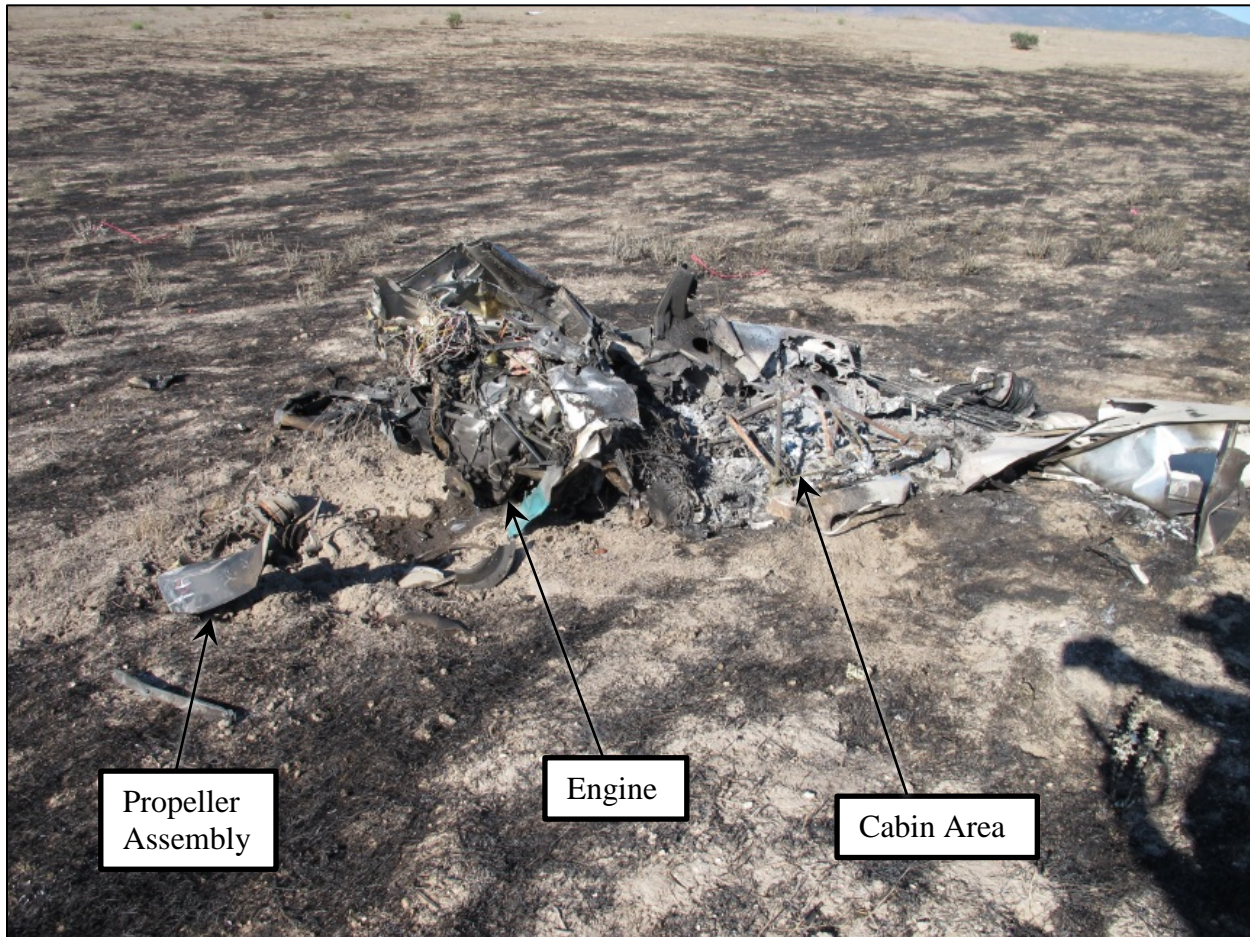
Figure 3-Cessna Main Wreckage

The Cessna's main wreckage contained part of the main cabin, engine, and propeller and was destroyed thermally and by impact forces. The main cabin consisted of parts of floor, seats and structure. The engine remained partially attached to the firewall and exhibited impact damage to its left side revealing cylinder overhead components. The propeller assembly separated from the engine and was found partially buried in a small crater. The propeller was heavily gouged and one blade had aft bending.

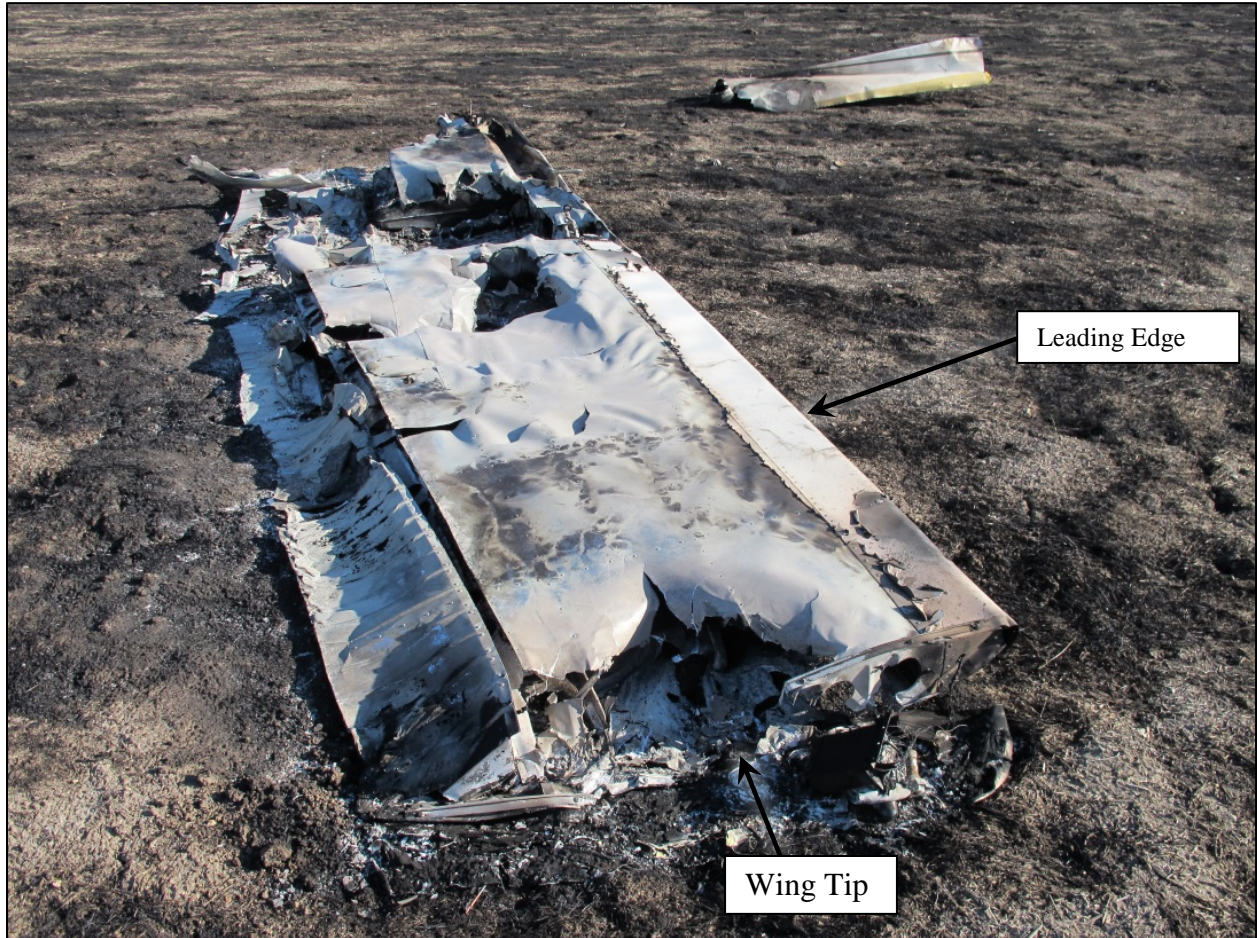
Figure 4-Cessna's Left Wing (Lower Wing Surface in View) and Rear Fuselage and Dorsal Fairing in the background.

The Cessna's left wing and a portion of the cabin roof remained intact and came to rest inverted. The wing and roof section had thermal damage. The flap and aileron flight control surfaces remained attached to the wing. The inboard portion of the leading edge of the left wing displayed impact damage and red colored transfer marks. The Cessna's fuselage and right wing were highly fragmented and spread throughout the debris field.

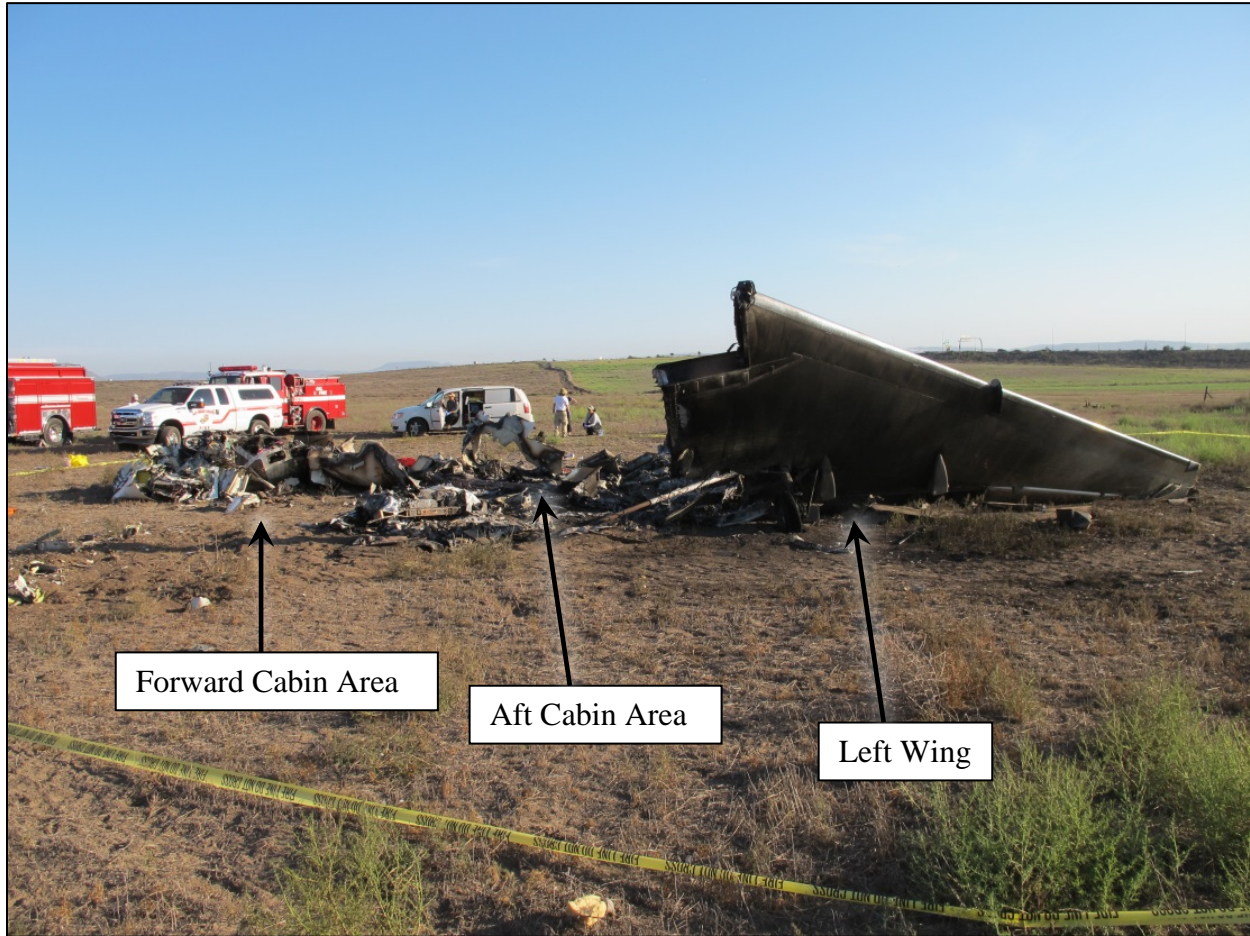
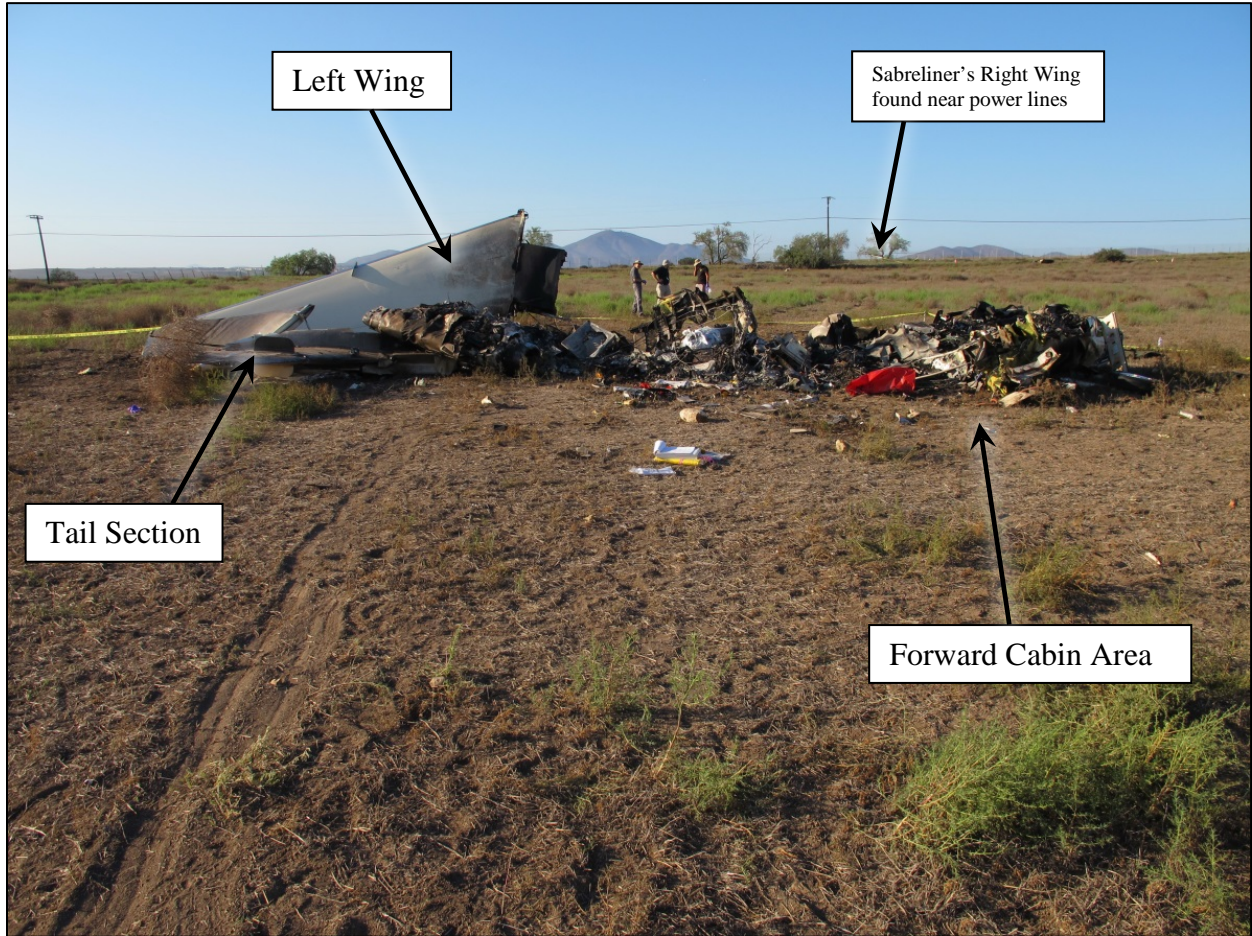
Figure 5-Sabreliner's Main Wreckage (South View)

The Sabreliner's debris field was contained within a radius of about 100 feet, and no Cessna parts were located within that radius. The Sabreliner came to rest at a magnetic heading of 060 degrees. The Sabreliner's main wreckage consisted of the cabin area, left wing, empennage, both engines and test pod. The forward cabin area came to rest on its upper left side and was crushed. The remaining cabin area was crushed and had thermal damage. The left wing came to rest on its trailing edge, supported at an angle by the wing's landing gear. Both engines were found near the tail section and displayed crush damage. The test pod and internal equipment had impact and thermal damage.

Figure 6-Sabreliner's Main Wreckage (North View)

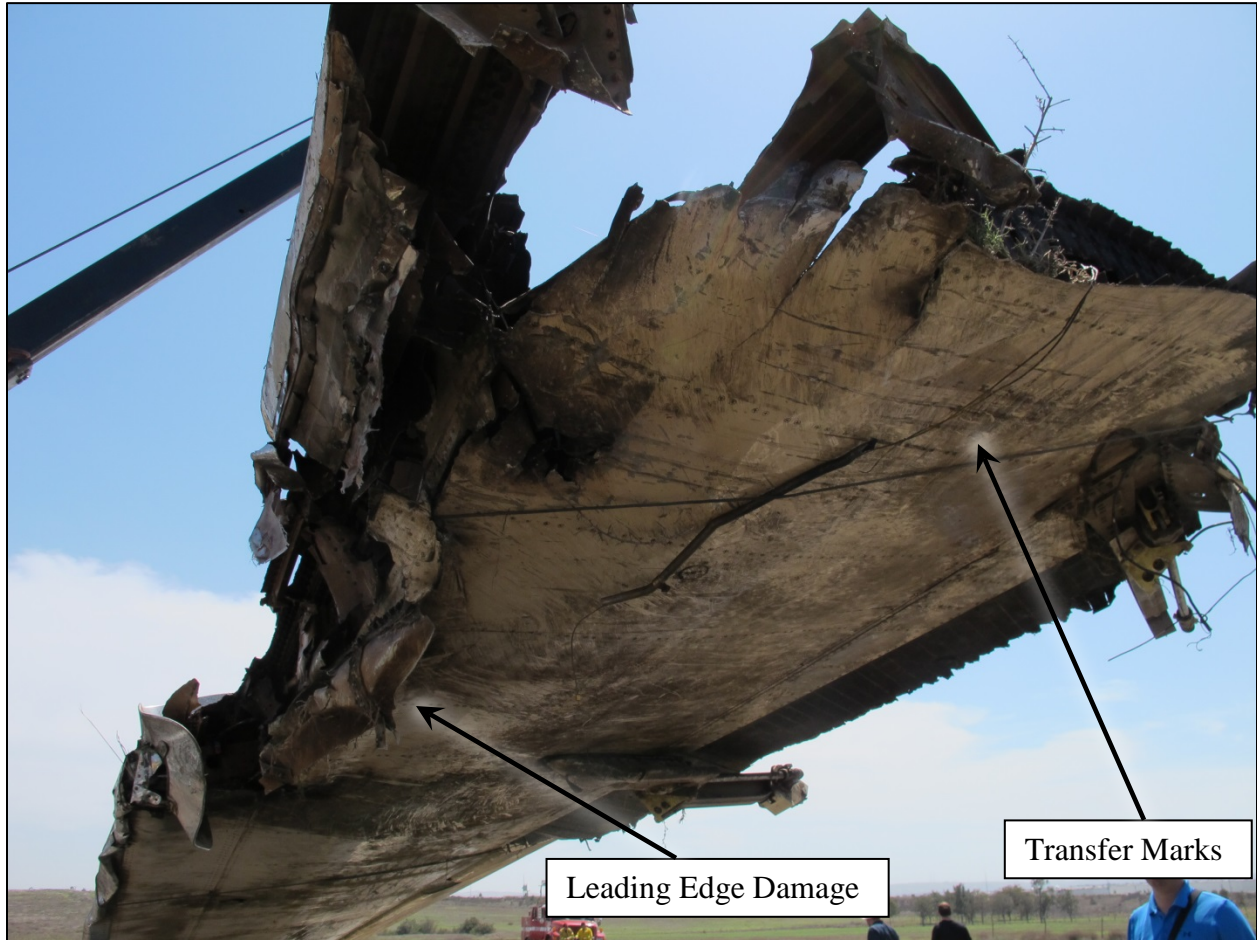
Figure 7-Sabreliner's Right Wing (leading edge damage)

The Sabreliner's right wing was found near the Cessna's debris field about 400 feet north of the Sabreliner's main wreckage. The wing displayed leading edge damage from near the tip to the separation of the inboard portion of the wing. About four feet of the inboard wing was missing. A section of leading edge from the stall fence inboard about 5 feet in length, displayed excessive leading edge damage revealing the internal surfaces of the wing. The remaining outboard section of the wing displayed impact marks and paint transfer marks.
