Highway Accident Brief

Fatal Pedestrian Collision with Sport Utility Vehicle Falls Church, Virginia, May 18, 2016

Accident Number:	HWY16SH012
Accident Type:	Fatal pedestrian collision with sport utility vehicle
Location:	Leesburg Pike (State Route 7) at Glen Carlyn Drive, Falls Church, Virginia
Date and Time:	May 18, 2016, about 3:40 p.m. eastern daylight time
Vehicle:	2012 Jeep Wrangler
Driver:	51-year-old male
Pedestrian:	71-year-old male
Fatalities:	1

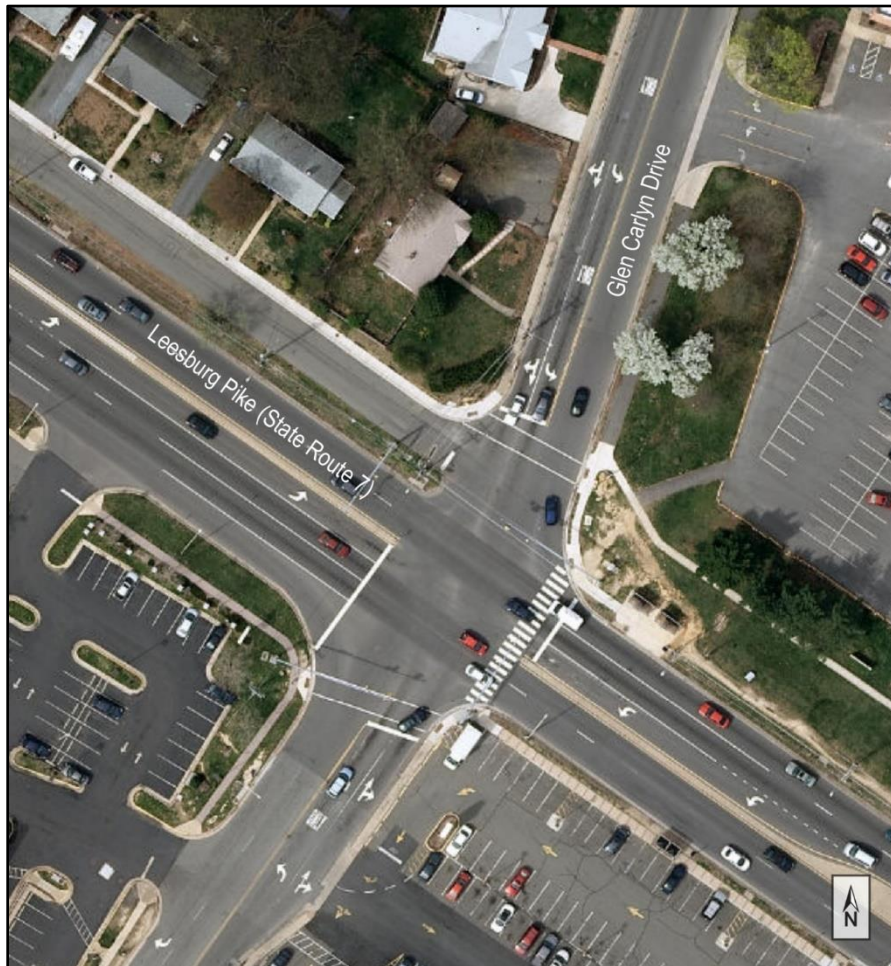
The area around the intersection includes sidewalks for pedestrians as well as marked pedestrian crosswalks (figure 2). Pedestrian-walk phases are incorporated in the timing sequence for the traffic lights at the intersection. A shopping center is located on the south side of Leesburg Pike. Metrobus stops and shelters are found on both sides of the highway—two shelters near the northeast corner of the intersection, and a smaller shelter in the middle of the block on the south side of Leesburg Pike (refer to figure 1). Local residents and law enforcement officers told investigators that pedestrian and bus traffic in the area is heavy.

Figure 2. Aerial view of crash location showing intersecting roadways, crosswalk, and surrounding businesses. (Base map by Google Earth)

The crash occurred during daylight hours. The roadway was dry, and the sky was overcast. Possible sight obstructions included a streetlight post on the southeast corner of the intersection near where the pedestrian would have stepped off the curb. The large post would have been between the driver and the pedestrian and might have momentarily obstructed their views of each other as the pedestrian walked behind it.

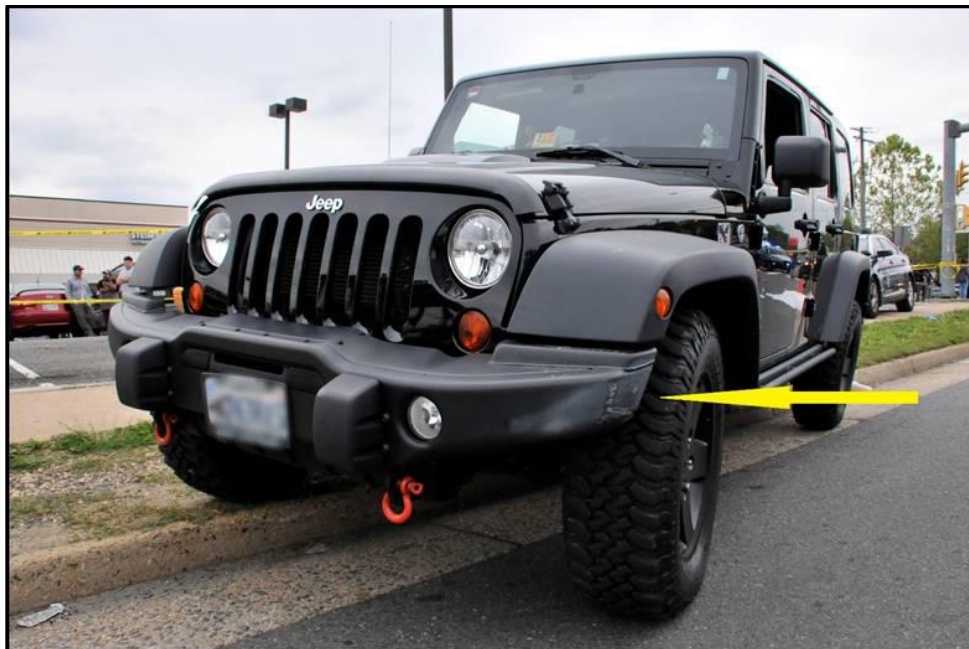
The crash vehicle was a 2012 Jeep Wrangler SUV. The owner purchased the vehicle in 2012 and was familiar with its operation. He stated that the SUV had no mechanical problems and had been in only one other collision, a minor one in 2012. The SUV was examined on the scene by law enforcement officers and NTSB investigators, who observed minor damage to the area of the left front bumper (figure 3).

Figure 3. Photograph showing minor contact damage (arrow) to left front bumper of SUV.
