National Transportation Safety Board

Highway Accident Brief

Fatal Pedestrian Collision with School Bus New York City, New York, October 14, 2016

Accident Number:	HWY17SH004
Accident Type:	Fatal pedestrian collision with school bus
Location:	West Fordham Road at Sedgwick Avenue, New York City, New York
Date and Time:	October 14, 2016, about 12:25 p.m. eastern daylight time
Vehicle:	2007 Ford school bus
Driver:	47-year-old male
Pedestrian:	43-year-old female
Fatalities:	1

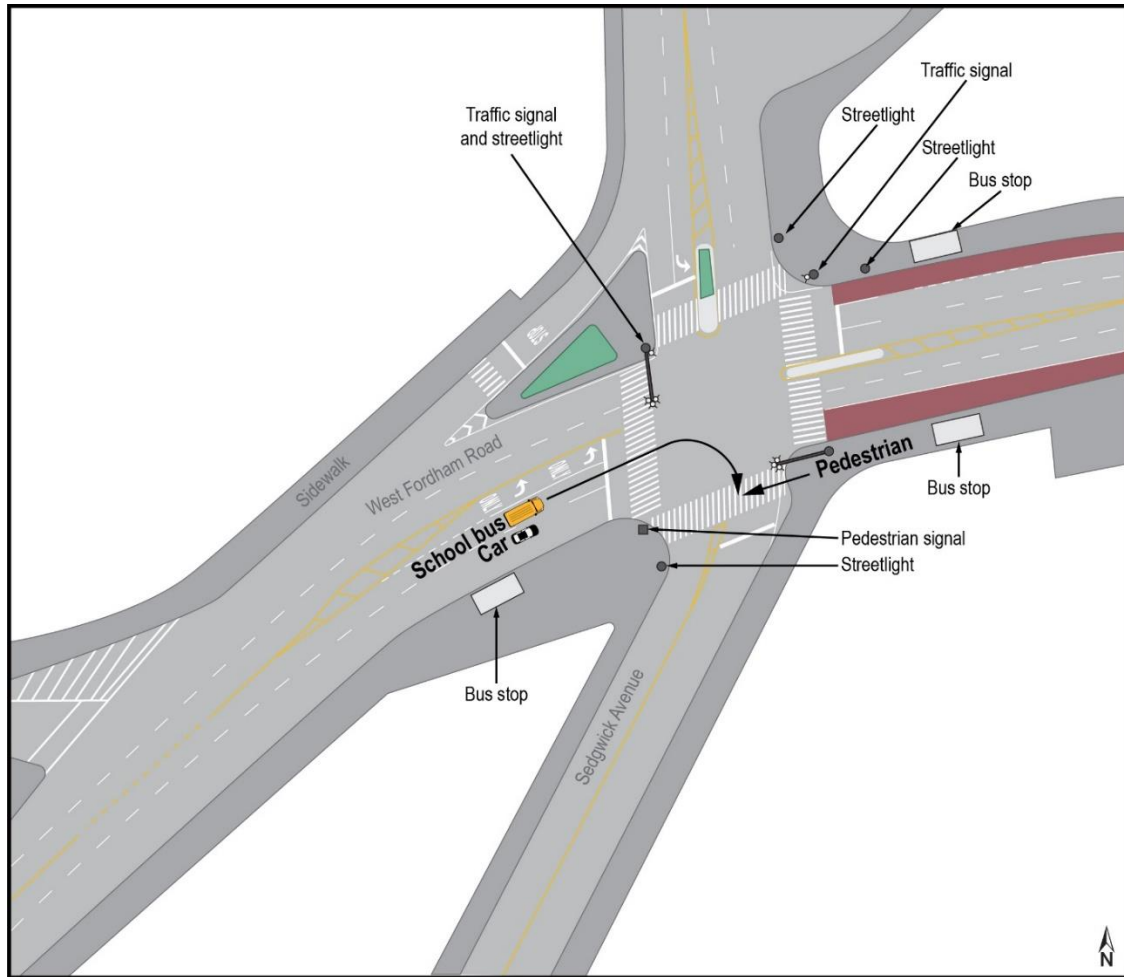
About 12:25 p.m. on Friday, October 14, 2016, a 2007 Ford school bus owned and operated by Mar-Can Transportation, Inc., was eastbound on West Fordham Road in the borough of the Bronx, New York City, New York. The investigation determined that the 47-year-old male driver was operating the bus while off duty, without passengers. (He was scheduled to start his afternoon shift 1 hour later.) As the bus approached the intersection of West Fordham Road and Sedgwick Avenue, the driver attempted to turn right onto Sedgwick Avenue. The bus was traveling in the left through lane on West Fordham Road, with another vehicle beside it in the right lane. The bus driver accelerated and made an abrupt turn in front of the other vehicle, causing its driver to slam on the brakes to avoid colliding with the bus. The bus overshot the turn and ended up on the east side of the double yellow line on Sedgwick Avenue, where it struck a 43-year-old female pedestrian in the crosswalk (figure 1).

Figure 1. Diagram of crash scene, showing path of bus as it turned right from West Fordham Road onto Sedgwick Avenue and struck pedestrian in crosswalk. Also shown are traffic signals, streetlights, and bus stops in immediate area.

The pedestrian had been walking on the south side of West Fordham Road and was crossing Sedgwick Avenue westbound in the marked crosswalk on a pedestrian WALK signal. Witnesses reported that the pedestrian had just left one of the businesses immediately east of the intersection and was carrying several bags of groceries. Being struck by the school bus caused the pedestrian to fall facedown onto the roadway, where the right front tire of the bus ran over her. Several witnesses screamed at the driver to stop. The driver continued forward, and the bus's right rear tire ran over the pedestrian.

The National Transportation Safety Board determines that the probable cause of the crash in New York City, New York, was the school bus driver's failure to stop for the pedestrian crossing the street in a marked crosswalk and on a WALK signal. Contributing to the crash was the driver's improper turn from the through lane (which included failing to yield to a vehicle in the right lane and turning into the wrong lane of the street the pedestrian was crossing).

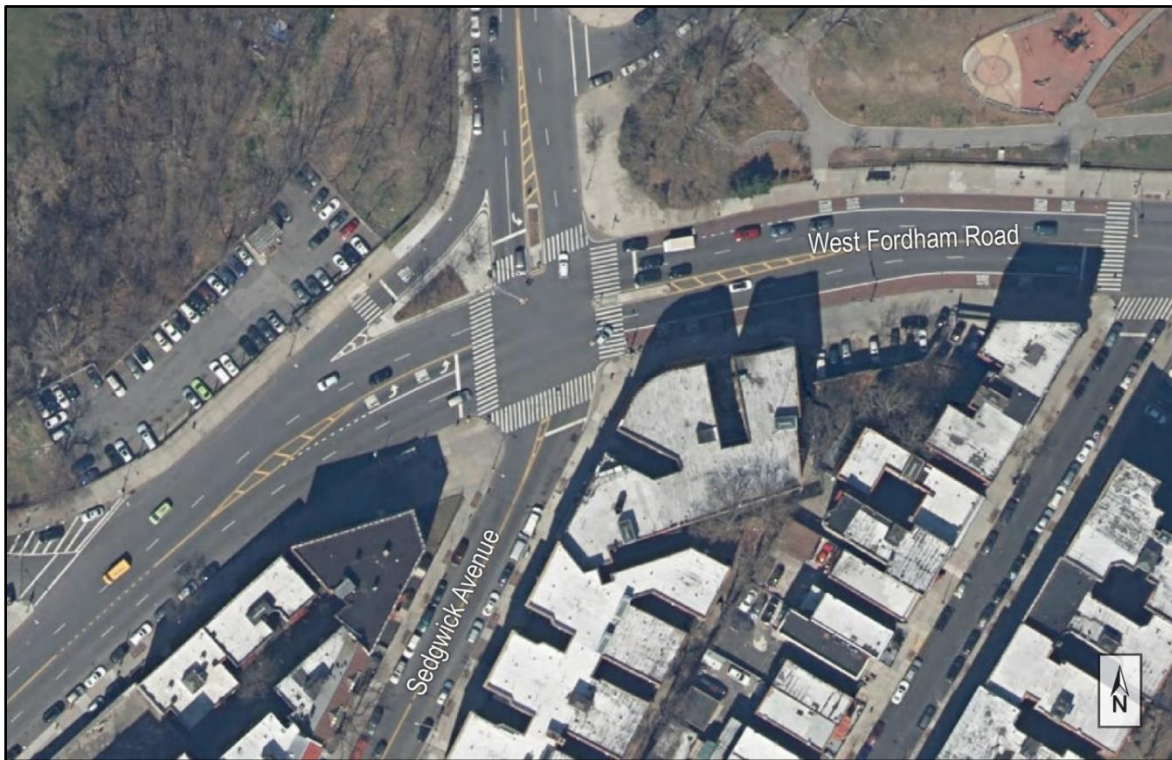
West Fordham Road is a commercial corridor in a residential zone. The area of the crash includes dozens of businesses, single-family houses, a public park, and nine apartment buildings that contain about 1,130 apartments (figure 2). The roadway runs east and west, with a double yellow line separating opposing lanes. Both sides of the roadway have two through lanes and one dedicated left-turn lane. In the eastbound direction, West Fordham Road has a significant uphill grade. Traffic signals control the intersection with Sedgwick Avenue (refer to figure 1), and all the crosswalks are well marked. The posted speed limit is 25 mph on both roads.

Figure 2. Aerial view of crash intersection showing crosswalks and other road markings on West Fordham Road and Sedgwick Avenue, with apartment buildings to south and parkland to north. (Base photo from New York state global information system)

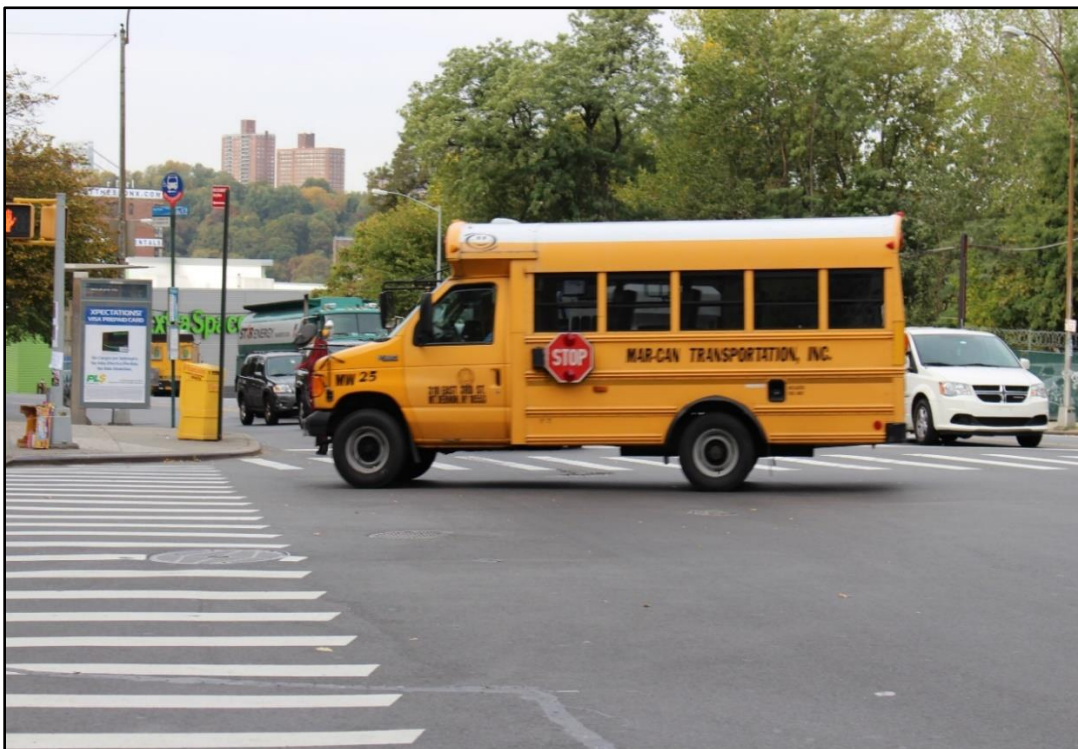
The crash vehicle was a 2007 Ford school bus (figure 3). The bus had a tracking device that used global positioning system technology to record its location and speed. According to the tracking data, the crash occurred at 12:23 p.m., and the bus was traveling 9 mph.

Figure 3. School bus similar to that involved in crash, shown turning left from West Fordham Road onto Sedgwick Avenue at crash intersection. (Crash bus was turning right from eastbound West Fordham Road, in lane where green truck can be seen.) View is west from crosswalk where pedestrian was struck.

The driver's air bag did not deploy in the collision. An examination of the vehicle found no structural damage. The only damage was minor scratches and a clean swipe mark on the right side of the front bumper.
