National Transportation Safety Board

Highway Accident Brief

Fatal Pedestrian Collision with Sport Utility Vehicle Old Saybrook, Connecticut, August 16, 2016

Accident Number:	HWY16SH024
Accident Type:	Fatal pedestrian collision with sport utility vehicle
Location:	Maple Avenue at Cambridge Court West, Old Saybrook, Connecticut
Date and Time:	August 16, 2016, about 8:11 p.m. eastern daylight time
Vehicle:	2007 Toyota FJ Cruiser
Driver:	73-year-old male
Pedestrian:	89-year-old male
Fatalities:	1

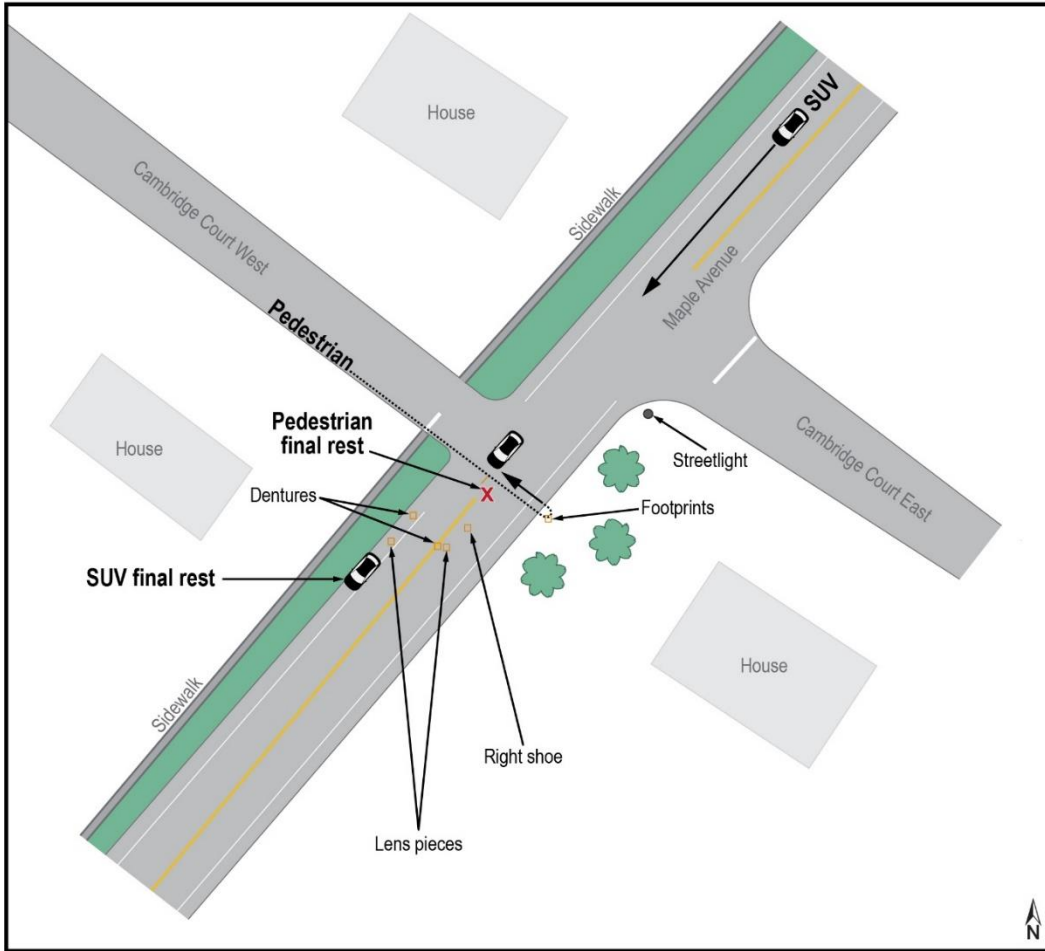
Figure 1. Diagram of crash scene showing pedestrian’s path back and forth across Maple Avenue, path of SUV on Maple Avenue, and final rest positions of pedestrian and SUV. Debris on roadway is also indicated.

About 8:11 p.m. on Tuesday, August 16, 2016, a 2007 Toyota FJ Cruiser sport utility vehicle (SUV) driven by a 73-year-old male was southbound on Maple Avenue in Old Saybrook, Middlesex County, Connecticut. At the intersection of Maple Avenue and Cambridge Court West, an 89-year-old male pedestrian walked from the west side of Maple Avenue to the soft dirt shoulder on the east side, according to a witness, then turned around and crossed the northbound lane of Maple Avenue. He walked about 2 feet into the southbound lane, where he was struck by the left front fender of the SUV (figure 1).

The pedestrian came to rest in the northbound lane of Maple Avenue. The SUV came to final rest south of the intersection. The pedestrian was transported to Middlesex Hospital–Shoreline Medical Center in Westbrook, Connecticut, where he was pronounced dead.

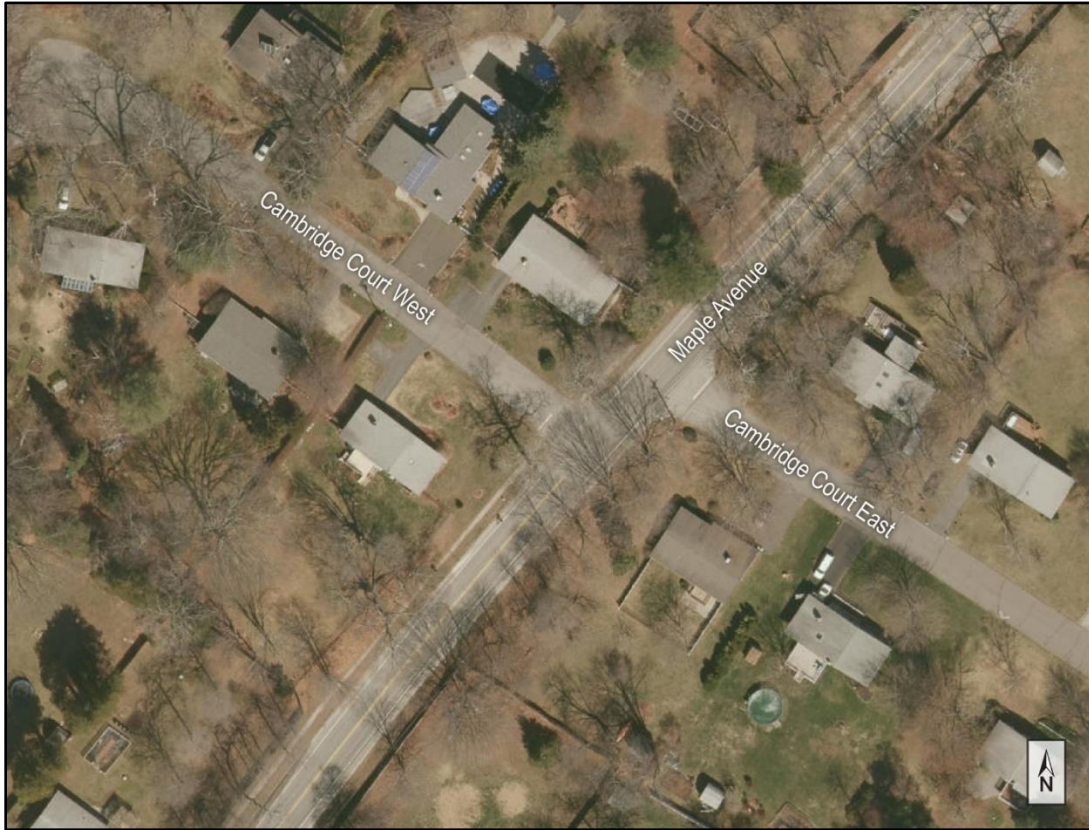
Figure 2. Aerial view of crash location showing intersection of Maple Avenue with Cambridge Court East and Cambridge Court West. (Base photo by Google Earth)

The area around Cambridge Court West and Maple Avenue is residential (figure 2). Maple Avenue is a two-lane asphalt roadway that has a single lane in each direction (northeast and southwest), separated by a double yellow center line. A single white line (“fog line”) separates the northeastbound travel lane from the shoulder. A raised curb and a grassy strip separate the sidewalk from the southwestbound lane. The posted speed limit for Maple Avenue is 35 mph.

The area has no crosswalks or pedestrian control signals. Street lighting is limited to a single lamp mounted on a pole at the intersection of Cambridge Court East and Maple Avenue. The light is above a tree canopy along the east side of Maple Avenue, and the trees project a shadow onto the shoulder of the roadway. No records for pedestrian collisions were found in the crash history of Maple Avenue.

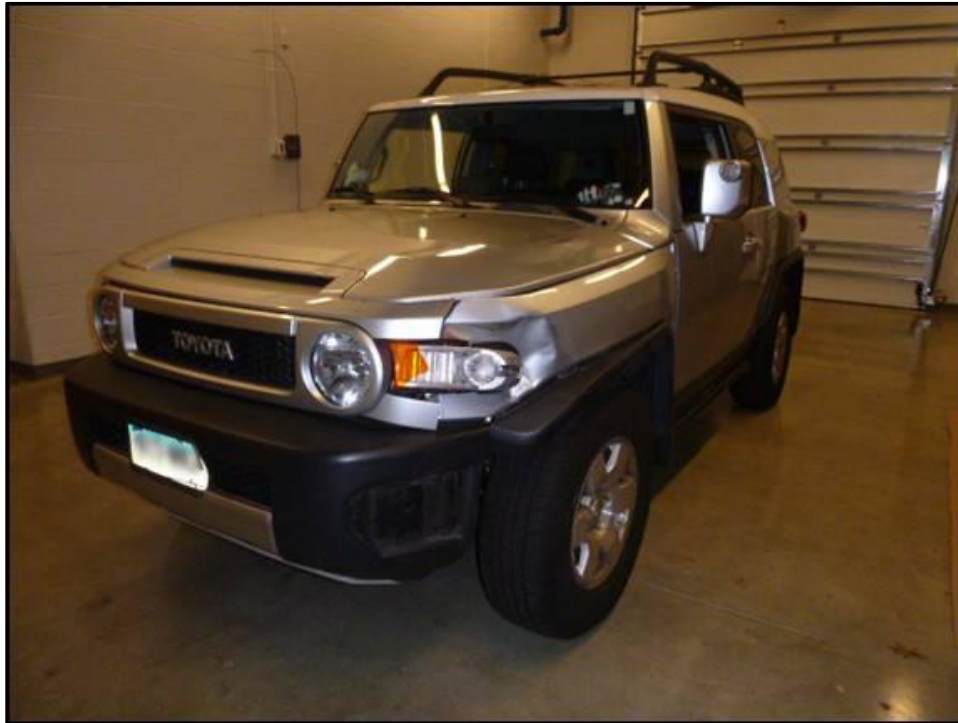
The crash vehicle was a 2007 Toyota FJ Cruiser SUV. The driver reported that the vehicle was in working order before the crash. Damage to the SUV postcrash included material transfer on the left front fender and front bumper and hood. The left front fender was displaced and dented, and the corner pad of the left front bumper was torn off (figure 3). The left side of the hood was also dented.

Figure 3. Front view of crash SUV showing damage to left fender near turn signal assembly.

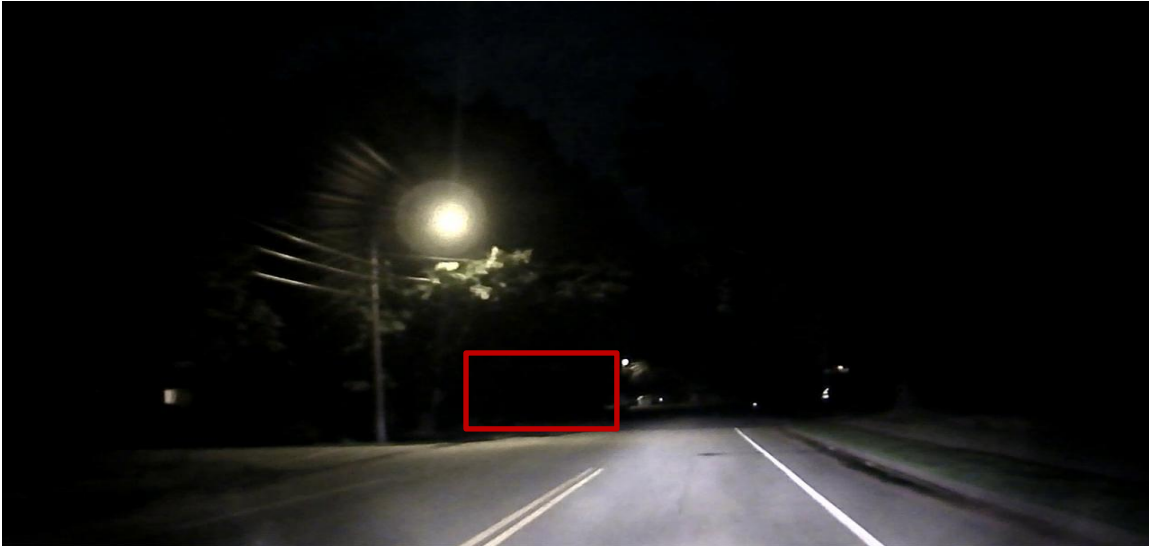
The Old Saybrook Police Department conducted a conspicuity test several hours after the collision (which occurred during twilight). A police vehicle equipped with a forward-facing camera traveled down Maple Avenue at two speeds, 30 mph and 35 mph. A pedestrian wearing a reflective vest stood on the shoulder at the east edge of Maple Avenue. In the test, the pedestrian was not visible to the driver (figure 4) until perpendicular to the outer left edge of the police vehicle's headlight beam.

Figure 4. Snapshot from video taken during police conspicuity test. Pedestrian wearing reflective vest was standing in area outlined by red rectangle.

NTSB investigators examined the crash scene on a later date, at the approximate time of the collision and in approximately the same lighting conditions. The investigators observed that visibility in the area was poor, particularly at the side and shoulder of the roadway, but that a pedestrian walking in the travel lane would have been illuminated by the nearby streetlight.
