National Transportation Safety Board

Highway Accident Brief

Fatal Pedestrian Collision with Car Washington, DC, August 18, 2016

Accident Number:	HWY16SH023
Accident Type:	Fatal pedestrian collision with car
Location:	9th Street and P Street NW, Washington, DC
Date and Time:	August 18, 2016, about 2:20 a.m. eastern daylight time
Vehicle:	2000 Mercedes-Benz CLK 320
Driver:	31-year-old female
Pedestrian:	44-year-old male
Fatalities:	1

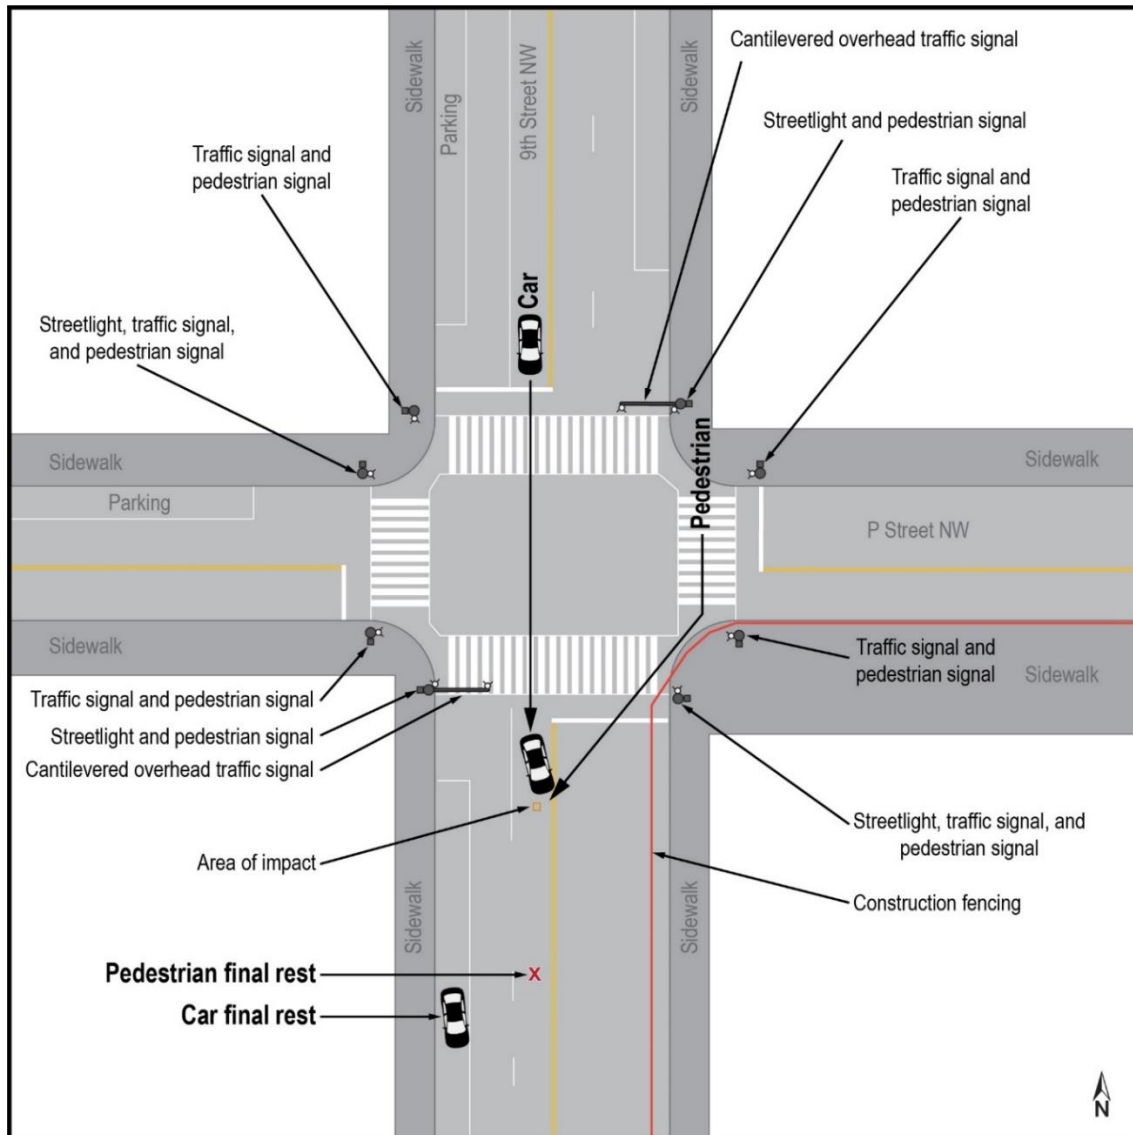
Figure 1. Diagram of crash scene showing path of vehicle, path of pedestrian, location of traffic control signals and construction fencing on sidewalk and street, location where pedestrian collided with car, and pedestrian's and car's final rest positions.

On Thursday, August 18, 2016, about 2:20 a.m., a 2000 Mercedes-Benz CLK 320 coupe was traveling south on 9th Street NW in Washington, DC. As the 31-year-old driver approached the intersection of 9th and P streets, the traffic signal for southbound vehicular traffic was green. A 44-year-old male, walking with a female companion, attempted to cross 9th Street from the southeast corner of the intersection (figure 1). Neither pedestrian was in the crosswalk.

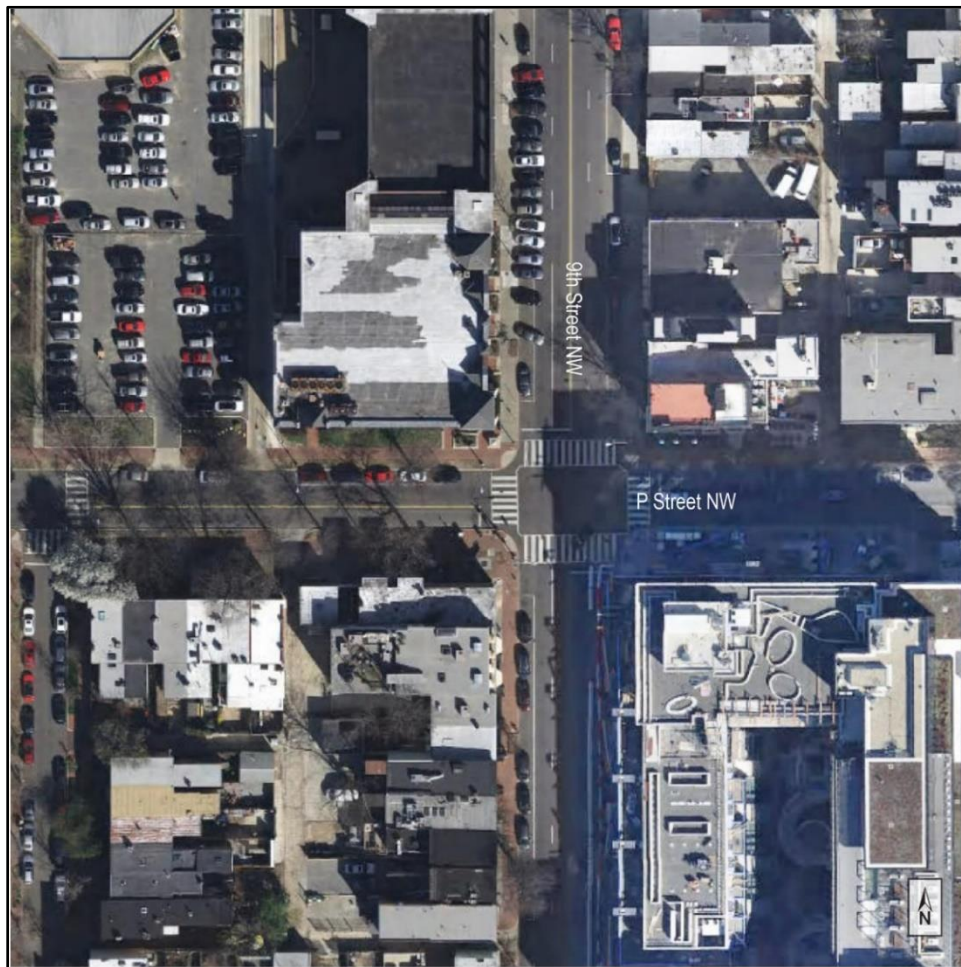
Figure 2. Aerial view of crash location showing crosswalks at intersection and building under construction on southeast corner. (Base photo from District of Columbia geographic information system)

The area around the intersection is both commercial and residential (figure 2). At the time of the crash, a large multistory building was under construction on the southeast corner of the

intersection, and fencing blocked the sidewalk and the parking lane on the east side of 9th Street. The other sidewalks around the intersection were unobstructed.

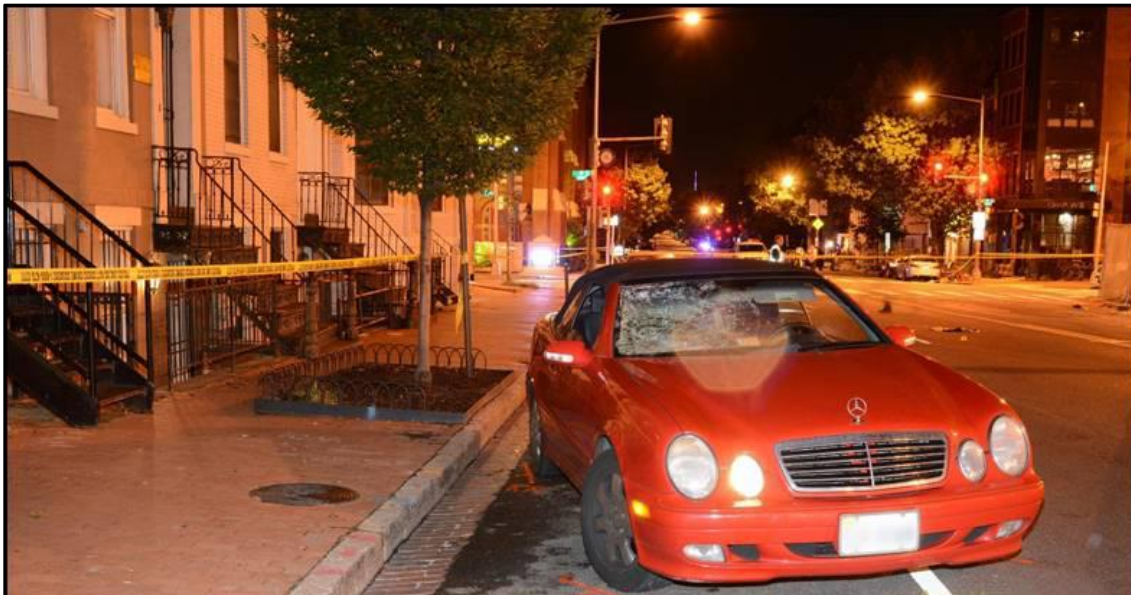
Figure 3. Crash car parked on 9th Street NW after collision. Note damage to windshield. (Source: Metropolitan Police Department, District of Columbia)

The car's left front head lamp was out and had been out before the crash. Damage to the vehicle included scratch marks on the right front bumper and right side of the hood and a smashed right windshield (figure 3). No mechanical defects were discovered after the crash.
