Highway Accident Brief

Fatal Pedestrian Collision with Minivan Thief River Falls, Minnesota, October 6, 2016

Accident Number:	HWY17SH002
Accident Type:	Fatal pedestrian collision with minivan
Location:	State Highway 59, Thief River Falls, Minnesota
Date and Time:	October 6, 2016, about 7:00 a.m. central daylight time
Vehicle:	2005 Chrysler Town and Country
Driver:	69-year-old female
Pedestrian:	7-year-old male
Fatalities:	1

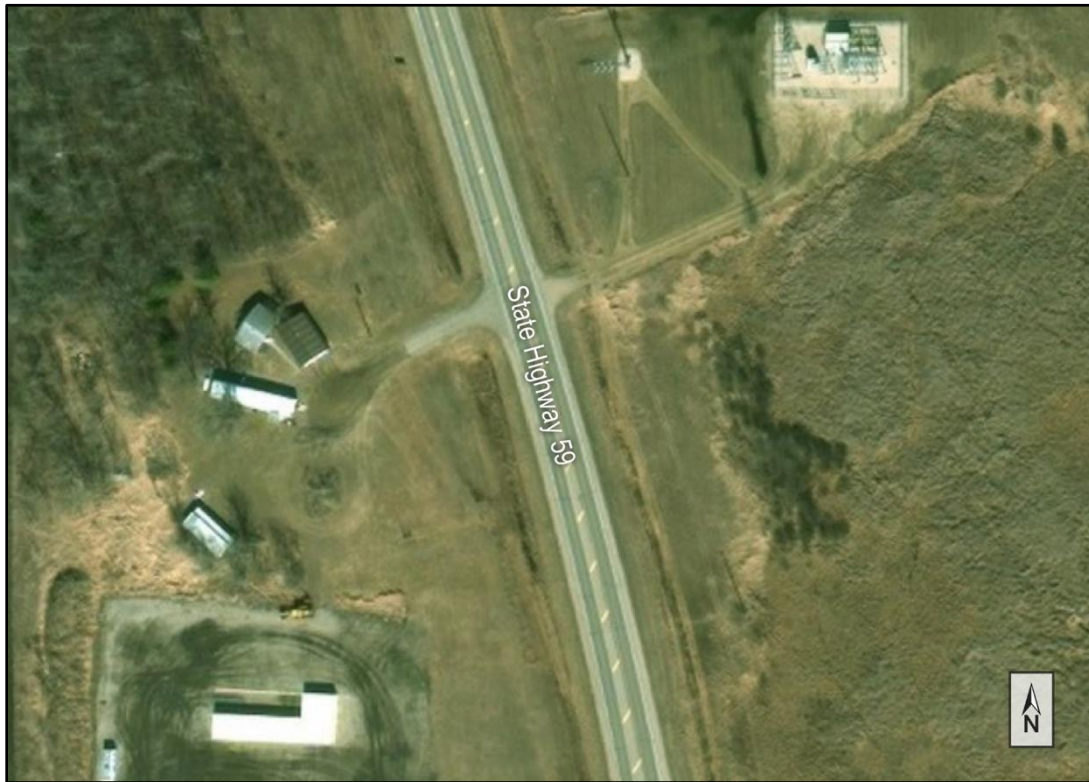
The crash occurred in a rural area, where fields and farms dominate the landscape (figure 2). State Highway 59 is a north/south, two-lane asphalt road that runs northwest to southeast in the area of the crash. The highway has a single lane in each direction, with a double yellow line separating the lanes and a white line separating the northbound lane from the shoulder. The area has no crosswalks, pedestrian control signals, or overhead street lights. Ambient lighting is limited to one lamppost on private property (where the pedestrian lived) across the street from the school bus pickup site. Investigators could not determine whether the light was on at the time of the crash.³ The posted speed limit is 60 mph.

Figure 2. Aerial view of crash location. Pedestrian was waiting with siblings on east side of highway, across road from driveway to his house, shown on left. (Base photo by DigitalGlobe)

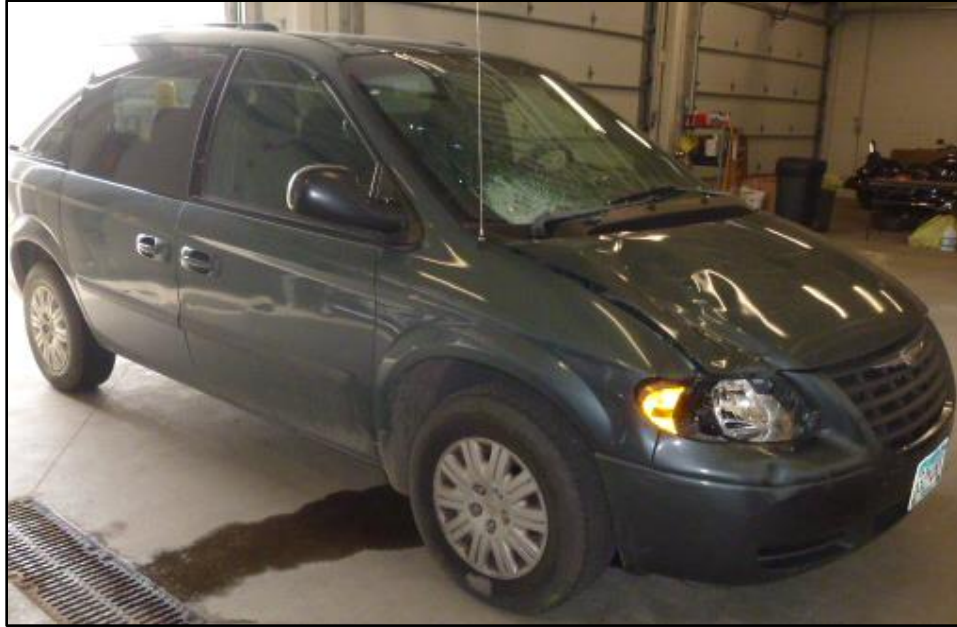
The crash vehicle was a 2005 Chrysler Town and Country minivan. The driver reported that the minivan was in working order before the crash. Damage to the minivan included dents on the right front bumper, headlight assembly, and hood (figure 3). A swipe mark (disturbance of dust and dirt) on the hood went up toward the windshield. The windshield was cracked on the lower right side. No blood or skin was observed in the fragments of windshield glass.

Figure 3. Photograph of minivan showing damage to right bumper, headlight assembly, hood, and windshield.
