# NATIONAL TRANSPORTATION SAFETY BOARD

## Electronic Devices

Specialist's Factual Report  
by Bill Tuccio, Ph.D.

Location: Dunnellon, Florida  
Date: April 5, 2014  
Aircraft: Fortuna Sonex  
Registration: N229P  
Operator: Private  
NTSB Number: ERA14FA464

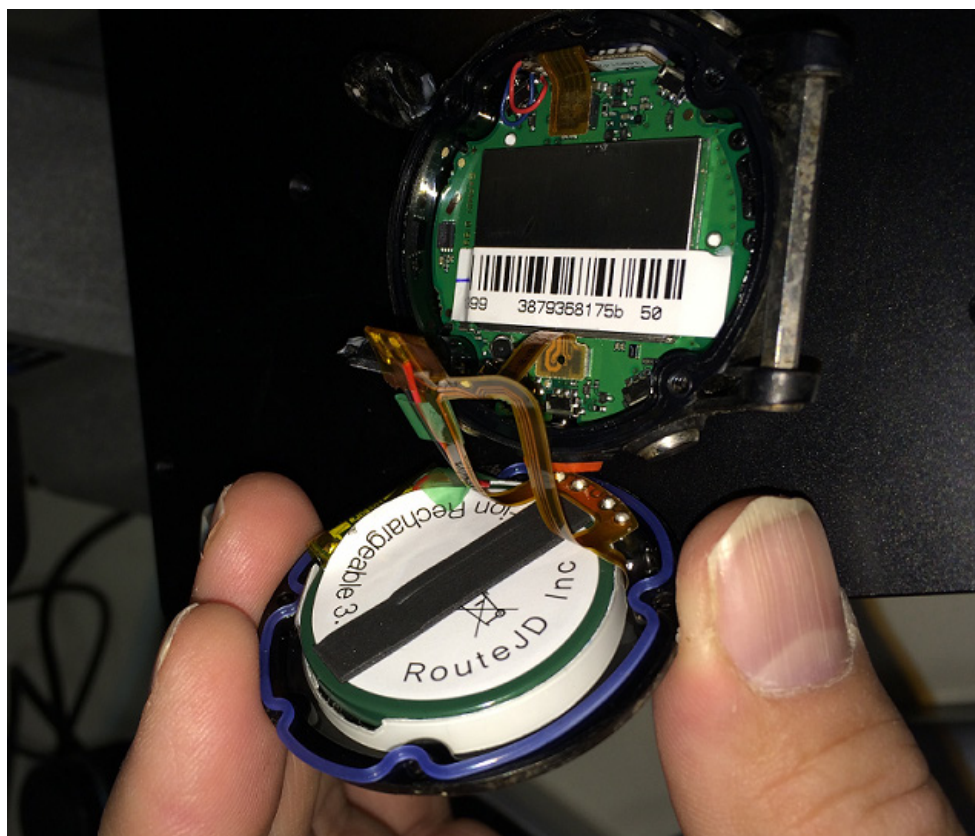
**Figure 2. Garmin D2 watch, internal inspection.**

Upon arrival at the NTSB Vehicle Recorder Division, an exterior examination revealed the unit had sustained minor damage and prolonged outdoor exposure, as shown in figure 1. An internal inspection revealed the unit was intact, as shown in figure 2. Using the device's proprietary cable, information was extracted normally using the manufacturer's software.

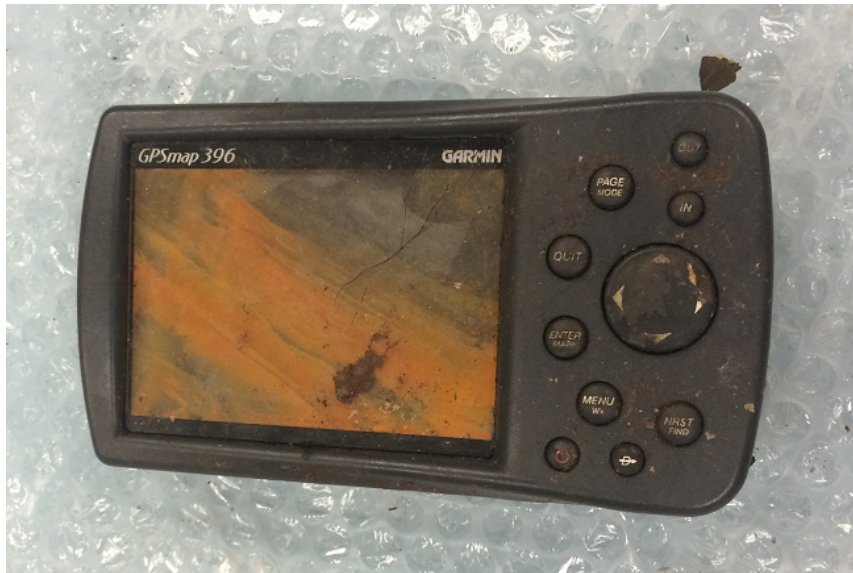
Figure 6. Garmin GPSMAP 396 as received.

Upon arrival at the NTSB Vehicle Recorder Division, an exterior examination revealed the unit had sustained minor impact damage and significant damage from outdoor exposure, as shown in figure 6. The unit was disassembled, all parts were rinsed with deionized water, excess water was driven off and parts de-greased using Acetone, and the unit further degreased and cleaned using Methonal. All parts and connections were then electro-washed with Cirozane spray using an acid brush. Figure 7 shows the parts after cleaning. After this treatment, the parts were dried and vacuum-baked for 12 hours at 50° C and 15 inHg. The unit was then reassembled and power applied. Although the screen did not display information, when a USB cable was connected from a PC to the unit the data were downloaded normally.

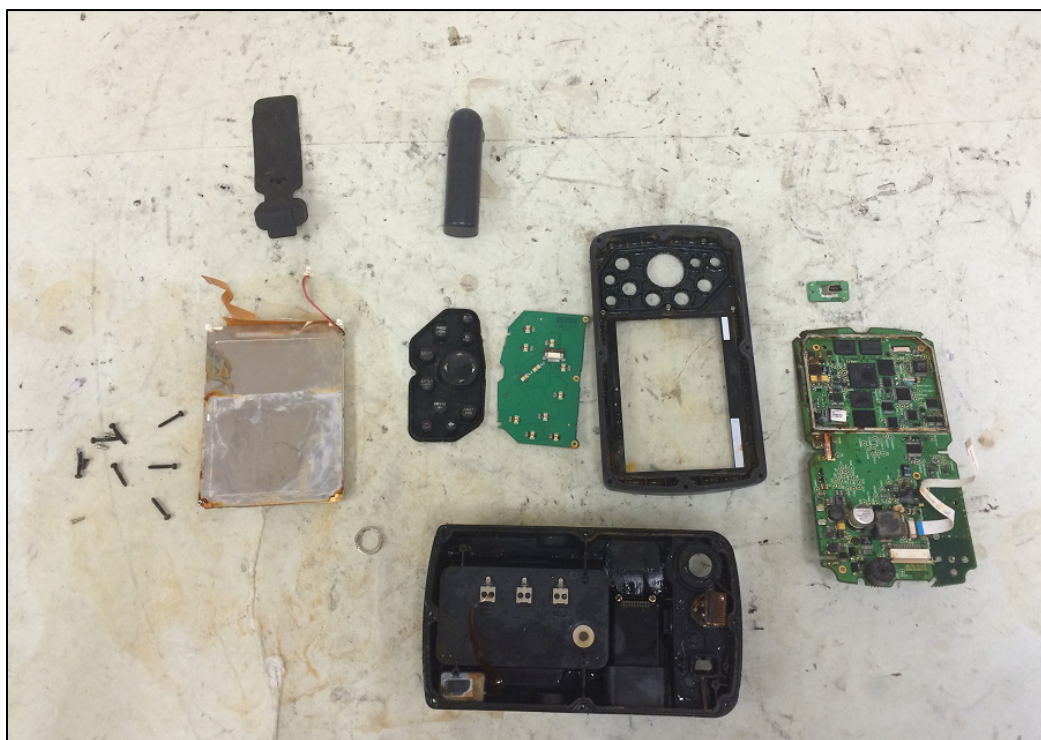
**Figure 7. Garmin GPSMAP 396 disassembled.**

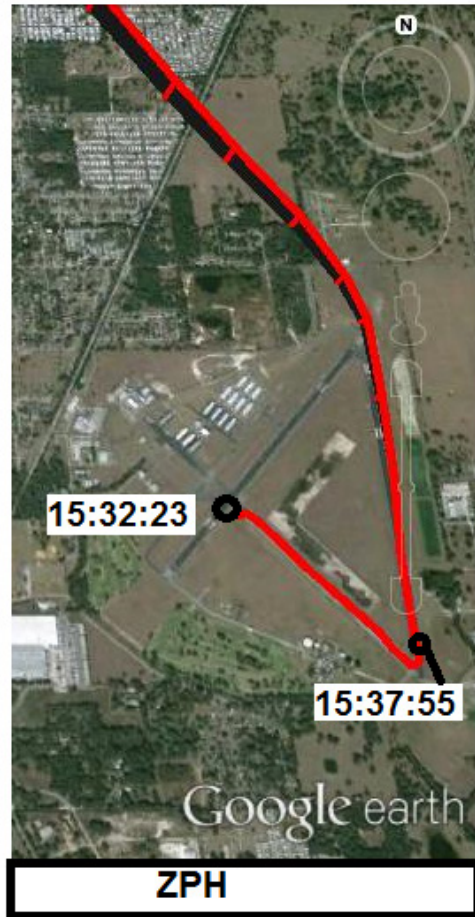
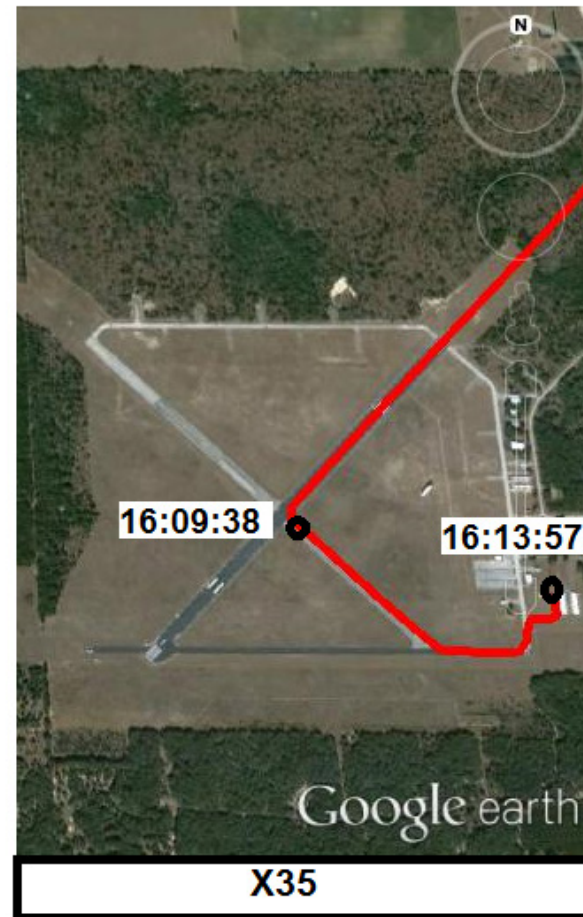
Figure 9. Prior flight, departure and arrival airport detail.

Figure 8 shows the prior flight on April 5, 2014, from Zephyrhills, Florida (ZPH) to X35. The recording began at 15:32:23 UTC and ended at 16:13:57 UTC (41 minutes, 34 seconds duration). Figure 9 shows data points at ZPH and X35; the aircraft departed at about 15:37:55 UTC and landed at about 16:09:38, a duration of 31 minutes, 43 seconds.

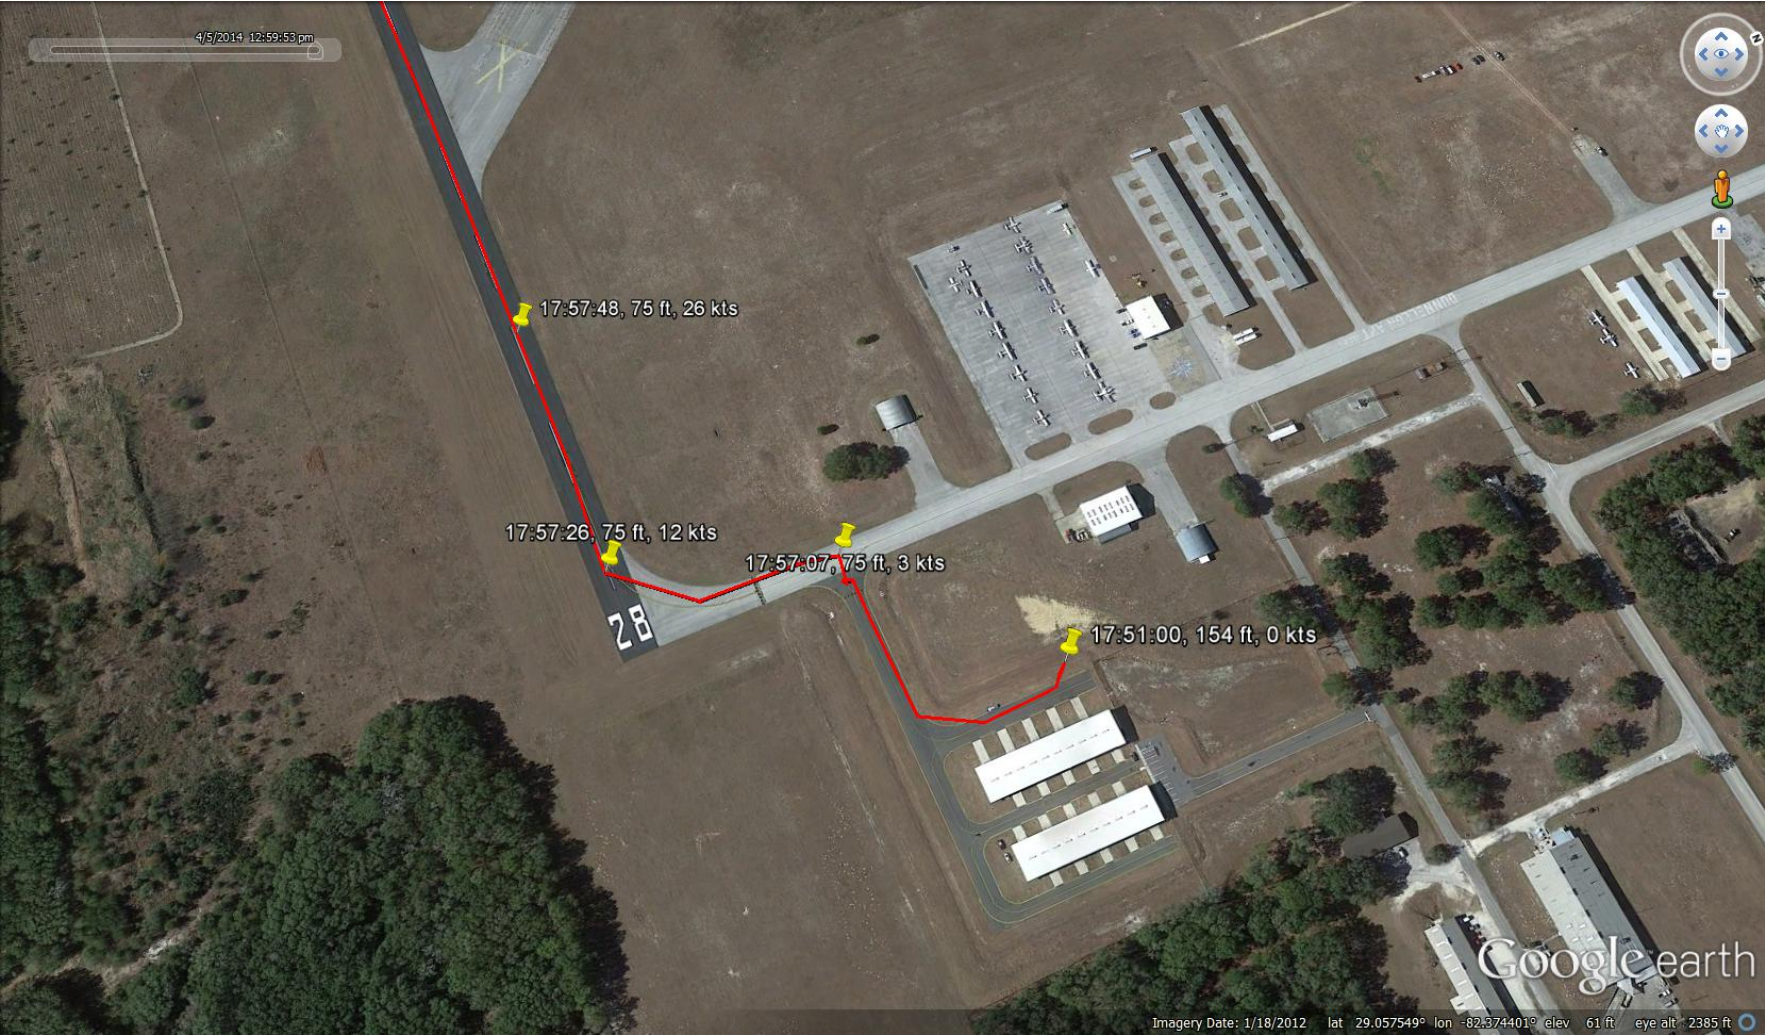
Figure 11. Accident flight, X35 start of recording, as recorded by Garmin 396.

Figure 11 shows the start of the accident recording at X35. The recording began at 17:51:00 UTC, the aircraft reached the taxiway by 17:57:07 UTC, and began the takeoff roll at 17:57:26 UTC.

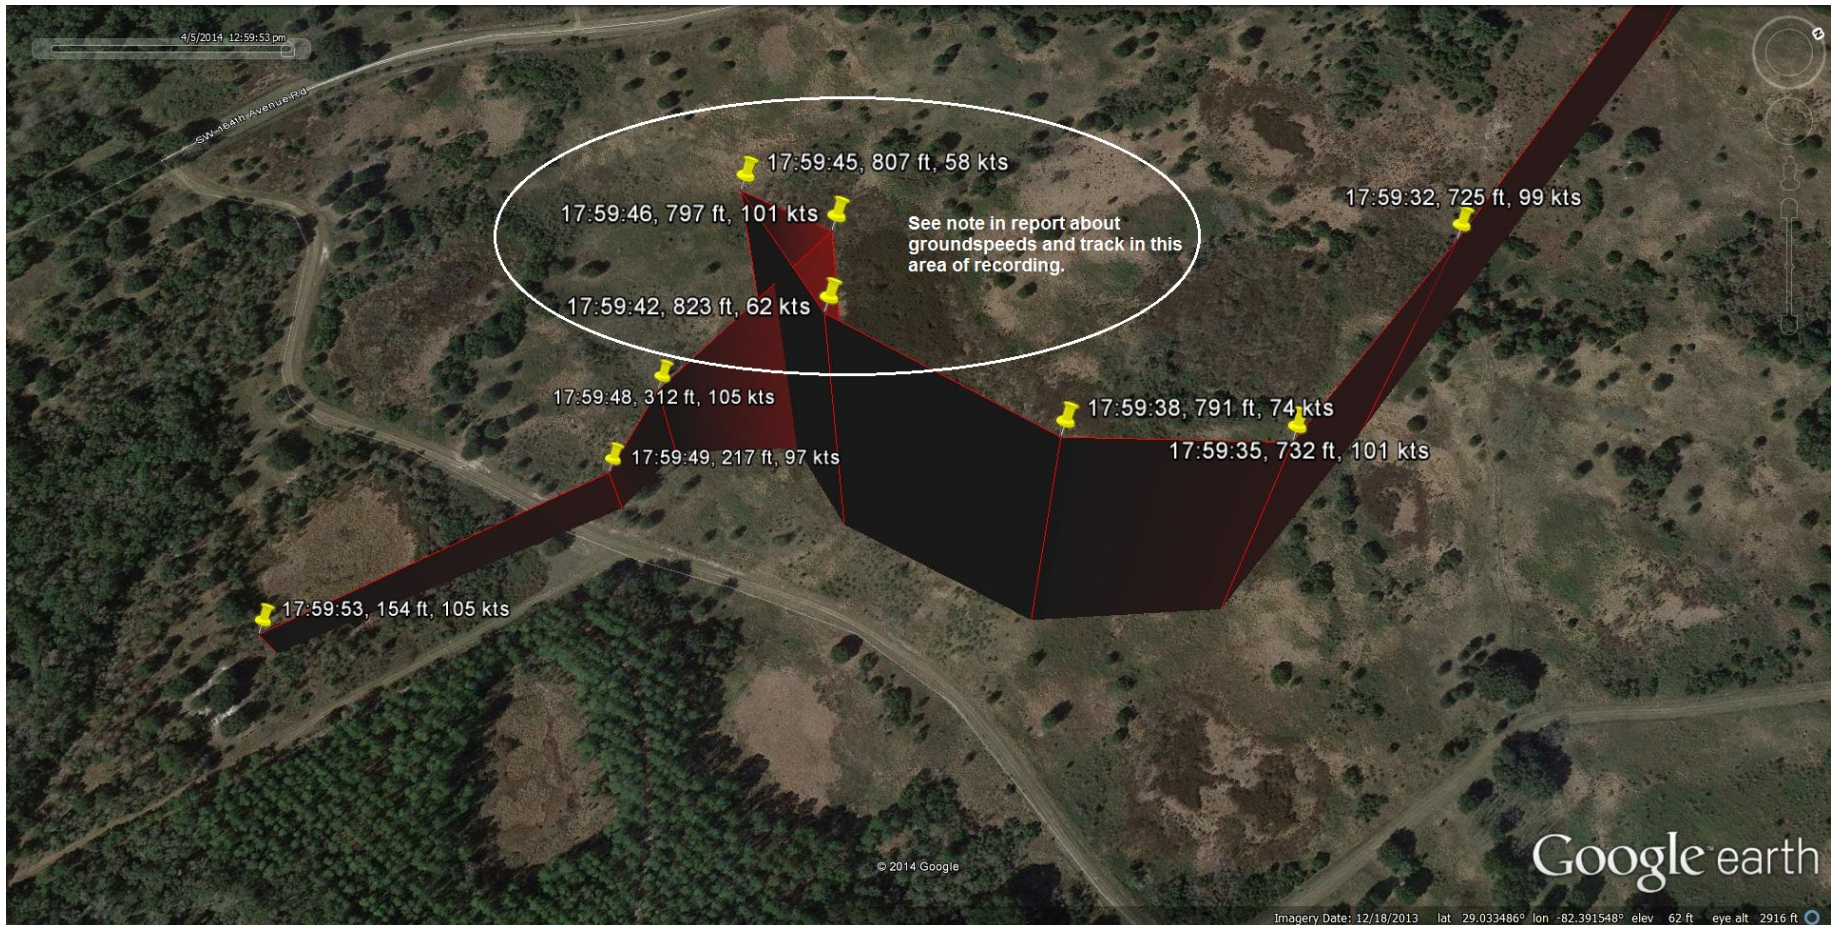
Figure 12. Accident flight, end of recording, as recorded by Garmin 396.

Figure 12 shows the end of the accident recording. At about 17:59:35 UTC, at an altitude of 732 feet MSL and a groundspeed of 101 knots, the aircraft track began to turn to the right about 90 degrees. Between 17:59:42 UTC and 17:59:48 UTC, the aircraft track changed from west towards the south, and the altitude decreased from about 800 feet to 312 feet MSL<sup>6</sup>. The aircraft continued to lose altitude and the last recorded point was 17:59:53 UTC.
