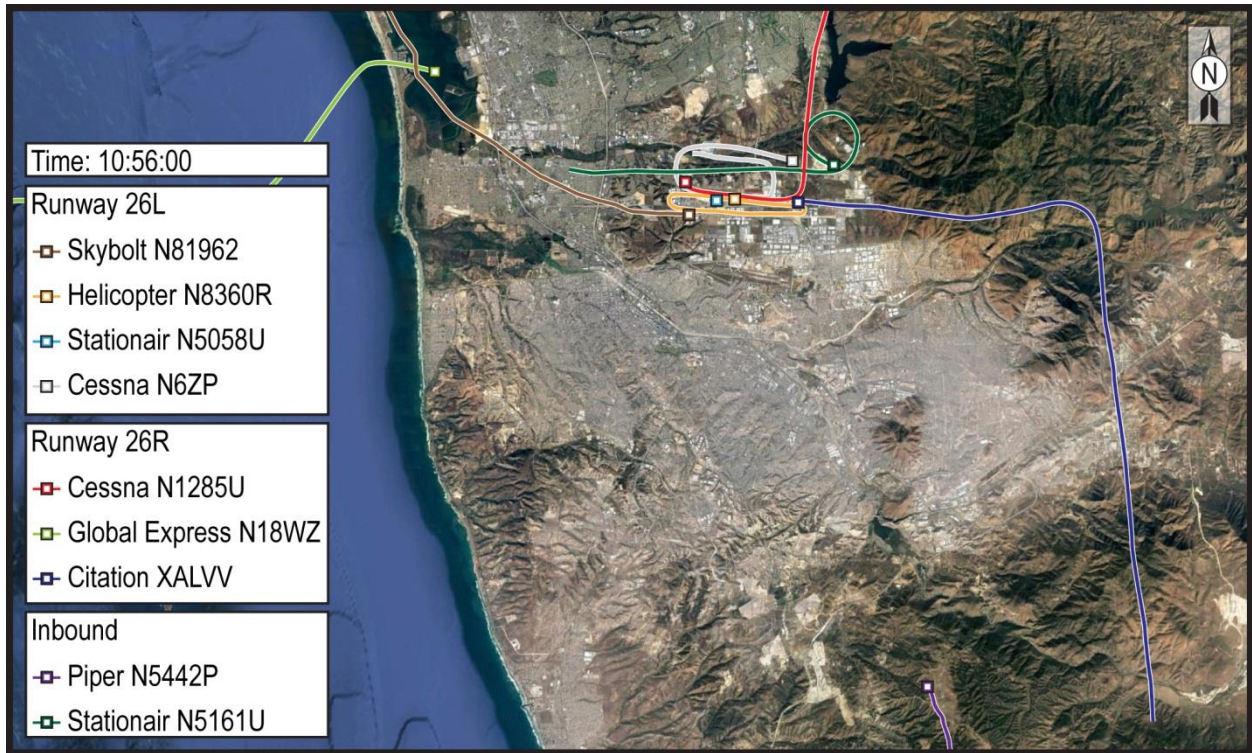
Figure 1. Aircraft in the SDM traffic pattern about 8 minutes before the accident.

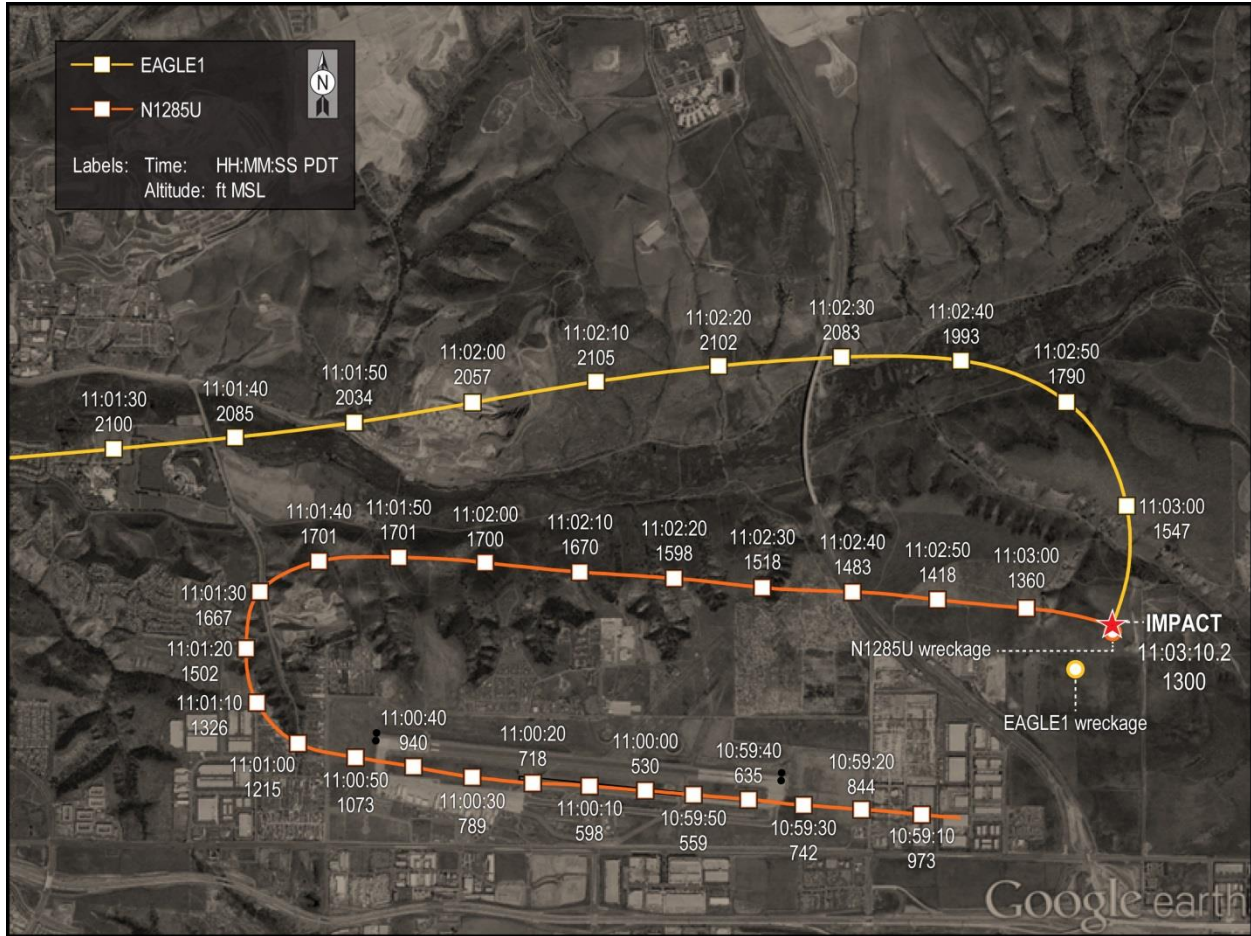
Figure 3. Calculated flight tracks of Eagle1 and N1285U.

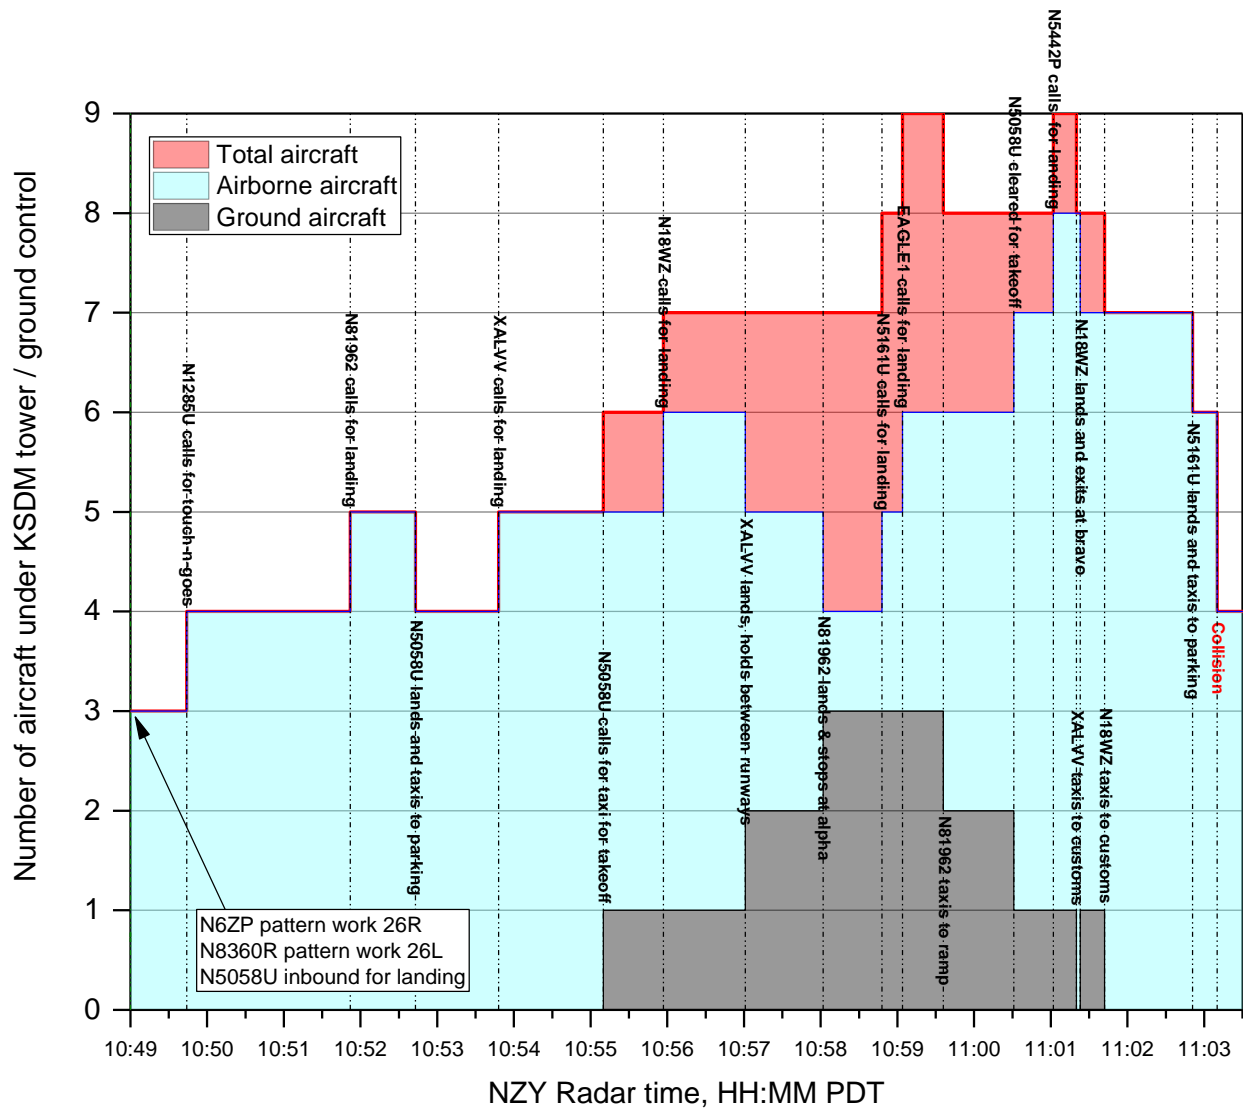
Figure 4. Total aircraft under SDM ATCT control from 1049 until the time of the collision.

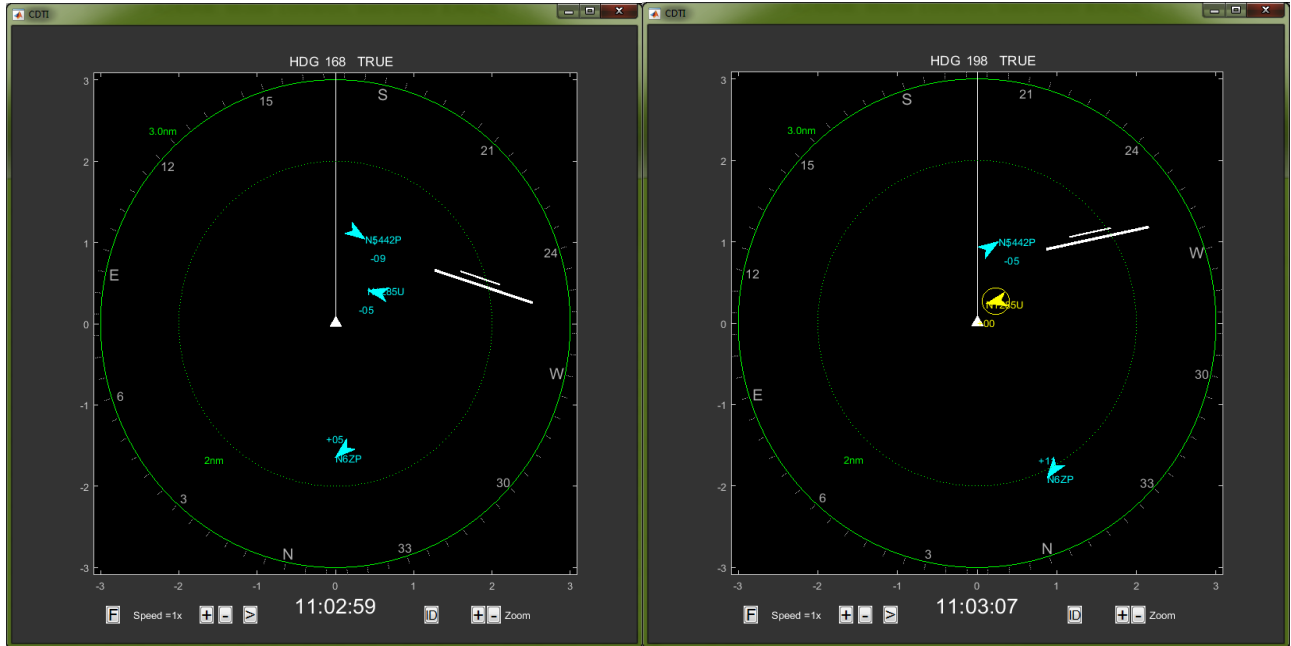
Figure 13. Simulated in-cockpit traffic display for Eagle1 at 1102:59 (left) and 1103:07 (right).
