NATIONAL TRANSPORTATION SAFETY BOARD

Personal Electronic Device Factual Report

**Specialist's Factual Report
by George Haralampopoulos**

Location:	Waterford, Michigan
Date:	January 10, 2014
Aircraft:	Cessna 310R
Registration:	N3829G
Operator:	Royal Air Freight, Inc
NTSB Number:	CEN14FA110

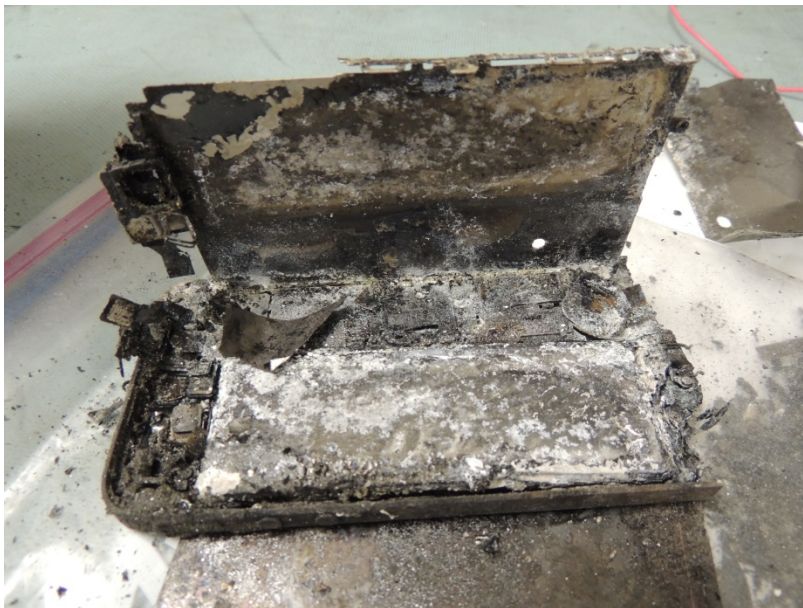
Upon arrival at the Vehicle Recorder Laboratory, an exterior examination revealed that the unit had sustained prolonged thermal exposure. An interior inspection revealed that the circuit board containing the unit's non-volatile memory sustained excessive thermal damage (figure 1) and the internal memory was not able to be recovered.

Figure 1. Apple iPhone 5, as received.
