NATIONAL TRANSPORTATION SAFETY BOARD

Cell Phone

Specialist's Factual Report
by **Bill Tuccio, Ph.D.**

Location: Aurora, Colorado
Date: March 19, 2014
Aircraft: Smith Aerostar 6011P
Registration: N90464
Operator: Private
NTSB Number: CEN14FA163

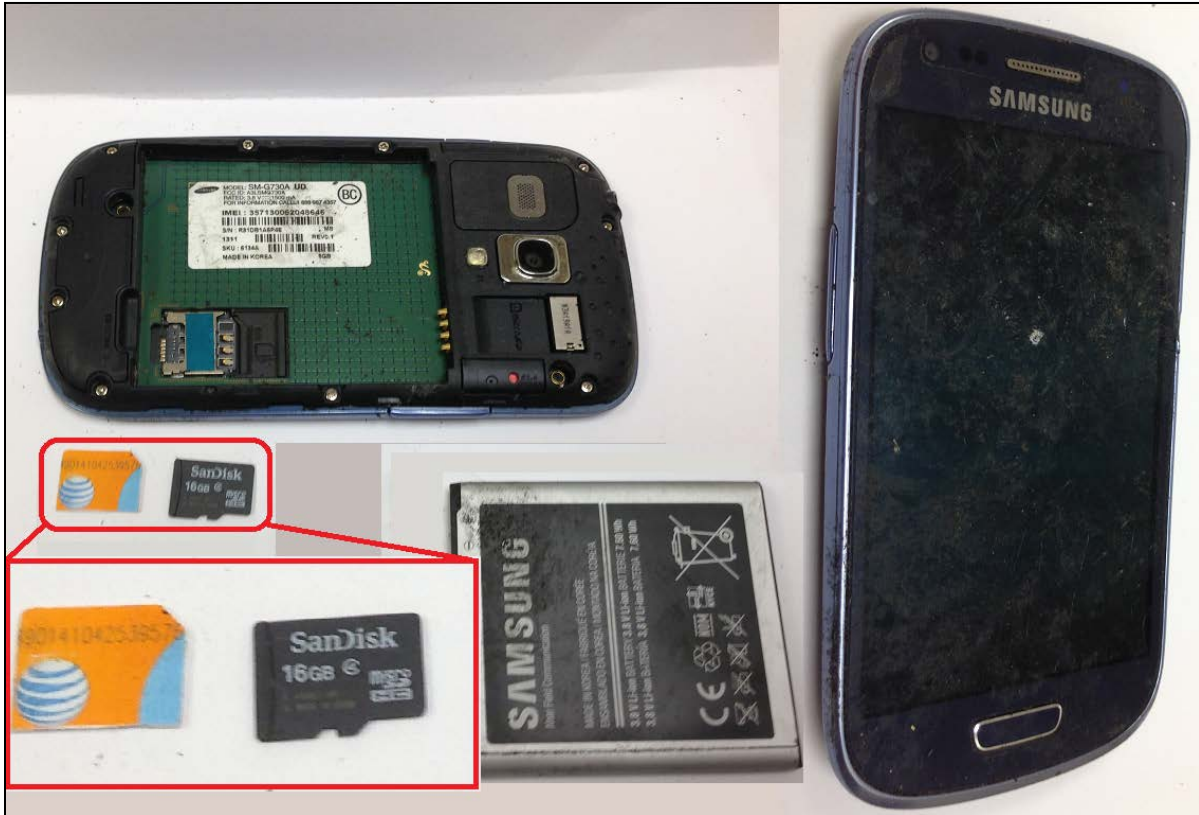
Figure 1. Samsung Galaxy S III Mini.

Upon arrival at the Vehicle Recorder Laboratory, an exterior examination revealed that the unit had sustained minor impact damage, including damage to the touch screen, as shown in figure 1. An internal inspection revealed no internal device damage and an undamaged 16GB microSD storage card. The phone was repaired and the contents of the phone and the microSD storage card were examined.
