NATIONAL TRANSPORTATION SAFETY BOARD
Vehicle Recorder Division
Washington, D.C. 20594

17 – Non-Volatile Memory Device Factual Report

A. EVENT

Location: Nashville, PA
Date/Time: December 22, 2011 / 1735 Eastern Standard Time (EST)¹
Aircraft Type/ID: Cessna 441 / N48BS
Operator: Private
NTSB Number: ERA12FA120

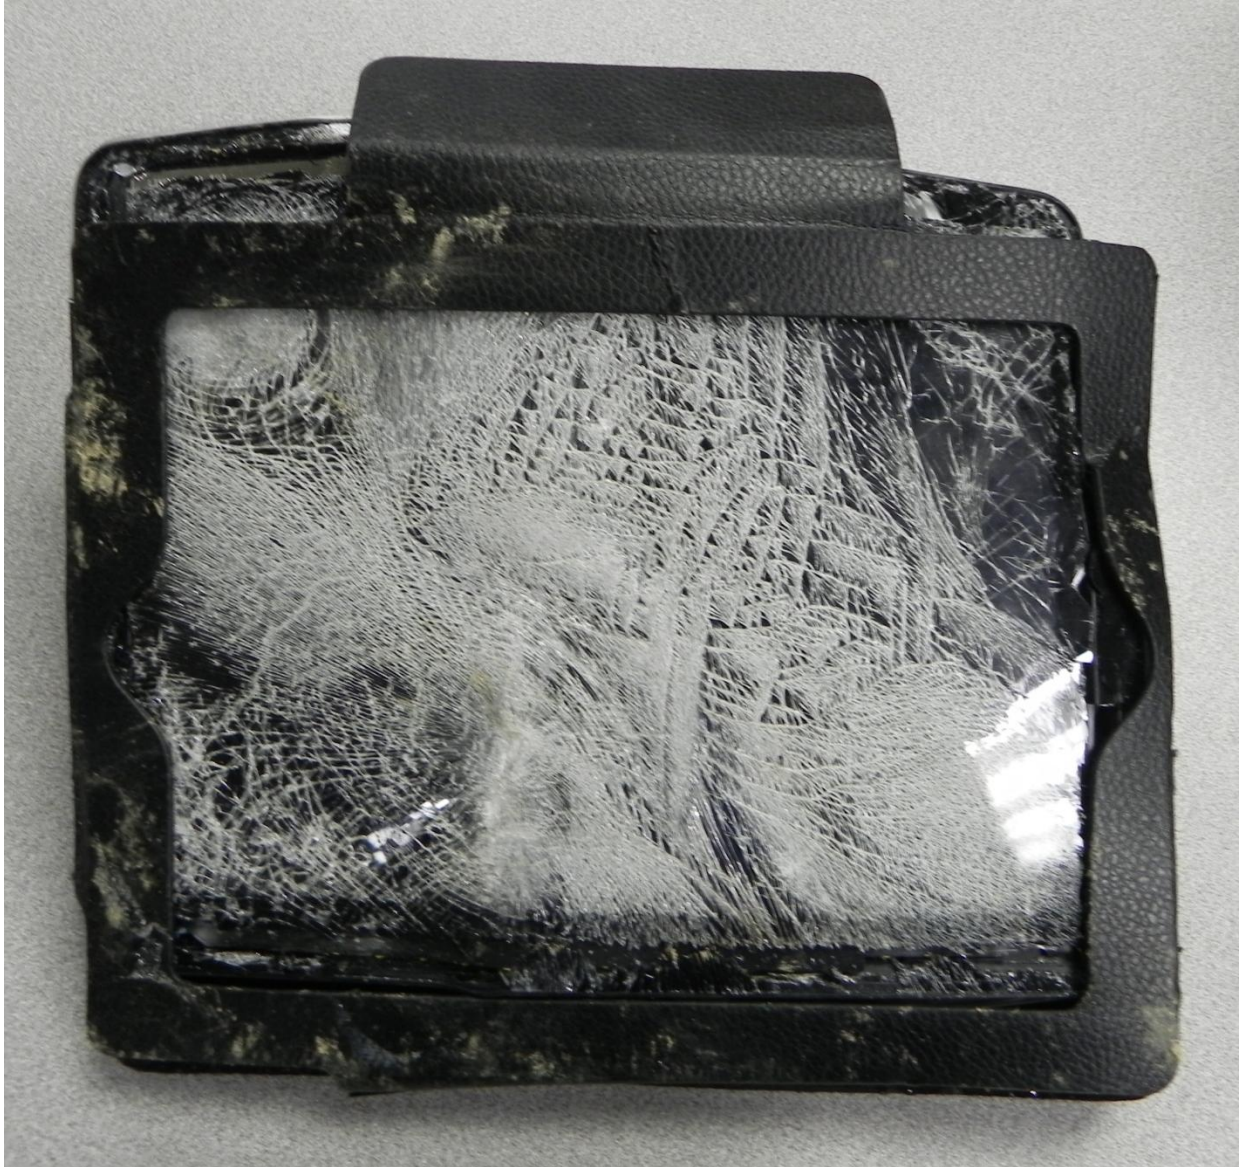
Figure 1. External front view of the Apple iPad (GB044RN6ETV) showing impact damage to the touchscreen.

Upon arrival at the Vehicle Recorder Laboratory, an exterior examination revealed that the unit had sustained significant impact damage (see figures 1 and 2). An internal inspection was performed and the internal processor and the main printed circuit boards (PCB) showed minor visual evidence of impact damage including spalling of the conformal coating over the electronic parts and integrated circuits. This conformal coating is applied to the board during manufacture, after parts placement, to protect the parts from moisture and environmental exposure. The main printed circuit board was evaluated using x-ray and microscopic analysis. This analysis indicated that the electronic bonds between the FLASH memory and microprocessor integrated circuits, and the main PCB, were likely to have been compromised due to impact damage and deformation.

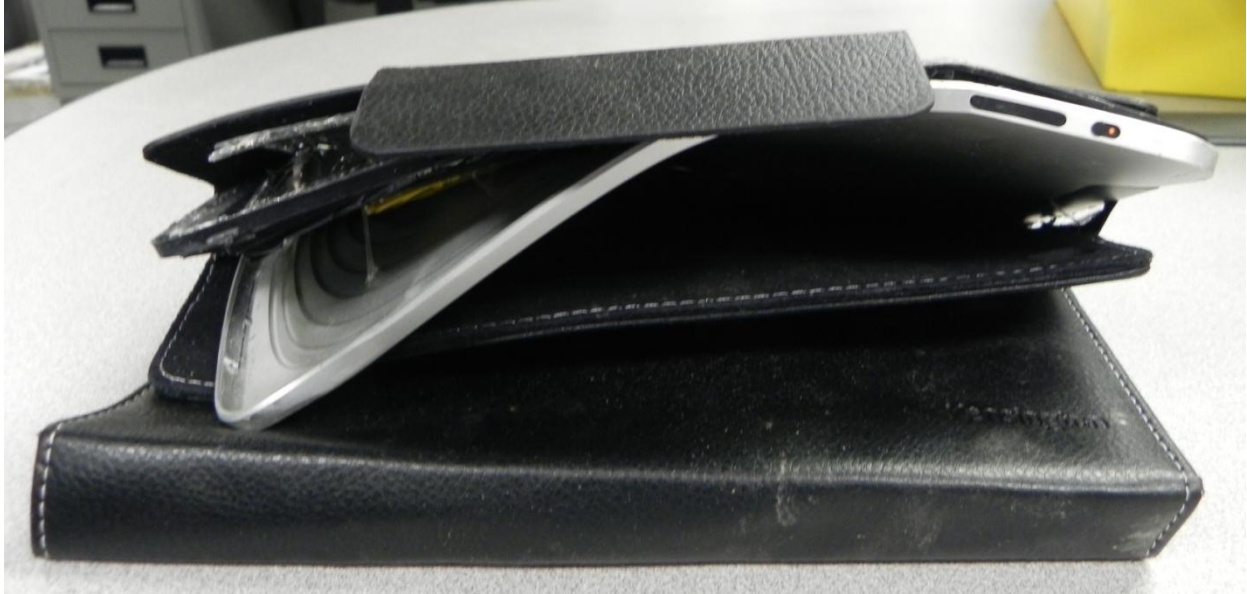
Figure 2. External side view of the Apple iPad (GB044RN6ETV) showing impact damage and severe deformation to the aluminum outer shell. The main printed circuit board (PCB) is located to the right in the image.
