**NATIONAL TRANSPORTATION SAFETY BOARD**  
Vehicle Recorder Division  
Washington, D.C. 20594

## 17 – Non-Volatile Memory Factual Report

Location:	Las Vegas, Nevada
Date/Time:	December 7, 2011 / 1630 Pacific Standard Time (PST) <sup>1</sup>
Aircraft Type/ID:	Eurocopter AS350-B2 / N37SH
Operator/Flight:	Sundance Helicopters / Landmark 57
NTSB Number:	DCA12MA020

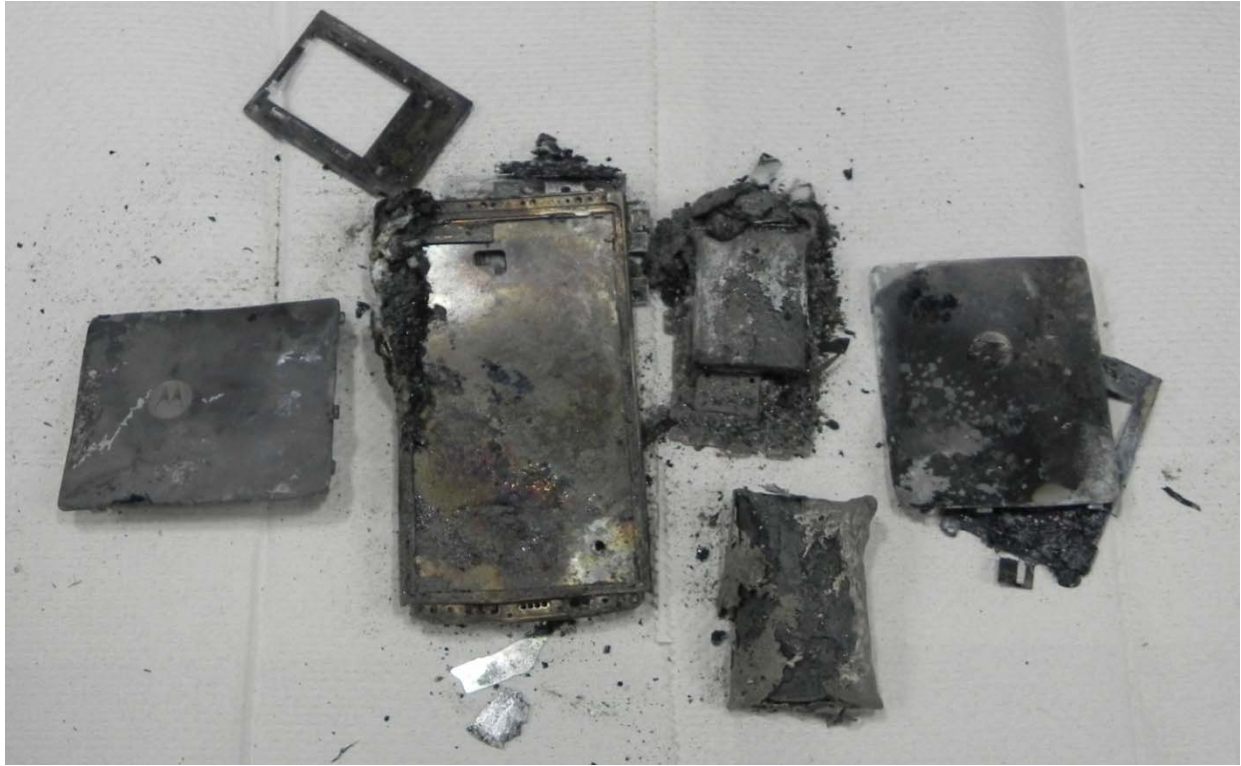
**Figure 1.** Remains of several smart-phone devices showing severe fire damage. One part shows traces of the Motorola logo.

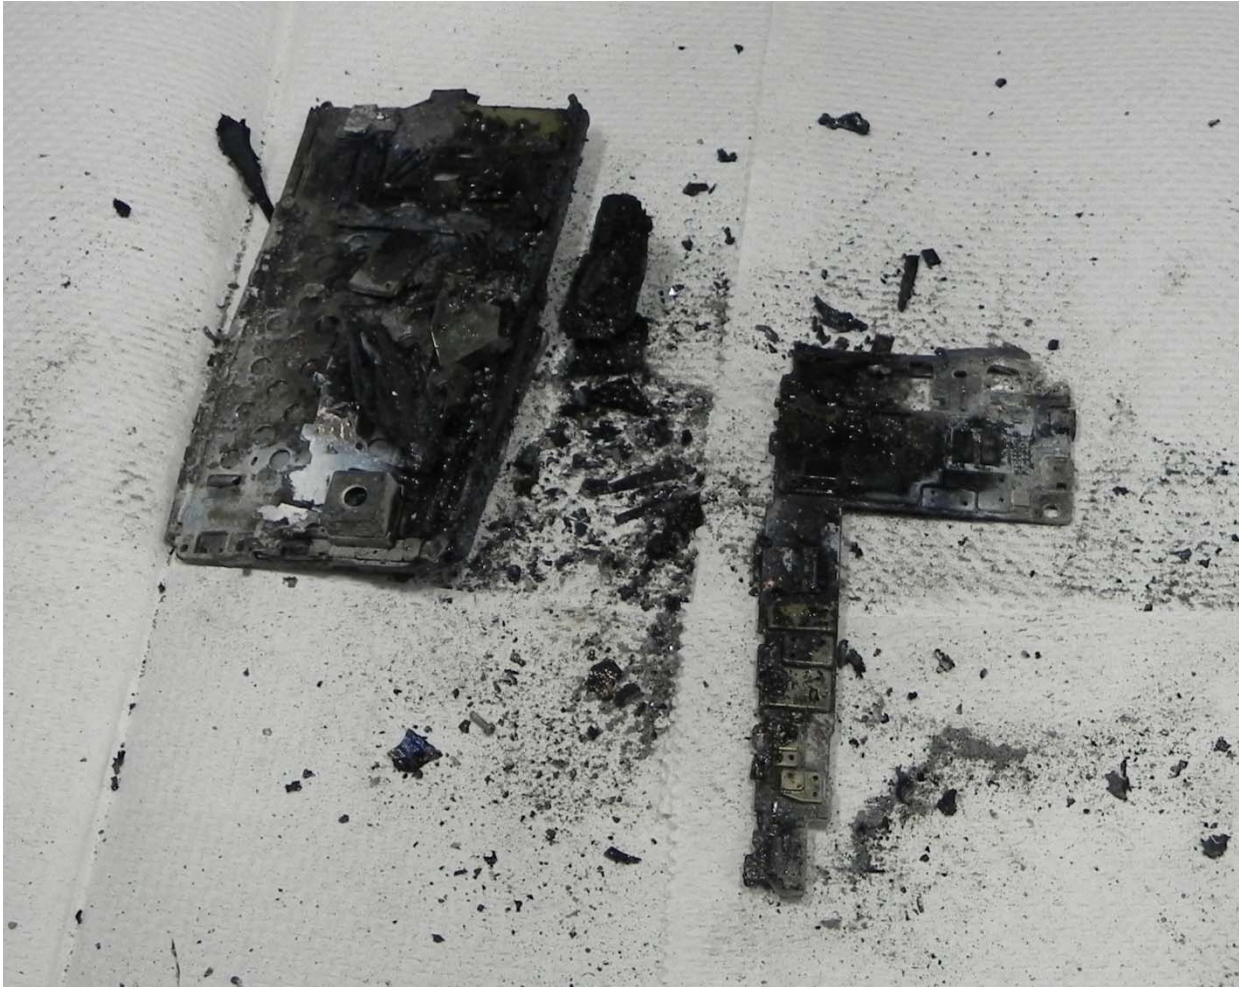
**Figure 2.** Remains of a smart-phone device showing severe fire damage.

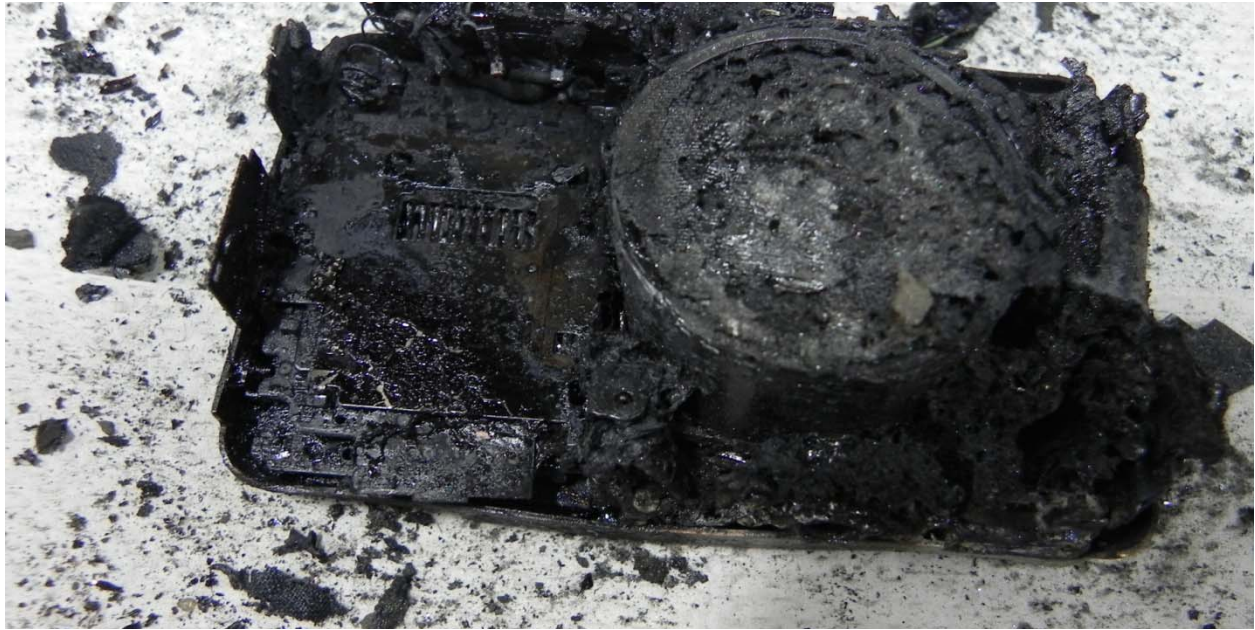
**Figure 3.** Remains of Sony Cybershot 10.1 mega-pixel digital camera showing severe fire damage.

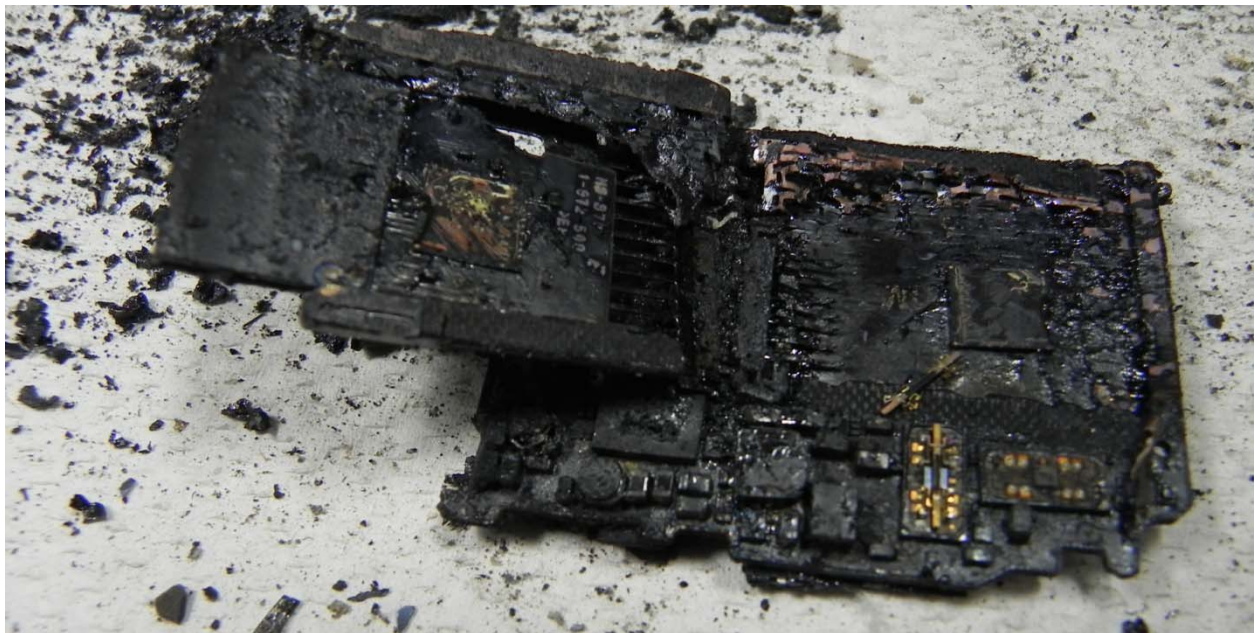
**Figure 4.** Internal remains of Sony Cybershot 10.1 mega-pixel digital camera showing severe fire damage.

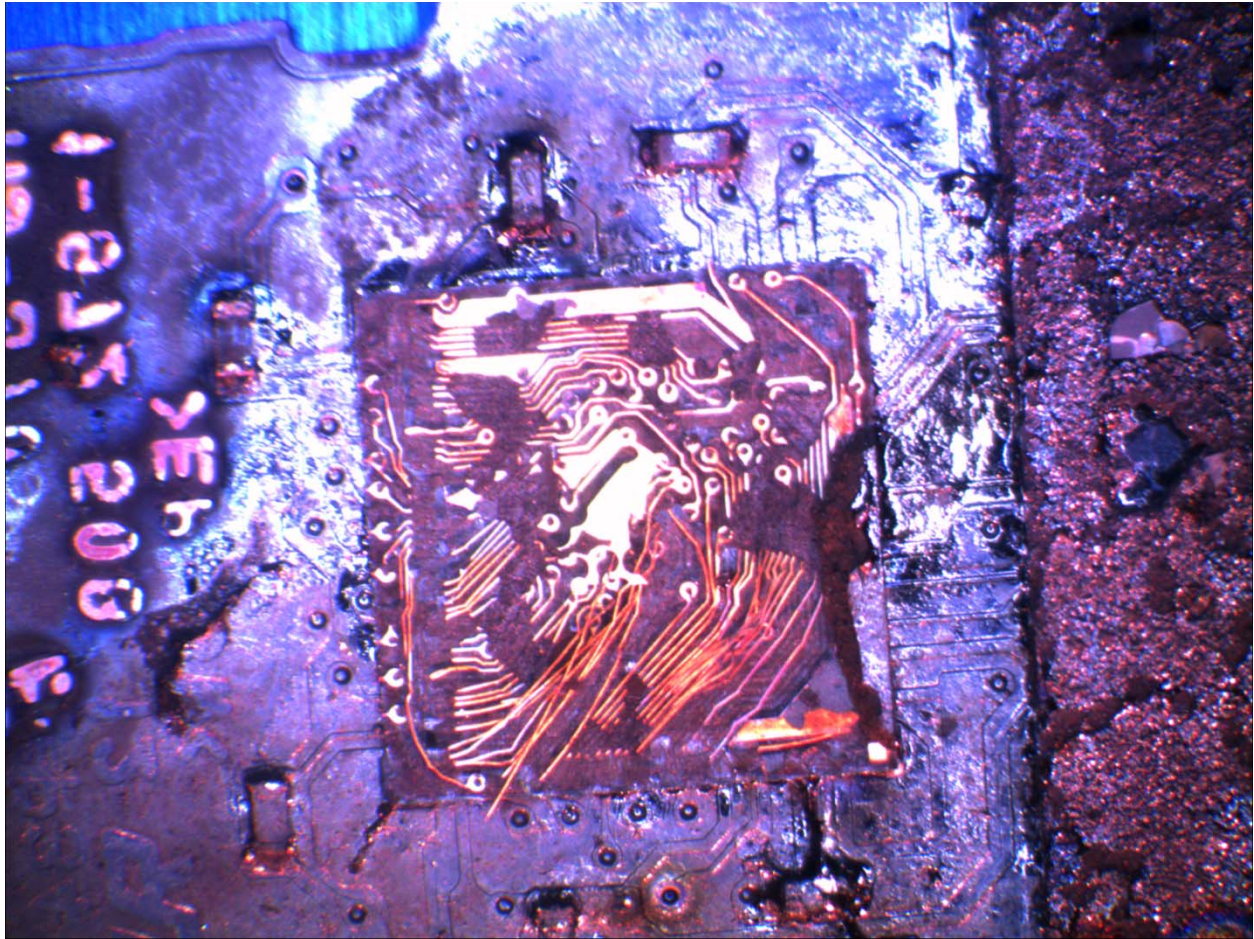
**Figure 5.** Internal view the of memory–stick controller integrated circuit from a Sony Cybershot 10.1 mega-pixel digital camera showing destruction due to fire.

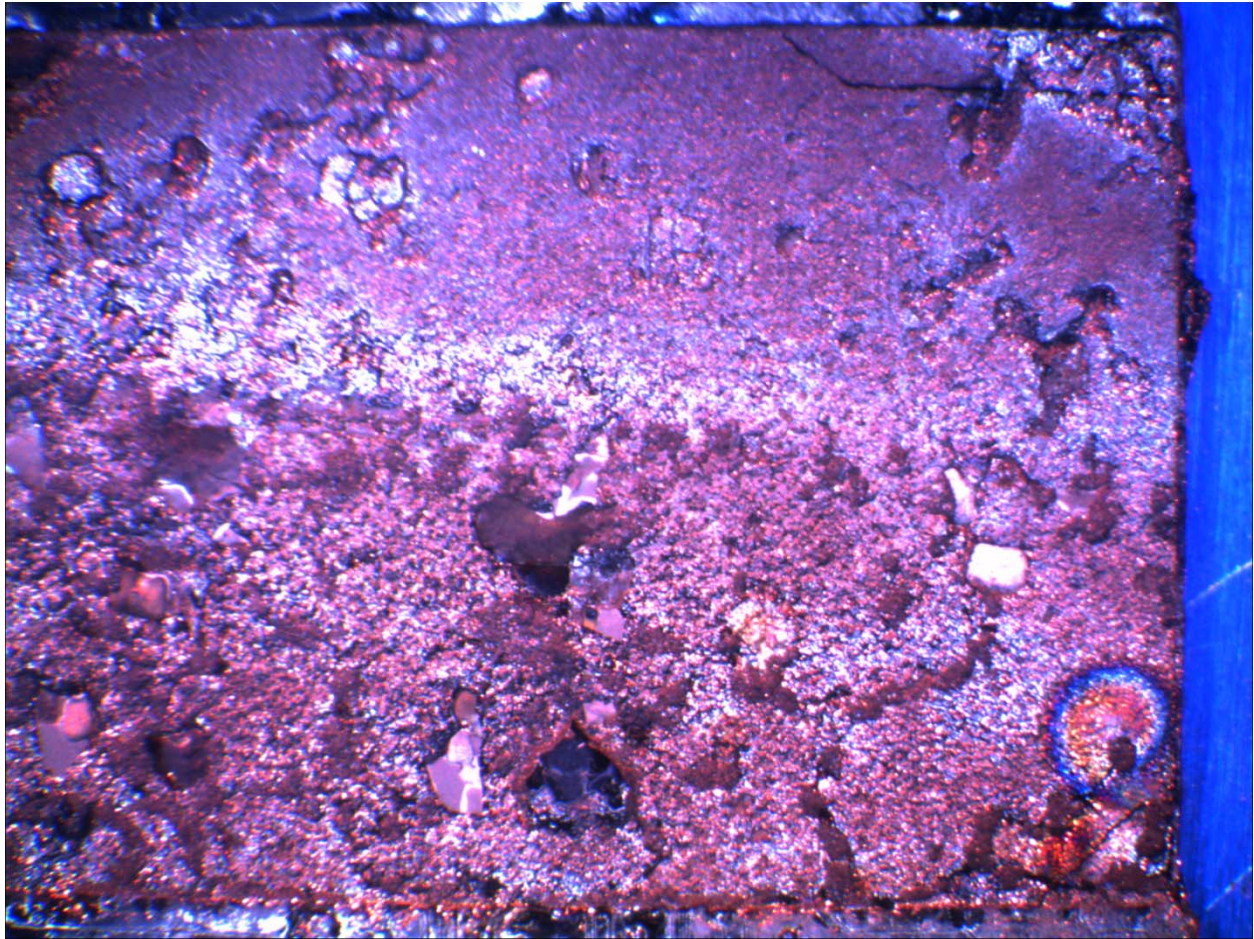
**Figure 6.** Internal view of memory–stick FLASH memory integrated circuit from a Sony Cybershot 10.1 mega-pixel digital camera, prior to de-lamination, showing destruction due to fire.
