#### NATIONAL TRANSPORTATION SAFETY BOARD

# **On-Board Image Recorder**

Specialist's Factual Report By Bill Tuccio, Ph.D.

NTSB Number: ERA14FA231

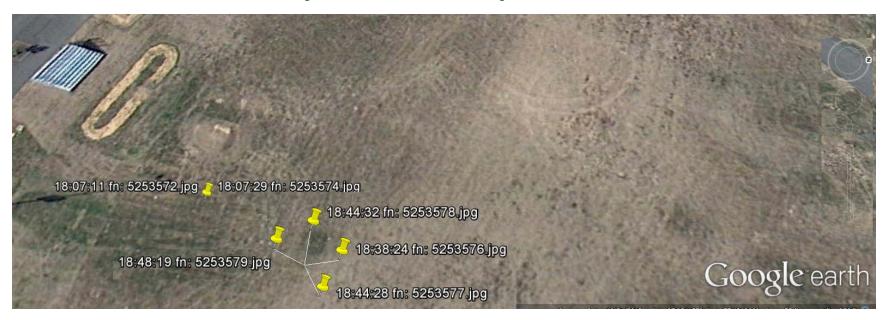
Figure 3. Points from 18:07:11 through 18:48:19 EDT.

Figure 2 is a Google Earth overlay of select points from table 1 plotted with latitude, longitude, and select metadata. Figures 3 through 11 show Google Earth overlays of all points from table 1. Note the weather and features shown in Google Earth are from satellite imagery at an earlier date and may not reflect the weather and features at the time of the accident. The point at 19:30:37 EDT (5253612.jpg) is likely an anomaly in the position determined by the iPhone.

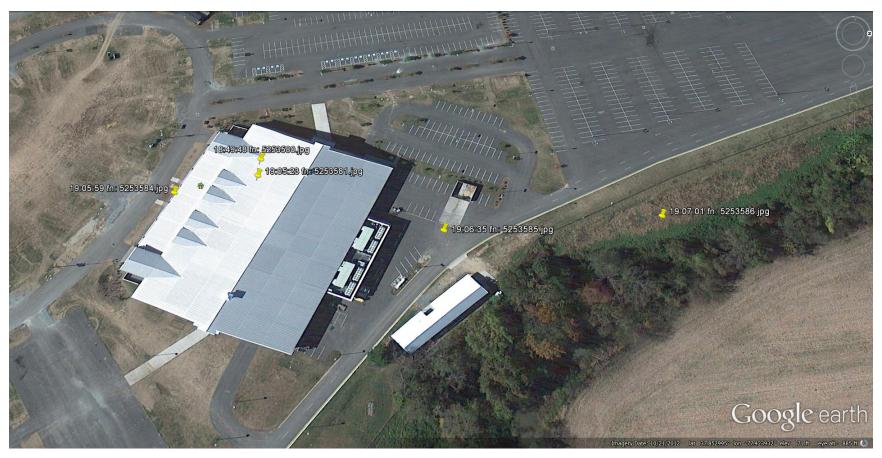
Figure 4. Points from 18:49:48 through 19:07:01 EDT.

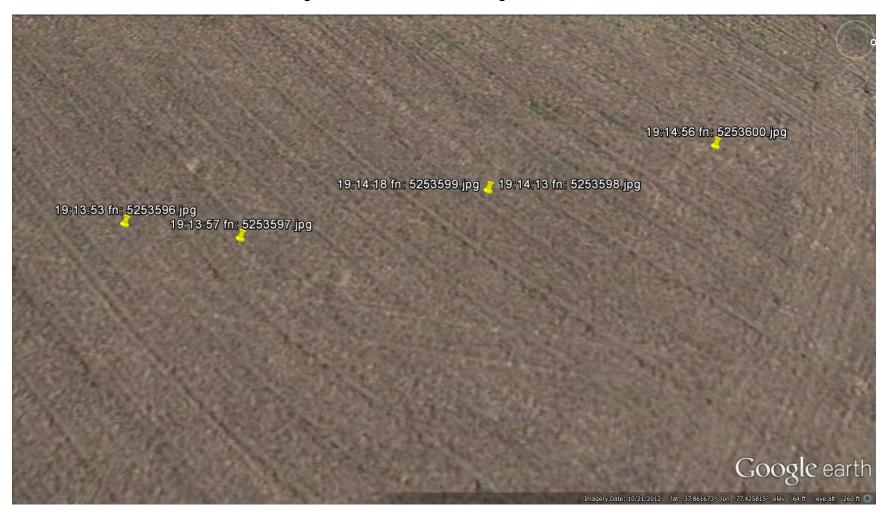
Figure 6. Points from 19:13:53 through 19:14:56 EDT.

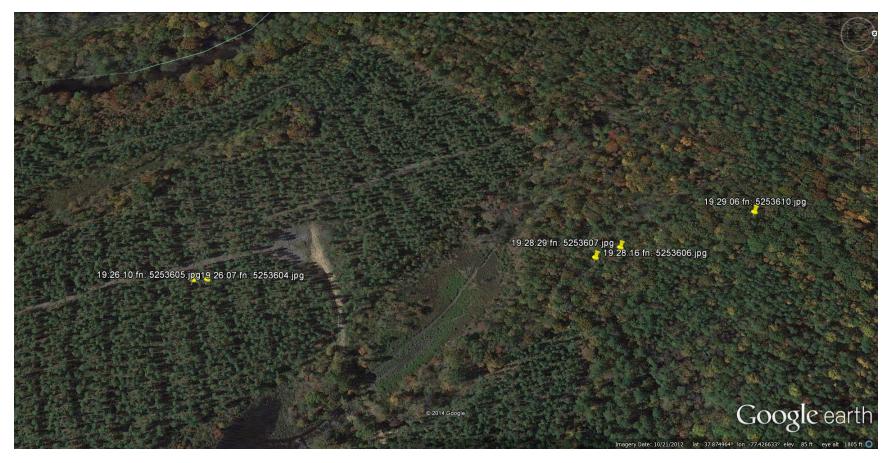
Figure 8. Points from 19:26:07 through 19:29:06 EDT.

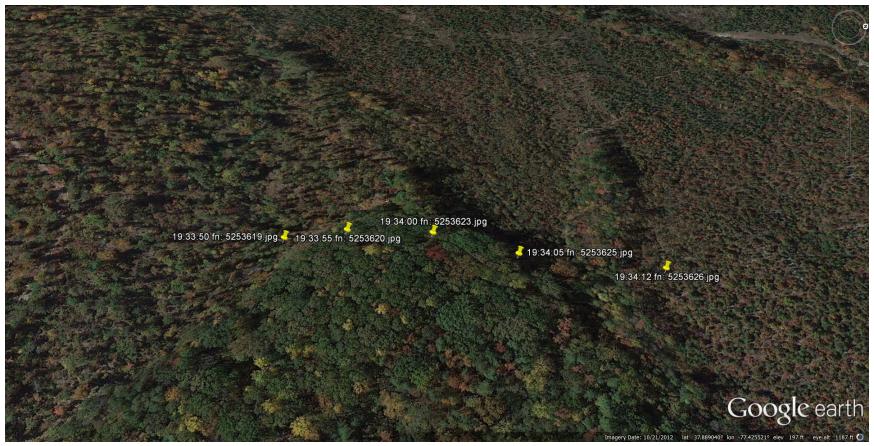
Figure 10. Points from 19:33:50 through 19:34:12 EDT.
