**NATIONAL TRANSPORTATION SAFETY BOARD
Office of Research and Engineering
Vehicle Recorder Division
Washington, D.C. 20594**

**GROUP CHAIRMAN'S FACTUAL REPORT OF
INVESTIGATION**

CEN15FA210

Onboard Image Recorder

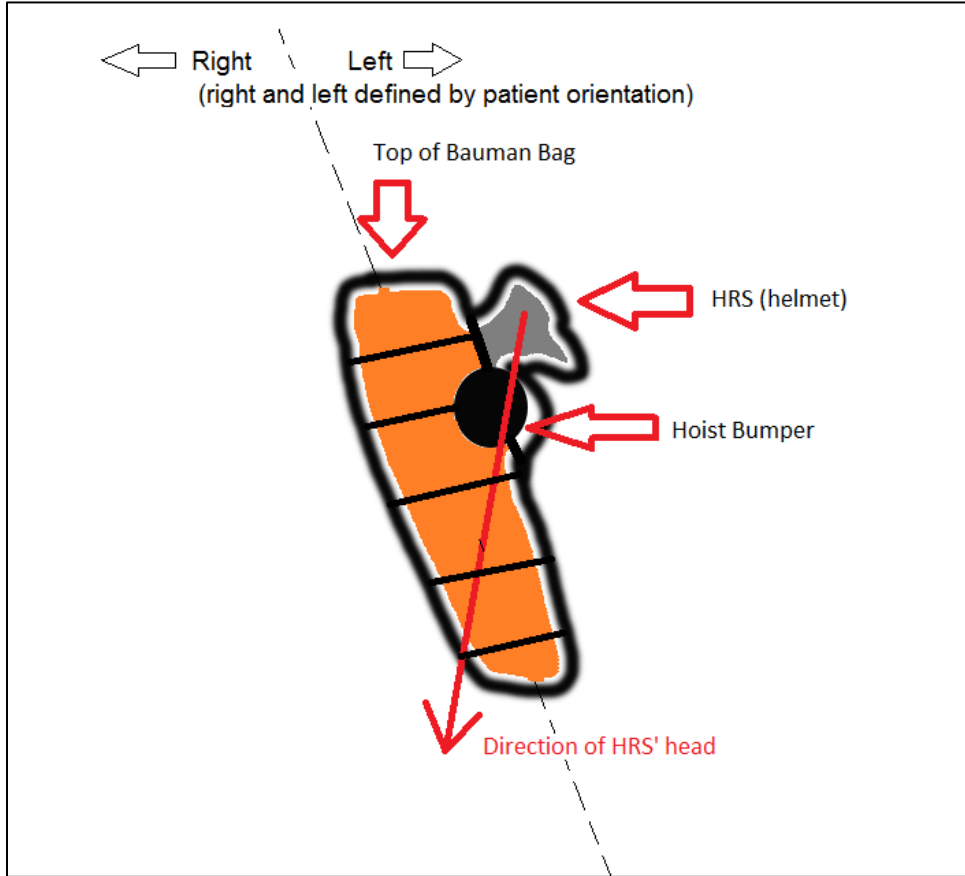
Figure 1. Schematic overhead orientation of various elements described at about 2143 CDT.

2143:27			Load rotation slowed to about 1 full rotation every 3 seconds.
2143:28	Rescue 20	[on radio discussing ground exit with AFD and two civilians.]	
2143:36	CC	spin is stopped.	Load rotation slowed to about 1/2 full rotation in 5 seconds.
2143:40			HRS leg movement was visible below the Bauman Bag and to the left side (see figure 1 for definition of left and right).
2143:41	CC	forty feet of cable out.	Helicopter belly lights illuminated the Bauman Bag, HRS, and hoist bumper such that the position of these three elements was clear. HRS was positioned on the left side of the Bauman Bag and HRS' head was in near proximity to head opening in the Bauman Bag. HRS' head was forward of the hoist bumper. HRS' helmet orientation was towards the aft of the Bauman Bag (see figure 1).
