**NATIONAL TRANSPORTATION SAFETY BOARD
Office of Research and Engineering
Vehicle Recorder Division
Washington, D.C. 20594**

**GROUP CHAIRMAN'S FACTUAL REPORT OF
INVESTIGATION**

HWY15MH006

Onboard Image Recorder

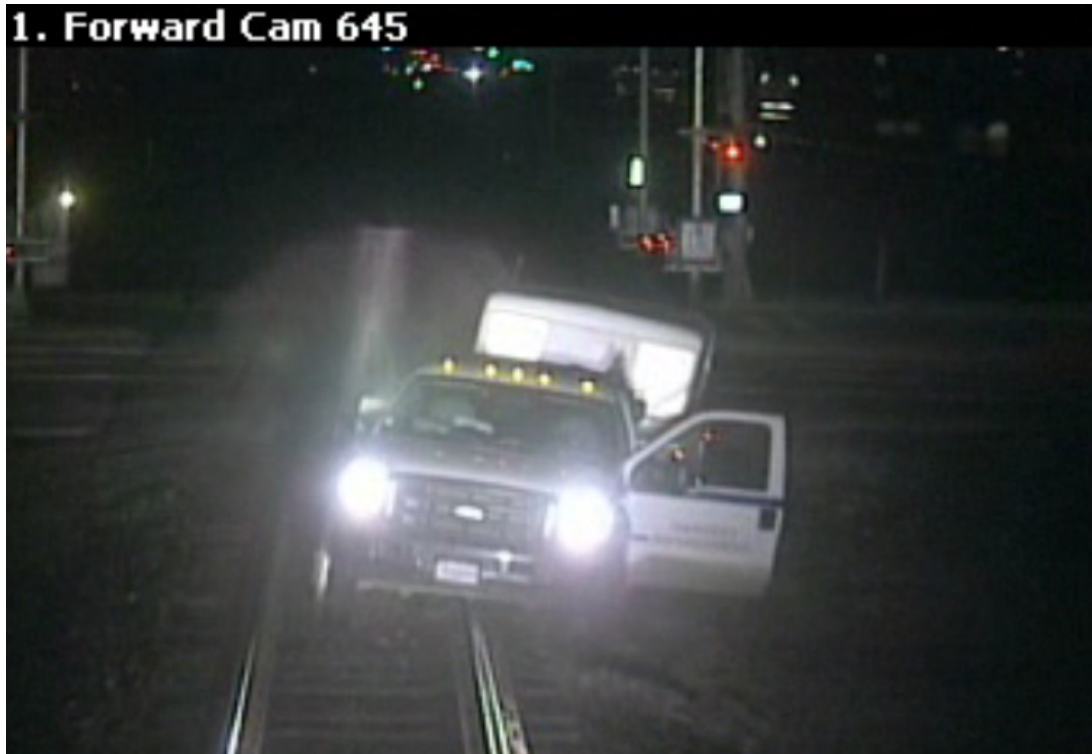
Figure 1. Metrolink #645's forward facing video at 5:42:41 PST.

Figure 1 shows an image from the Metrolink #645's forward facing camera at 5:42:41 PST.

5:42:40	645 In-Cab Profile	ET was no longer visible to any camera (control compartment was now empty).		
5:42:41	645 Fwd Facing	No persons were visible in or around the accident truck. The S. Rice Ave. grade crossing gates were down and red lights were flashing.
