NATIONAL TRANSPORTATION SAFETY BOARD
Vehicle Recorder Division
Washington, DC 20594

Onboard Image, Audio, and Data Recorder

Specialist's Factual Report By Sean Payne

Location: Hazelhurst, Wisconsin
Date: April 26, 2018
Aircraft: Airbus Helicopters AS350B2, N127LN
Operator: Air Methods Corporation
NTSB Number: CEN18FA149

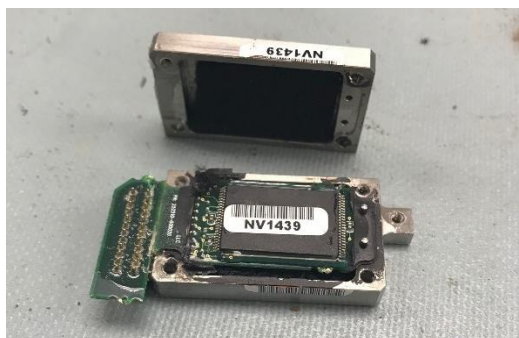
The device was disassembled in the laboratory and the internal non-volatile memory (NVM) was extracted from the unit. The internal NVM is shown in figure 2.

Figure 2. The internal NVM as it was extracted from the device.

The internal NVM was undamaged. The internal NVM was de-soldered from the device and each NVM chip was read using a Xeltek series 6000 chip reader. The chip reader produced two binary images of the contents of the NVM. Using manufacturer supplied conversions, the binary data was attempted to be converted back to image, audio and parametric data. This conversion process resulted in the recovery of approximately the last 8 minutes of recorded images, the last 20 minutes of recorded audio and no parametric data. The manufacturer supplied conversion process was unable to recover the entire dataset, and large portion of the accident flight was not available for review at this time. The group transcription exercise was postponed until all data could be conclusively recovered.

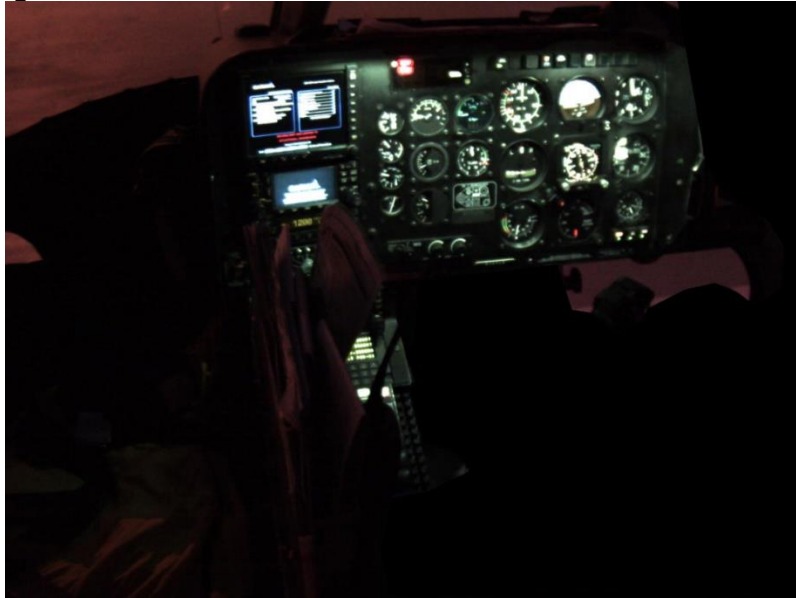
Figure 3 is a screenshot taken from the recorder that shows an example of the camera's image on the flight previous to the accident. The pilot has been redacted from this image.

Figure 3. A capture from the Appareo image recorder, serial number VIS-FG06 installed on N127LN, taken prior to the flight previous to the accident flight. The pilot has been redacted.

The Vision 1000 unit provided a field of view as shown in figure 3. The recording was captured at night, as such, the image was dark, most of the instrument panel indications could be distinguished, but it was difficult to determine details of the accident pilot and some of his movements. In general, large movements by the accident pilot were discernable and transcribed, however, due to lighting conditions, it is possible that not all physical actions by the accident pilot were detected. The medical crew members were not visible in the image.
