NATIONAL TRANSPORTATION SAFETY BOARD

OPERATIONS GROUP FACTUAL REPORT

DCA 08 MM 004

Vessel:	<i>Cosco Busan</i>
Date:	November 7, 2007
Time:	0830 PST (UTC -8)
Location:	40° 27.0' N, 073° 48.0' W
Owner:	Regal Stone Limited, Hong Kong
Managing Operator:	Fleet Management Limited, Hong Kong
Charterer:	Hanjin Shipping Company Limited, Seoul, Korea
Complement:	24 crew members

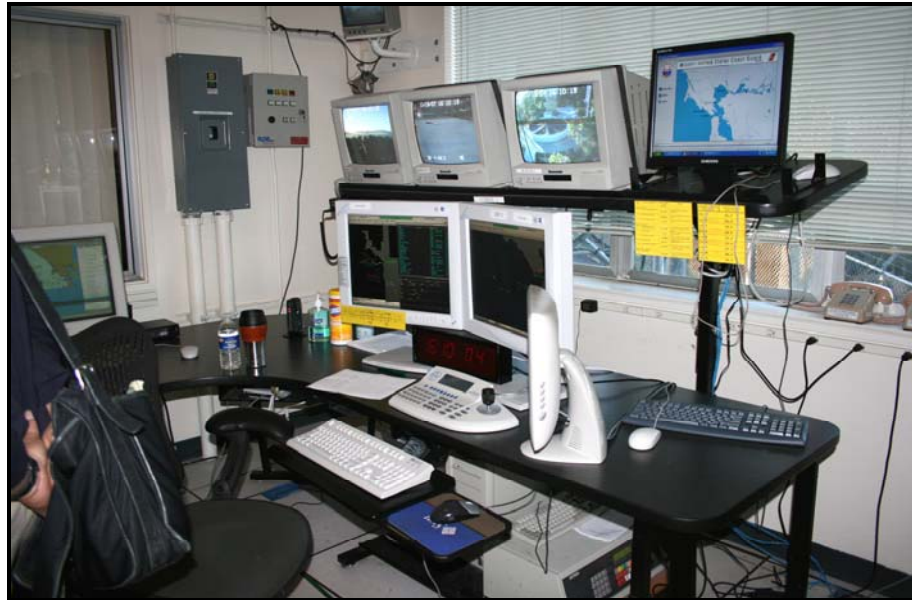
Figure 1. VTS San Francisco VTS controller station.
