NATIONAL TRANSPORTATION SAFETY BOARD

YIP Simulator Test Plan

OPERATIONAL FACTORS

DCA17FA075

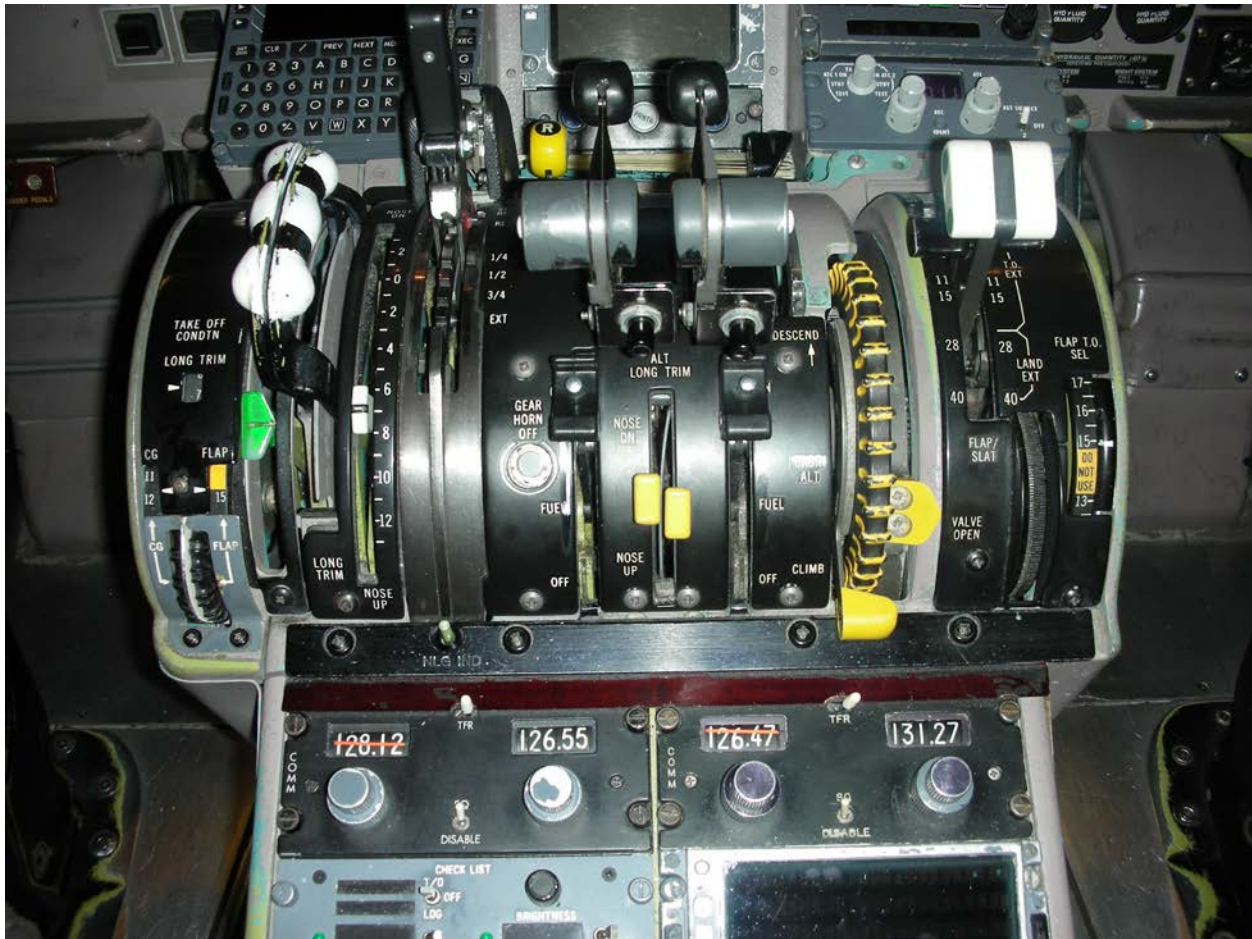
Photo 1: Center Quadrant set up for flight control check.

- Faced airplane to the north to simulate taxi to runway 27 at YIP, conducted flight control check.
- Conducted flight control check
 - a. Document procedure:

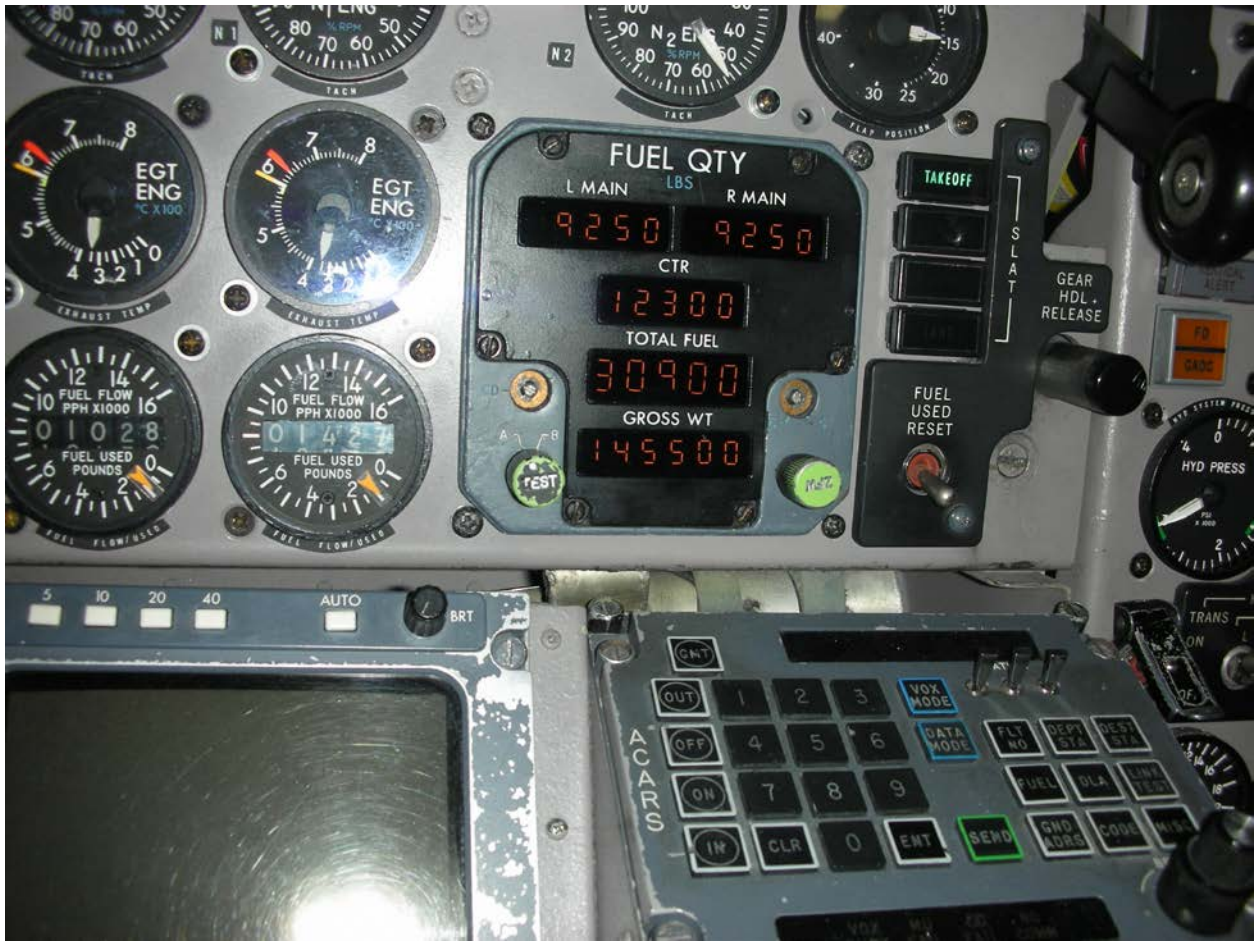
Photo 2: Fuel panel indications.

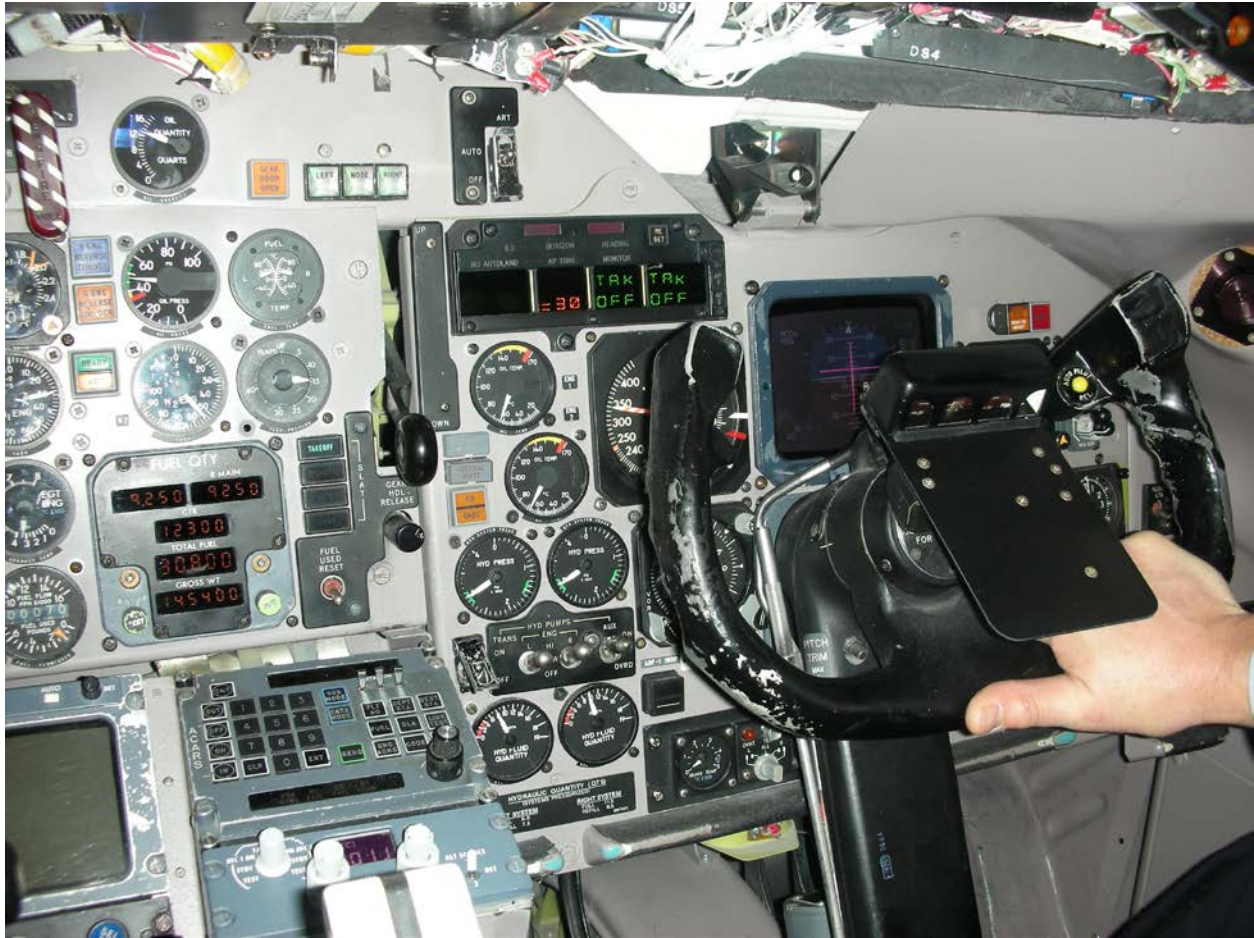
Photo 4: photo of control column full forward.

- Normal procedure: aileron checked to the left then right, then control column full back, then full forward. While column is full forward, pilot looks for “elevator power on” light on overhead annunciator panel. There was no hydraulic pressure indications, no aural alerts. The power on light tells the crew that pressure was available to the elevator tabs. Aileron check was verified with the “spoiler deployed” light on the overhead annunciator panel. There was no hydraulic indication during this check.

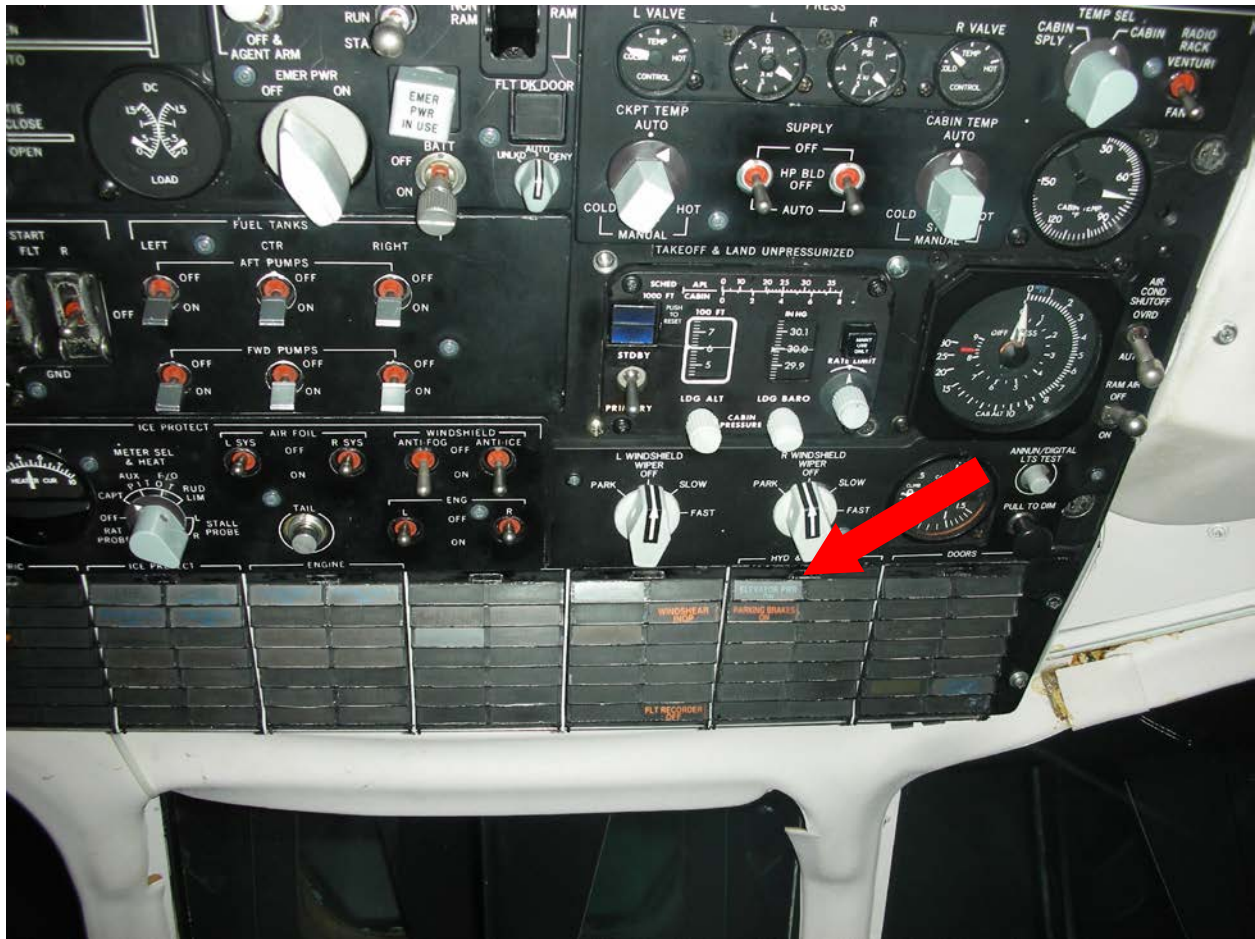
Photo 5: Overhead annunciator indications with control column full forward. “Elevator Pwr On” light indicated by arrow.
