NATIONAL TRANSPORTATION SAFETY BOARD

Collision of Two Trolleys
Southeastern Pennsylvania Transportation Authority
January 4, 2017
Philadelphia, PA

NTSB Accident No. DCA17FR003

Operations Factual Report
Ryan Frigo – Group Chairman

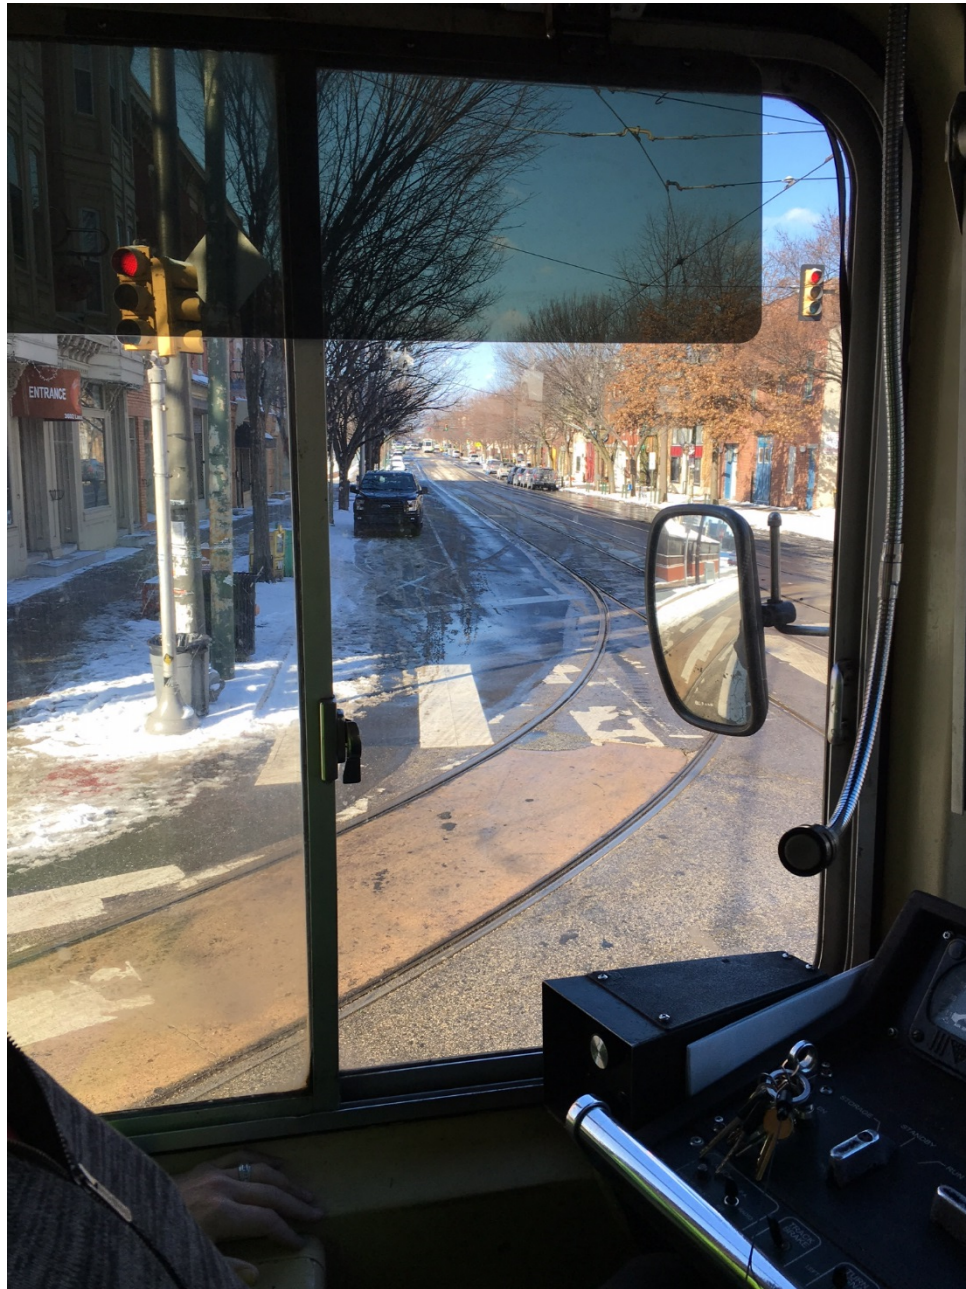
Figure 1: Photo taken by NTSB investigator of when an exemplar operator has advanced preview of standing Trolley at accident site.

On Sunday, January 8, 2017, after job safety briefings for each group of investigators, investigators conducted sight distance tests from a test trolley to determine the advanced preview of the struck trolley from an exemplar operator. Investigators also collected video image data from various locations at the test site.

- The exemplar trolley operator was able to identify the stationary trolley at 38th St. about 965 ft. from the rear of the struck trolley, while negotiating through the 36th St. wye³.
- Investigators noted that there were clear lines of sight in the direction of travel on Lancaster Ave.

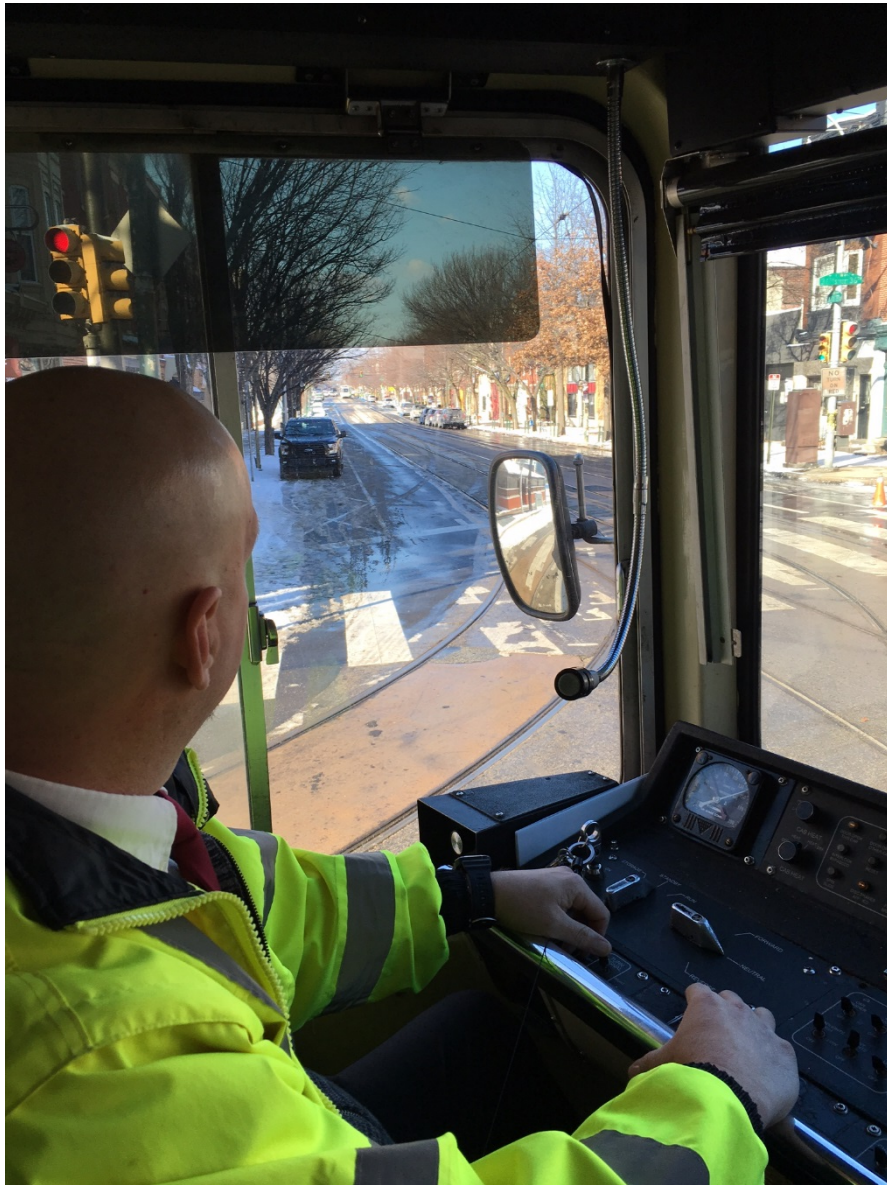
Figure 2: Photo taken by NTSB investigator of an exemplar operator negotiating the 36th St. to Lancaster Ave. wye.
