National Transportation Safety Board

Group Chairman's Factual Report

OPERATIONAL FACTORS

NTSB ACCIDENT NUMBER: ERA17FA066

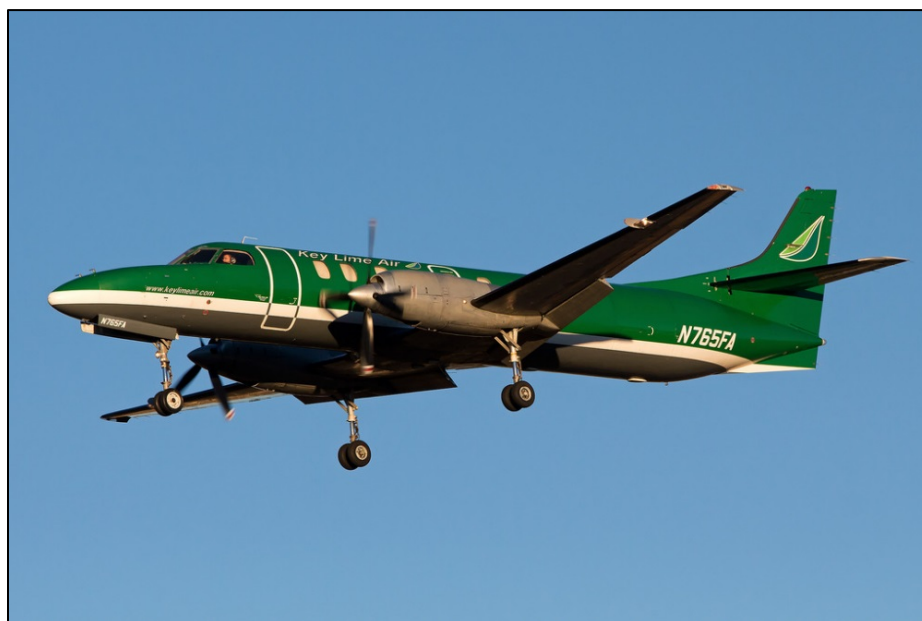
Photo 1: Picture of Accident Airplane

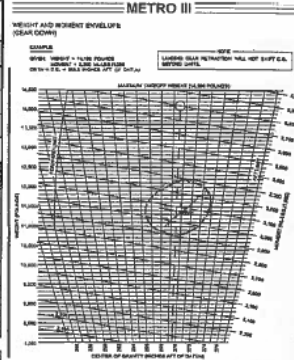
FIGURE 3-48 WEIGHT AND BALANCE MANUFACTURER'S DATA, SOURCE: MAY 2006, REVISION: DEC 1991

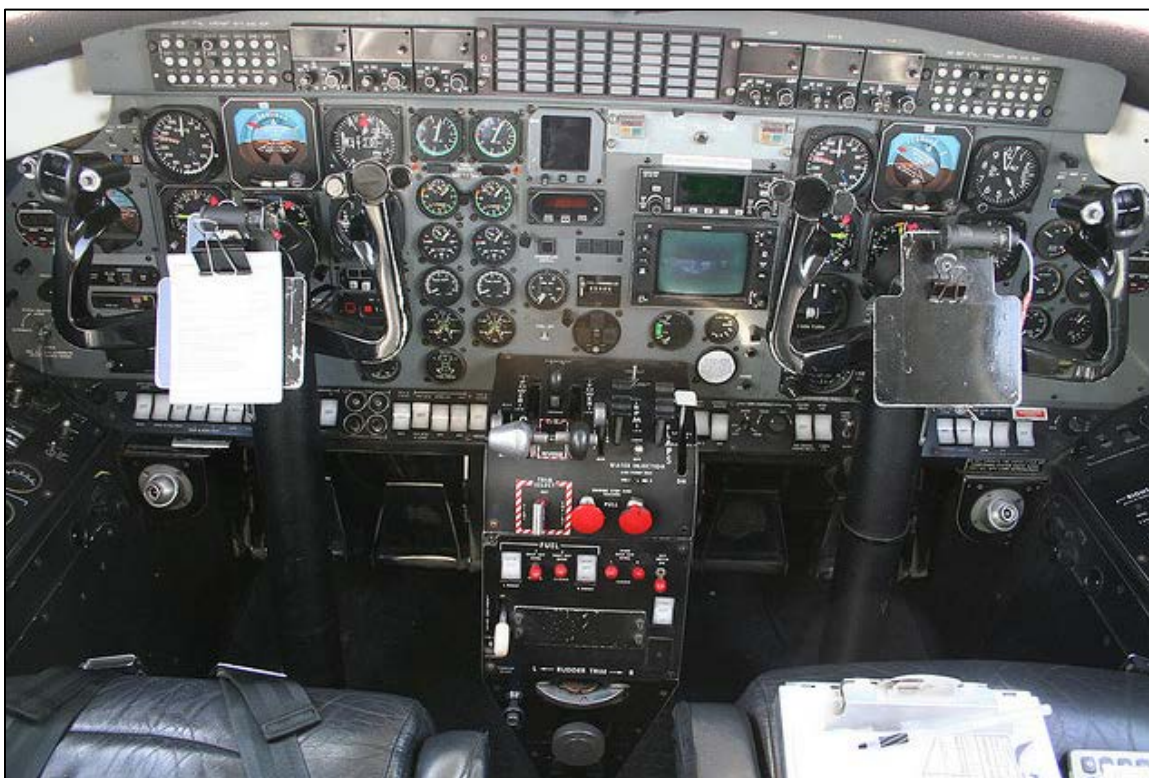
Dual Collins VIR-32 Navigation Receivers	Bendix King RDS-81 Weather Radar
Dual Collins ADF-60A ADF Systems	Bendix King KEA-346 Encoding Altimeter
Dual Collins RMI-30 RMI	Bendix King KAS-297 Altitude Alerter
Dual Collins MCS-65 Compass System	Aerosonic Altimeter
Collins DME-42 DME Transceiver	King KLN-90B GPS System
Dual Jet 510-24L Gyro Horizons

Photo 2: Exemplar SA-227AC Cockpit

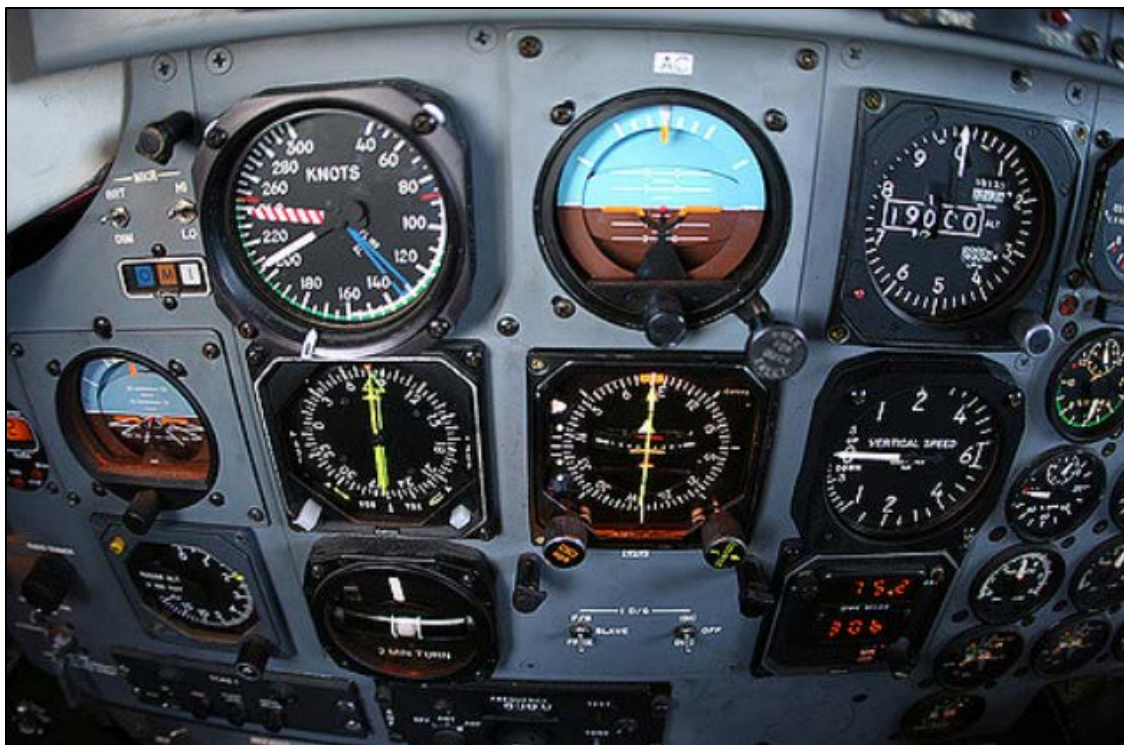
Photo 3: Pilot Side Flight Instruments

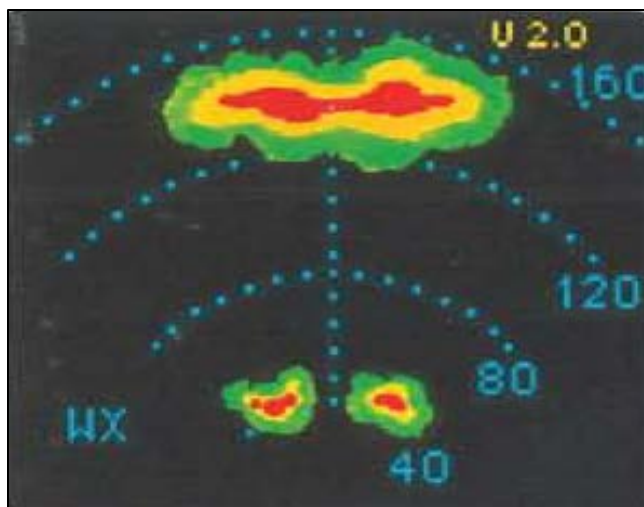
The airplane was equipped with a Bendix King RDS 81 onboard radar sensor and display. The equipment was designed to display varying levels of precipitation and had pilot controllable range selectors, weather alert functions, automatic and manual radar gain control. According to the ATC transcript, the pilot stated that he planned to “see what the radar is painting” during the enroute descent. Due to the post-crash fire, the investigation was unable to determine if the device was operational or in use during flight.

Figure 9: Exemplar Radar Sensor Storm Picture
