NATIONAL TRANSPORTATION SAFETY BOARD
Vehicle Recorder Division

Specialist's Factual Report
By Christopher Babcock

Location: Rio Linda, California
Date: August 3, 2017
Aircraft: Lancair IV-TP
Registration: N420M
Operator: Private
NTSB Number: WPR17FA179

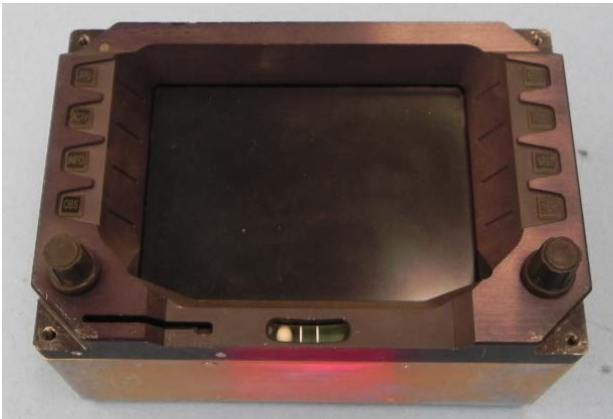
Figure 1. IDU SN IDA110063LSS, as received.

The MFD can display navigational information by way of a moving map as well as engine related data. Figures 1 and 2 show the IDUs recovered in this accident.

While both units were identified with an identical part number, one unit contained a turn and slip indicator.

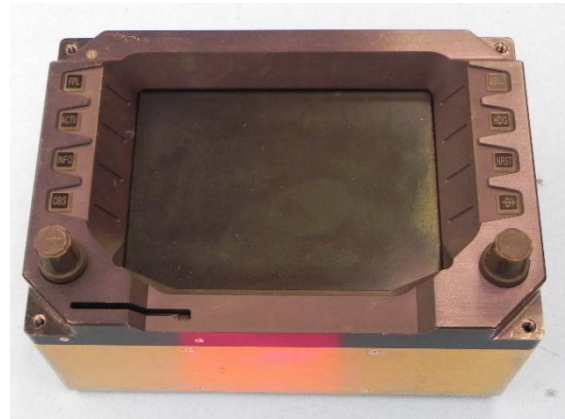
Figure 2. IDU SN IDA110060LSS, as received.

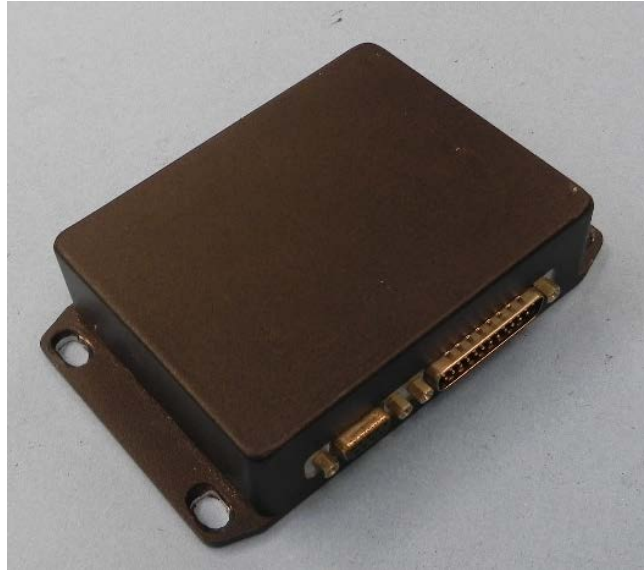
Figure 3. TSLM-M601, as received.

During flight the TSLM monitors primary parameters ITT, N1, N2, and if needed torque. If any of them breach their maximums the TSLM will turn on the exceed annunciation light to alert the operator. Each start, run and exceed event are recorded by the TSLM in a format showing turbine temperature, N1, N2, voltage, and more versus time. Figure 3 shows the TSLM-M601, as received in the laboratory.

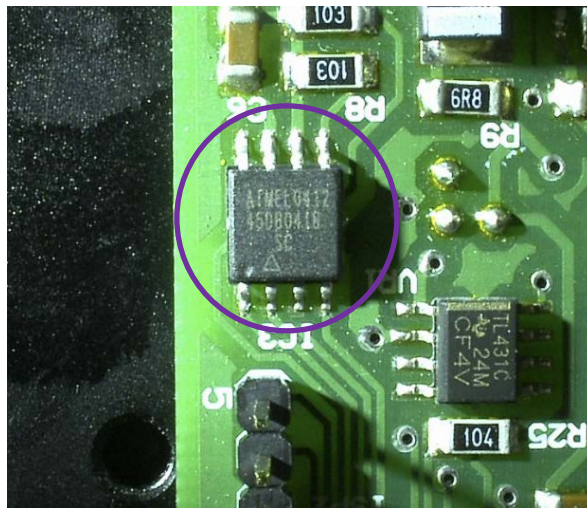
Figure 4. NVM memory device from TSLM (circled).

Upon arrival at the Vehicle Recorder Laboratory, an exterior examination revealed the unit had not sustained any damage, however, the data was unable to be extracted using the manufacturer's software. The non-volatile memory (NVM) device (Figure 4) was imaged and the data was recovered from the chip image file.¹

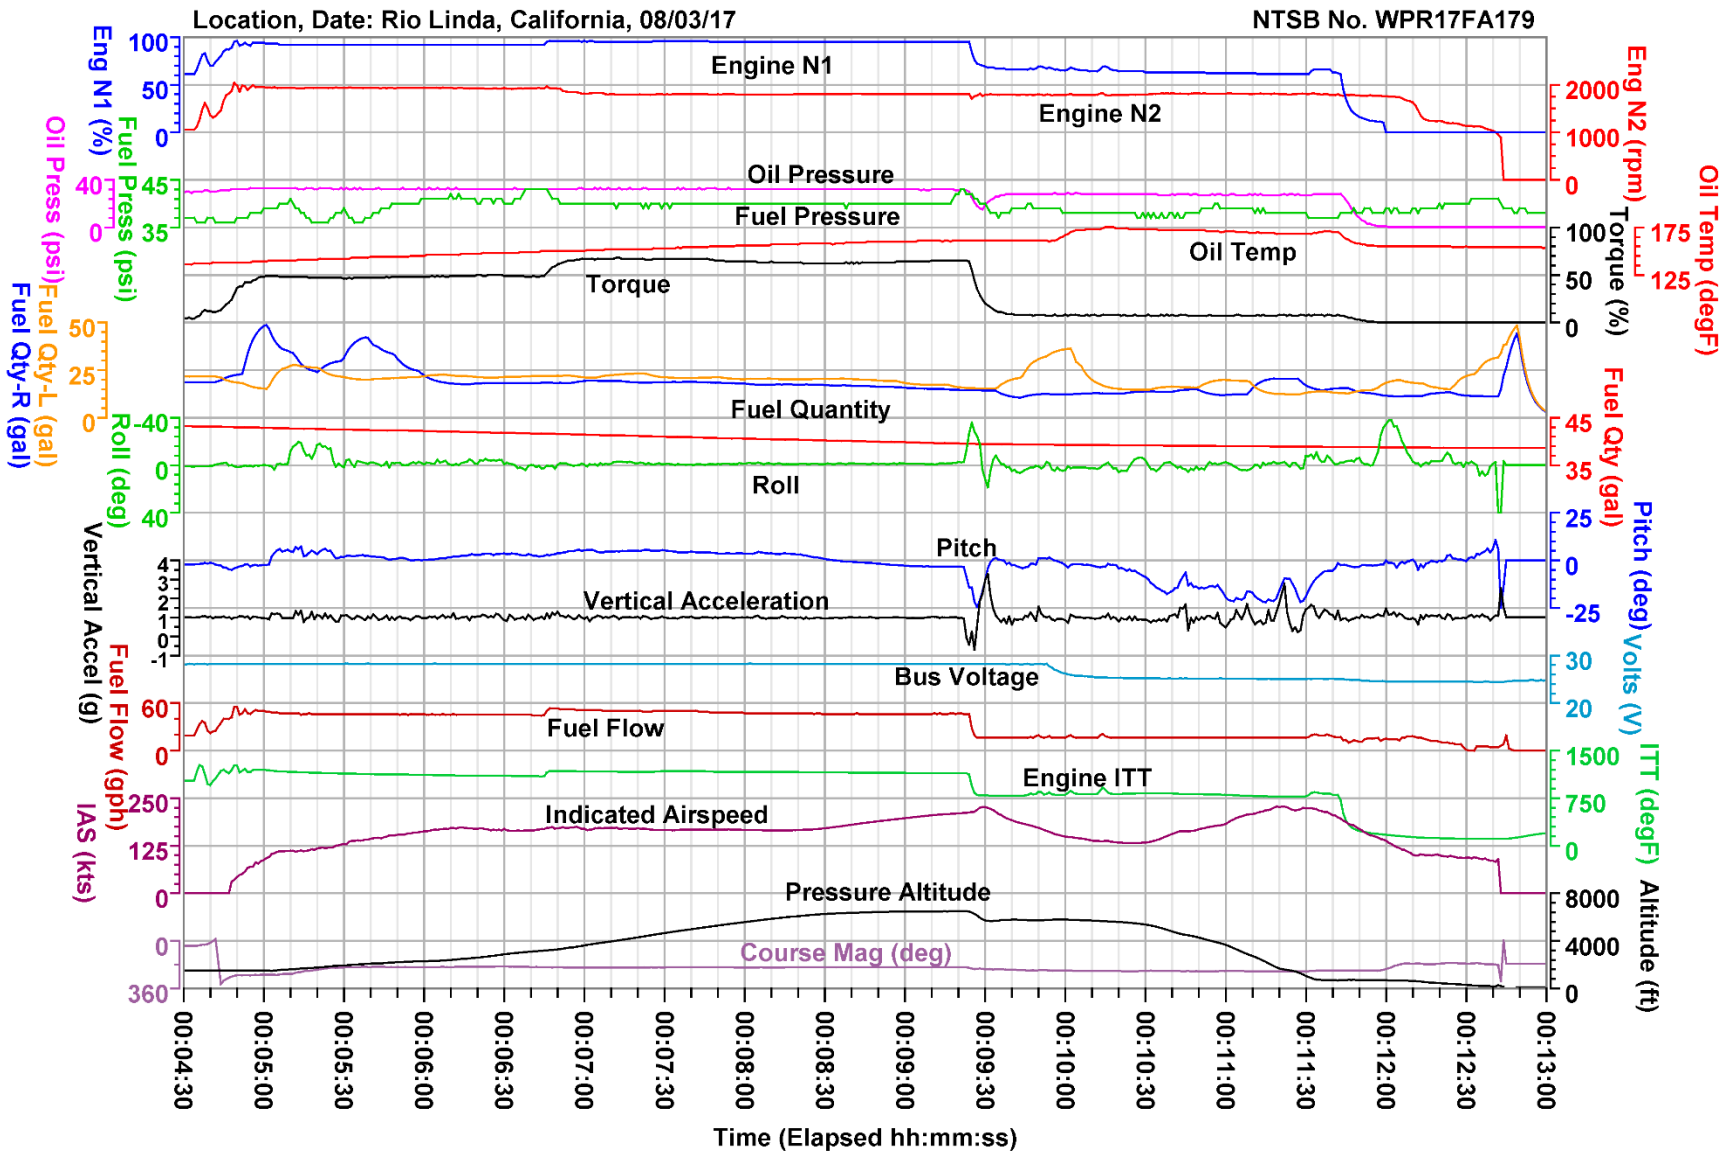
Figure 7. Flight data from entire accident flight.

The aircraft departed Auburn at about 4:50 (mm:ss) elapsed time and climbed to about 6500 feet and turned toward the southwest. At 9:17 elapsed time, the fuel pressure began to rise from about 40 psi to 43 psi. At 9:22 elapsed time, the aircraft pitched down and banked to the left, reaching 25° nose down and 36° left wing down. At 9:24 elapsed time, the N1, N2, fuel flow, and ITT began decreasing. The aircraft returned to near level pitch at about 9:32 elapsed time, experiencing about 3.3 g vertical acceleration. The aircraft turned about 30° to the right.

Figures 5 and 6 show the aircraft's flight path in Google Earth. Figure 7 shows flight data from the entire accident flight. Figure 8 shows flight data during the upset event of the accident flight. Figure 9 shows flight data from the upset event through the end of the flight. Figure 10 shows flight data from the previous flight from Sierra Sky Park to Auburn

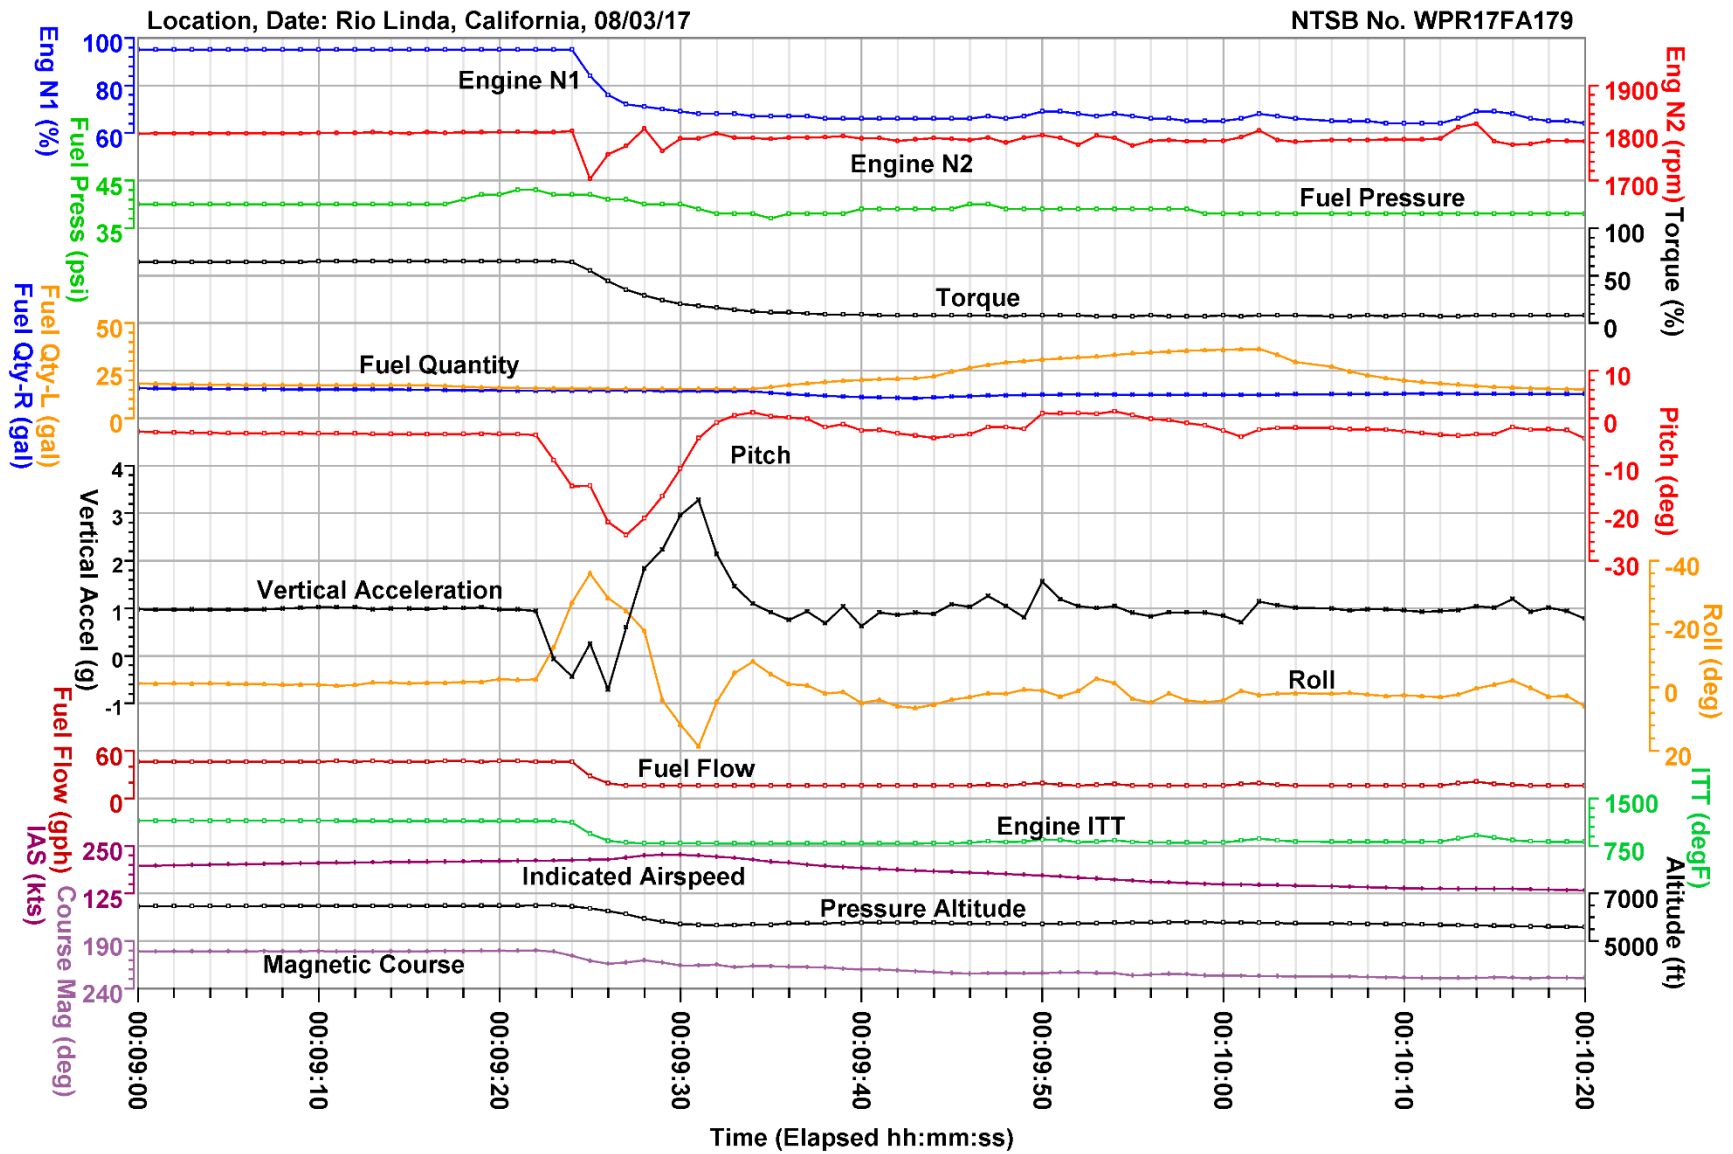
Figure 8. Flight data from upset event.

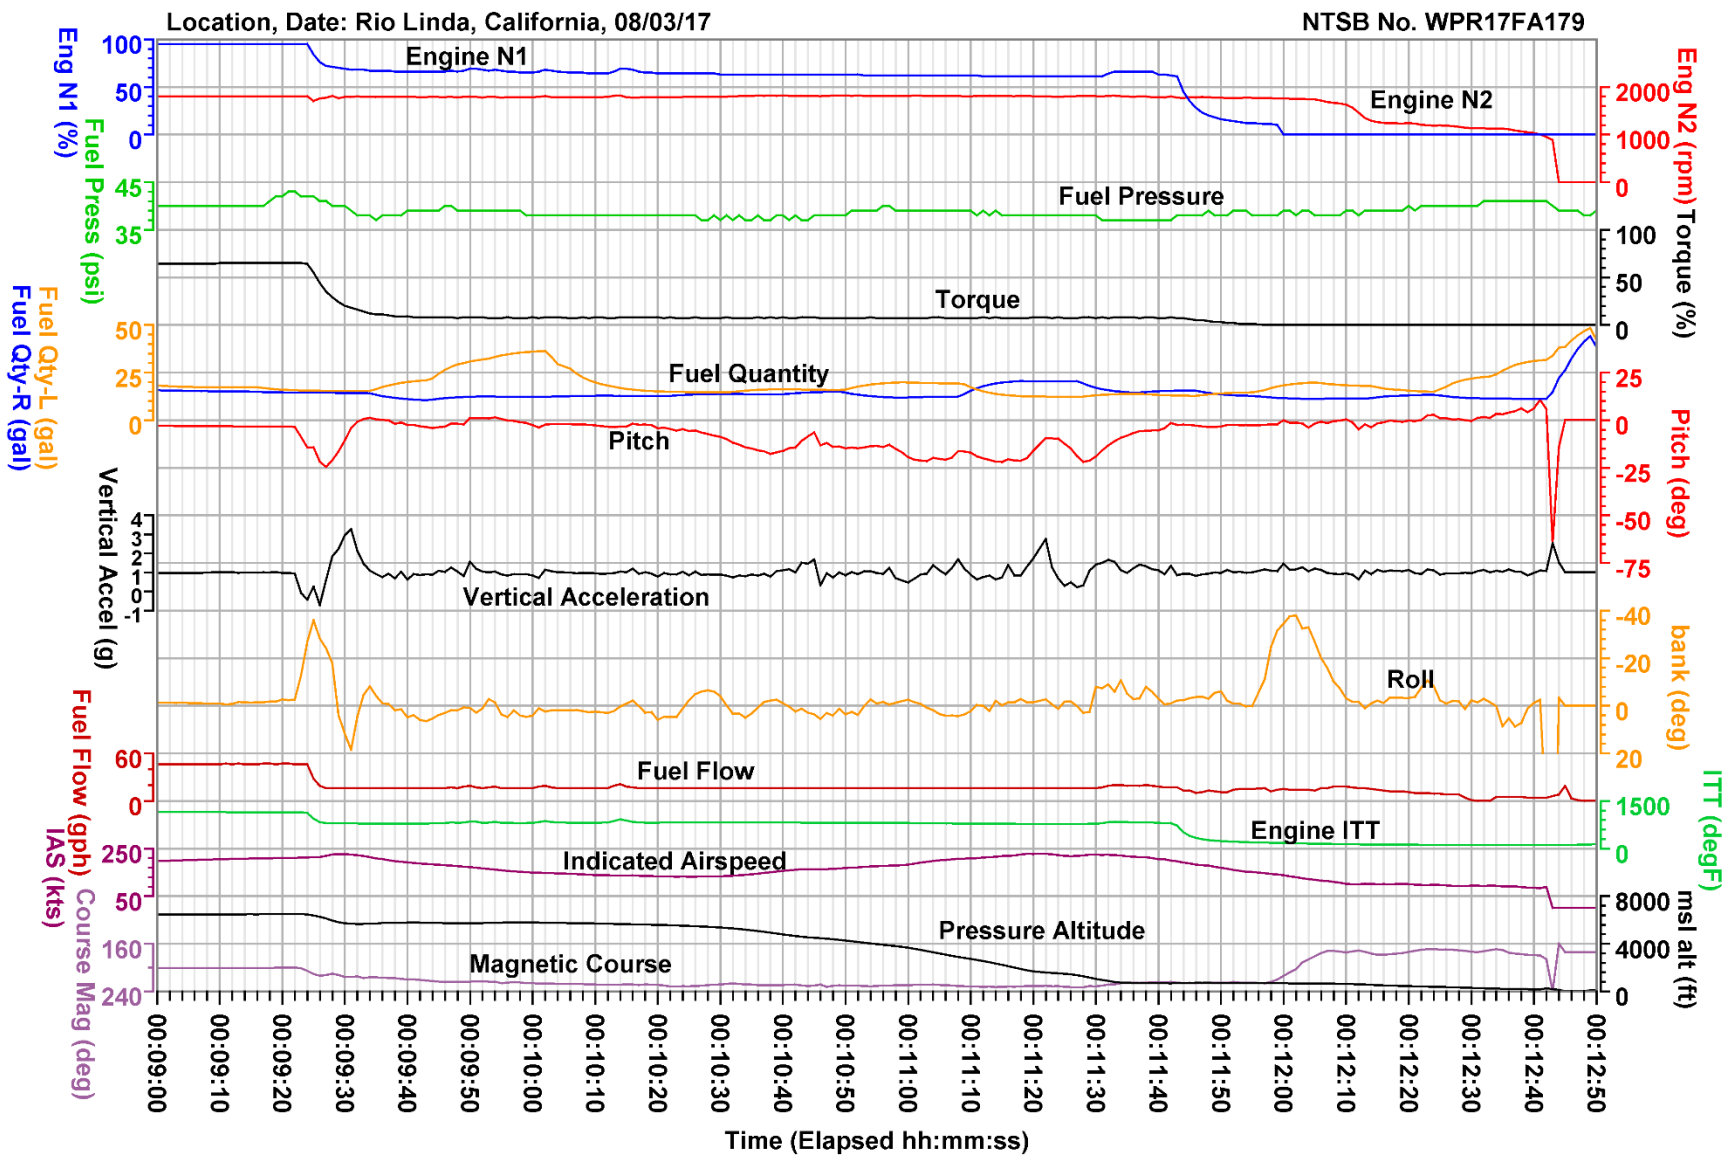
Figure 9. Flight data from upset event through the end of flight.

The N1 stabilized at about 65% and N2 rose back to about 1800 rpm, but torque continued to drop to about 8%. At 11:44 elapsed time, N1 began falling to zero. N2 decreased to about 1000 rpm and torque decreased to zero. At 12:00 elapsed time, the aircraft banked about 40° to the left, aligning with runway 16 at McClellan Airfield. At 12:44 elapsed time, several parameters showed discontinuities consistent with the aircraft striking an object at a recorded altitude of 100 ft. The Google Earth terrain model elevation at this point is about 70 ft.

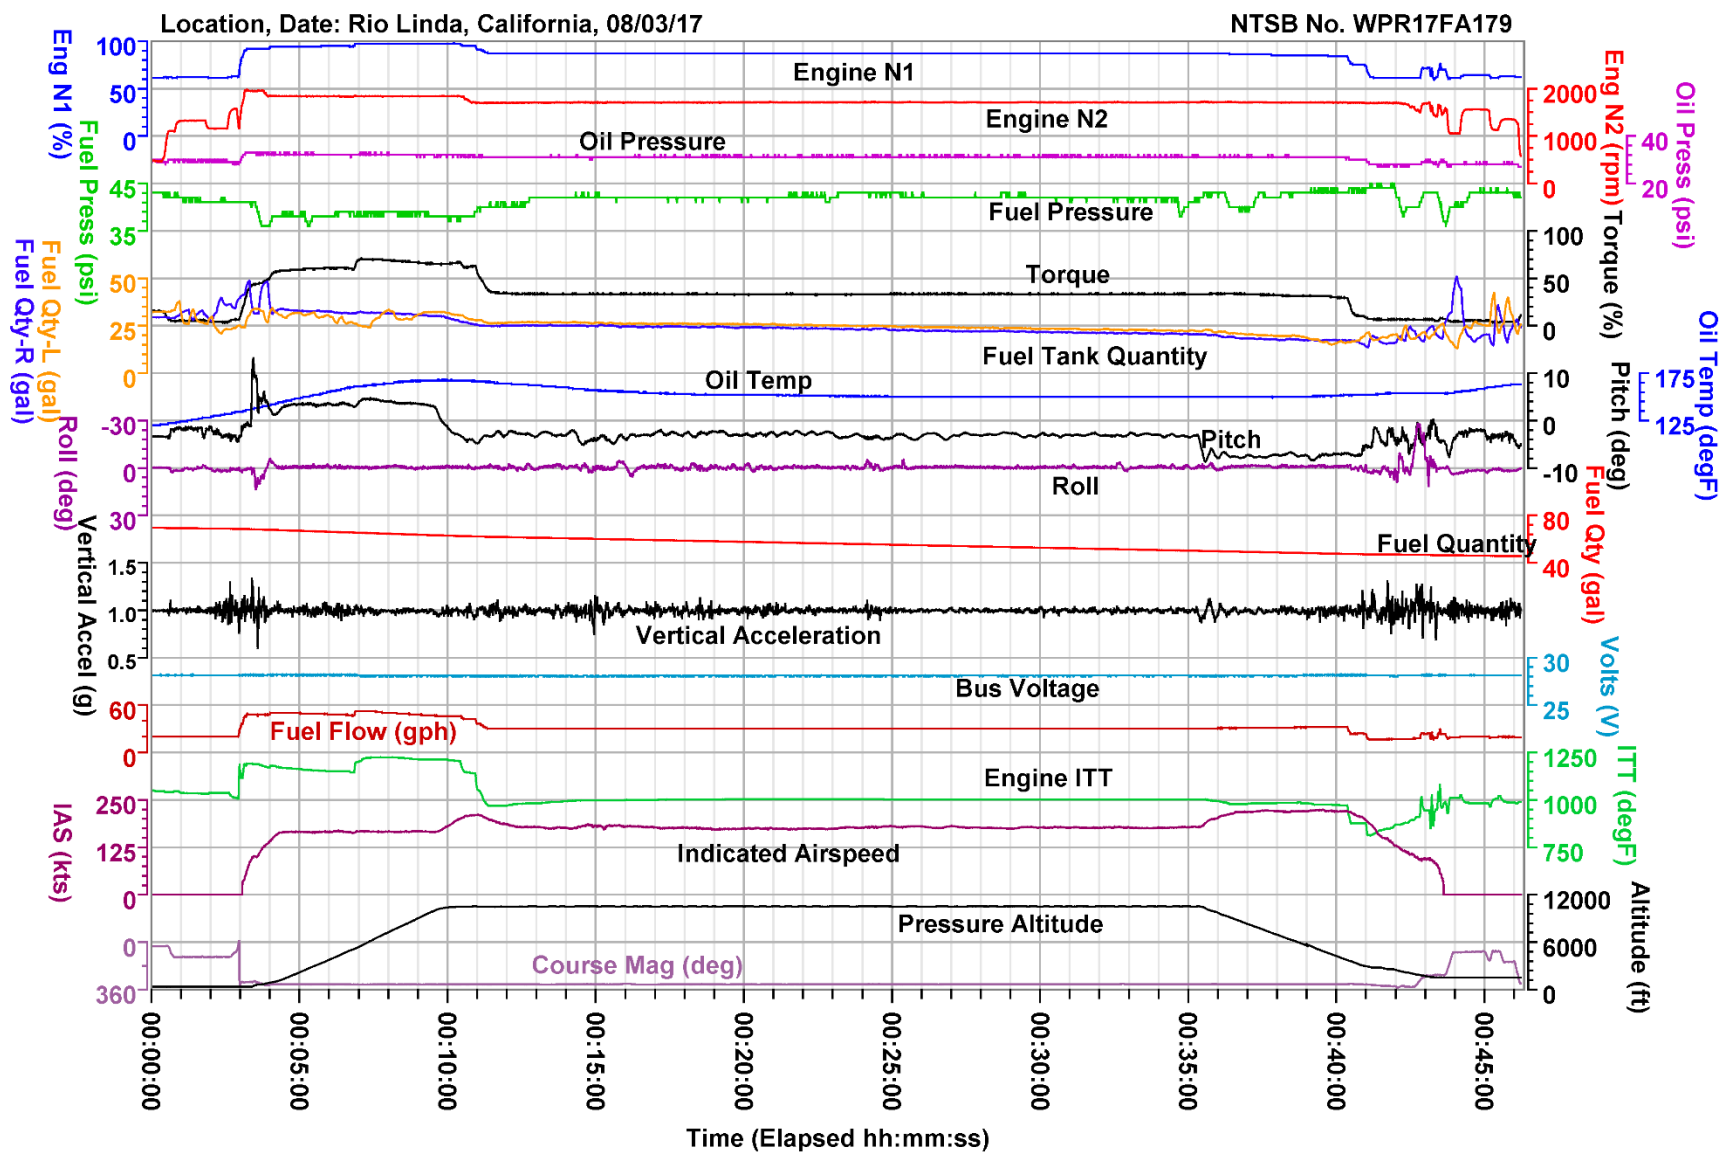
Figure 10. Flight data for previous flight.

for comparison. All data used to generate Figures 5-10 can be found in comma separated format in the public docket for this accident as Attachment 1 to this report.
